**Contract No. HY/2011/09 HZMB Hong Kong Link Road –  
Section between HKSAR Boundary and Scenic Hill  
Revised Monthly EM&A Report for October 2015 (EP-352/2009/D)**

**Contract HY/2011/09**  
**Hong Kong-Zhuhai-Macao Bridge**  
**Hong Kong Link Road-Section between**  
**HKSAR Boundary and Scenic Hill**  
**Monthly EM&A Report**  
**October 2015**  
**(Version 2.0)**

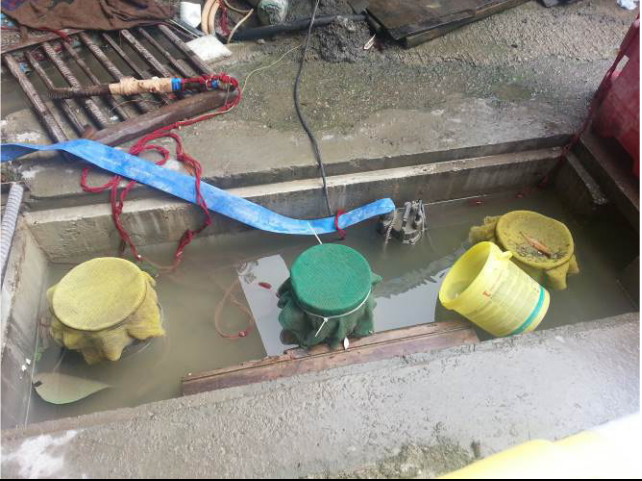
<p><b>Ref No:</b> 1501006-R01</p> <p><b>Impact:</b> Water Quality (B3)</p> <p><b>Details:</b> The wastewater which pumping out from the pit area near P111 should be properly treated before discharging out.</p>

Ref. No.	Non-Compliance	Related Item No.
-	None identified	-
Ref. No.	Remarks/Observations	Related Item No.
	<b>A. Water Quality</b>	
151006-R01	• The wastewater which pumping out from the pit area near P111 should be properly treated before discharging out.	B3
151006-R06	• To replace the worn sand bags for protecting the gully at P82.	B4
	<b>B. Ecology</b>	
151006-R04	• To erect the fencing for protecting trees at P102 and P91.	C31
	<b>C. Air Quality</b>	
151006-R02	• Clear the used cement bags at P110 or store it properly (i.e. cover with tarpaulin etc.) before disposal.	D7 and D20
	<b>D. Noise</b>

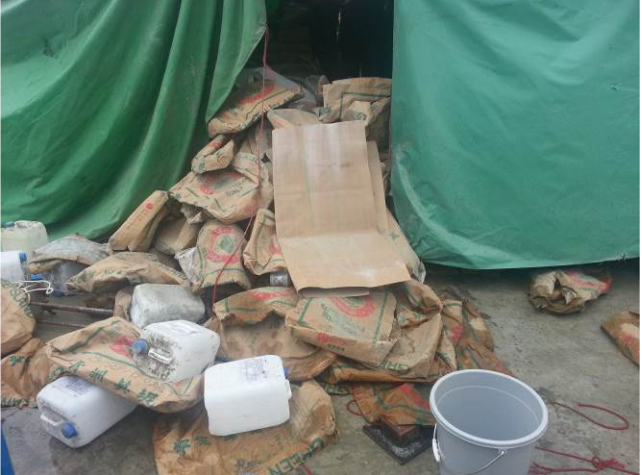
<p><b>Ref No:</b> 151006-R02</p> <p><b>Impact:</b> Air Quality (D7 and D20)</p> <p><b>Details:</b> Clear the used cement bags at P110 or store it properly (i.e. cover with tarpaulin etc.) before disposal.</p>

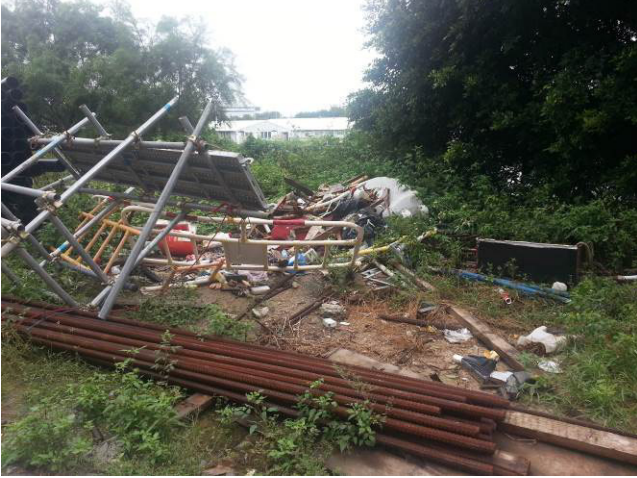
**P107**

• No environmental deficiency was identified during site inspection.	
	<b>E. Waste / Chemical Management</b>	
151006-R03	• Clear the accumulated rubbish at near P107 and P84.	F1i.
151006-R05	• Provide drip tray for the chemical containers at P84.	F9
	<b>F. Permits/Licences</b>

**Ref No:** 151006-R03

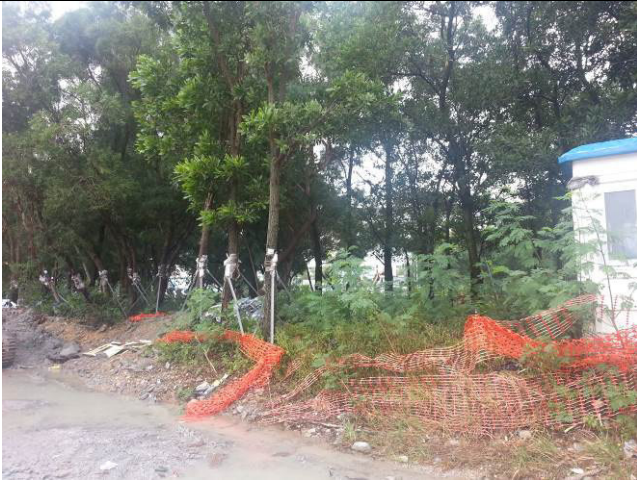
**Ref No:** 151006-R04

**Impact:**  
Ecology (C31)

**Details:**  
To erect the fencing for protecting trees at P102 and P91.

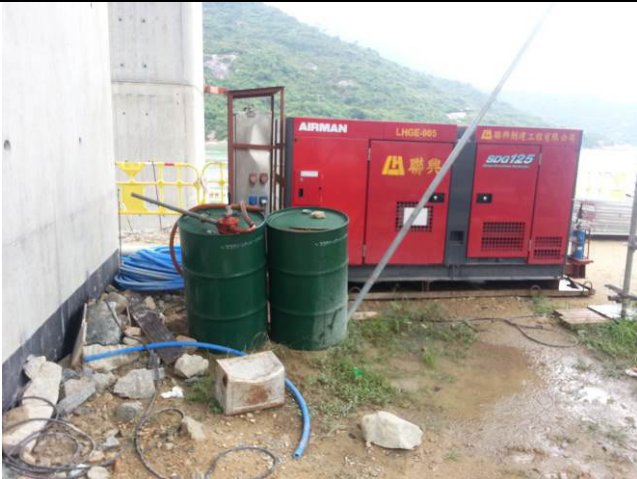
**Ref No:** 151006-R05

**Impact:**  
Waste / Chemical Management (F9)

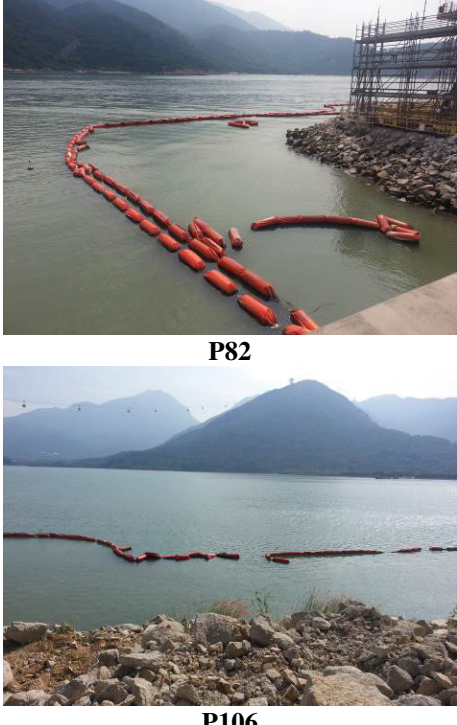
<p>P82</p> <p>P106</p>	<p><b>Ref No:</b> 151013-R03</p> <p><b>Impact:</b> Water Quality (B26)</p> <p><b>Details:</b> Properly deploy the silt curtain at P82 and P106.</p>

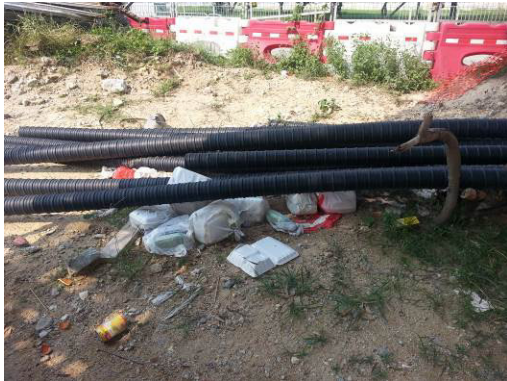
Clear the accumulated rubbish / construction wastes at P85, P86 and P87.

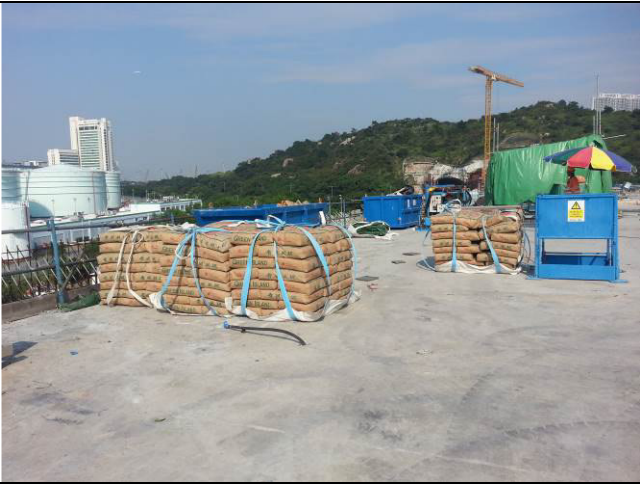
<p><b>Ref No:</b> 151013-R07</p> <p><b>Impact:</b> Air Quality (D20)</p> <p><b>Details:</b> Properly cover the cement bags (&lt;20bags) with tarpaulin sheet at P110. (bridge-deck)</p>
 	<p><b>Ref No:</b> 151013-R08</p> <p><b>Impact:</b> Air Quality (D7 &amp; D20)</p> <p><b>Details:</b> Clear the used cement bags regularly or store it properly (i.e. cover with tarpaulin sheet) before disposal at P110. (bridge-deck)</p>

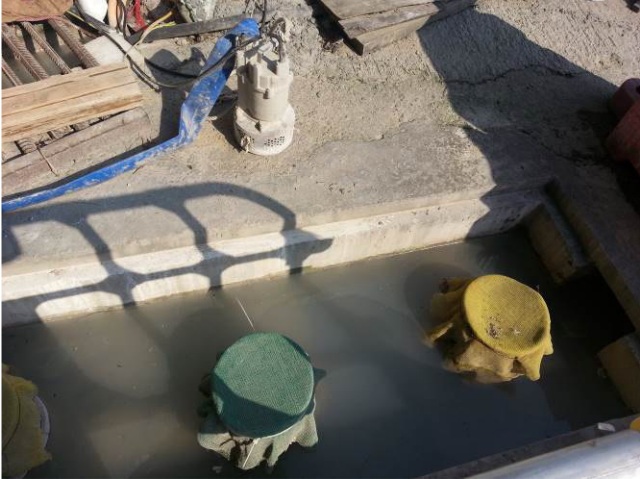
<p><b>Ref No:</b> 1501006-R01</p> <p><b>Impact:</b> Water Quality (B3)</p> <p><b>Details:</b> The wastewater which pumping out from the pit area near P111 should be properly treated before discharging out.</p> <p><b>Follow Up:</b> The water pump was removed from the pit area.</p>

Parameters	Date	Observations and Recommendations	Follow-up
<i>Water Quality</i>	06/10/2015	The wastewater which pumping out from the pit area near P111 should be properly treated before discharging out.	Rectification/improvement was observed during the follow-up audit session on 13 October 2015.
	06/10/2015	To replace the worn sand bags for protecting the gully at P82.	Rectification/improvement was observed during the follow-up audit session on 13 October 2015.
	13/10/2015	Leakage of muddy water was observed from the cofferdam at P69. The Contractor was reminded to repair the damaged silt curtain to prevent the muddy water discharging to the sea.	Rectification/improvement was not observed during the follow-up audit sessions. Further follow-up on this item is required.
	13/10/2015	Properly deploy the silt curtain at P82 and P106.	Rectification/improvement was not observed during the follow-up audit sessions. Further follow-up on this item is required.

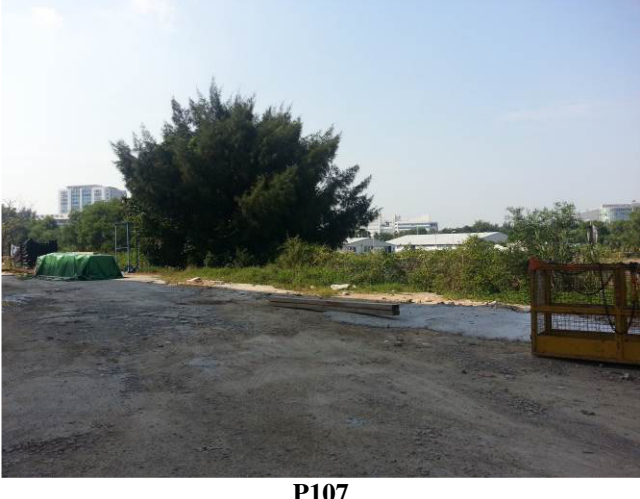
<p style="text-align: center;"><b>P107</b></p>	<p><b>Ref No:</b> 151006-R03</p> <p><b>Impact:</b> Waste / Chemical Management (F1i.)</p> <p><b>Details:</b> Clear the accumulated rubbish at near P107 and P84.</p> <p><b>Follow Up:</b> The accumulated rubbish at near P107 was cleared.</p>

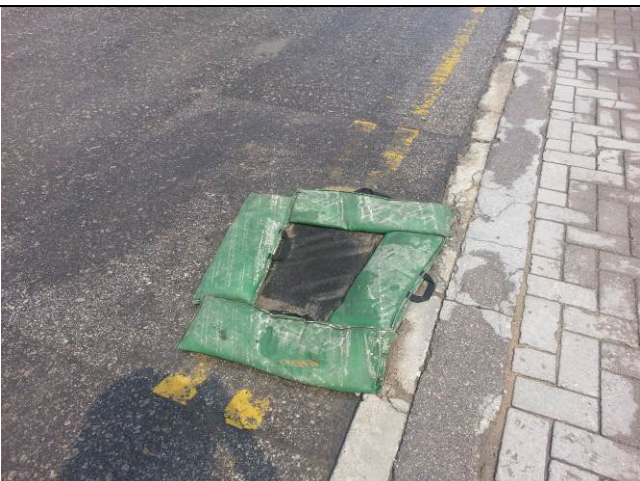
<p><b>Ref No:</b> 151006-R06</p> <p><b>Impact:</b> Water Quality (B4)</p> <p><b>Details:</b> To replace the worn sand bags for protecting the gully at P82.</p> <p><b>Follow Up:</b> The worn sand bags were removed.</p>

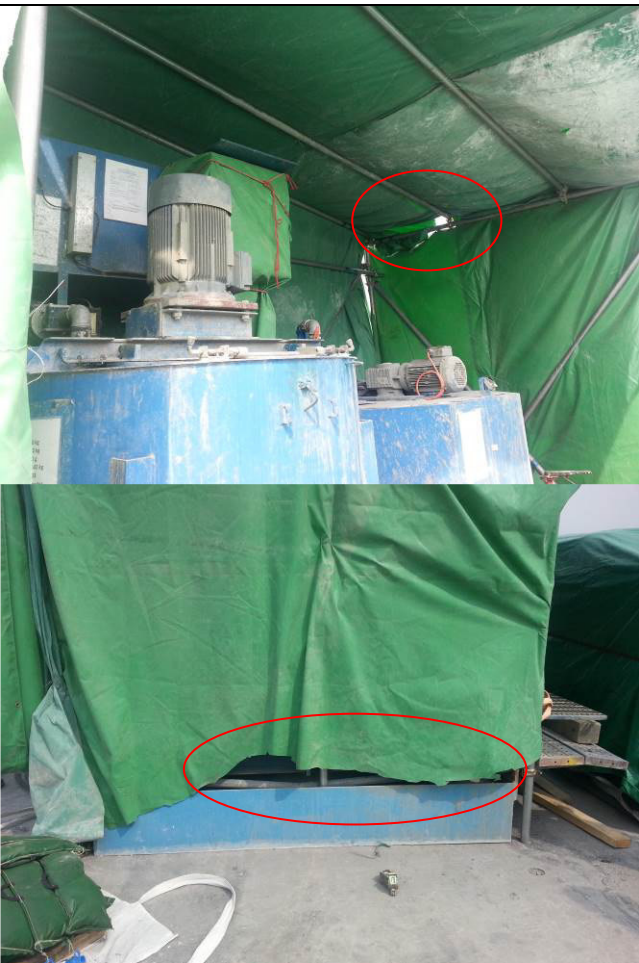
<p><b>Ref No:</b> 151020-R04</p> <p><b>Impact:</b> Air Quality (D13 &amp; D20)</p> <p><b>Details:</b> Ensure the grout mixing area is fully enclosed with 3 sides and top shelter at P108 (bridge-deck).</p>

13/10/2015	To erect the fencing for protecting trees at P102 and P91.	Rectification/improvement was not observed during the follow-up audit sessions. Further follow-up on this item is required.
<i>Air Quality</i>	06/10/2015	Clear the used cement bags at P110 or store it properly (i.e. cover with tarpaulin etc.) before disposal.	Rectification/improvement was observed during the follow-up audit session on 20 October 2015.
	13/10/2015	Properly cover the cement bags (<20bags) with tarpaulin sheet at P110. (bridge-deck)	Rectification/improvement was observed during the follow-up audit session on 20 October 2015.
	13/10/2015	Clear the used cement bags regularly or store it properly (i.e. cover with tarpaulin sheet) before disposal at P110. (bridge-deck)	Rectification/improvement was observed during the follow-up audit session on 20 October 2015.
	20/10/2015	Ensure the grout mixing area is fully	Rectification/improvement

Parameters	Date	Observations and Recommendations	Follow-up
		enclosed with 3 sides and top shelter at P108 (bridge-deck).	was not observed during the follow-up audit sessions. Further follow-up on this item is required.
	28/10/2015	Debagged cement bags were observed not covered properly at P79. The Contractor was reminded to properly cover the debagged cement bags, e.g. sheltered on top and 3 sides.	Rectification/improvement was observed during the follow-up audit session on 3 November 2015.
<i>Noise</i>	N/A <sup>(1)</sup>	N/A <sup>(1)</sup>	N/A <sup>(1)</sup>
<i>Waste / Chemical Management</i>	06/10/2015	Clear the accumulated rubbish at near P107 and P84.	Rectification/improvement was observed during the follow-up audit session on 20 October 2015.
	06/10/2015	Provide drip tray for the chemical containers at P84.	Rectification/improvement was observed during the follow-up audit session on 20 October 2015.

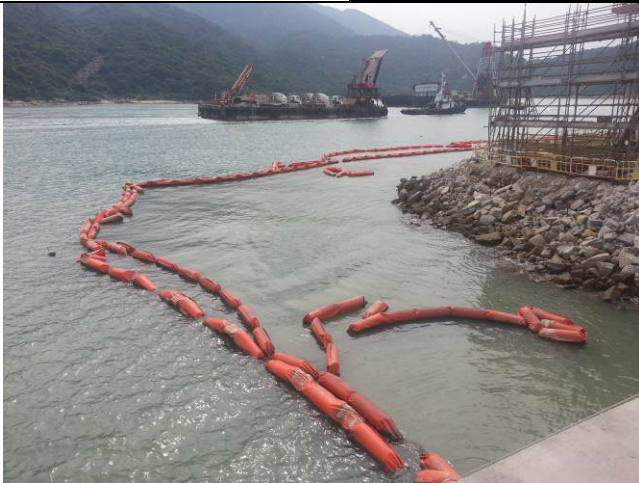
**Details:**  
Properly deploy the silt curtain at P82 and P106.

**Follow Up:**  
Silt curtain was deployed properly.

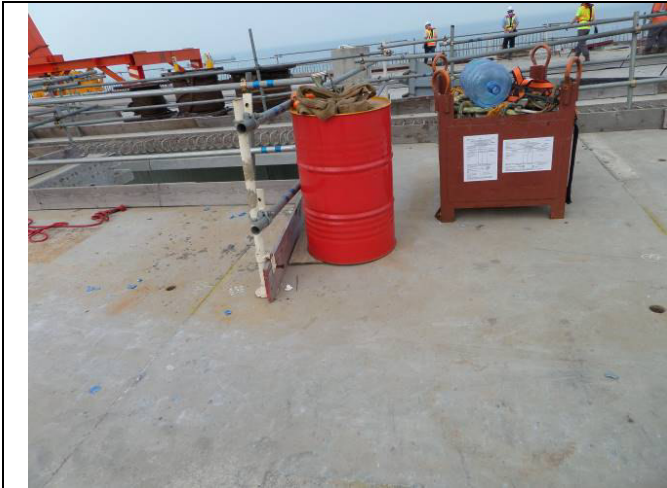
LG2 (P45)

**Details:**  
Oil container was observed without label and proper drip tray at P45(LG2) and P54. The Contractor was reminded to provide drip trays for oil containers and label it properly.
