**Re: Agreement No. CE 48/2011 (EP)
Environmental Project Office for the
HZMB Hong Kong Link Road, HZMB Hong Kong Boundary Crossing
Facilities, and Tuen Mun-Chek Lap Kok Link – Investigation**

**Contract No. HY/2011/09 HZMB Hong Kong Link Road –
Section between HKSAR Boundary and Scenic Hill
Revised Monthly EM&A Report for November 2015 (EP-352/2009/D)**

Contract HY/2011/09
Hong Kong-Zhuhai-Macao Bridge
Hong Kong Link Road-Section between
HKSAR Boundary and Scenic Hill
Monthly EM&A Report
November 2015
(Version 2.0)

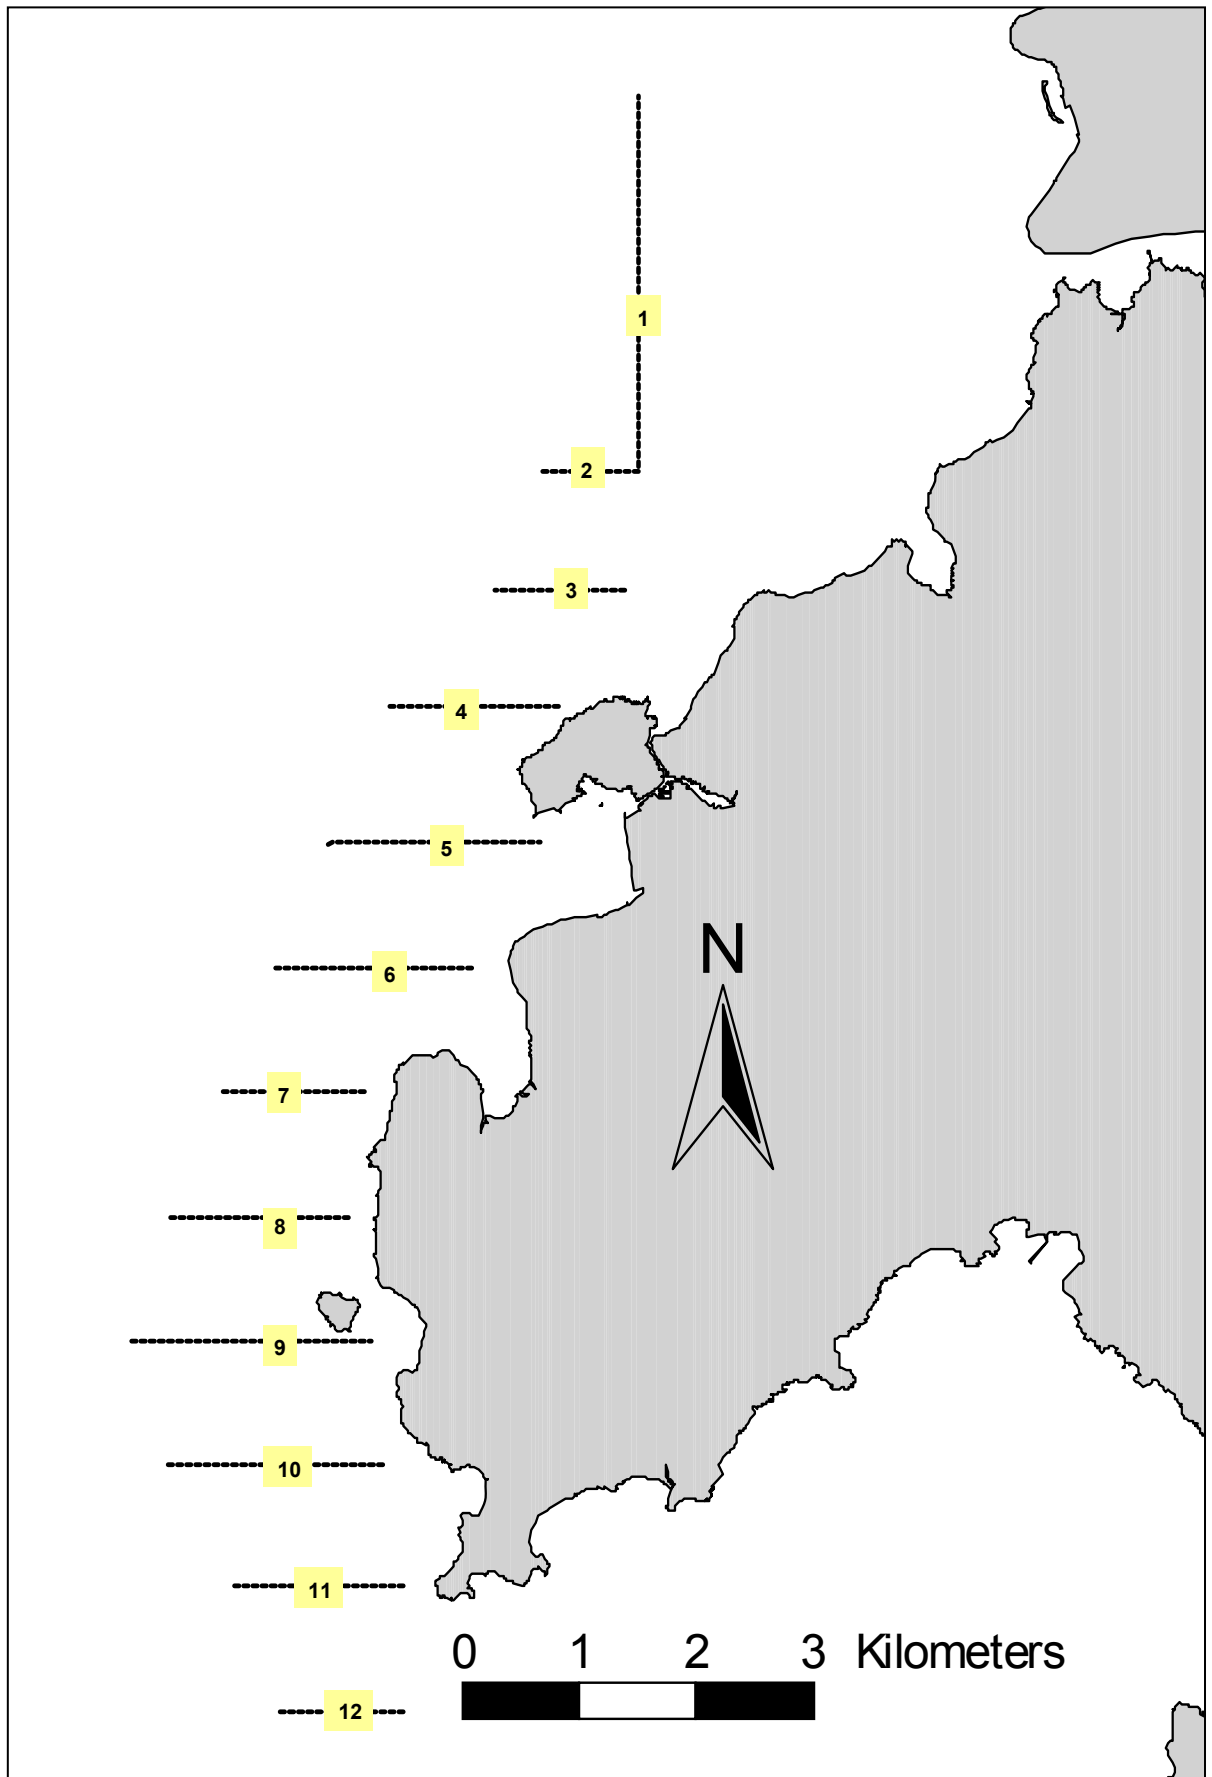
Figure 1. Transect Line Layout in West Lantau Survey Areas

6.8 From these surveys, a total of 67.40 km of survey effort was collected, with 78.4% of the total survey effort being conducted under favorable weather conditions (i.e. Beaufort Sea State 3 or below with good visibility) Out of the 67.40 km of survey effort, the total survey effort conducted on primary lines (the horizontal lines perpendicular to the coastlines) was 45.32 km.

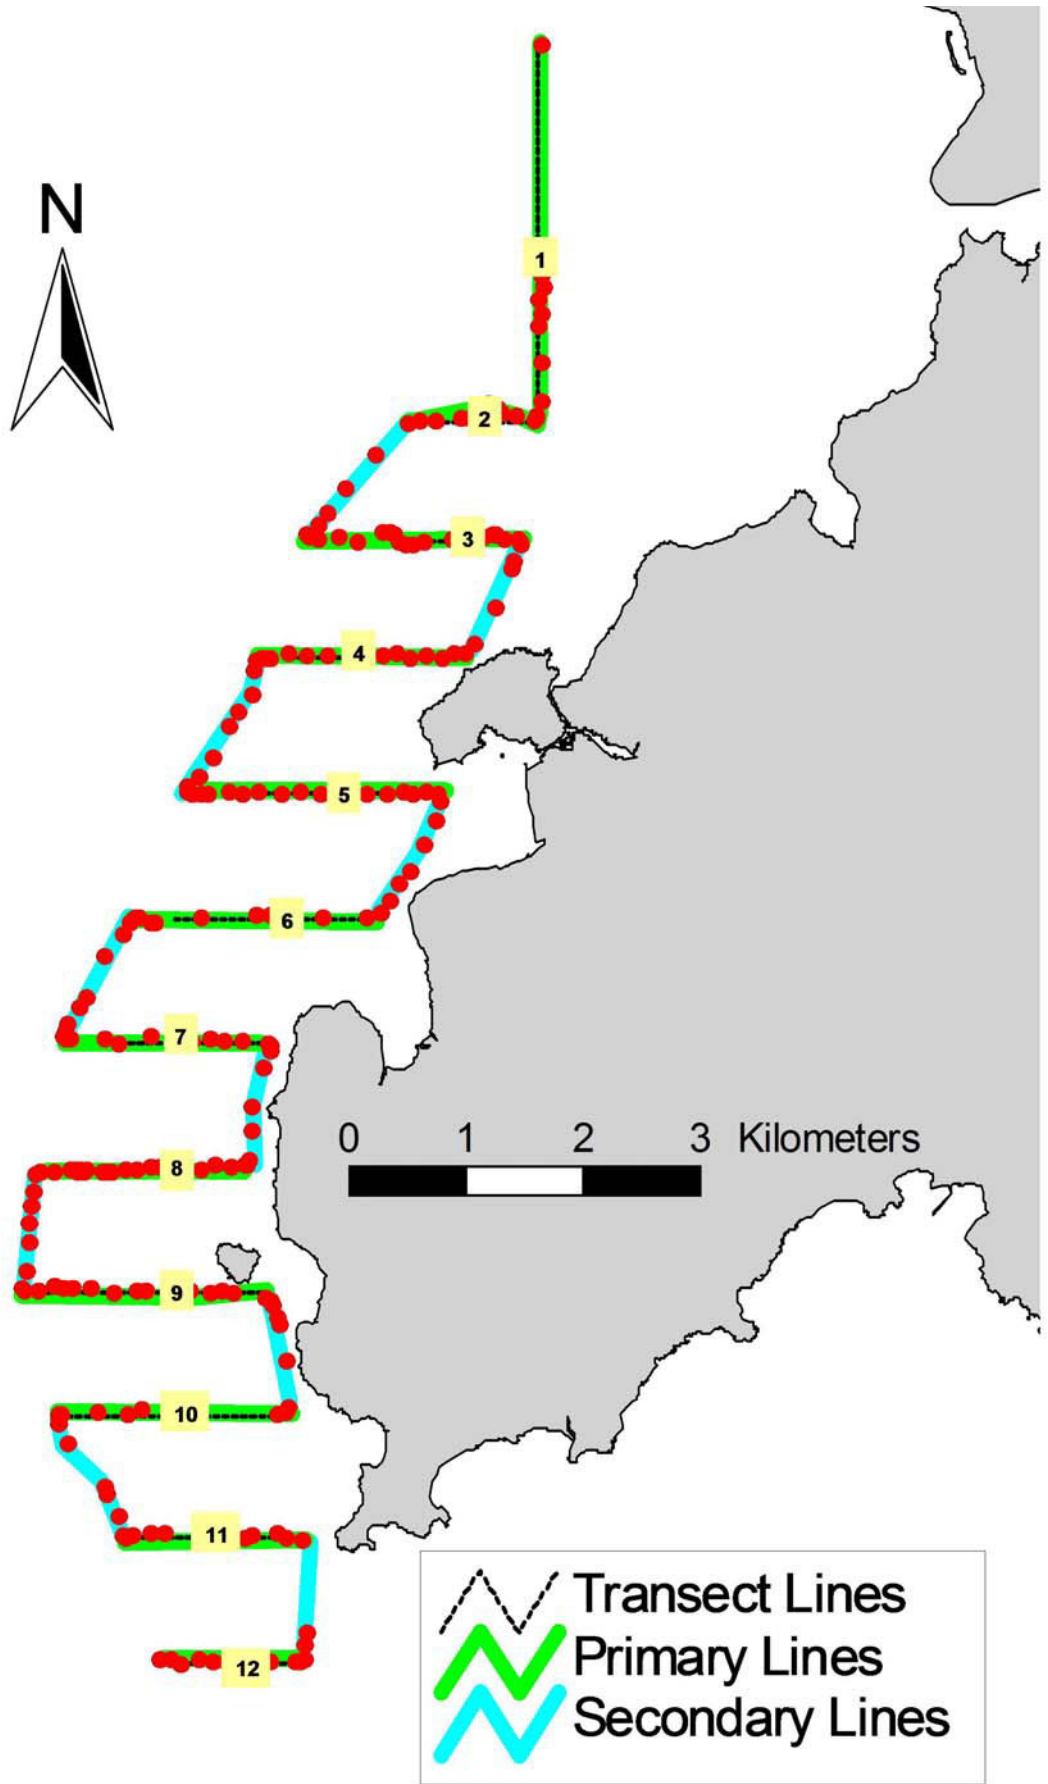
Figure 2. Survey Route on November 13th, 2015 (note: red dots represent the tracked positions of survey boat logged continuously by GPS throughout the course of the survey)

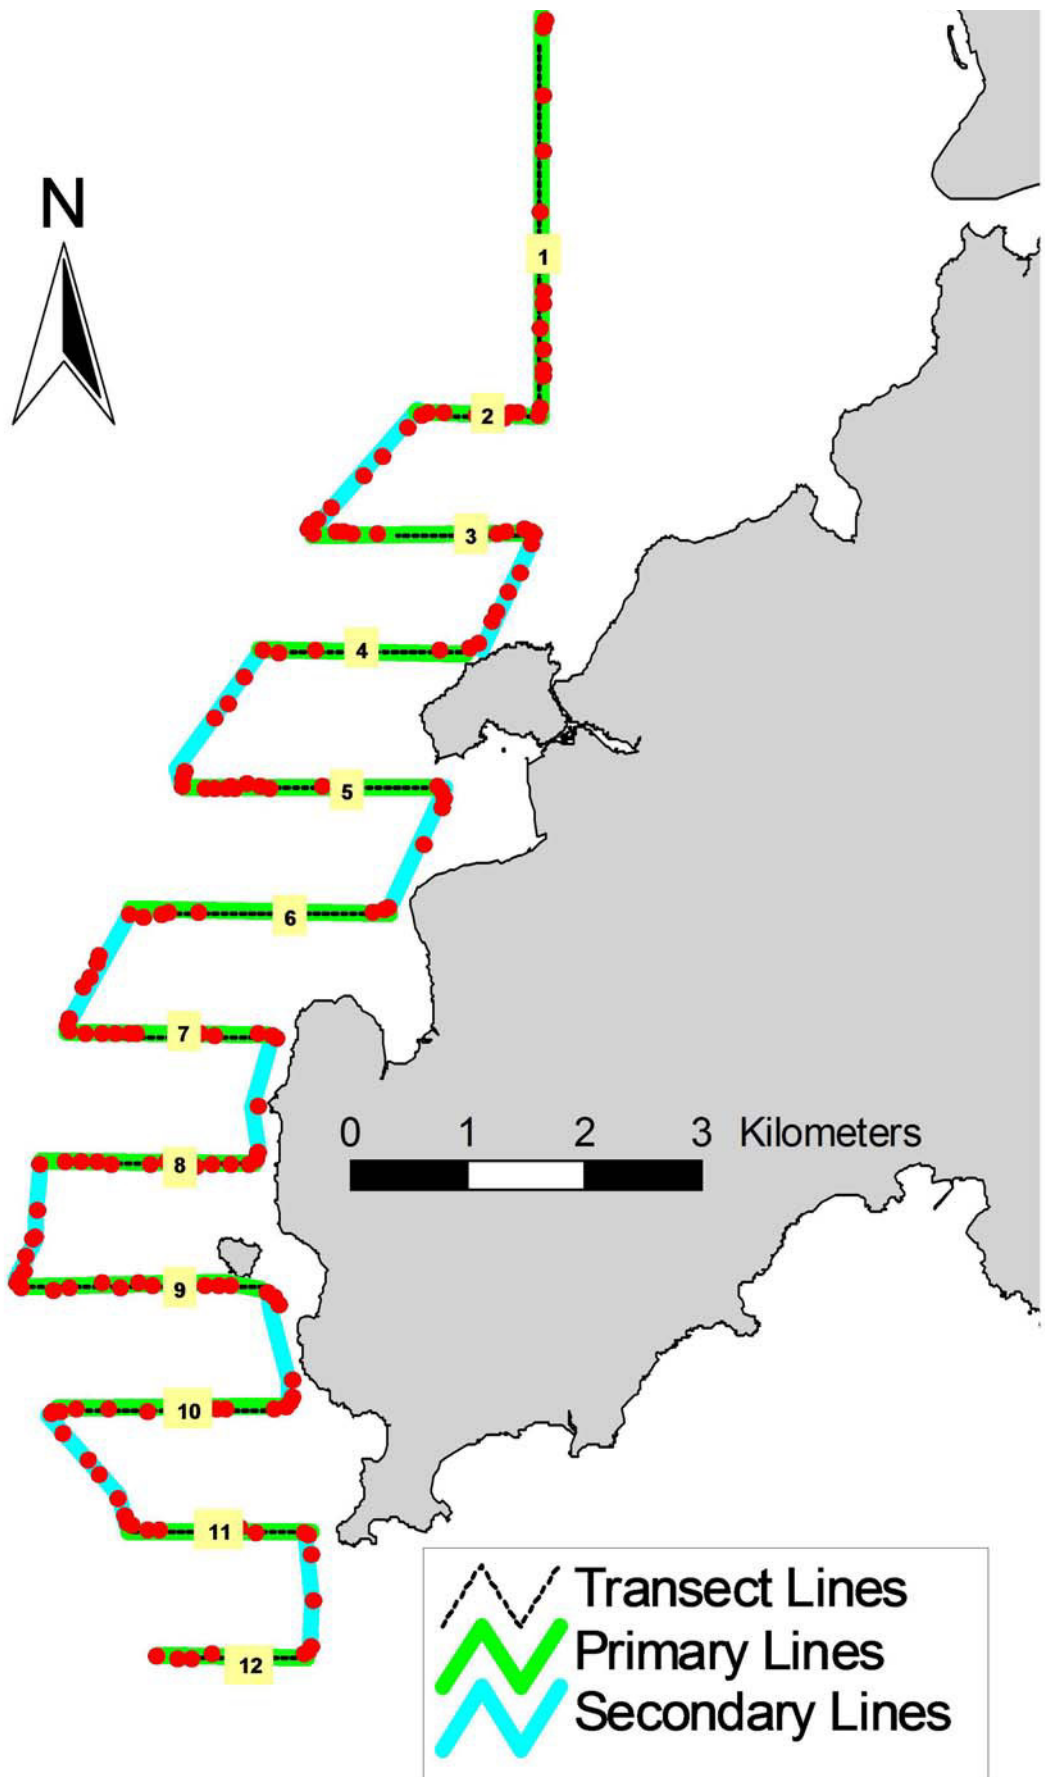
Figure 3. Survey Route on November 19th, 2015 (note: red dots represent the tracked positions of survey boat logged continuously by GPS throughout the course of the survey)

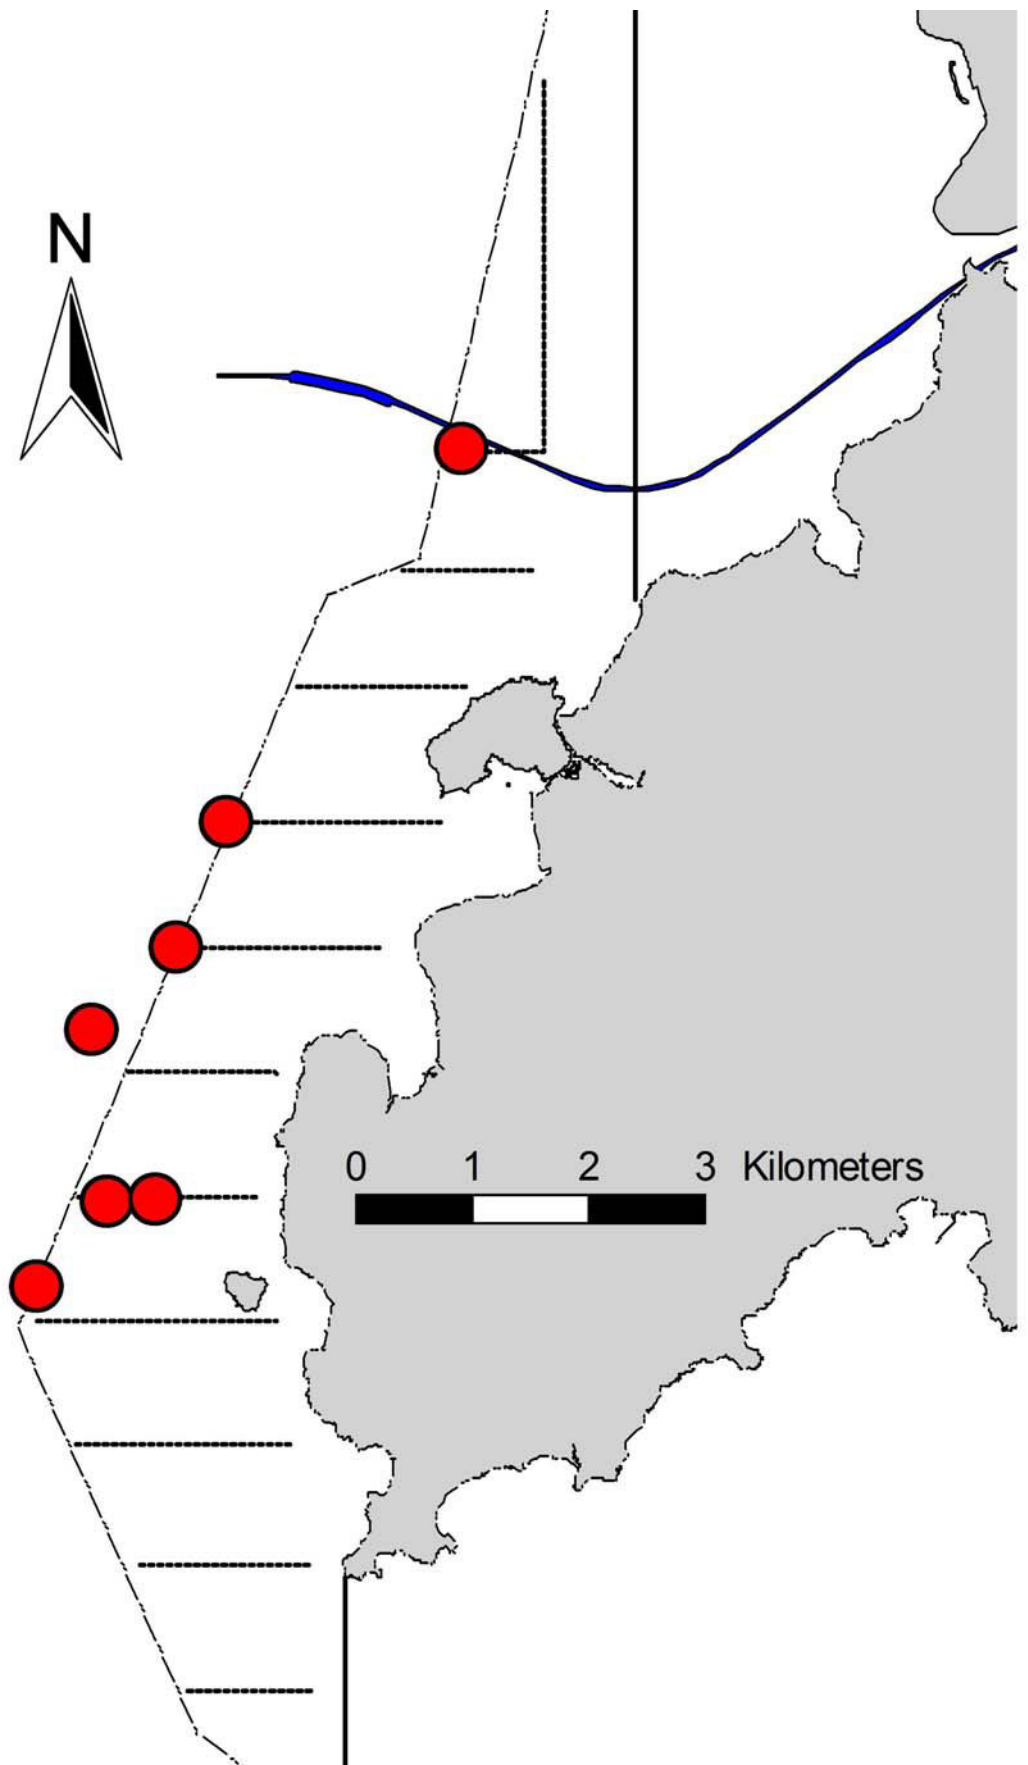
Figure 4. Distribution of Chinese White Dolphin Sighting during November 2015 HKLR09 Monitoring Surveys

- 6.12 Three of the seven dolphin groups were composed of only 1-2 animals, while the other four dolphin groups were moderate in size with 4-6 animals per group.
- 6.13 During this month of dolphin monitoring, marine construction activities have continued under this contract. However, no adverse impact on Chinese white dolphins was noticeable from general observations.
- 6.14 Evaluation of impacts on dolphins due to construction work will be conducted in the quarterly EM&A report.
- 6.15 Detailed monitoring methodology and results can be found in **Appendix I**.

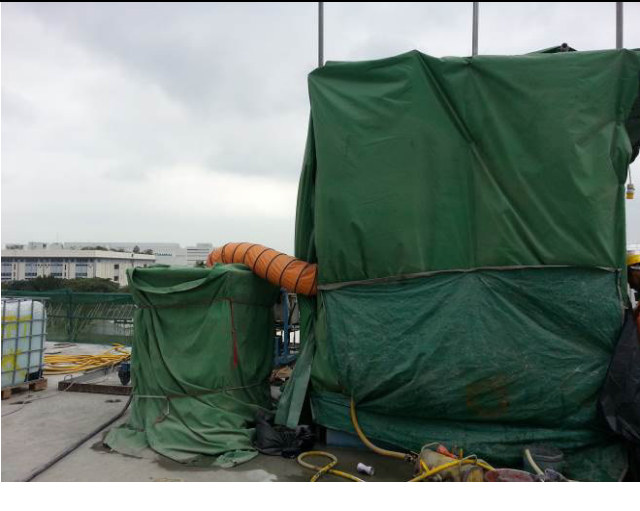
<p>Ref No: 151020-R04</p> <p>Impact: Air Quality (D13 & D20)</p> <p>Details: Ensure the grout mixing area is fully enclosed with 3 sides and top shelter at P108 (bridge-deck).</p> <p>Follow Up: The grout mixing area was observed fully enclosed with 3 sides and top shelter.</p>
 	<p>Ref No: 151020-R05</p> <p>Impact: Water Quality (B16)</p> <p>Details: To seal the base of water barrier with cement at P110.</p> <p>Follow Up: Sand bag bund was provided at the base of water barrier.</p>

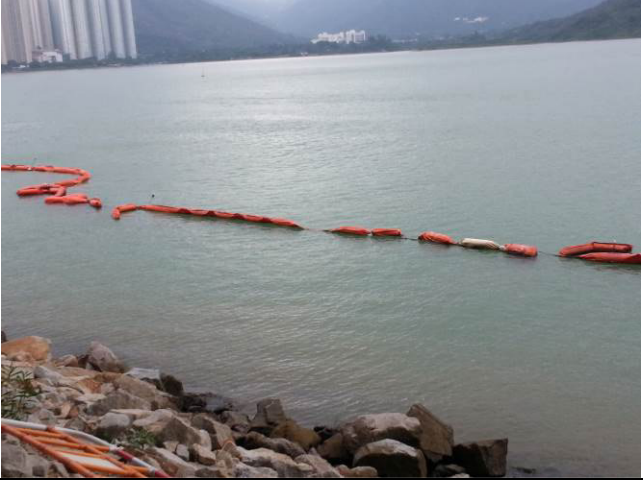
<p>Ref No: 151110-R04</p> <p>Impact: Water Quality (B4)</p> <p>Details: Properly deploy the silt curtain at P106.</p>

03/11/2015	Properly deploy the silt curtain at P106 and P98.	Rectification/improvement was observed during the follow-up audit session on 25 November 2015.
	03/11/2015	To direct the wastewater from the grouting mixing to the sedimentation tank at near P107.	Rectification/improvement was observed during the follow-up audit session on 10 November 2015.
	10/11/2015	Clear the sedimentation tank to ensure it can function properly at P106 (Portion C).	Rectification/improvement was observed during the follow-up audit session on 17 November 2015.
	10/11/2015	Clear the handrail at the seawall area at P106 (Portion A).	Rectification/improvement was observed during the follow-up audit session on 25 November 2015.
	10/11/2015	Properly deploy the silt curtain at P106.	Rectification/improvement was observed during the follow-up audit session on 25 November 2015.
	10/11/2015	Clear the U-Channel at P102.	Rectification/improvement was not observed during the follow-up audit session. Further follow-up on this item is required.

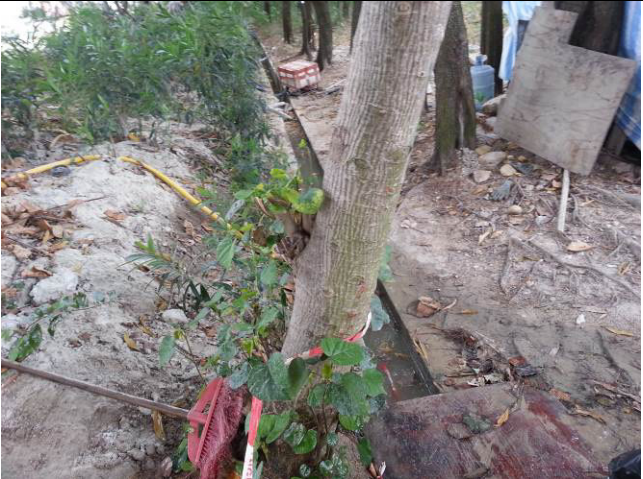
<p>Ref No: 151110-R05</p> <p>Impact: Water Quality (B3i.)</p> <p>Details: Clear the U-Channel at P102.</p>

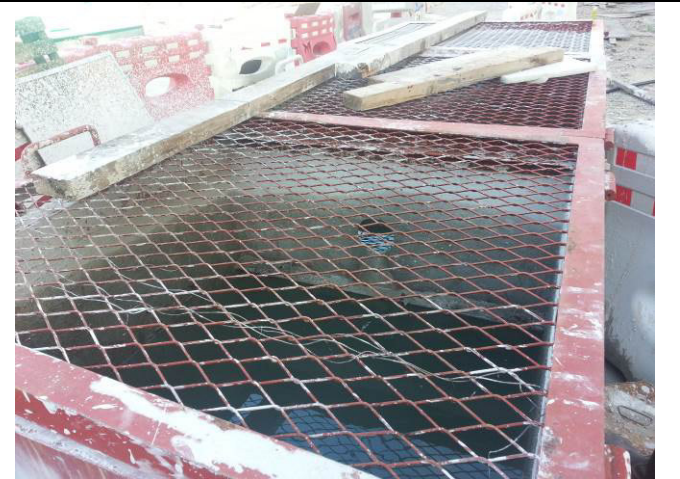
<p>Ref No: 151110-R02</p> <p>Impact: Waste / Chemical Management (F8)</p> <p>Details: Clear the sedimentation tank to ensure it can function properly at P106 (Portion C).</p> <p>Follow Up: Sedimentation tank was cleared.</p>

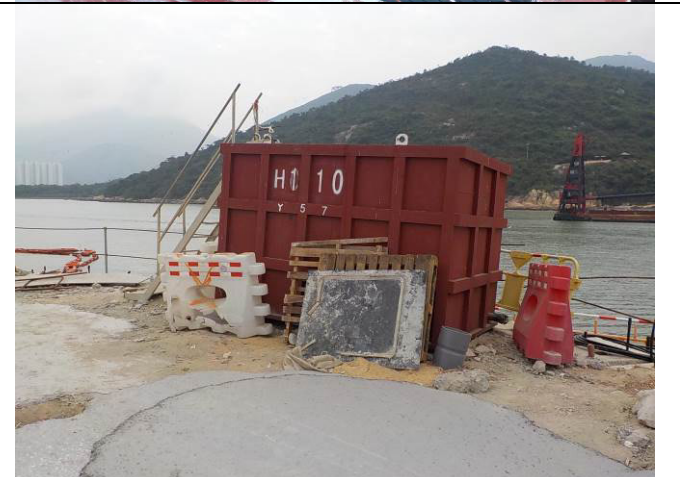
<p>Ref No: 151110-R07</p> <p>Impact: Water Quality (B25)</p> <p>Details: Clear the accumulated wastes at P83.</p> <p>Follow Up: Accumulated wastes were cleared.</p>

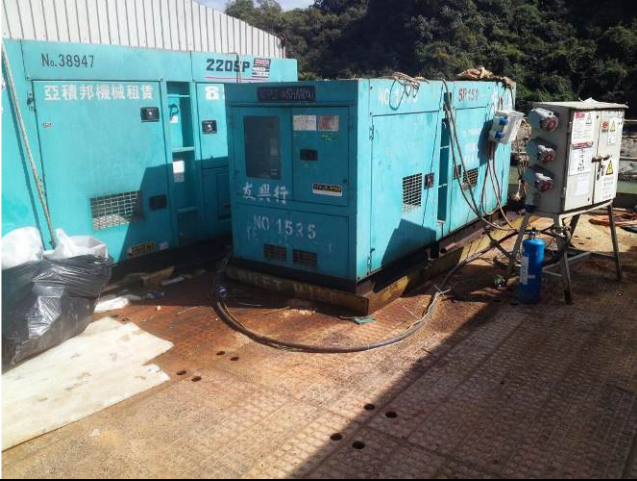
<p>Ref No: 1501117-R01</p> <p>Impact: Waste / Chemical Management (F9)</p> <p>Details: Provide drip tray for the chemical containers at P70.</p> <p>Follow Up: The chemical containers were removed.</p>

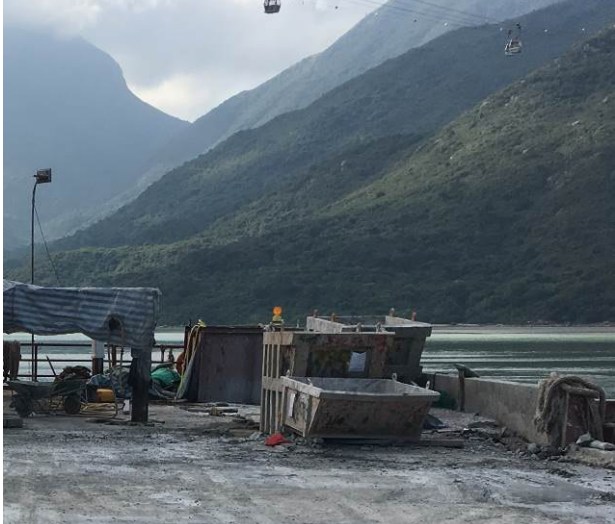
<p>Ref No: 151117-R02</p> <p>Impact: Water Quality (B20)</p> <p>Details: Provide sufficient skip for temporary storage of concrete waste at Tung Shun 329.</p> <p>Follow Up: Sufficient skip was provided.</p>

10/11/2015	Ensure the wetsep at P82 can function properly before discharging the treated water.	Rectification/improvement was observed during the follow-up audit session on 25 November 2015.
	17/11/2015	Provide sufficient skip for temporary storage of concrete waste at Tung Shun 329.	Rectification/improvement was observed during the follow-up audit session on 25 November 2015.
	17/11/2015	Properly deploy the silt curtain at P106, P75, P81 and P68.	Rectification/improvement was observed during the follow-up audit session on 25 November 2015.
