**Re: Agreement No. CE 48/2011 (EP)
Environmental Project Office for the
HZMB Hong Kong Link Road, HZMB Hong Kong Boundary Crossing
Facilities, and Tuen Mun-Chek Lap Kok Link – Investigation**

**Contract No. HY/2011/09 HZMB Hong Kong Link Road –
Section between HKSAR Boundary and Scenic Hill
Revised Monthly EM&A Report for December 2015 (EP-352/2009/D)**

Contract HY/2011/09
Hong Kong-Zhuhai-Macao Bridge
Hong Kong Link Road-Section between
HKSAR Boundary and Scenic Hill

Monthly EM&A Report

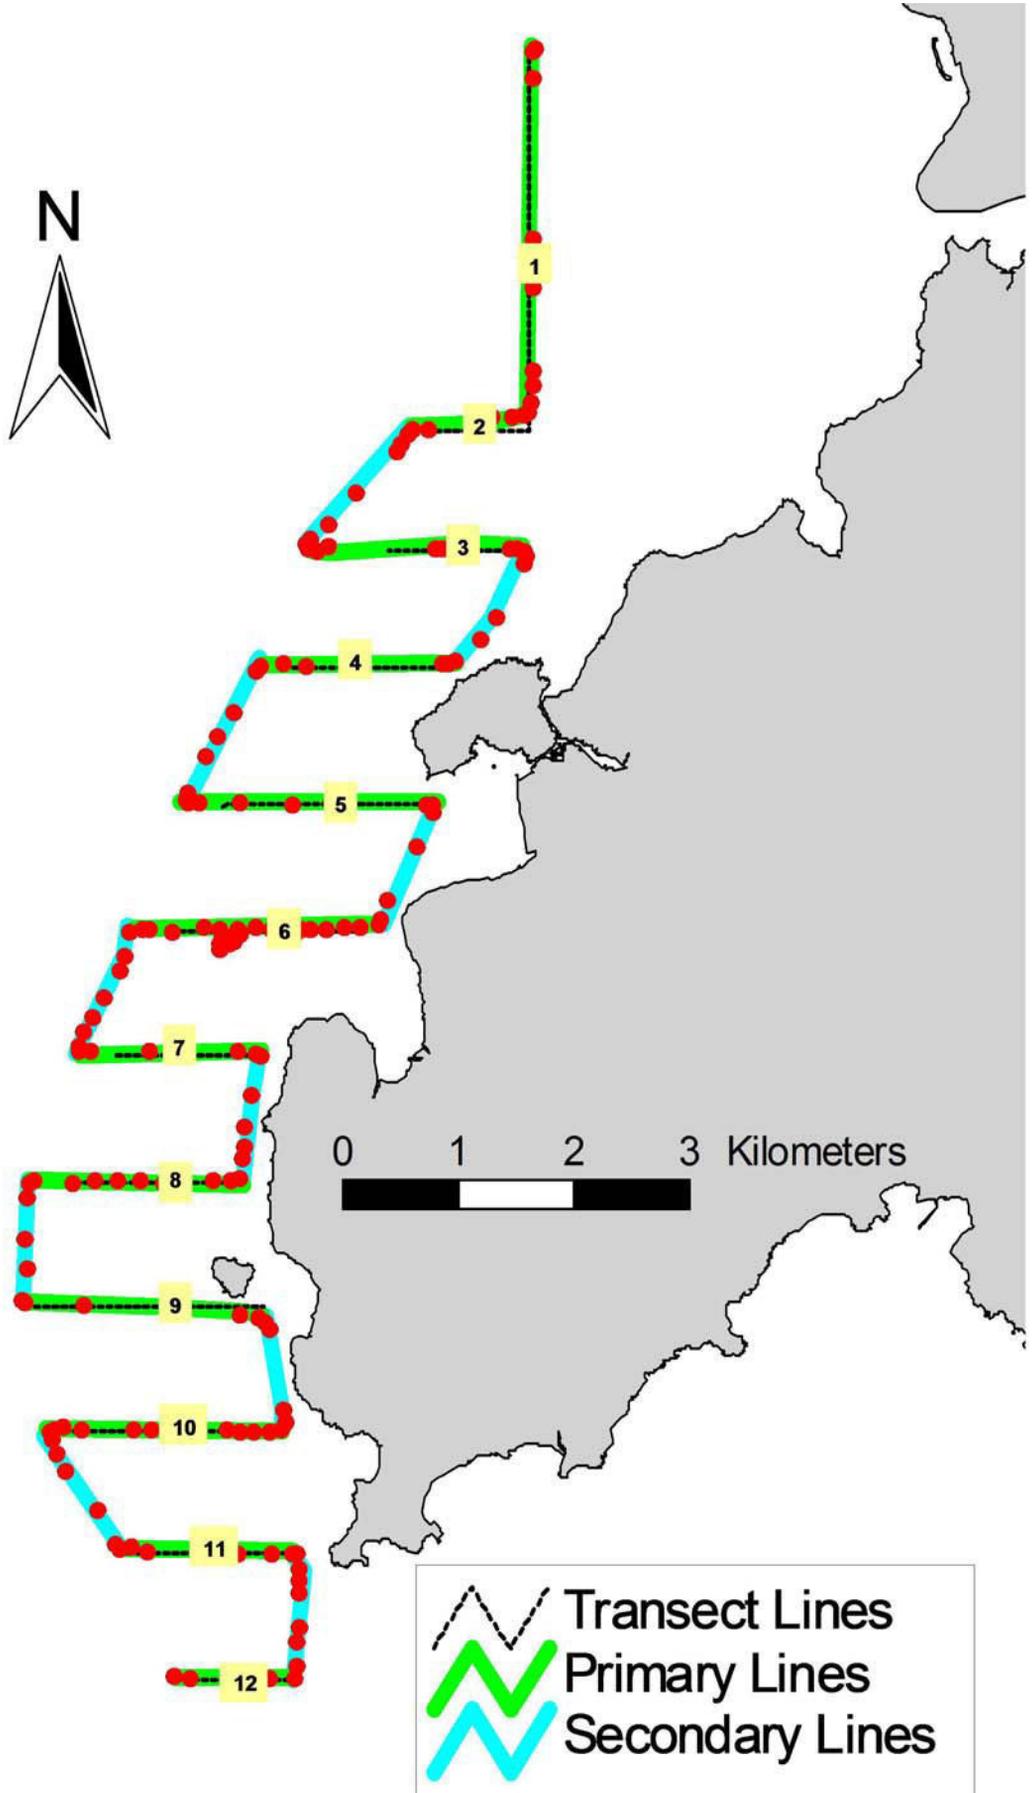
Figure 2. Survey Route on December 3rd, 2015 (note: red dots represent the tracked positions of survey boat logged continuously by GPS throughout the course of the survey)

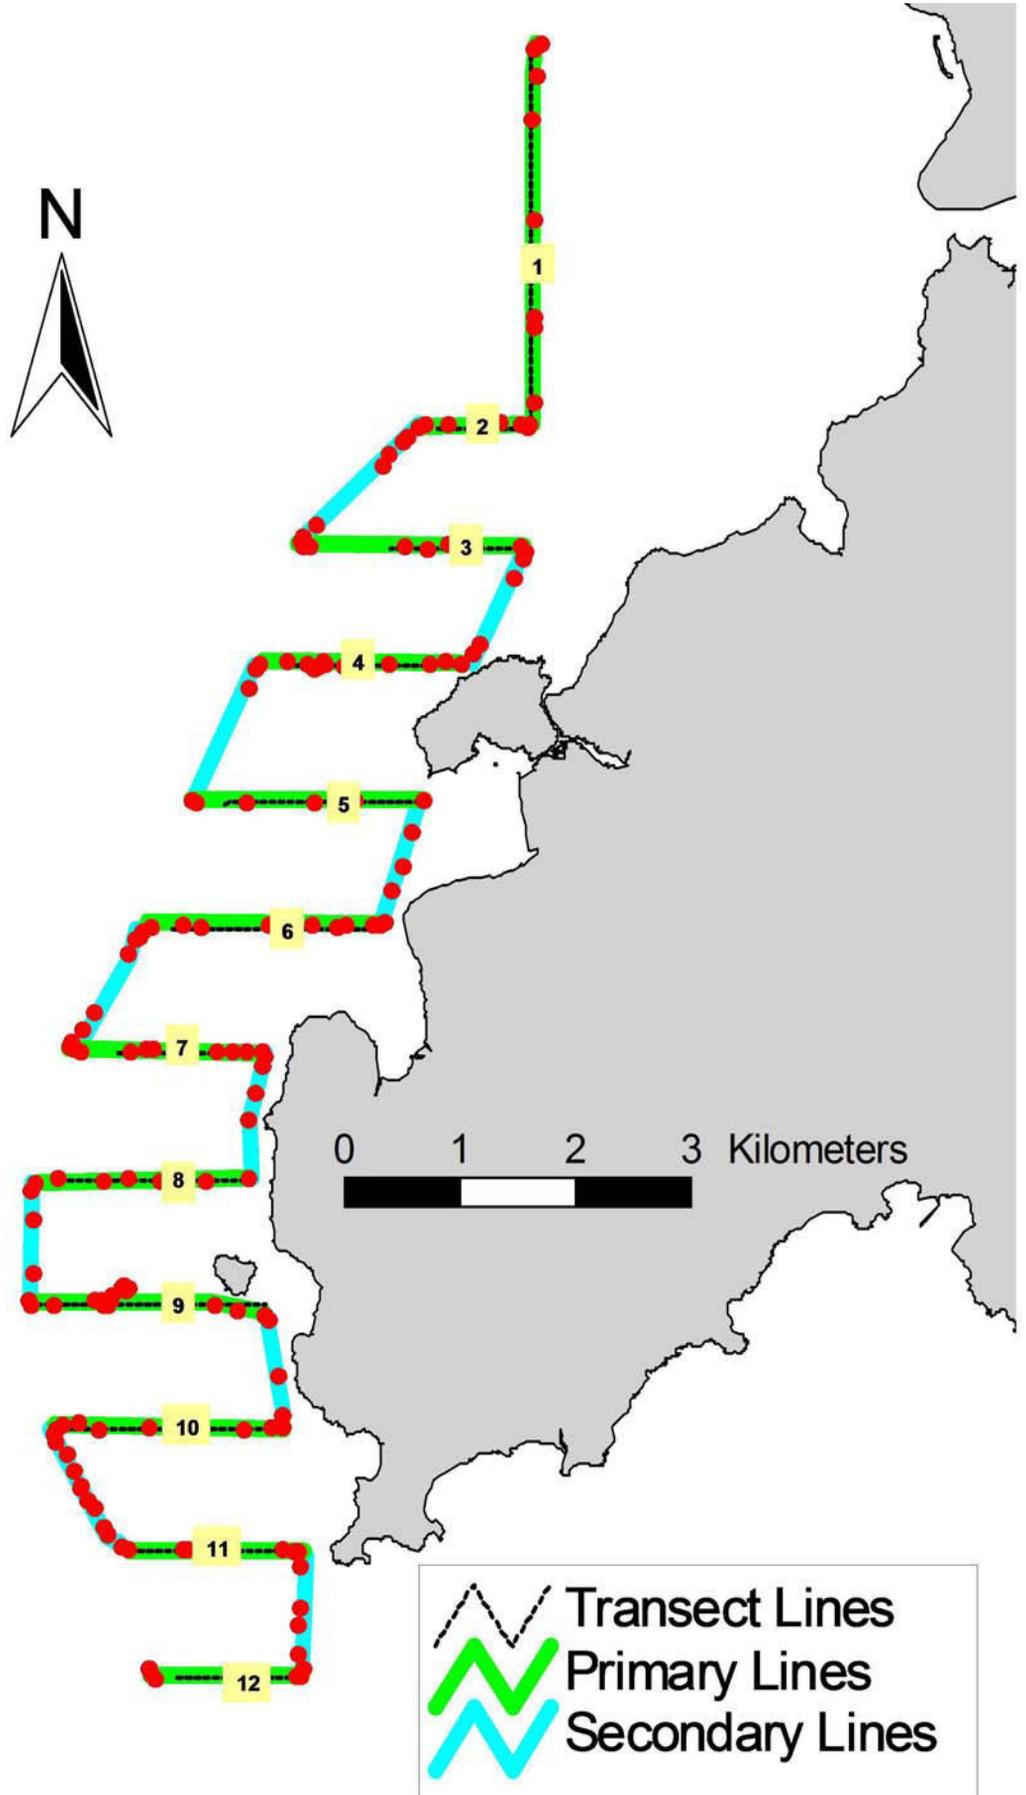
Figure 3. Survey Route on December 10th, 2015 (note: red dots represent the tracked positions of survey boat logged continuously by GPS throughout the course of the survey)

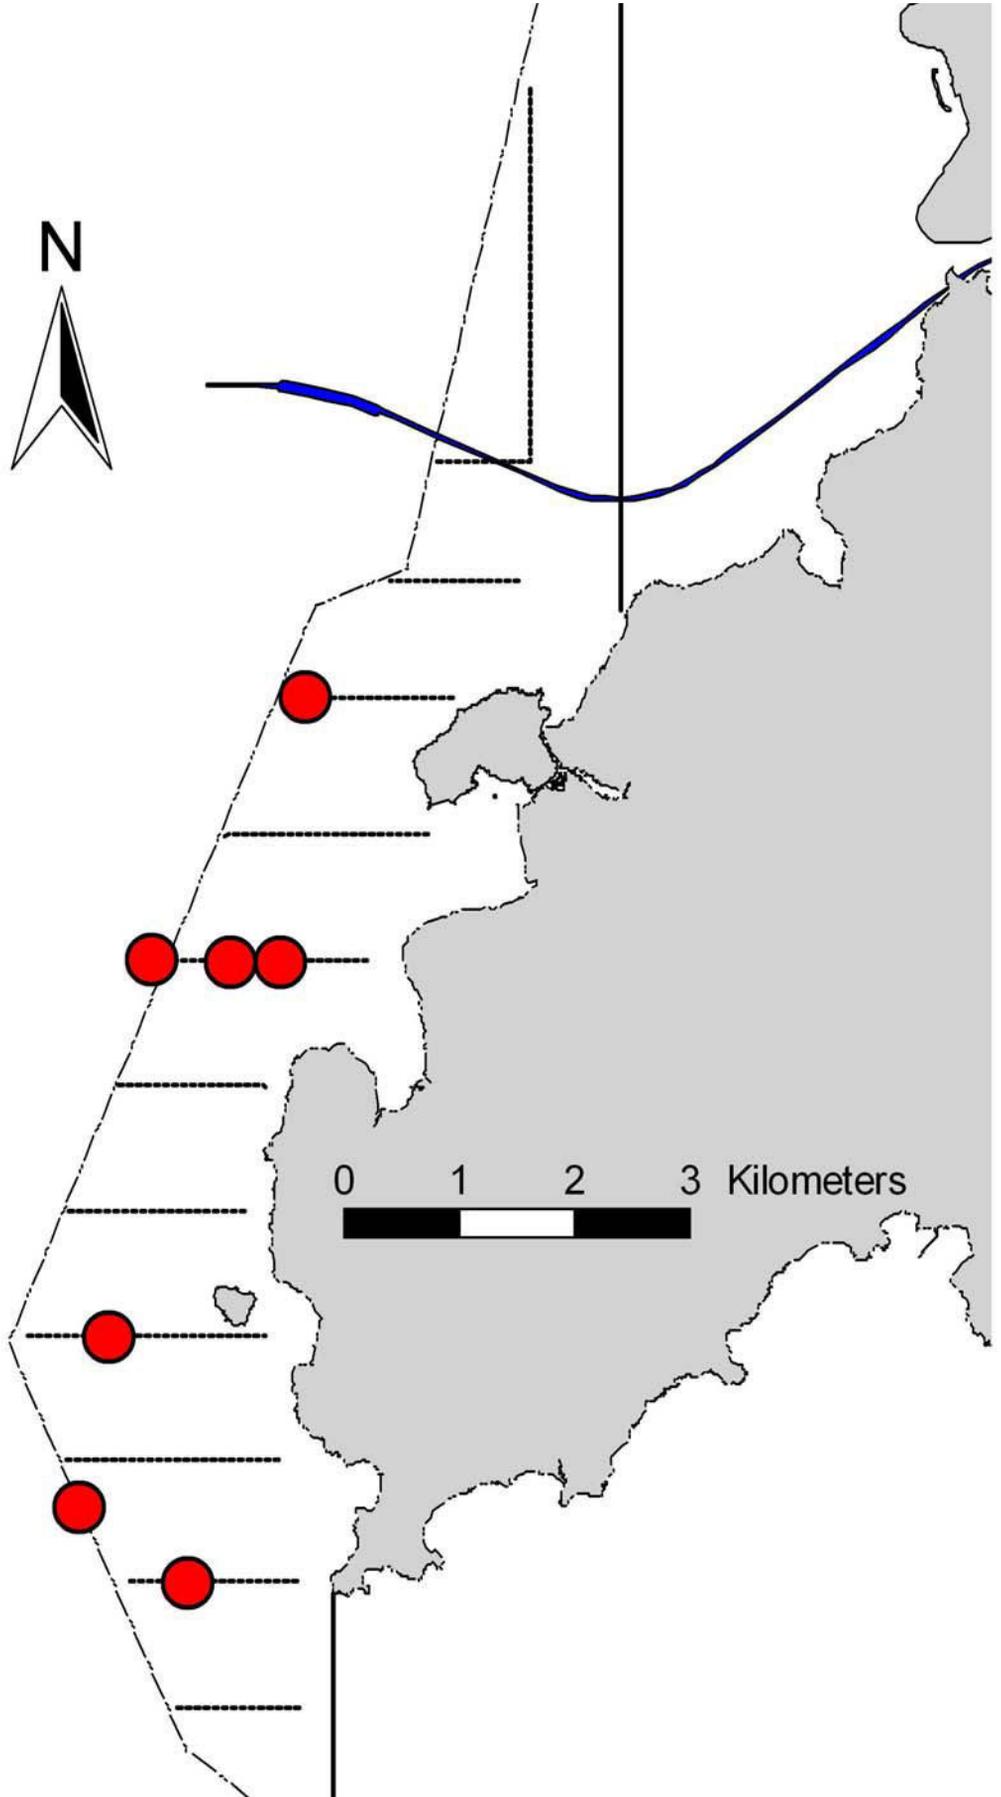
Figure 4. Distribution of Chinese White Dolphin Sighting during December 2015 HKLR09 Monitoring Surveys

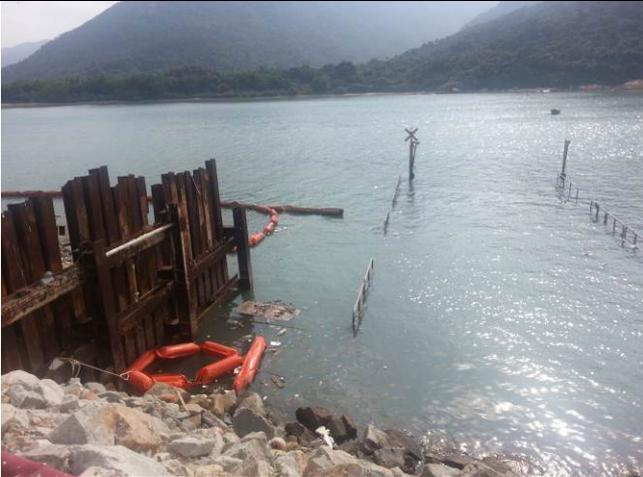
<p>Ref No: 1501201-R04</p> <p>Impact: Water Quality (B21)</p> <p>Details: Clear the floating rubbish and damaged silt curtain at P91.</p>

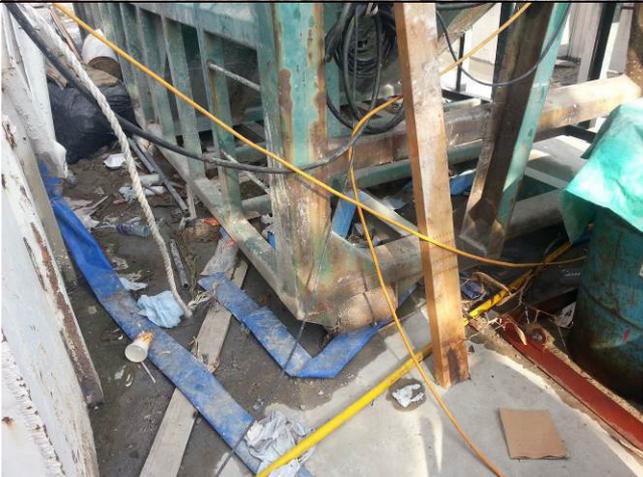
<p>Ref No: 1501201-R05</p> <p>Impact: Waste / Chemical Management (F1iii.)</p> <p>Details: Clear the rubbish at near the wetsep at Portion C (P110).</p>

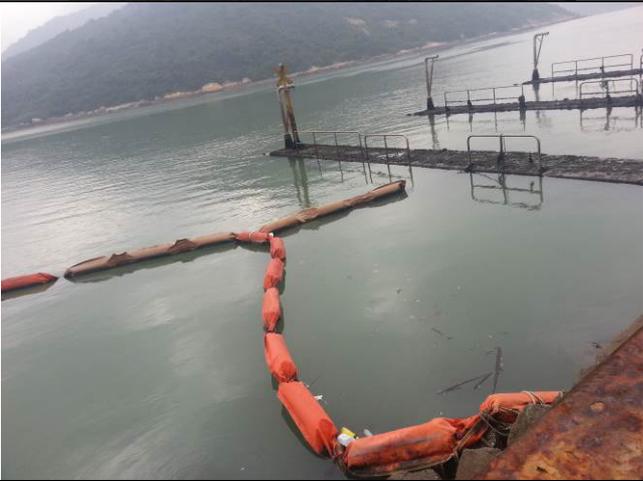
<p>Ref No: 1501210-R07</p> <p>Impact: Water Quality (B21)</p> <p>Details: Clear the floating rubbish and damaged silt curtain at P91.</p>

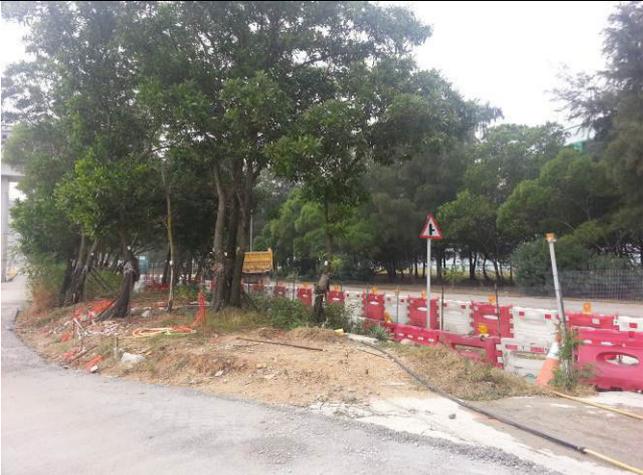
<p>Ref No: 1501210-R08</p> <p>Impact: Ecology (C31)</p> <p>Details: Properly erect the fencing to protect the trees at P98.</p>

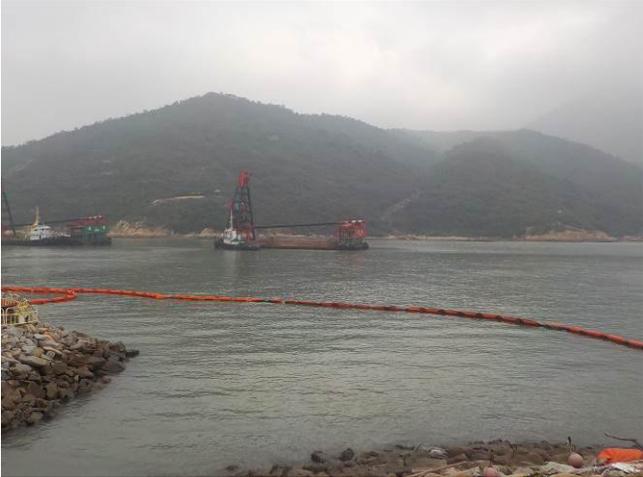
<p>Ref No: 1501201-R01</p> <p>Impact: Water Quality (B25)</p> <p>Details: Properly deploy the silt curtain at P81 and P83.</p> <p>Follow Up: The silt curtain was properly deployed.</p>

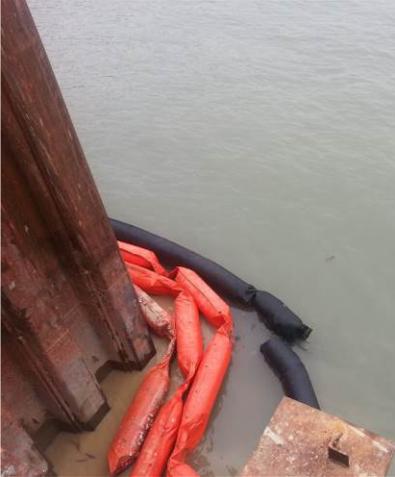
<p>Ref No: 1501215-O01</p> <p>Impact: Water Quality (B26)</p> <p>Details: Minor sediment plume was observed outside the silt curtain at P69. The Contractor was reminded to rectify this deficiency accordingly.</p>

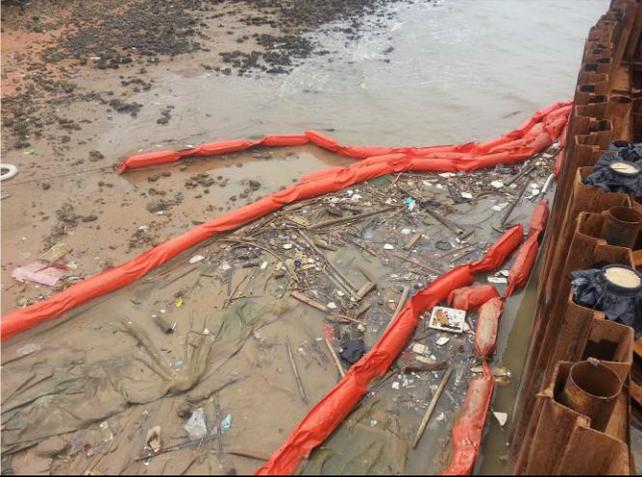
<p>Ref No: 1501215-O02</p> <p>Impact: Water Quality (B21)</p> <p>Details: Floating rubbish was observed within the silt curtain at P69. The Contractor was reminded to clear it ASAP.</p>

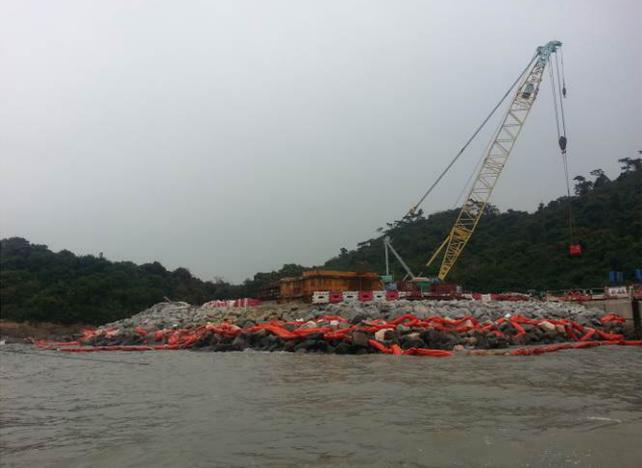
<p>Ref No: 1501215-R03</p> <p>Impact: Water Quality (B25)</p> <p>Details: Properly deploy the silt curtain at P68.</p>

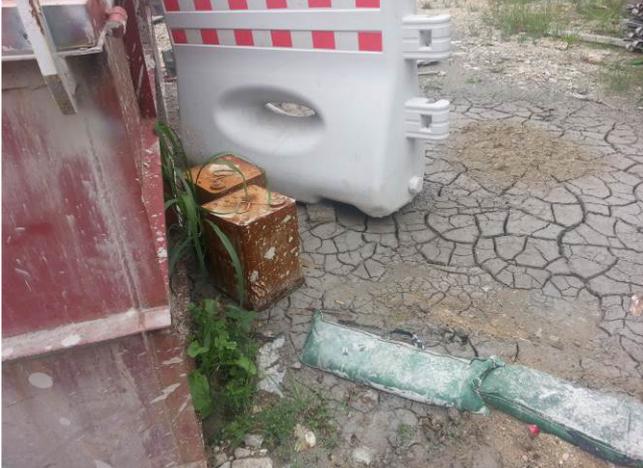
<p>Ref No: 1501215-R06</p> <p>Impact: Waste / Chemical Management (F3i. & F8)</p> <p>Details: Clear the oil containers and oil leakage at near the discharging point at P106 (Portion C).</p>

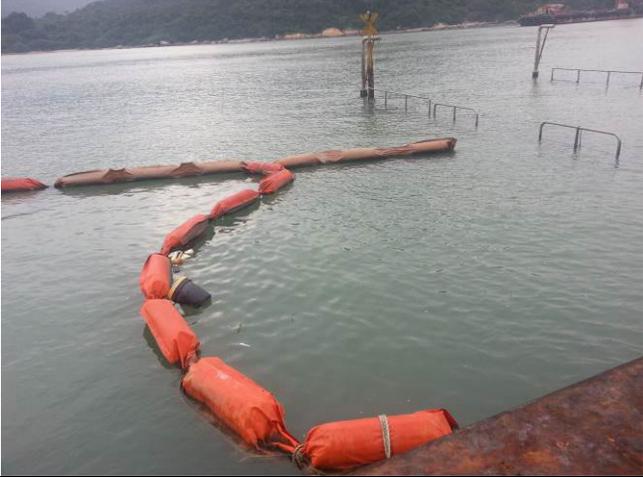
<p>Ref No: 1501215-R07</p> <p>Impact: Water Quality (B21 & B25)</p> <p>Details: Clear the floating rubbish and damage silt curtain at P91.</p>

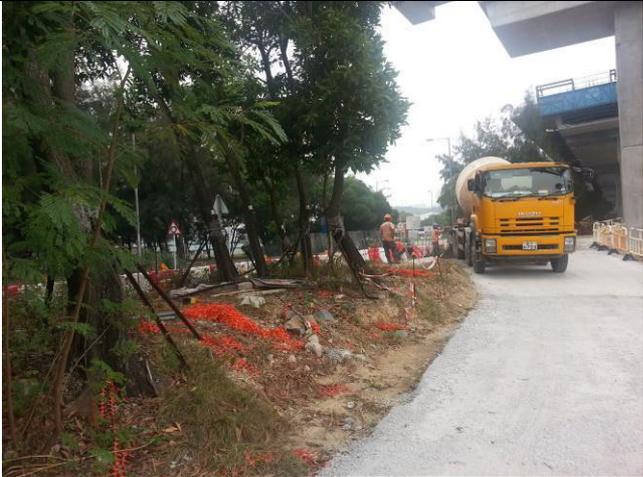
<p>Ref No: 1501215-R08</p> <p>Impact: Ecology (C31)</p> <p>Details: Properly erect the fencing to protect the trees at P98.</p>

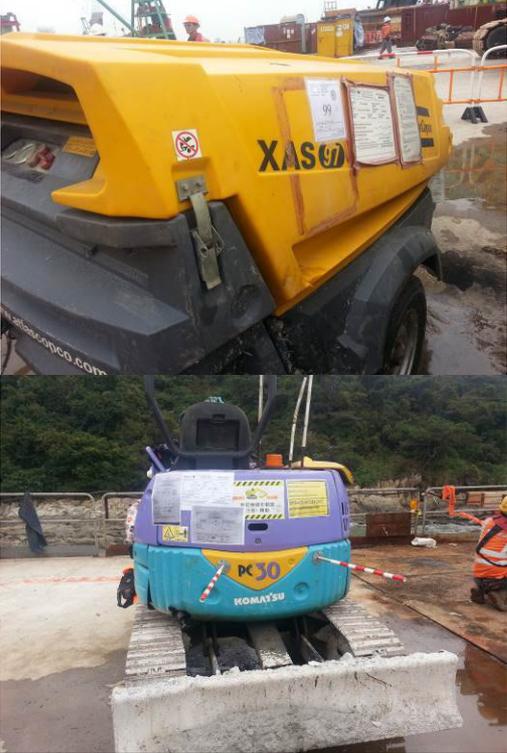
<p>Ref No: 1501210-R02</p> <p>Impact: Air Quality (D26) Noise (E8)</p> <p>Details: Provide NRMM label and noise emission label for the air compressor and excavator which will be used on site at P68.</p> <p>Follow Up: The noise emission label and NRMM label were provided for the air compressor and excavator respectively.</p>

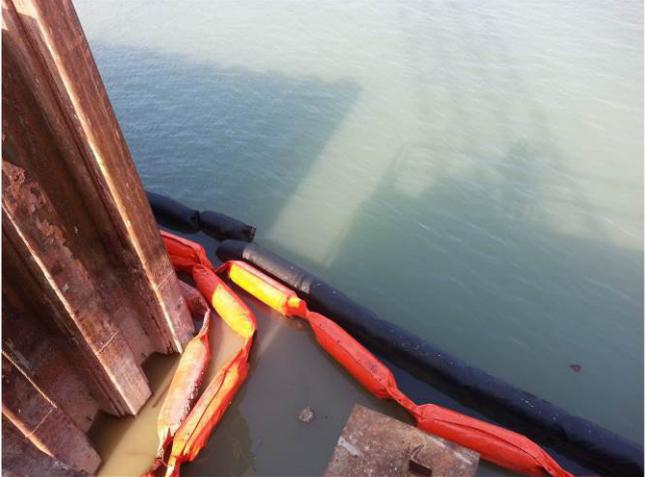
<p>Ref No: 1501215-O01</p> <p>Impact: Water Quality (B26)</p> <p>Details: Minor sediment plume was observed outside the silt curtain at P69. The Contractor was reminded to rectify this deficiency accordingly.</p> <p>Follow Up: The silt curtain was deployed again and no further sediment plume was observed outside the silt curtain.</p>

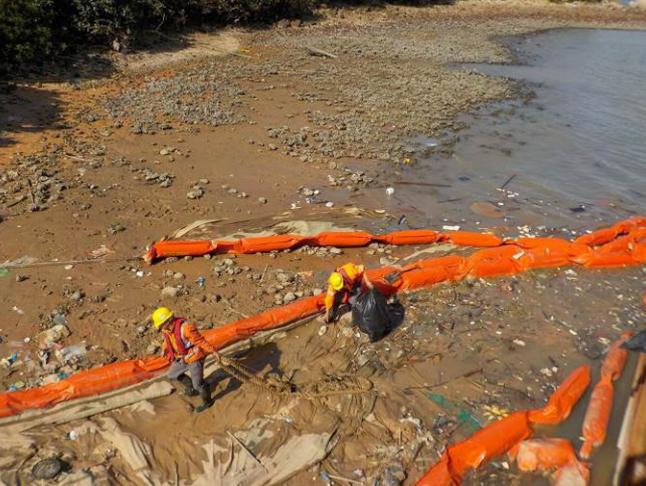
<p>Ref No: 1501215-O02</p> <p>Impact: Water Quality (B21)</p> <p>Details: Floating rubbish was observed within the silt curtain at P69. The Contractor was reminded to clear it ASAP.</p> <p>Follow Up: The floating rubbish within the silt curtain was cleared by the workers.</p>

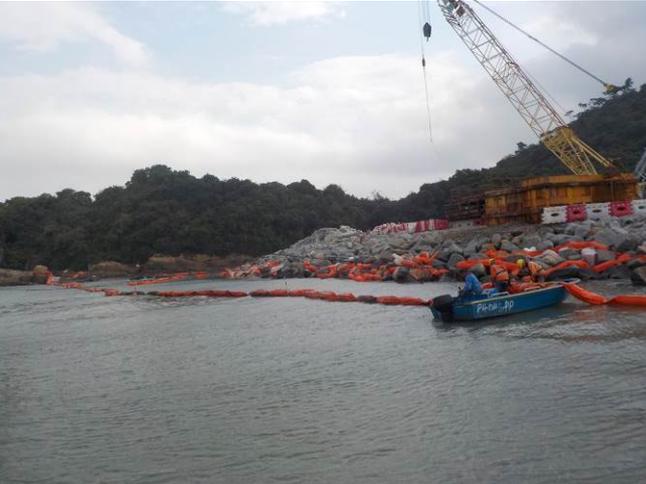
<p>Ref No: 1501215-R03</p> <p>Impact: Water Quality (B25)</p> <p>Details: Properly deploy the silt curtain at P68.</p> <p>Follow Up: The silt curtain at P68 was deployed regularly to ensure it can function properly.</p>

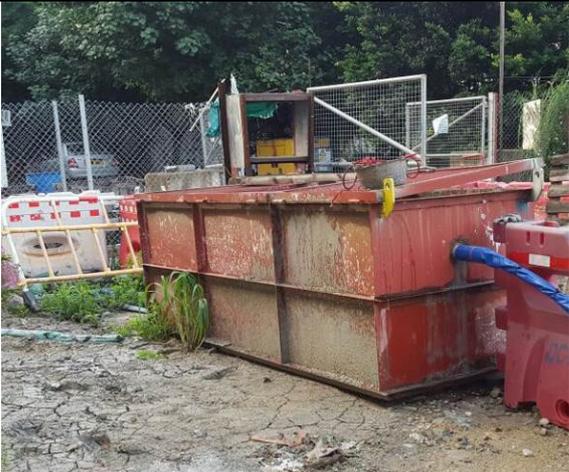
<p>Ref No: 1501215-R06</p> <p>Impact: Waste / Chemical Management (F3i. & F8)</p> <p>Details: Clear the oil containers and oil leakage at near the discharging point at P106 (Portion C).</p> <p>Follow Up: The oil containers and oil leakage were cleared.</p>

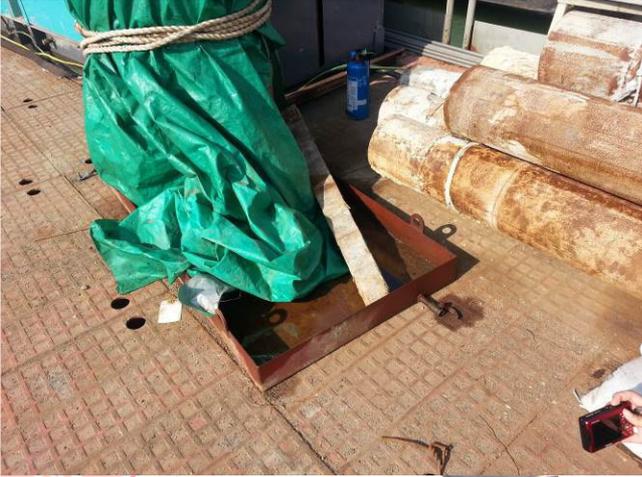
<p>Ref No: 1501229-R02</p> <p>Impact: Waste / Chemical Management (F9)</p> <p>Details: Ensure the valves at the drip tray are closed to avoid the leakage of oily water at P69 & P70.</p>

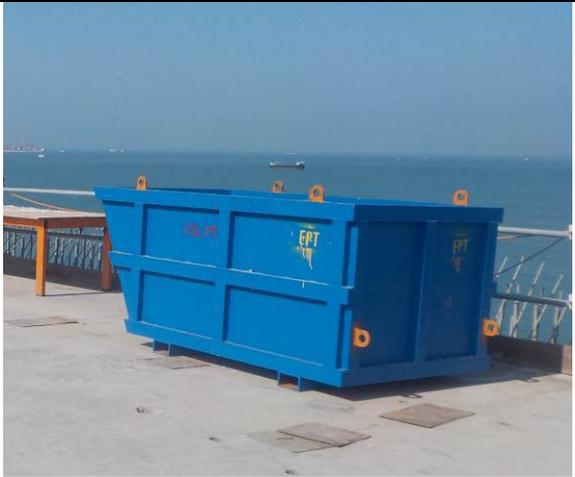
<p>Ref No: 1501223-R03</p> <p>Impact: Waste / Chemical Management (F1i.)</p> <p>Details: Clear the accumulated rubbish at P64 regularly.</p> <p>Follow Up: The skip with full rubbish was replaced</p>
