Contract No. HY/2011/09
Hong Kong-Zhuhai-Macao Bridge
Hong Kong Link Road – Section between HKSAR Boundary and Scenic Hill

Quarterly EM&A Report – December 2015 to February 2016

**Contract No. HY/2011/09 HZMB Hong Kong Link Road –
Section between HKSAR Boundary and Scenic Hill
Quarterly EM&A Report No. 12 for December 2015 to February 2016**

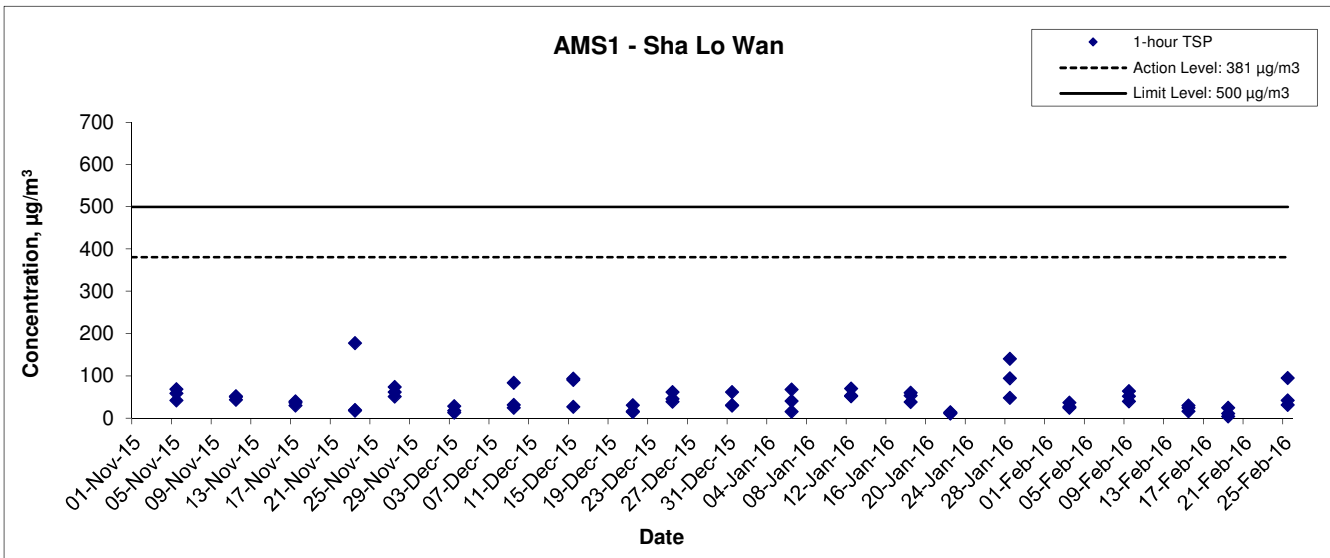
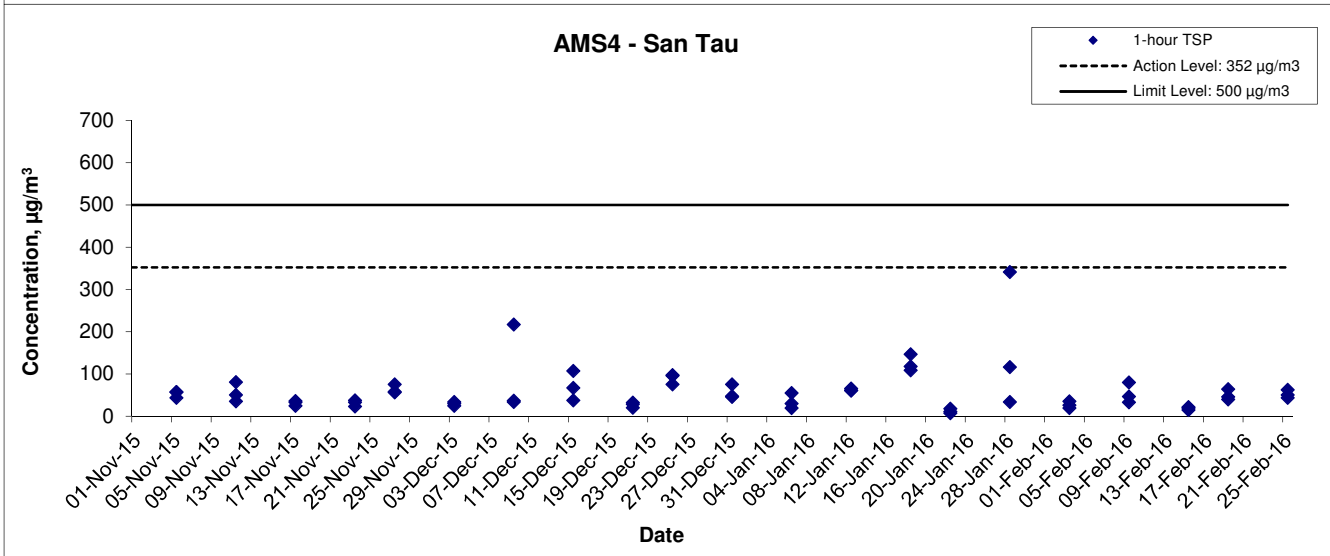
Title Contract No. HY/2011/09 Hong Kong-Zhuhai-Macao Bridge Hong Kong Link Road – Section between HKSAR Boundary and Scenic Hill Graphical Presentation of 1-hour TSP Monitoring Results	Scale N.T.S	Project No. MA12014	
	Date Feb 16	Appendix B

1-hour TSP Concentration Levels

- 5.2 For 1-hour TSP monitoring, no Action/Limit Level exceedance was recorded in the reporting period.
- 5.3 For 24-hour TSP monitoring, no Limit Level exceedance was recorded. One Action Level exceedance for 24-hr TSP monitoring at AMS4 was recorded on 22 January 2016.
- 5.4 According to the investigation, no dust generation works was conducted at near the monitoring station during the monitoring and observable dust source from construction activity under Contract No. HY/2011/09. In addition, village lorry which emitted heavy smoke was observed. Therefore, the exceedance is considered not due to the Contract.

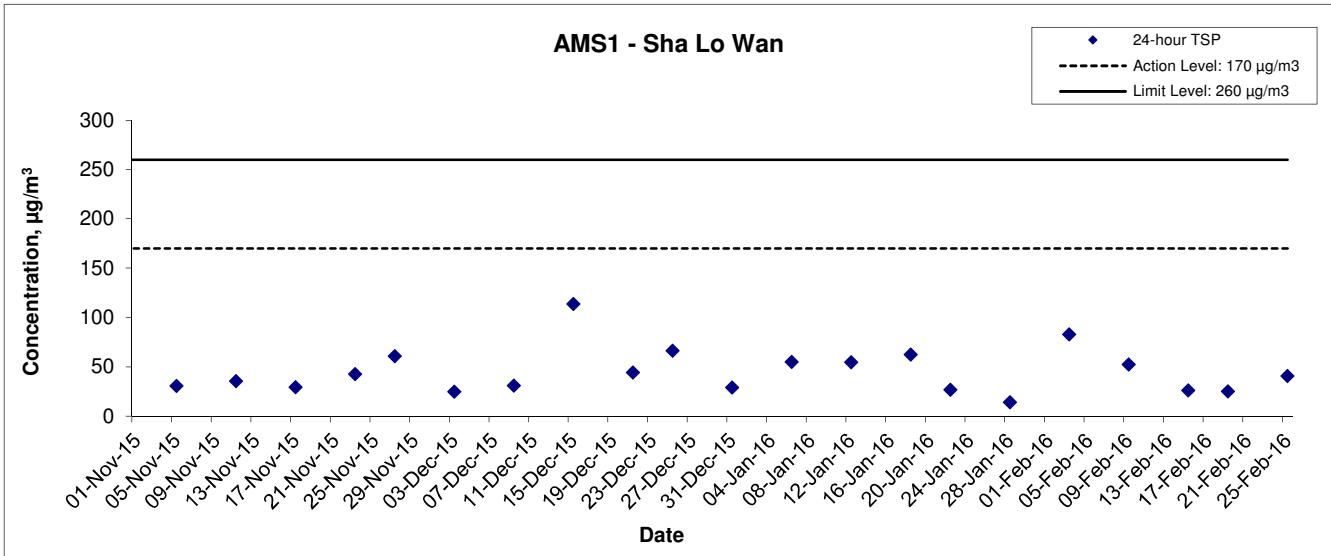
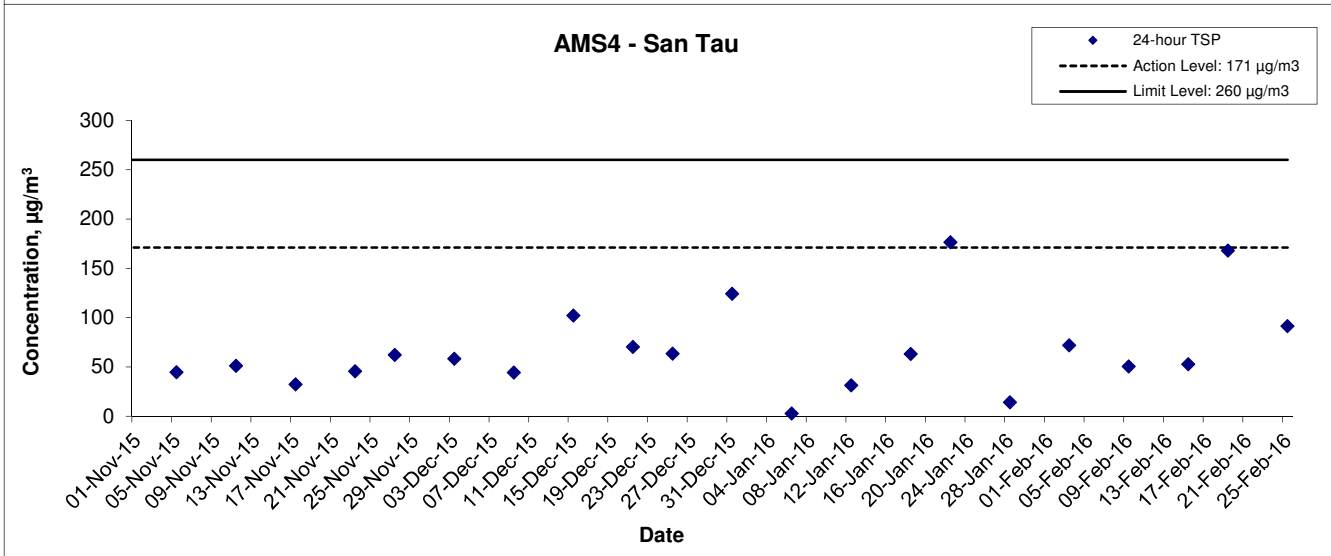
Title Contract No. HY/2011/09 Hong Kong-Zhuhai-Macao Bridge Hong Kong Link Road – Section between HKSAR Boundary and Scenic Hill Graphical Presentation of 24-hour TSP Monitoring Results	Scale N.T.S	Project No. MA12014	
	Date Feb 16	Appendix C

24-hour TSP Concentration Levels

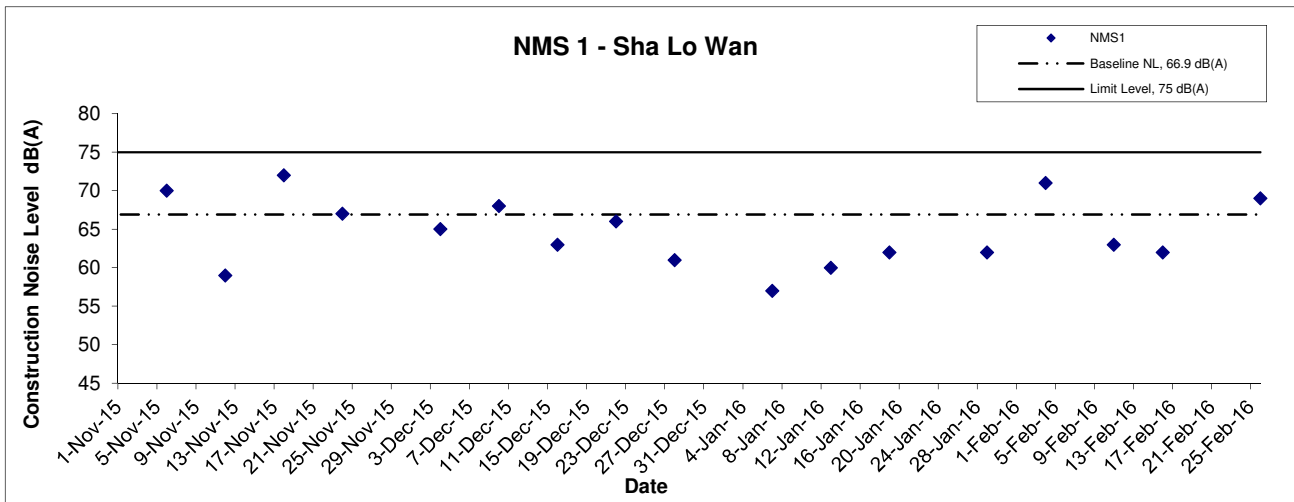
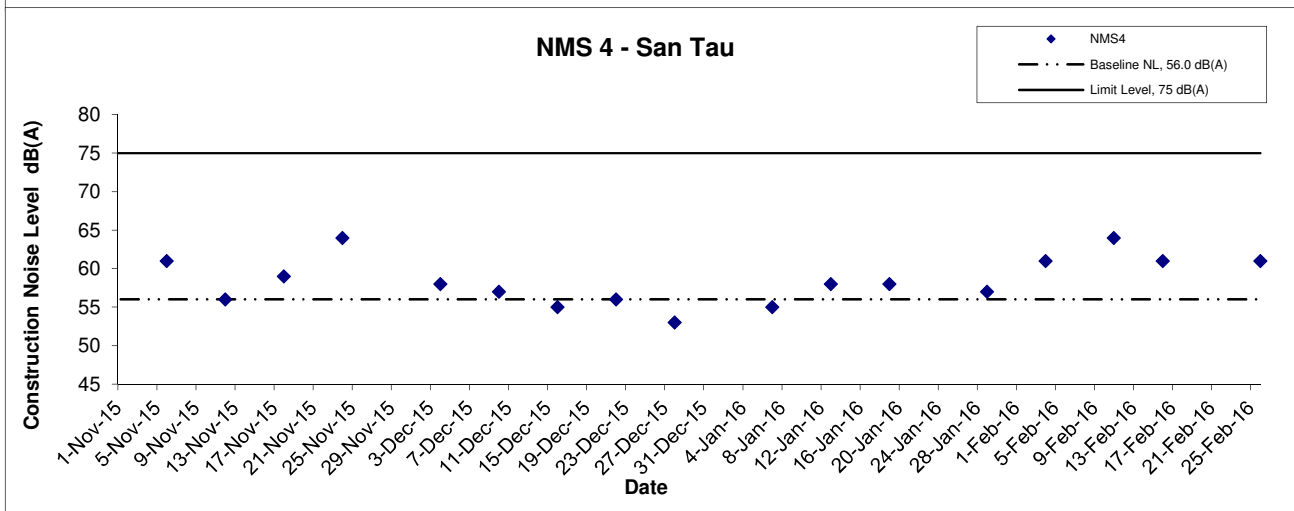
Title Contract HY/2011/09 Hong Kong-Zhuhai-Macao Bridge Hong Kong Link Road-Section between HKSAR Boundary and Scenic Hill Graphical Presentation of Construction Noise Monitoring Results	Scale N.T.S	Project No. MA12014	
	Date Feb 16	Appendix D

Noise Levels

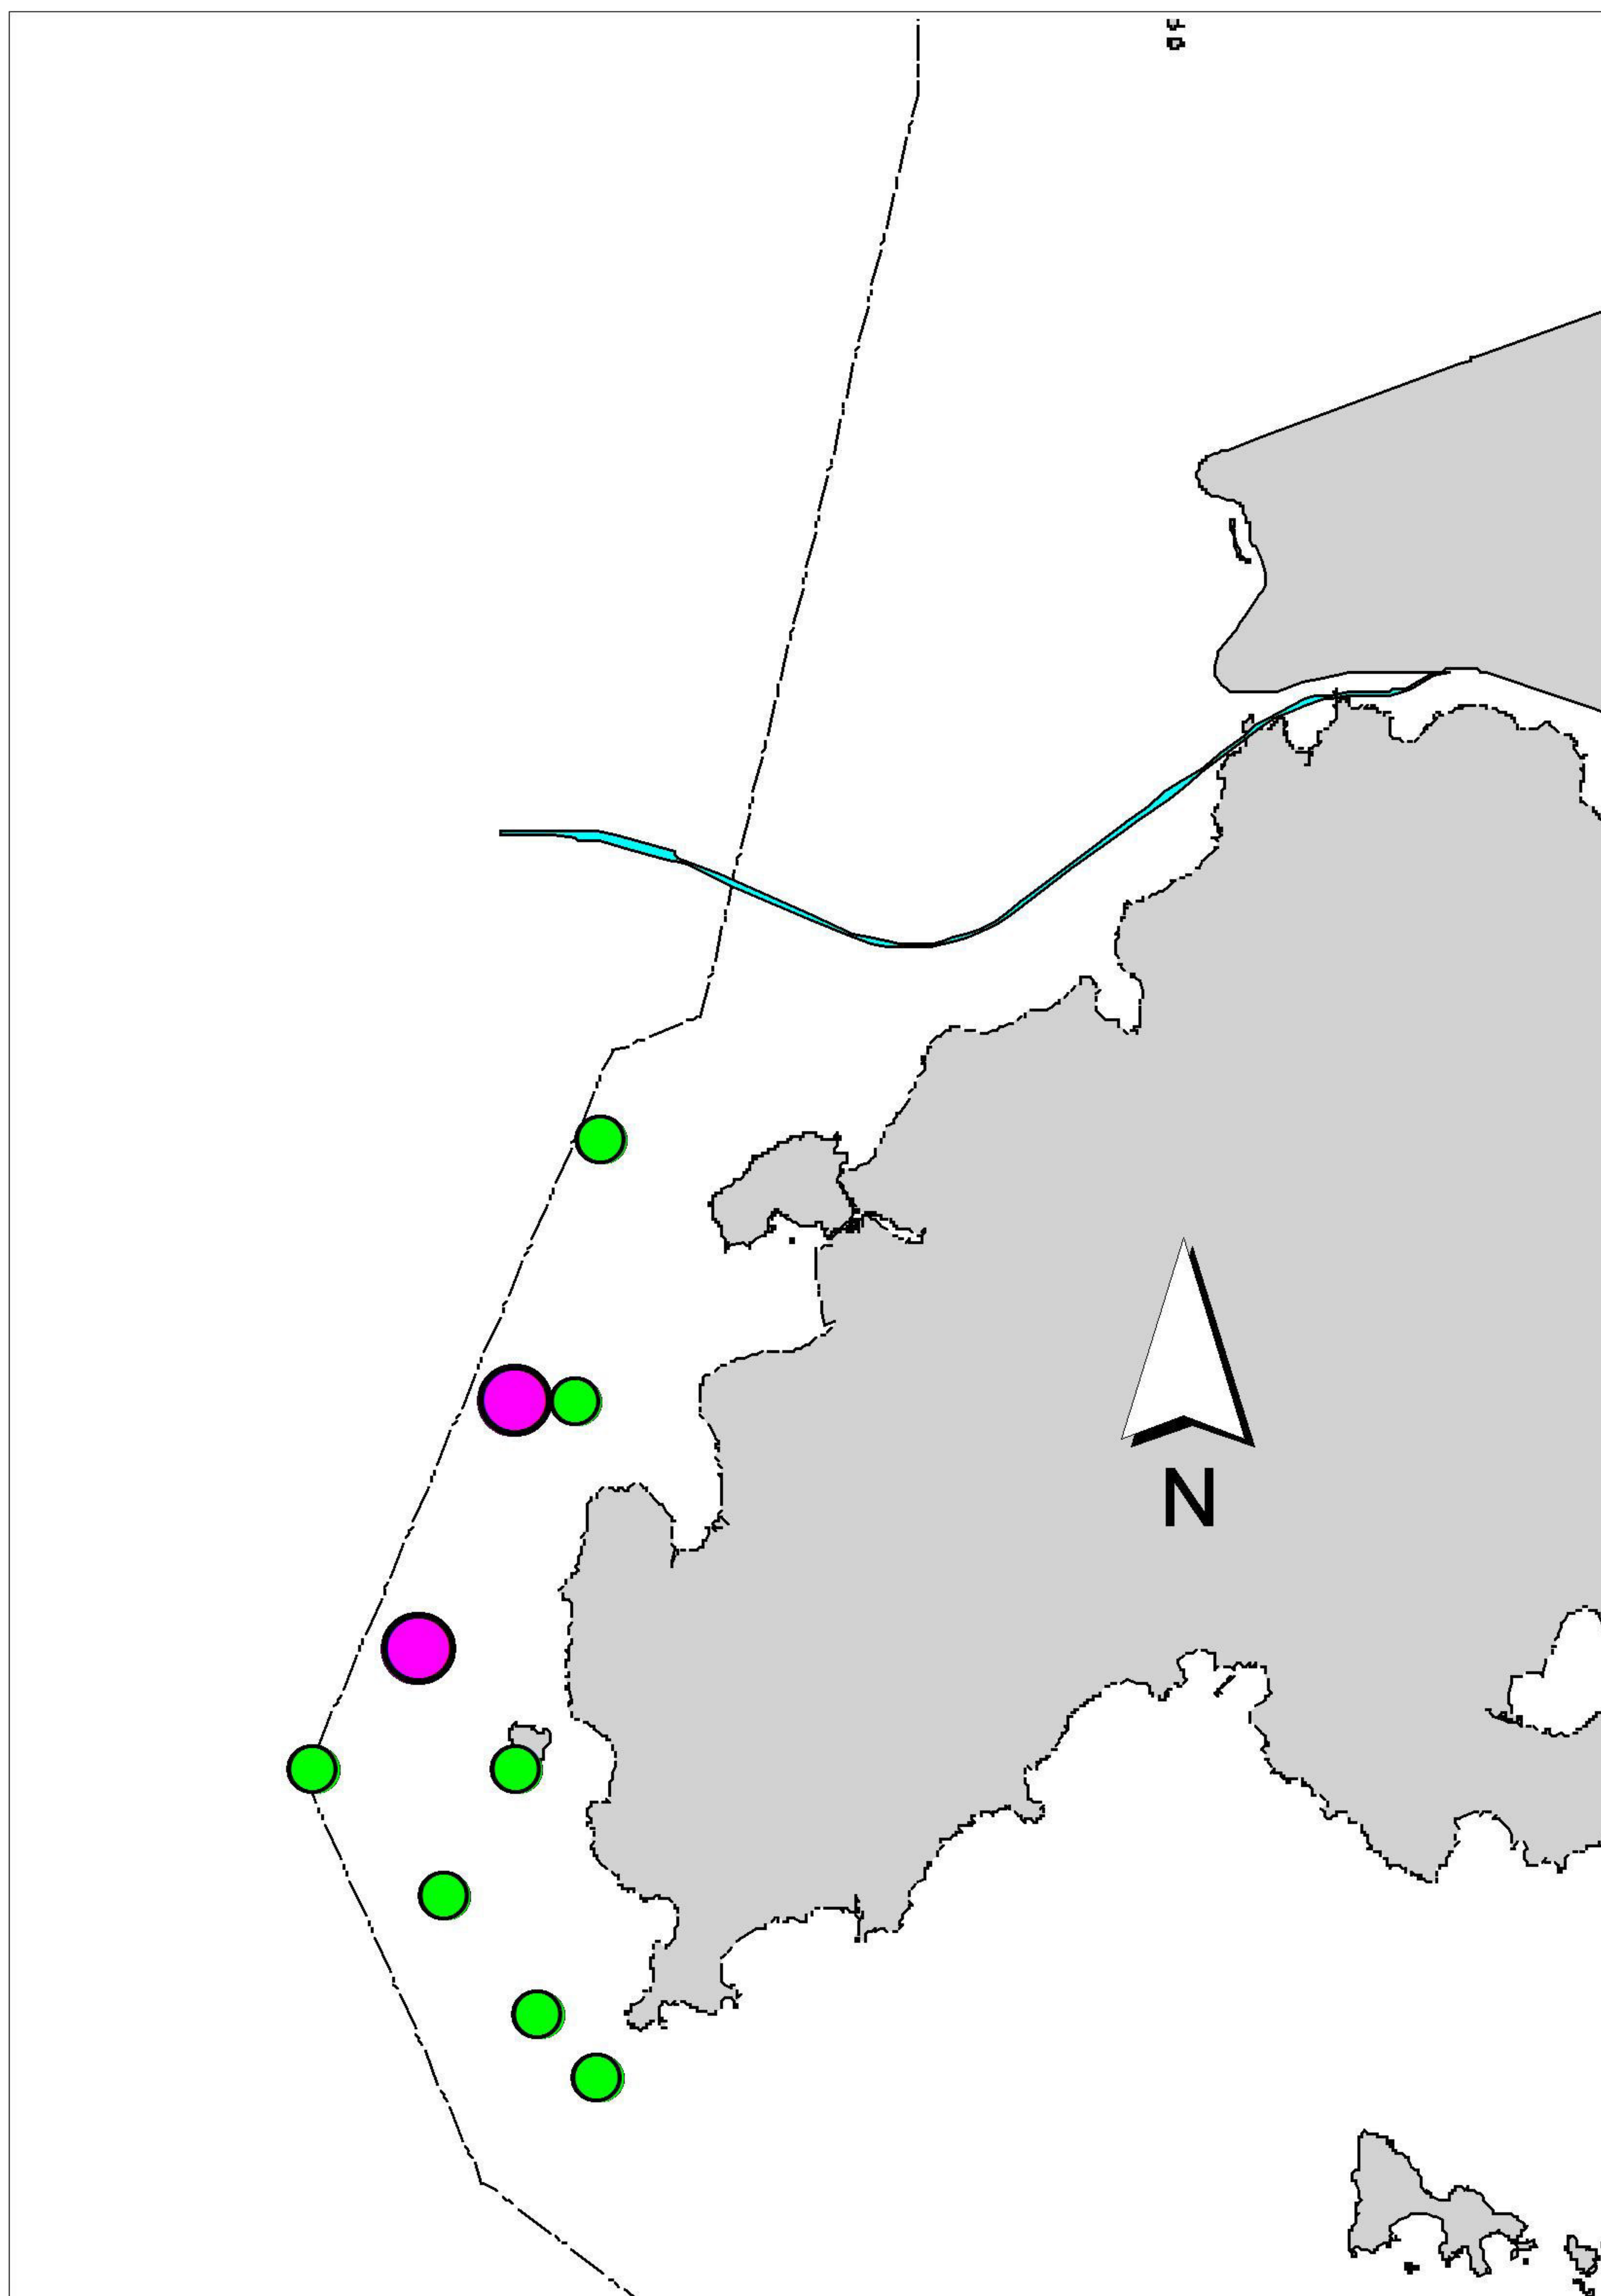
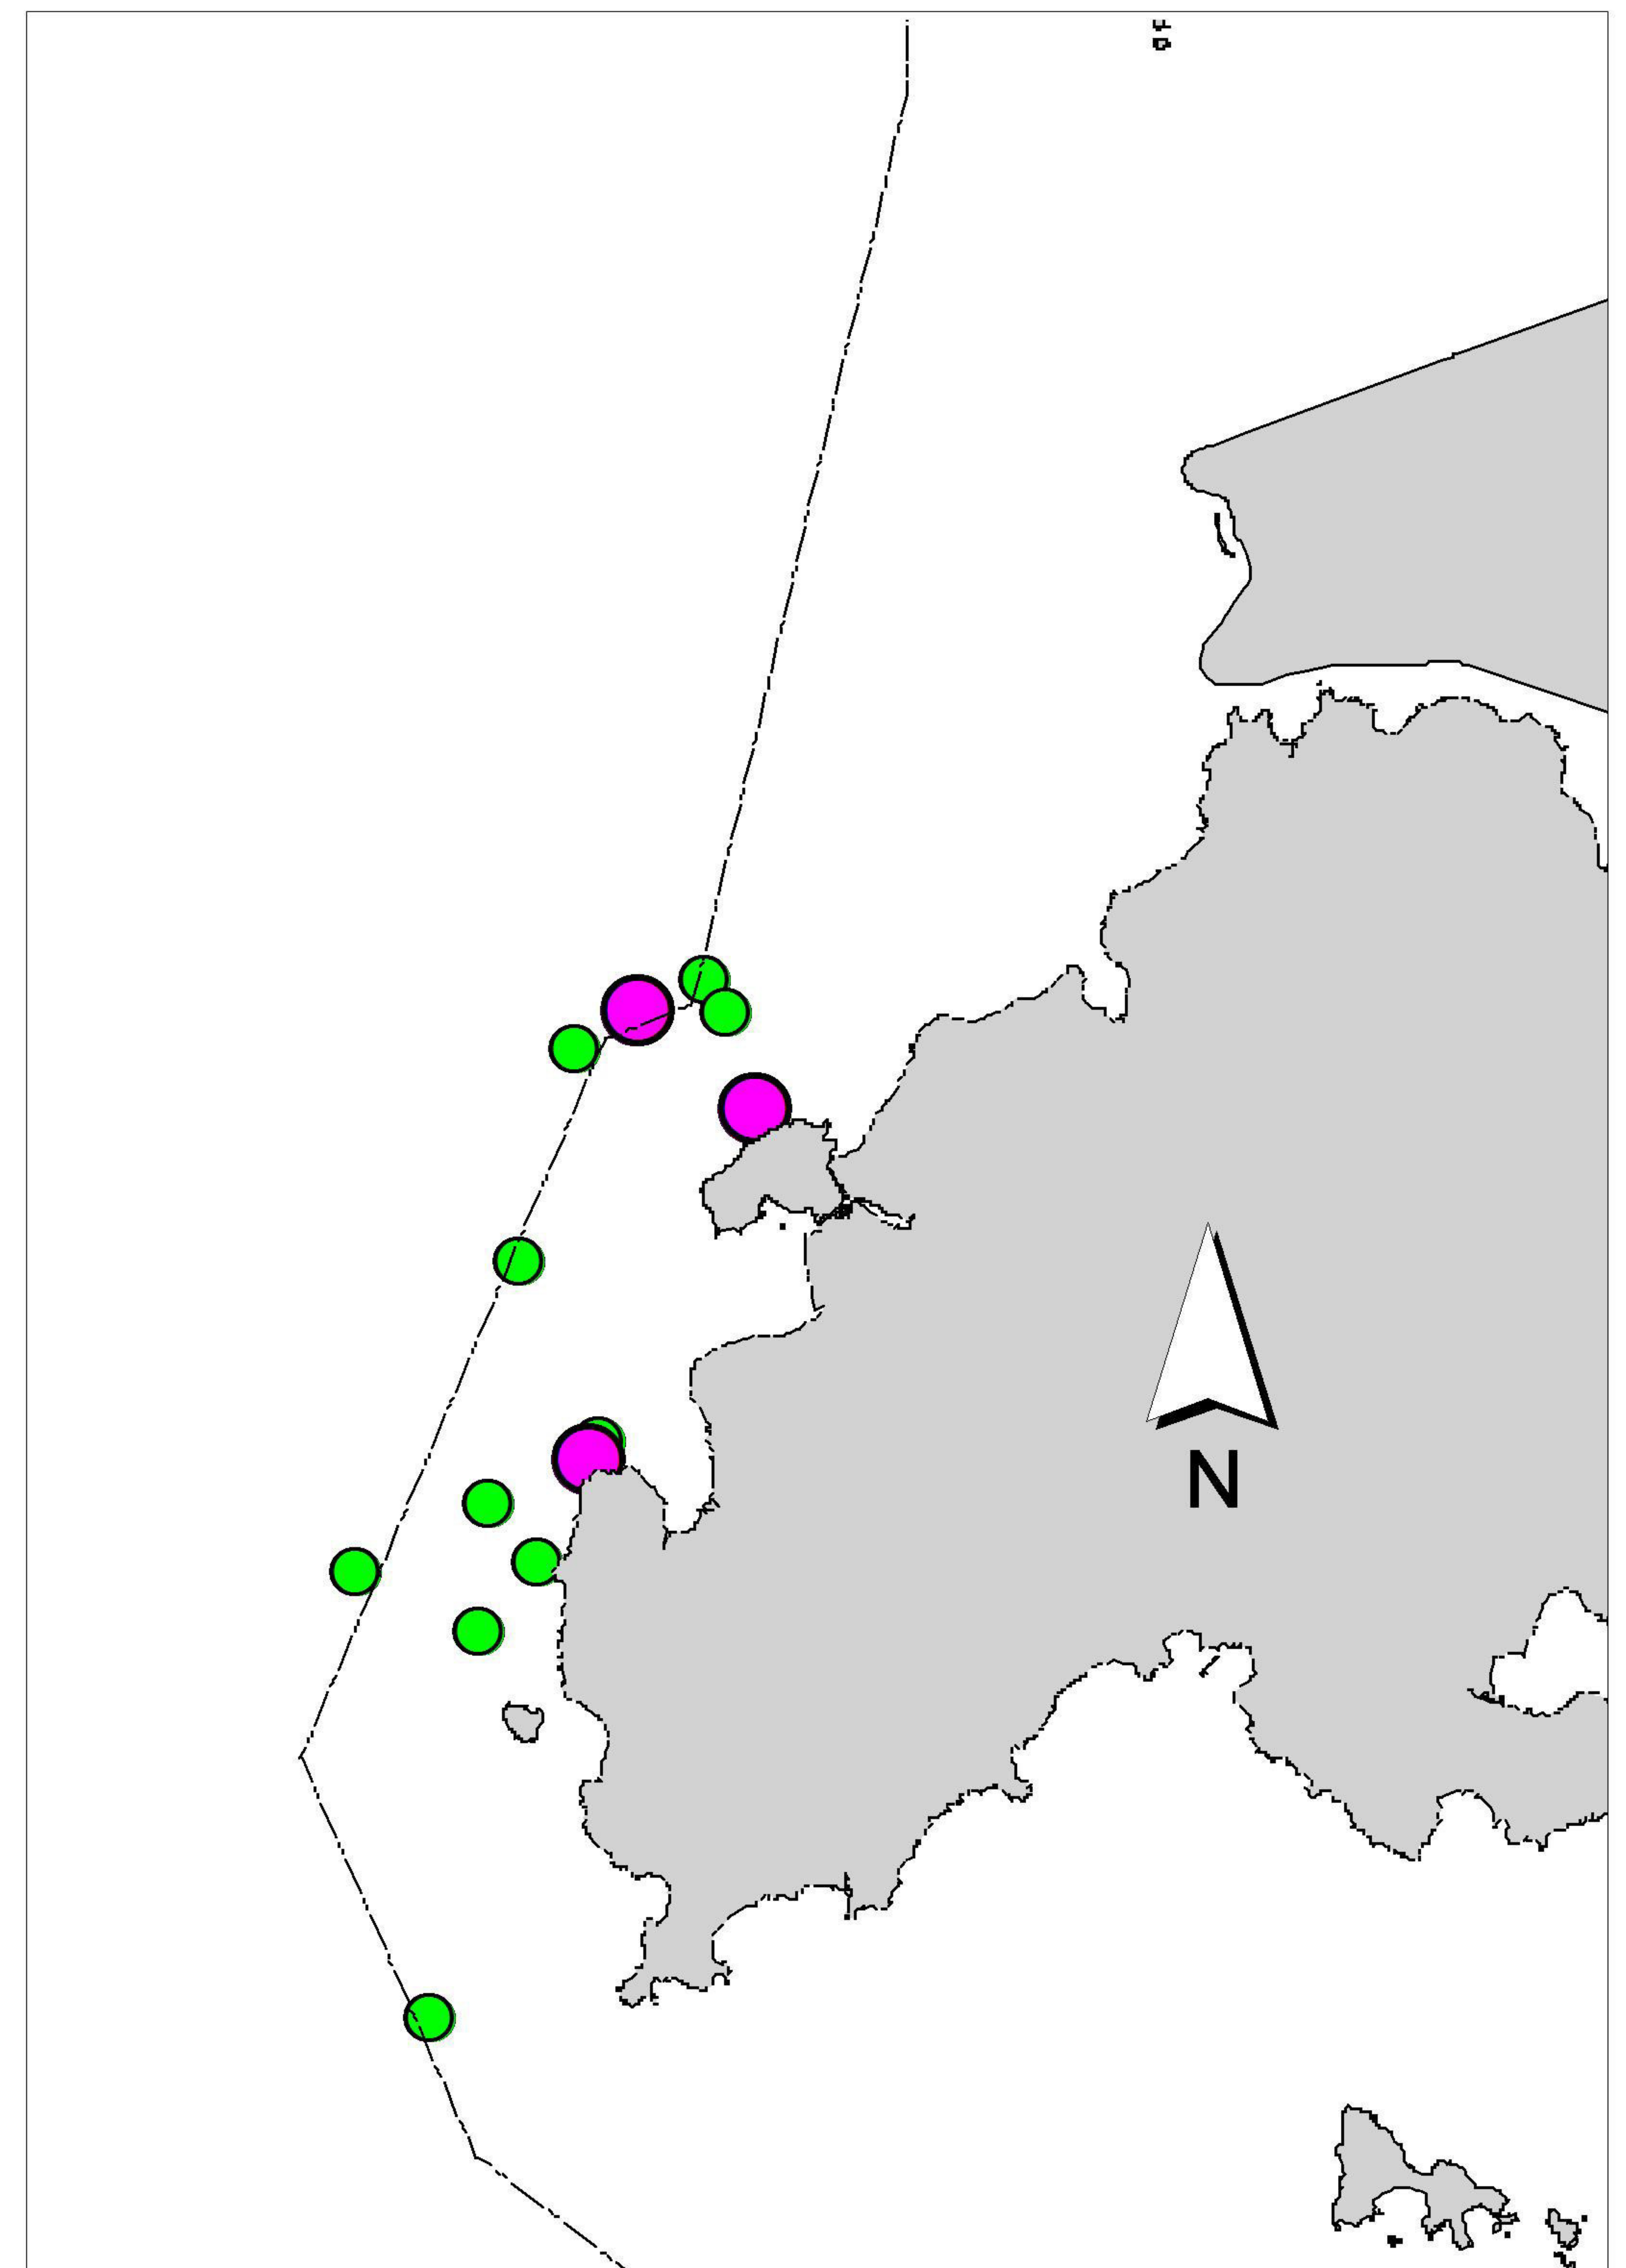
Figure 4. Distribution of Chinese white dolphins with larger group sizes during HKLR09 impact phase (left: December 2015 – February 2016) and baseline monitoring surveys (right: September – November 2011) (green dots: group sizes of 5 or more; purple dots: group sizes of 10 or more)

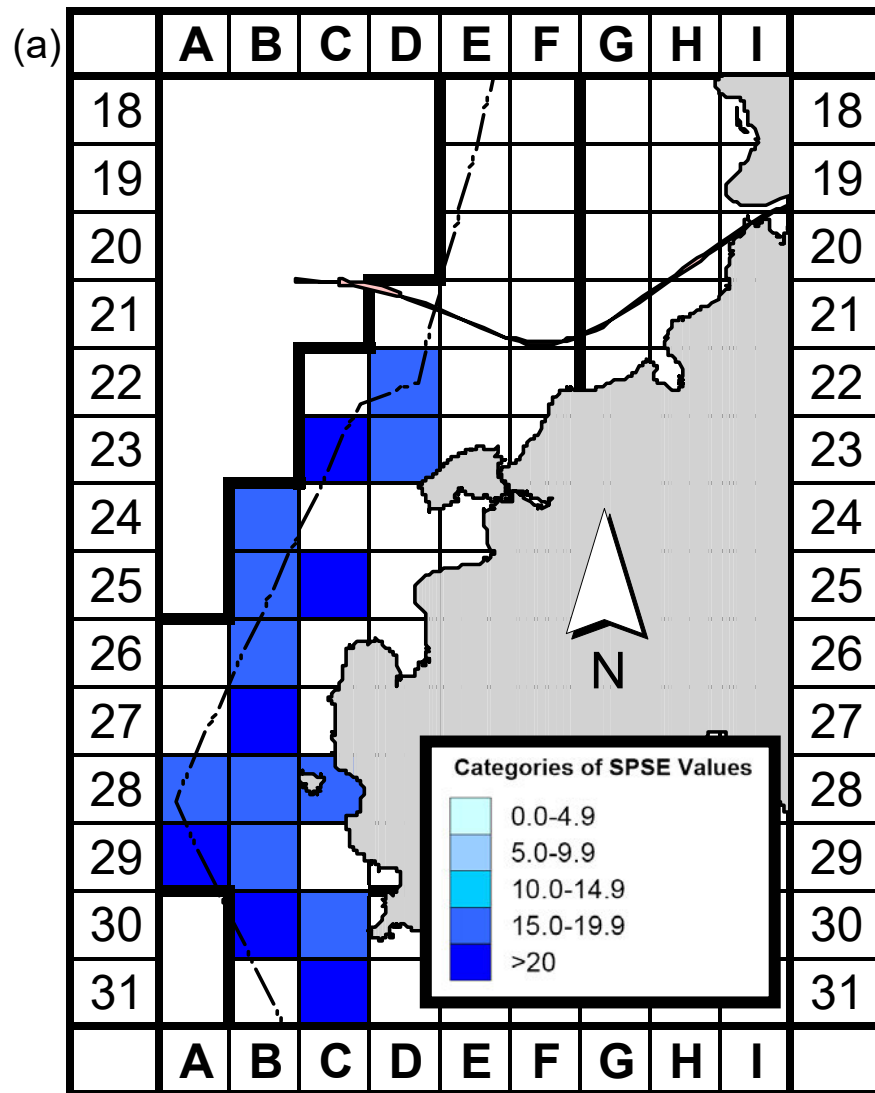
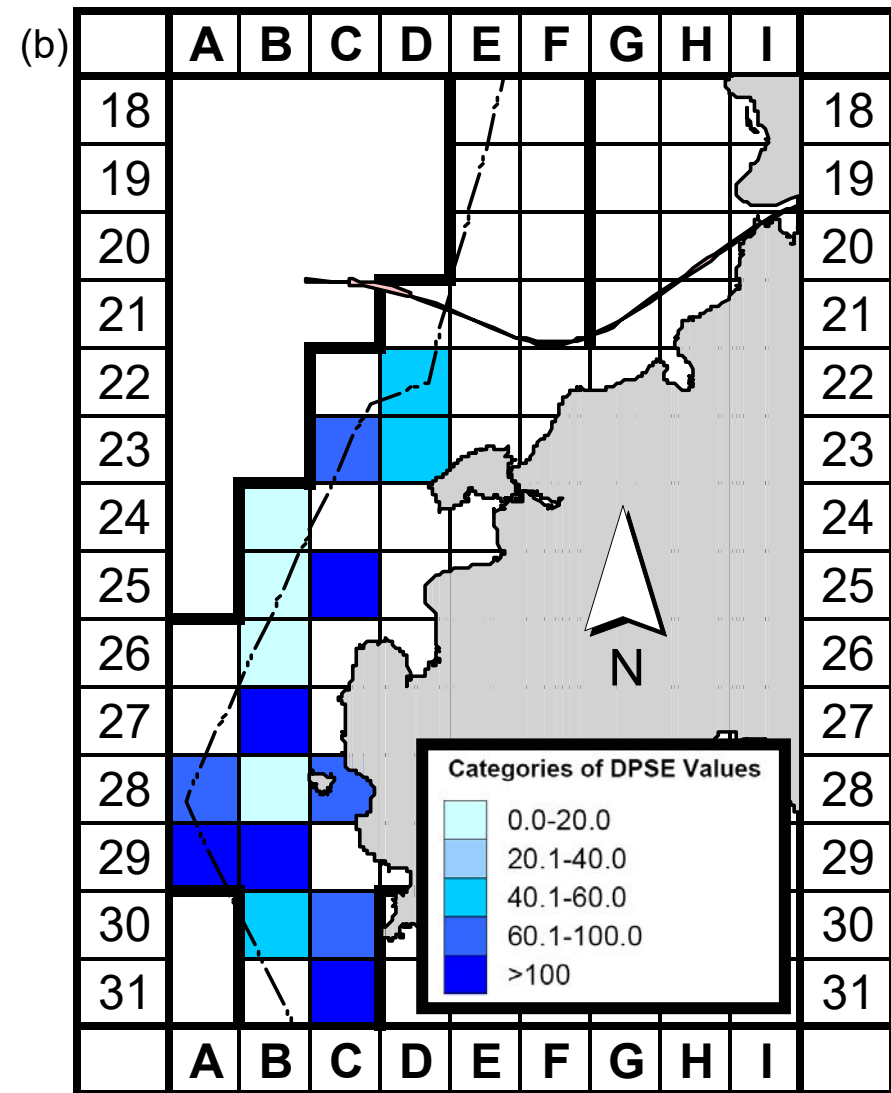
Figure 5a. Sighting density of Chinese white dolphins with corrected survey effort per km² in West Lantau survey area, using data collected during HKLR09 impact monitoring period (Dec 15-Feb 16) (SPSE = no. of on-effort sightings per 100 units of survey effort)

- 4.23 From December 2015 to February 2016, the most heavily utilized habitats by the dolphins were primarily found between Kai Kung Shan and Fan Lau, while a few grids near Tai O Peninsula and Yi O also recorded higher dolphin densities (**Figures 5a and 5b of Appendix F**). However, it should be cautioned that the amount of survey effort

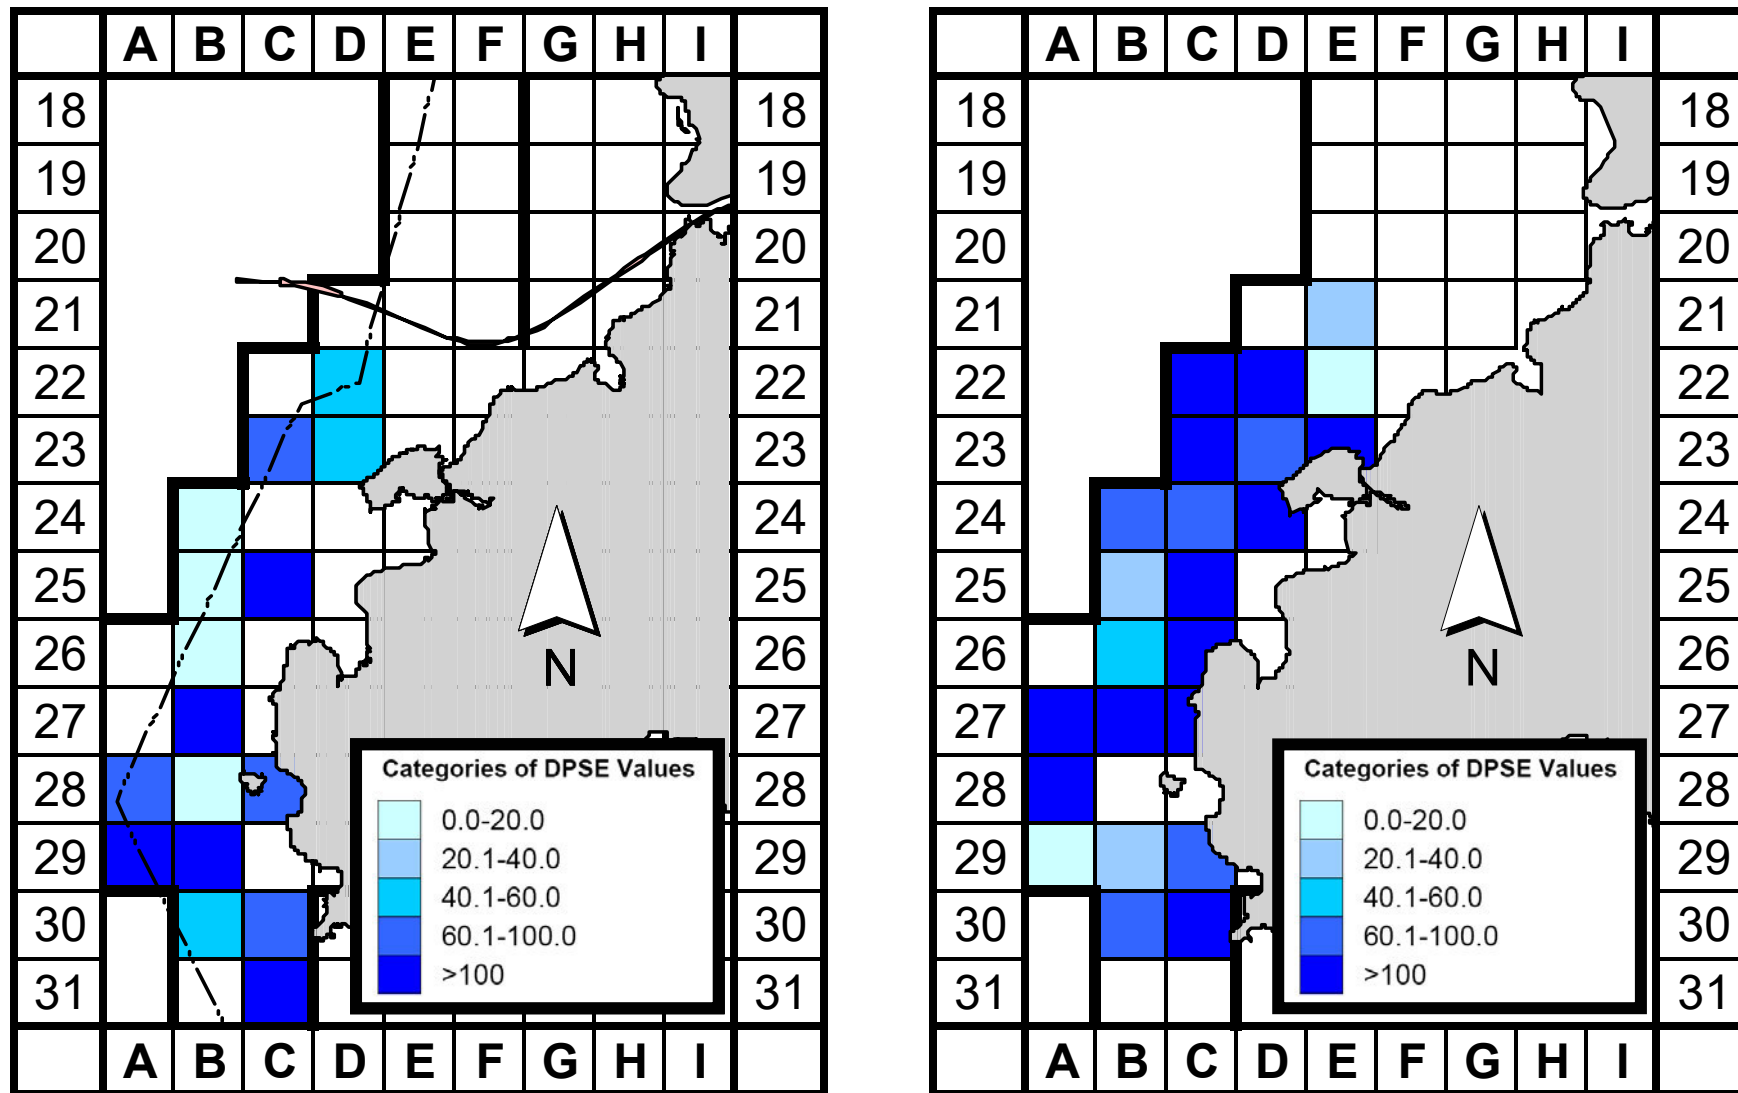
Figure 6. Comparison of density of Chinese white dolphins with corrected survey effort per km² in West Lantau survey area between the impact monitoring period (December 2015 - February 2016; left) and baseline monitoring period (September-November 2011; right) (DPSE = no. of dolphins per 100 units of survey effort)
