Contract No. HY/2011/09
Hong Kong-Zhuhai-Macao Bridge
Hong Kong Link Road – Section between HKSAR Boundary and Scenic Hill

Quarterly EM&A Report – December 2015 to February 2016

**Contract No. HY/2011/09 HZMB Hong Kong Link Road –
Section between HKSAR Boundary and Scenic Hill
Quarterly EM&A Report No. 12 for December 2015 to February 2016**

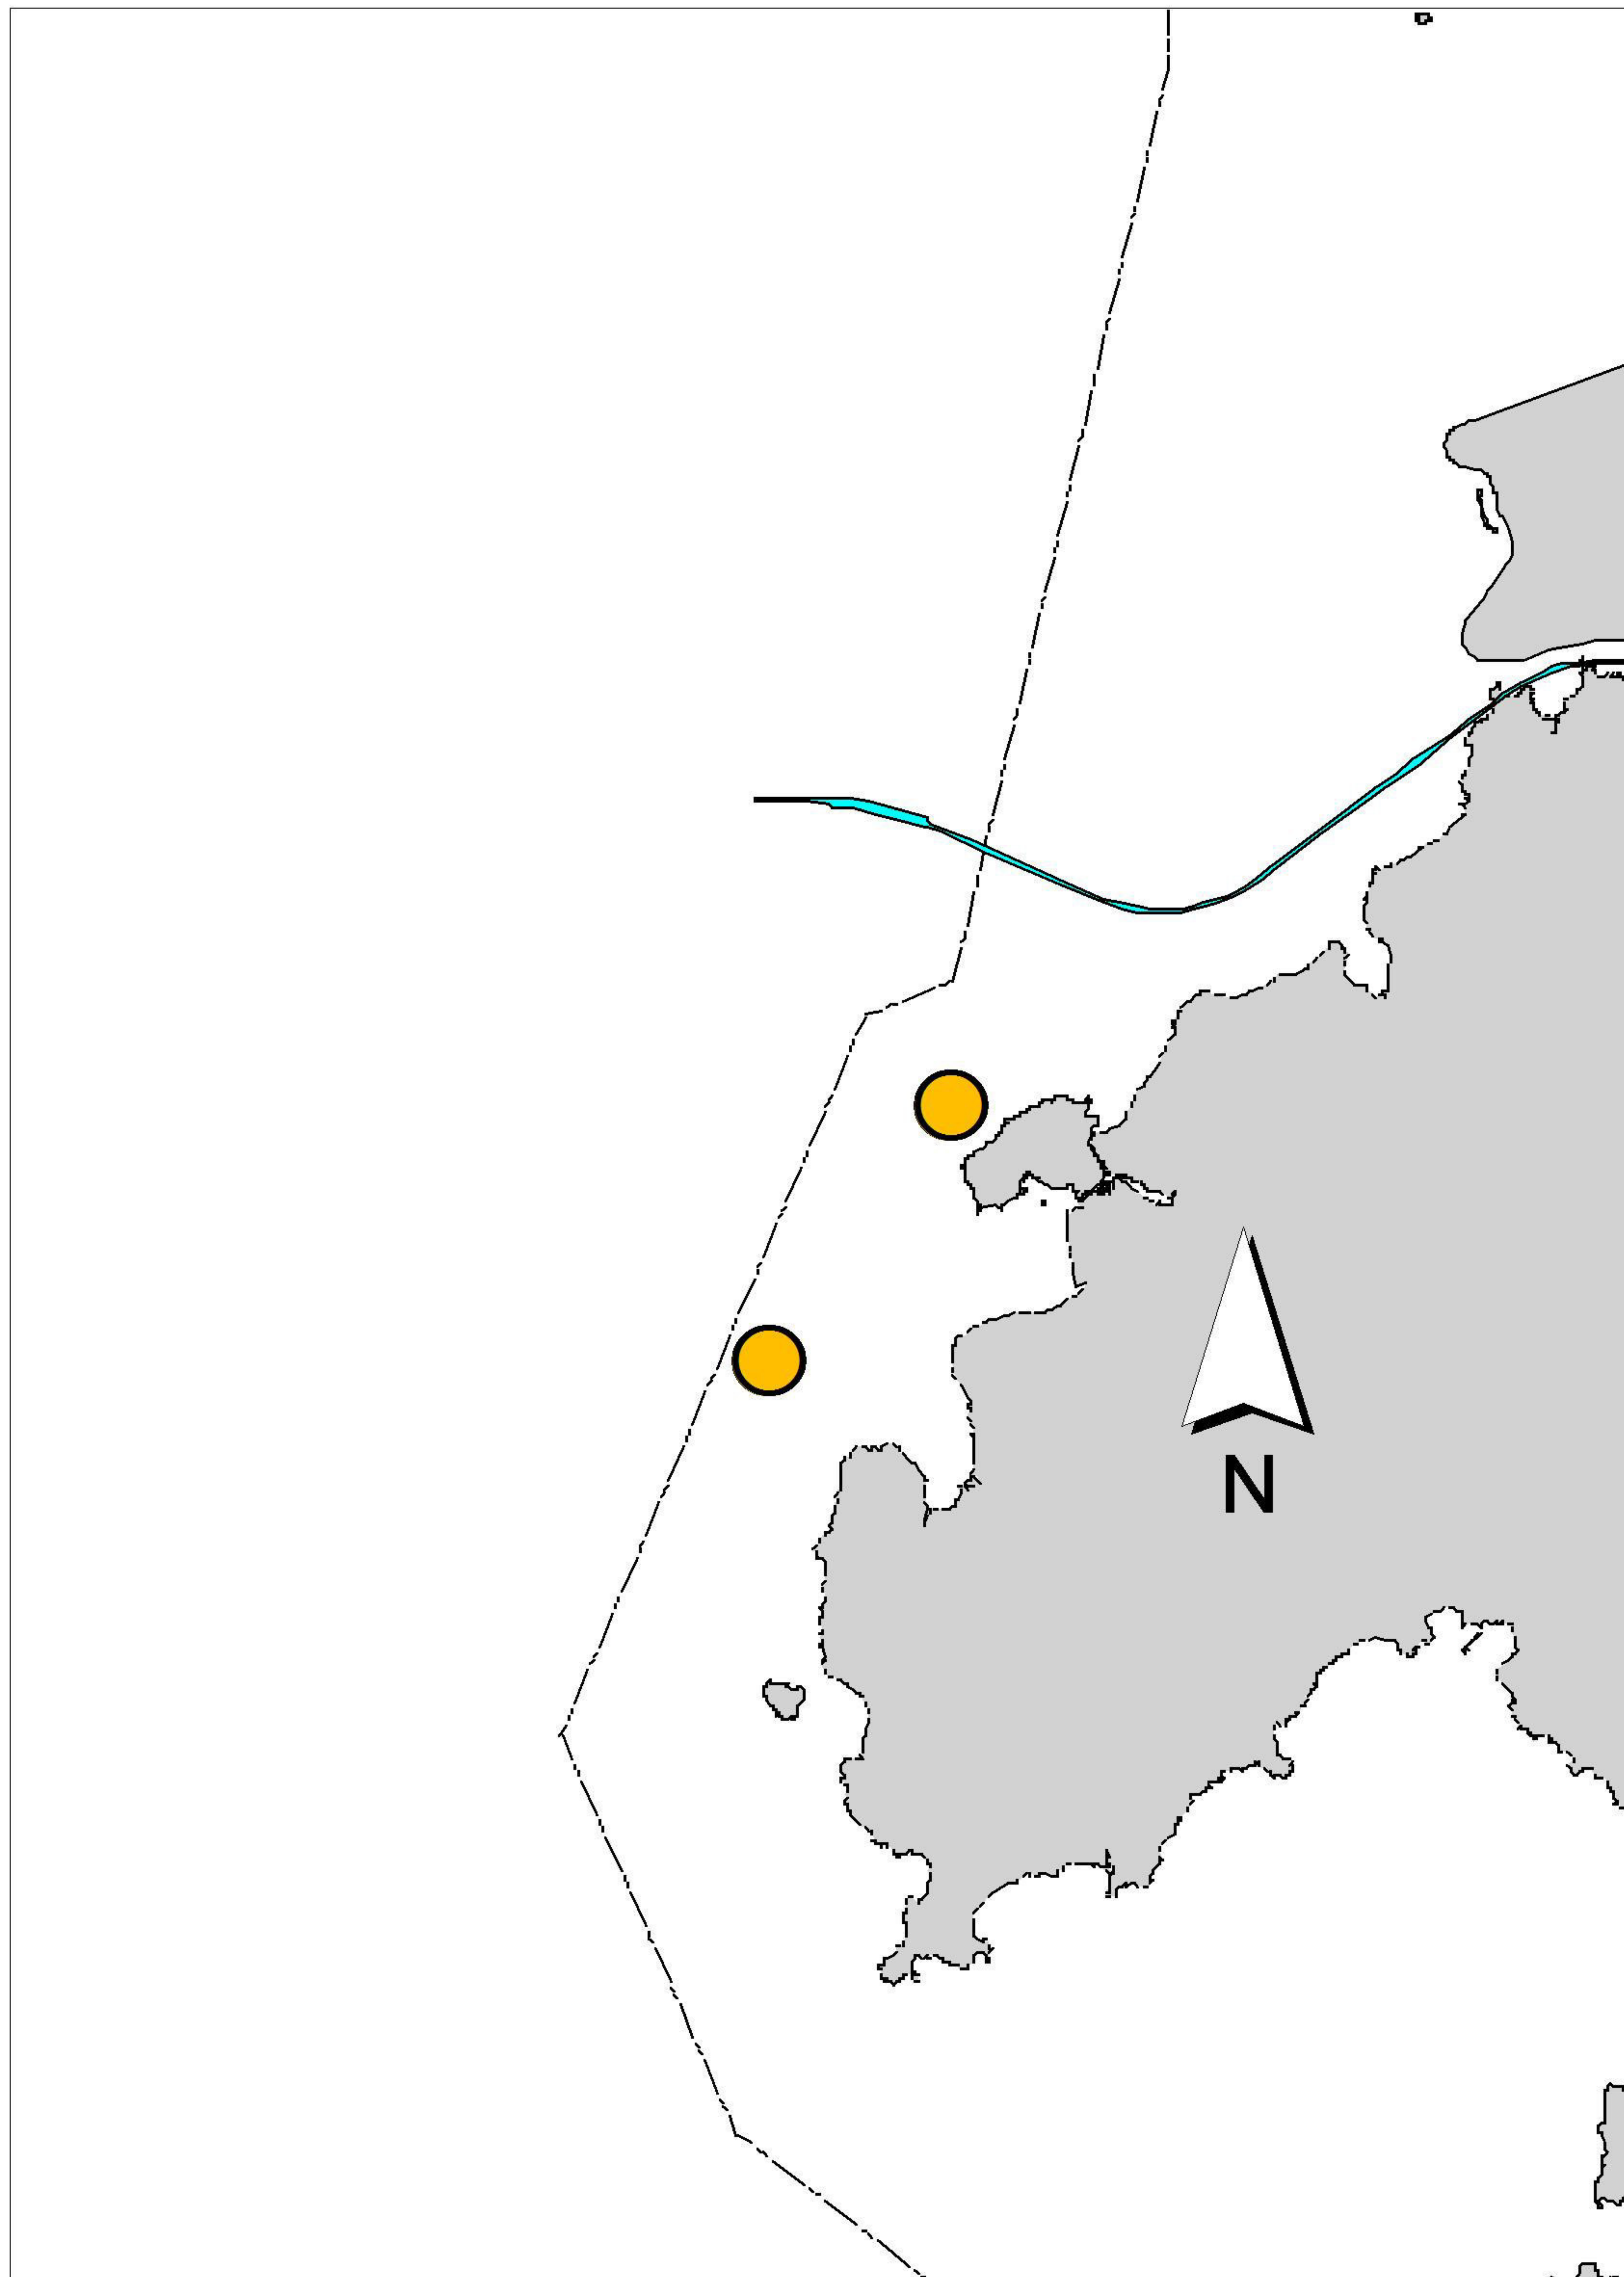
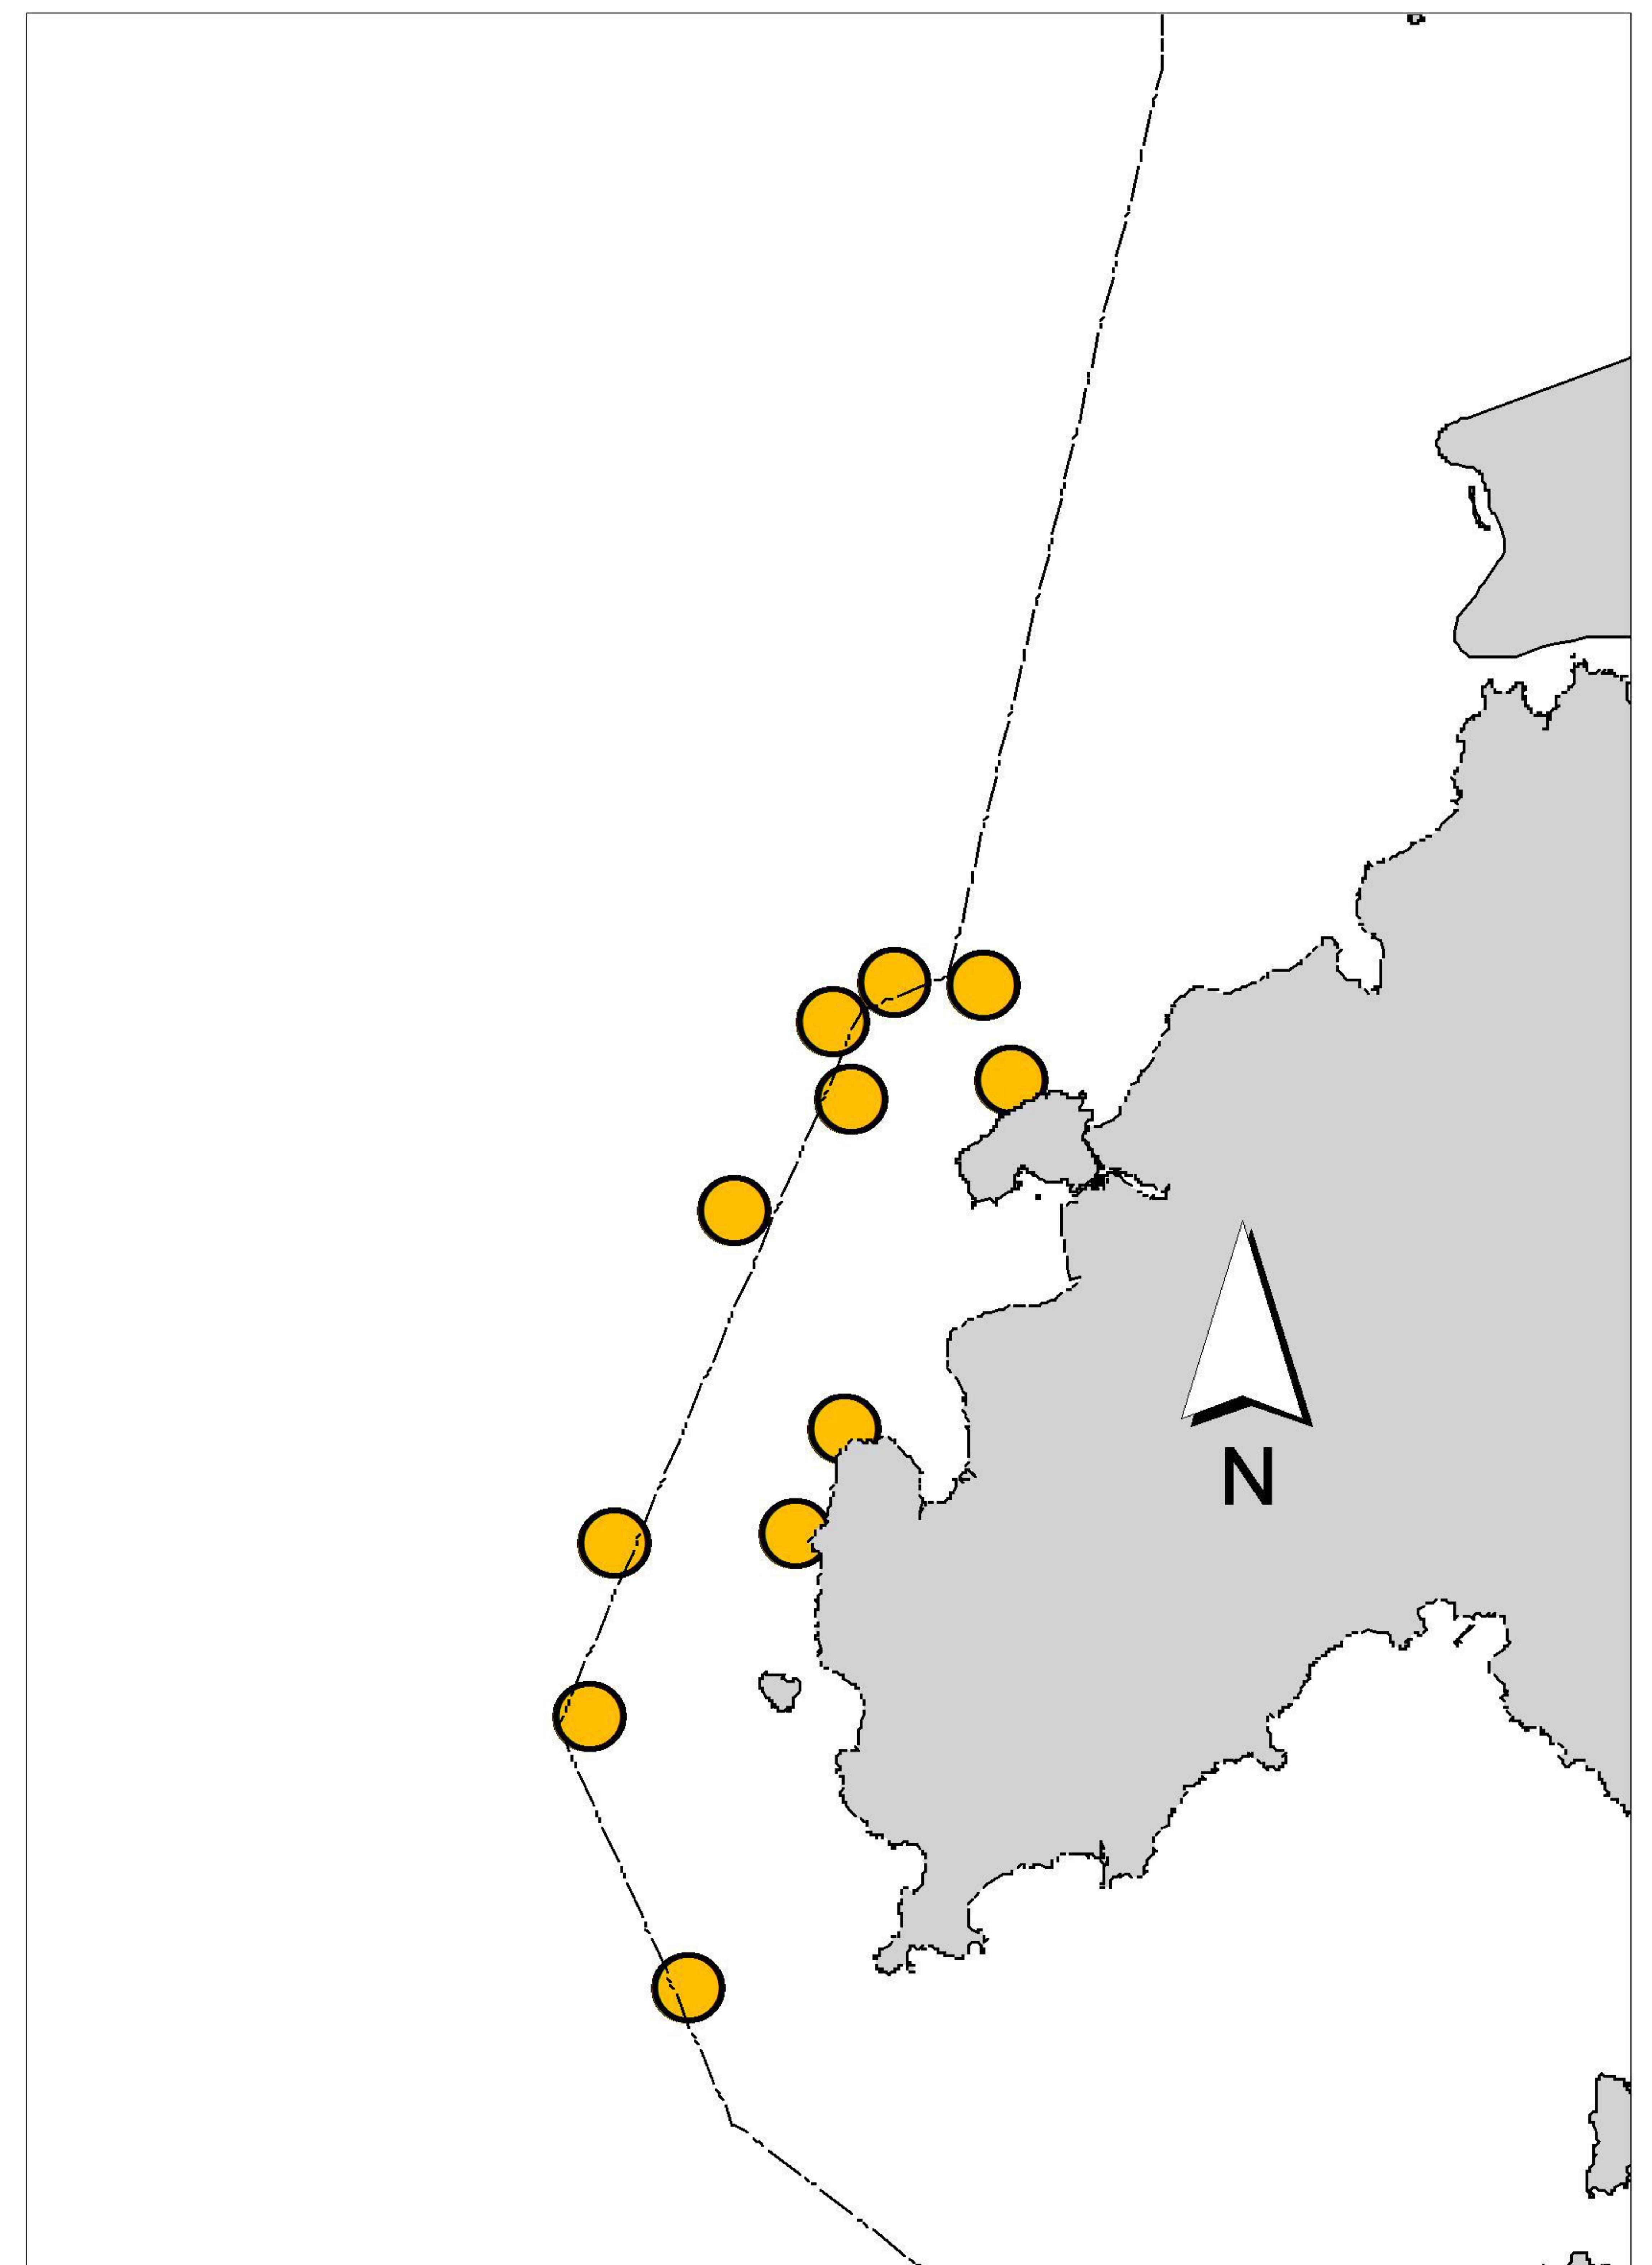
Figure 7. Distribution of young calves of Chinese white dolphins during HKLR09 impact phase (left: December 2015 – February 2016) and baseline monitoring surveys (right: September – November 2011)

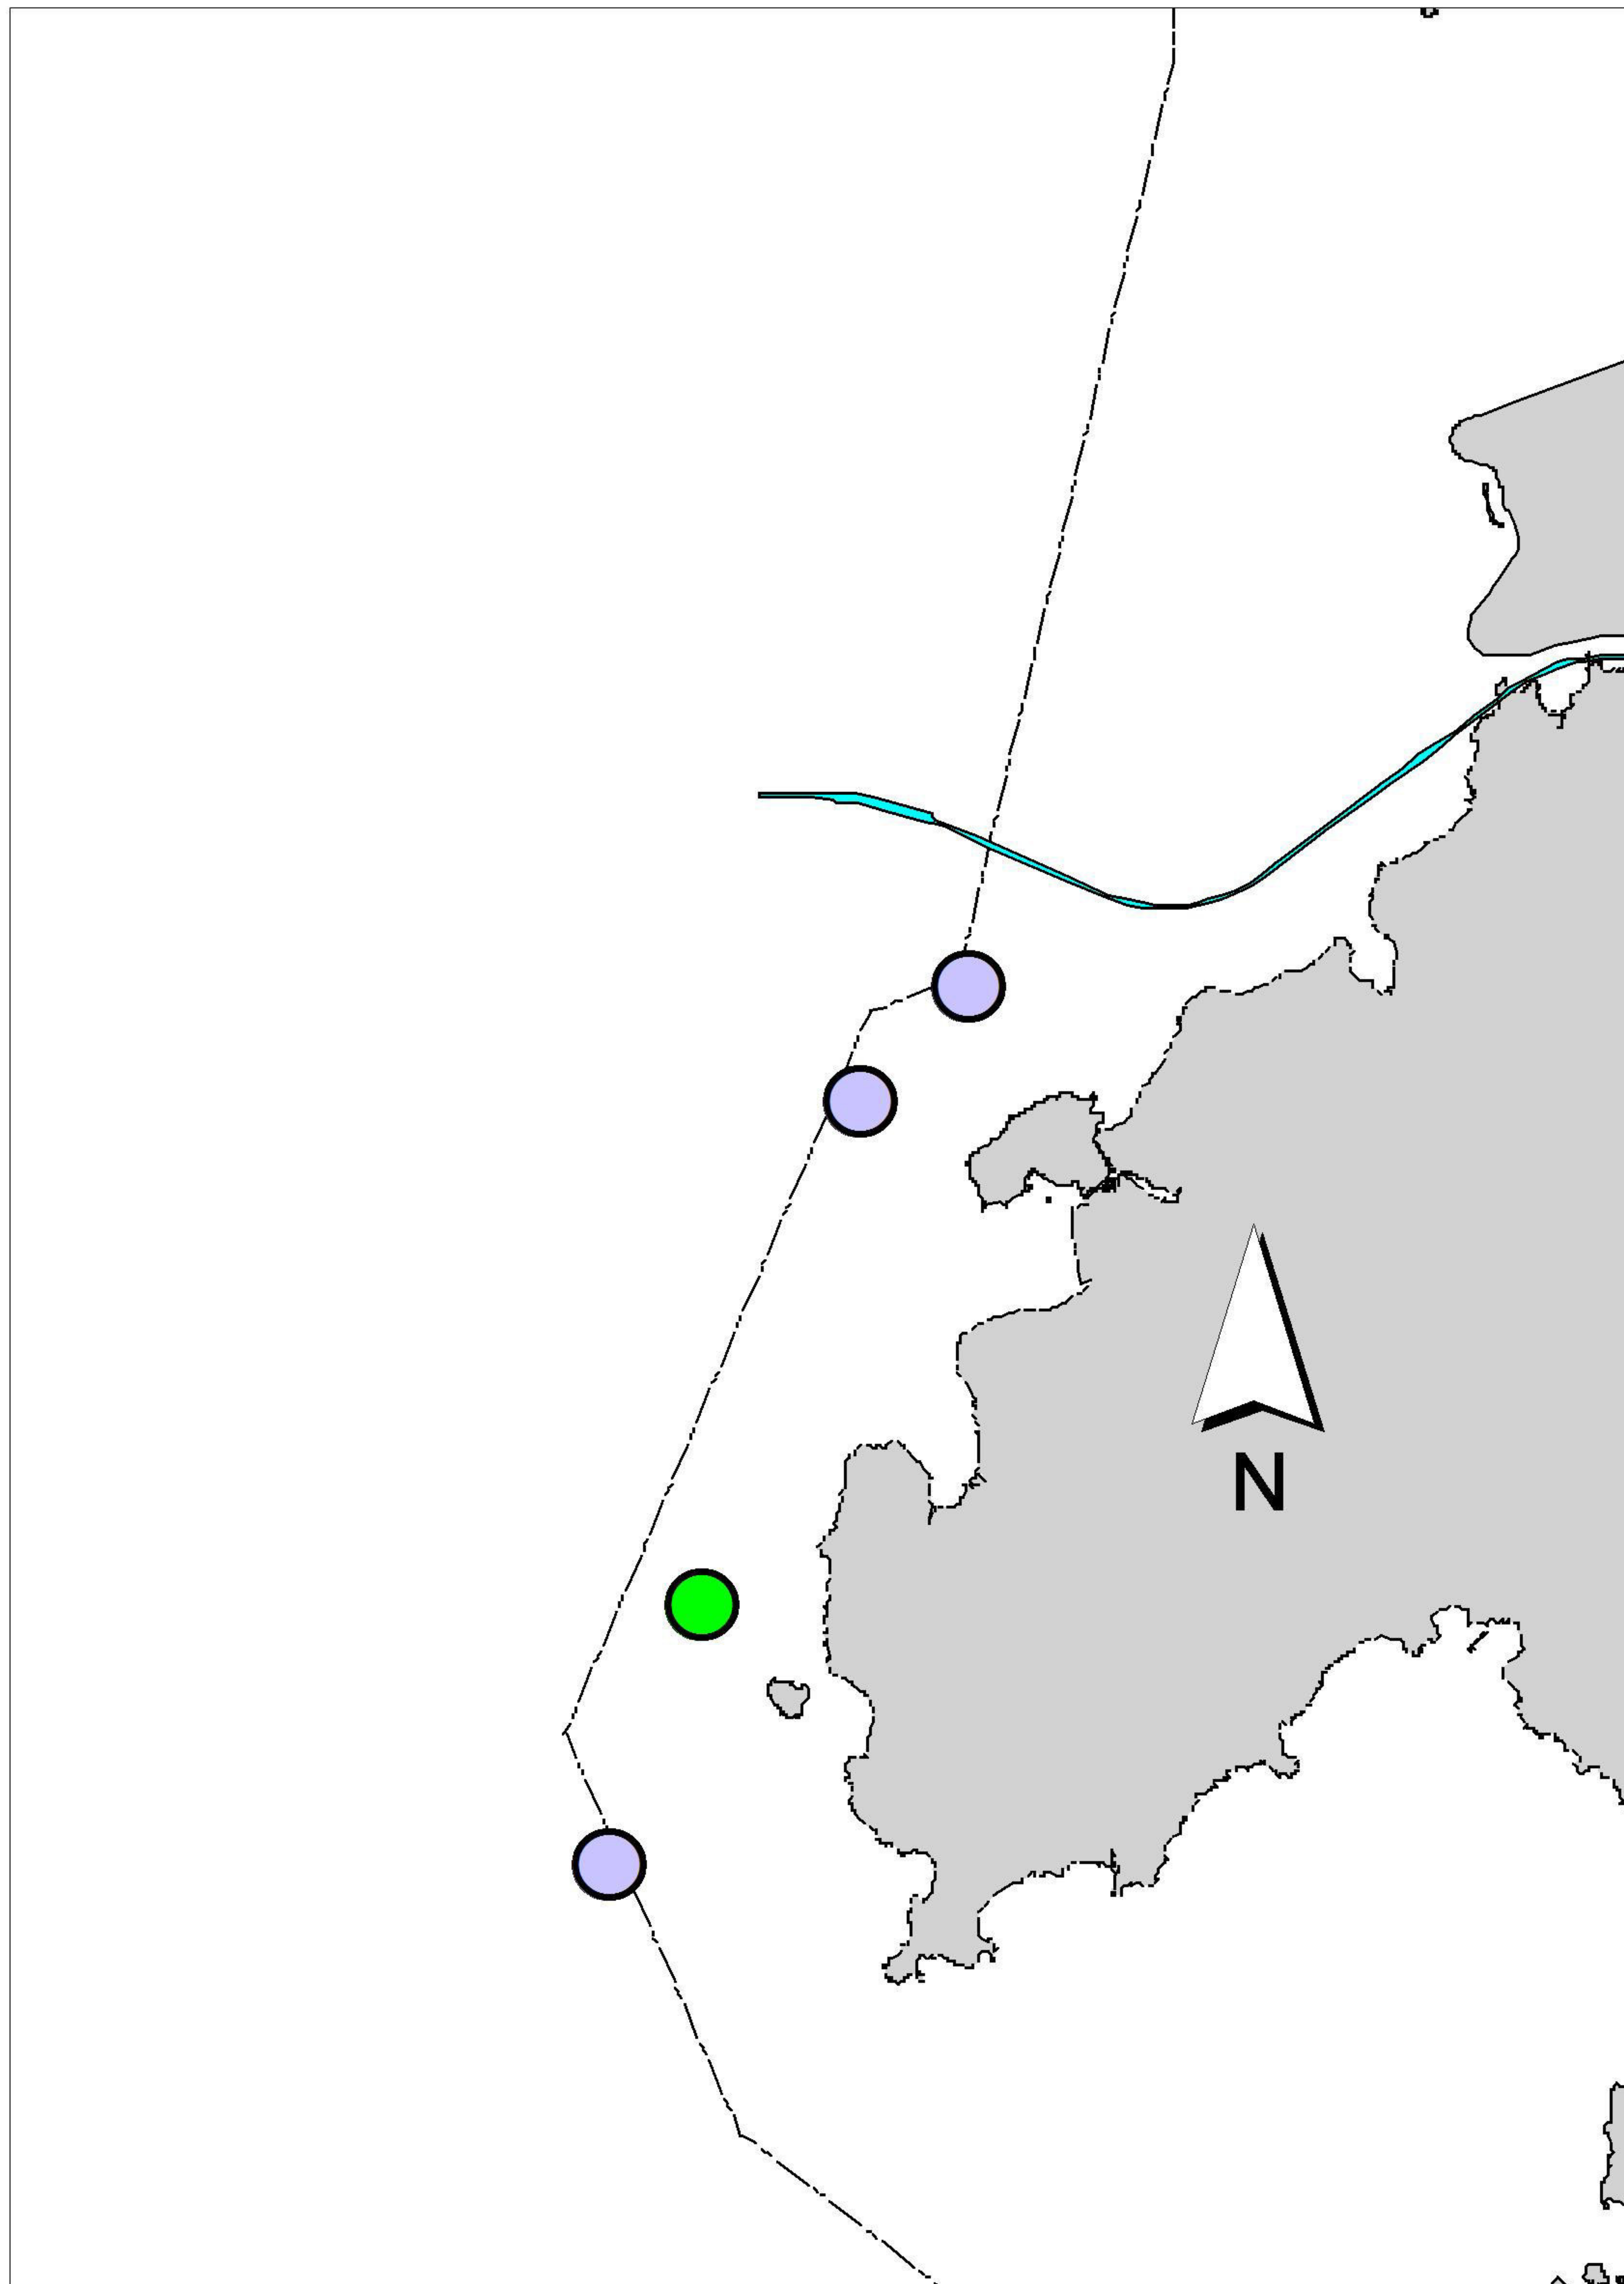
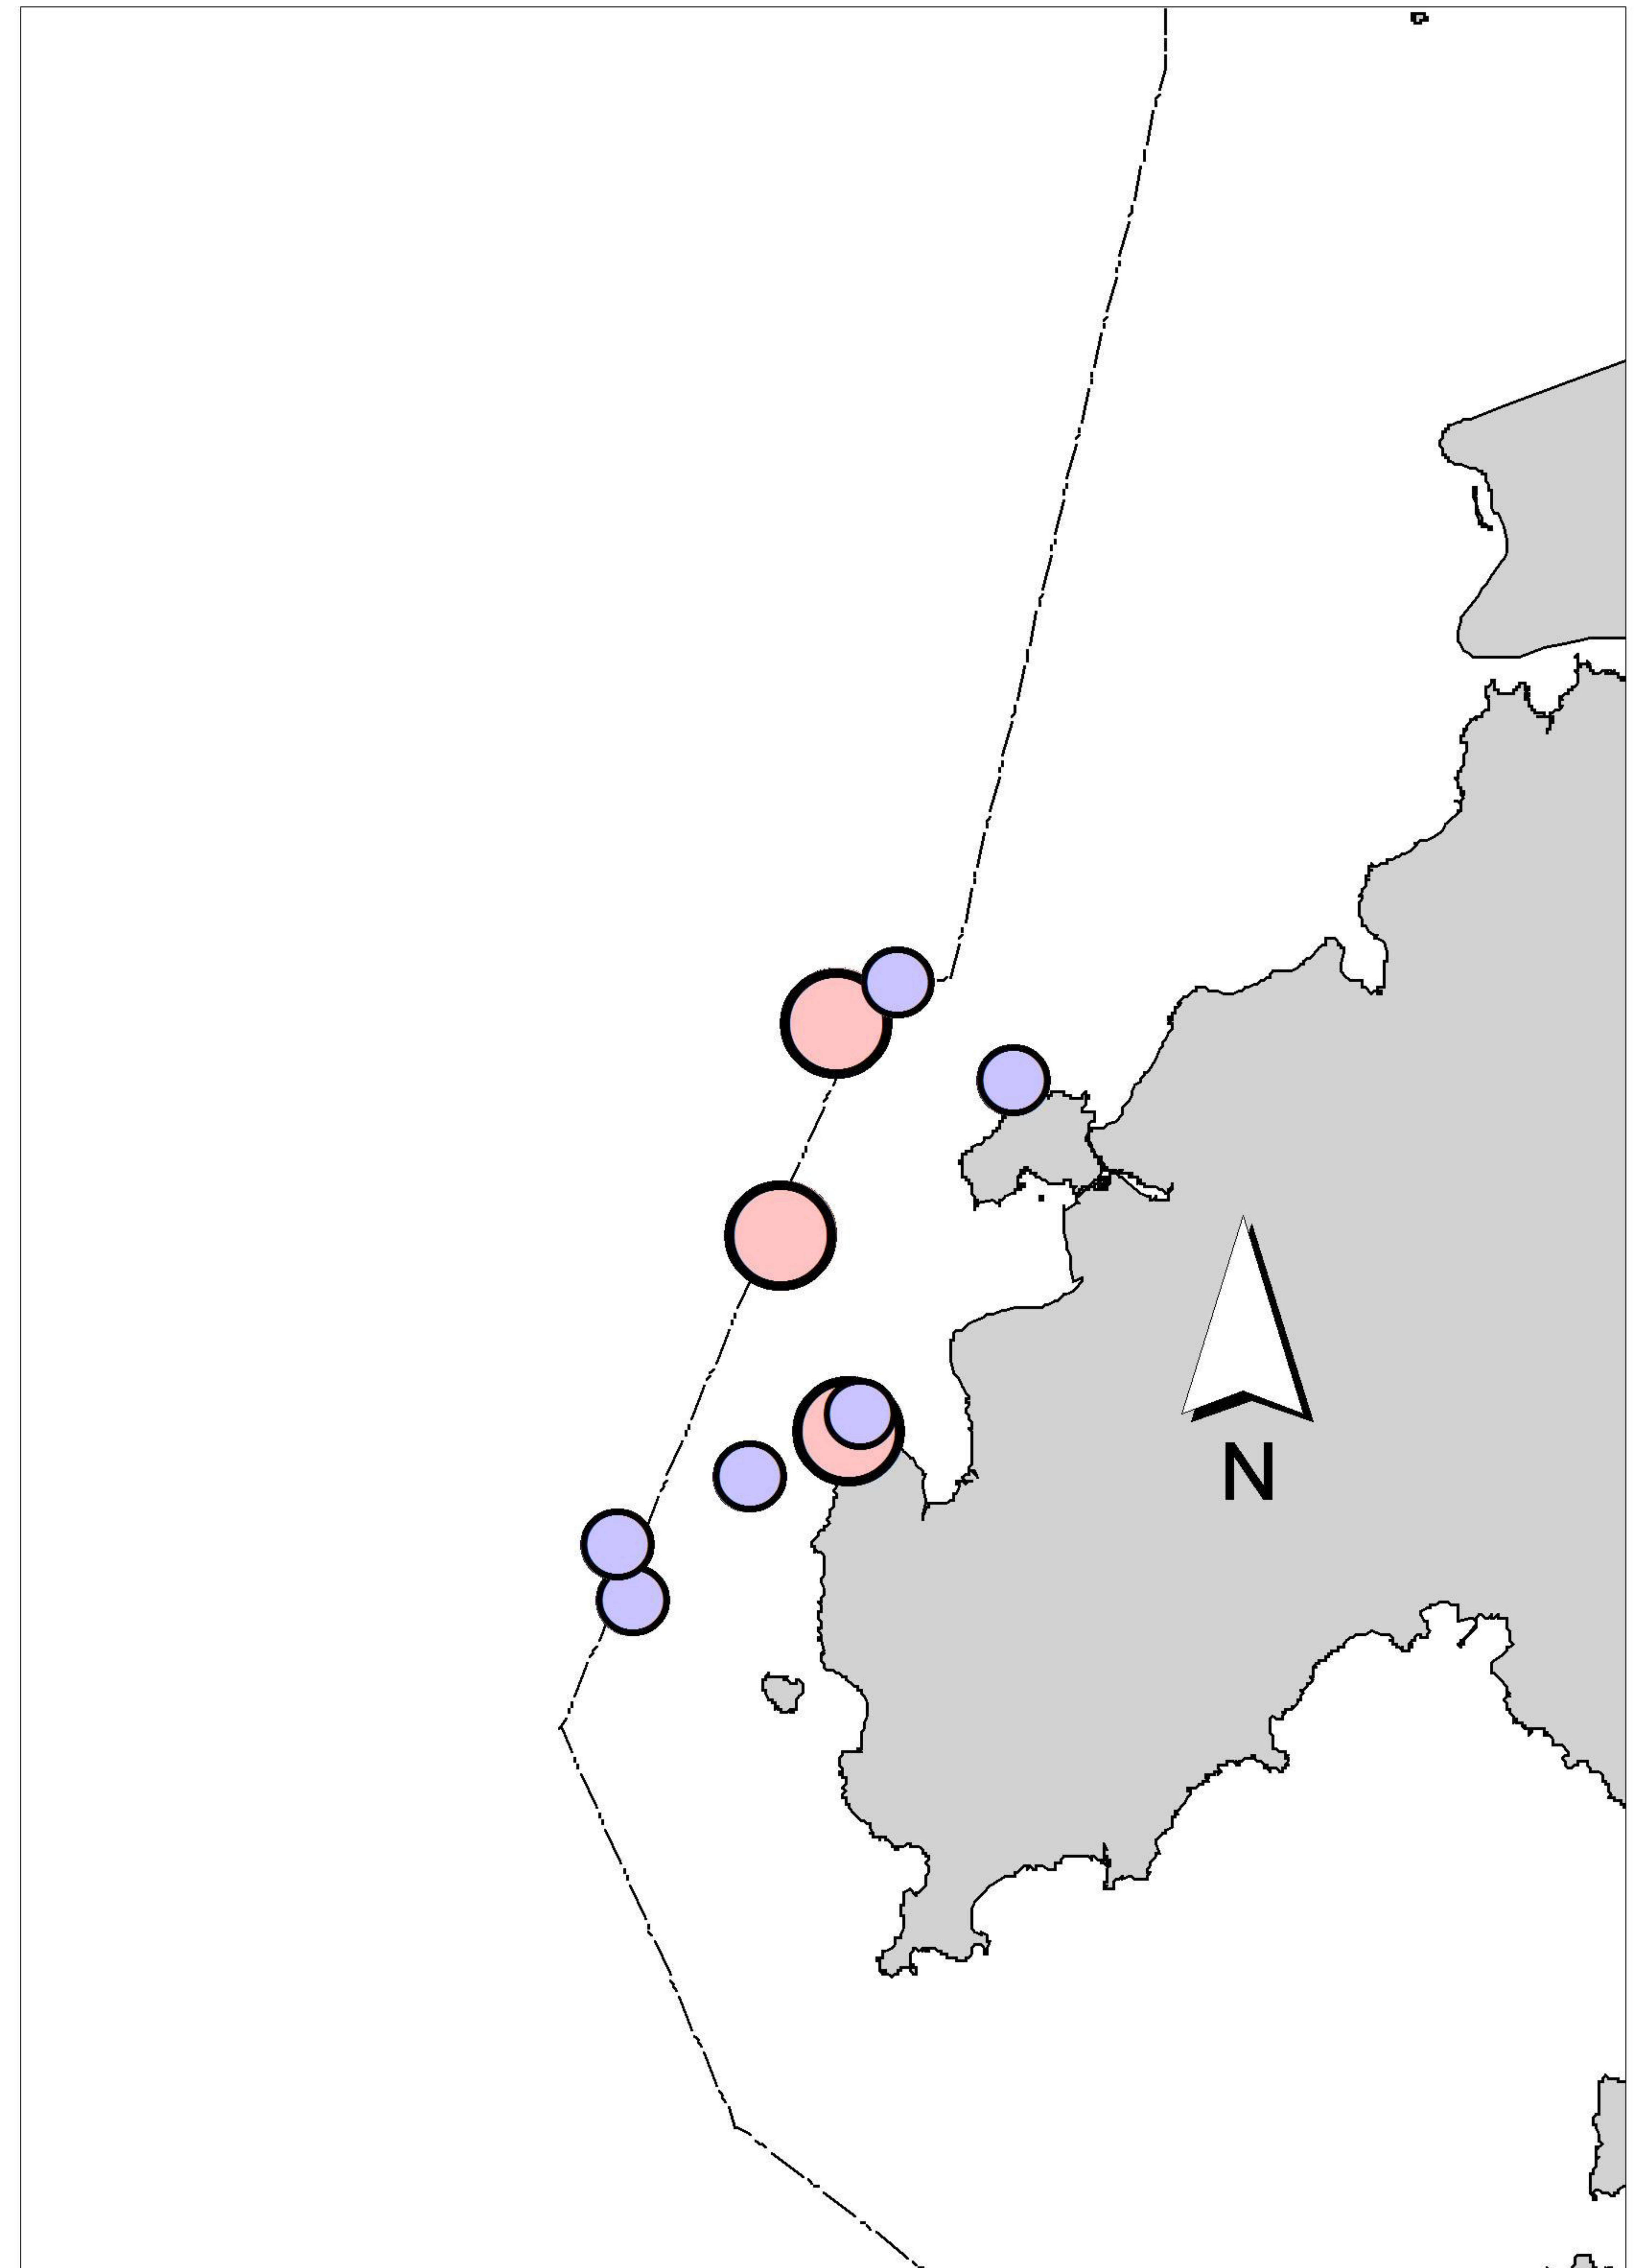
Figure 8. Distribution of dolphins engaged in feeding (in purple), socializing (in pink) and traveling (in green) activities during HKLR09 impact phase (left: December 2015 – February 2016) and baseline monitoring surveys (right: September – November 2011)

- 2.3.4. Behavioural analysis – When dolphins were sighted during vessel surveys, their behaviour was observed. Different activities were categorized (i.e. feeding, milling/resting, traveling, socializing) and recorded on sighting datasheets. This data was then input into a separate database with sighting information, which can be used to determine the distribution of behavioural data with a desktop GIS. Distribution of sightings of dolphins engaged in different activities and behaviours would then be plotted on GIS and carefully examined to identify important areas for different activities of the dolphins.
