Contract No. HY/2011/09
Hong Kong-Zhuhai-Macao Bridge
Hong Kong Link Road – Section between HKSAR Boundary and Scenic Hill

Submission under Environmental Permit (EP-352/2009/D – Condition 4.4)
Quarterly EM&A Report – March to May 2016

**Contract No. HY/2011/09 HZMB Hong Kong Link Road –
Section between HKSAR Boundary and Scenic Hill
Quarterly EM&A Report No. 13 for March to May 2016**

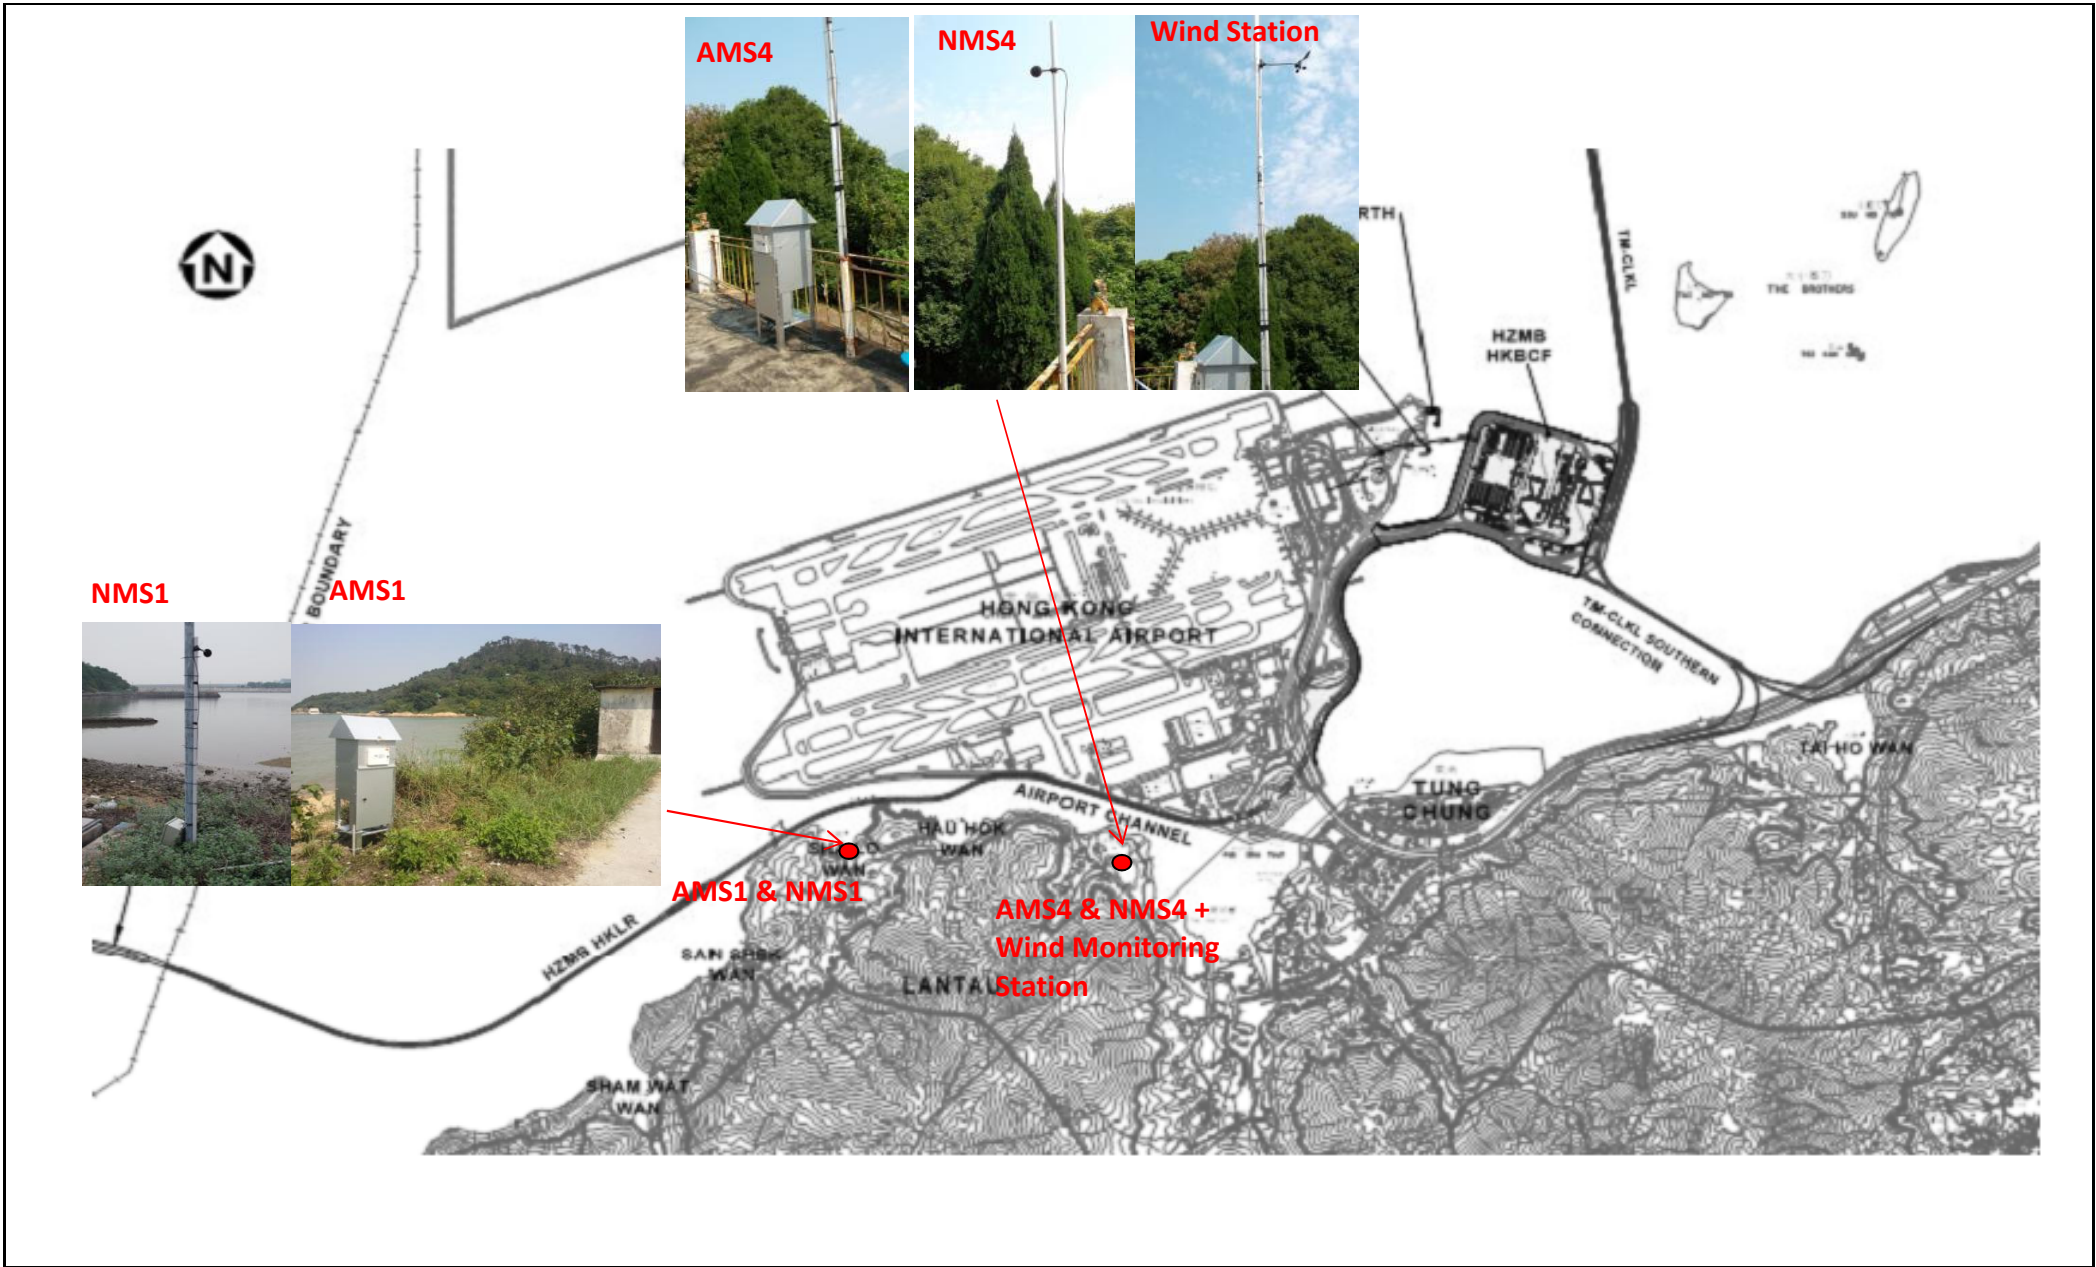
Title	Contract No. HY/2011/09 Hong Kong-Zhuhai-Macao Bridge Hong Kong Link Road – Section between HKSAR Boundary and Scenic Hill	Scale	N.T.S	Propose No.	MA12014	CINOTECH
		Date	Feb-13	Figure	3	
Locations of Air Quality and Noise Monitoring Stations
