Contract No. HY/2011/09
Hong Kong-Zhuhai-Macao Bridge
Hong Kong Link Road – Section between HKSAR Boundary and Scenic Hill

Submission under Environmental Permit (EP-352/2009/D – Condition 4.4)
Monthly EM&A Report – February 2017

**Contract No. HY/2011/09 HZMB Hong Kong Link Road –
Section between HKSAR Boundary and Scenic Hill
Revised Monthly EM&A Report for February 2017 (EP-352/2009/D)**

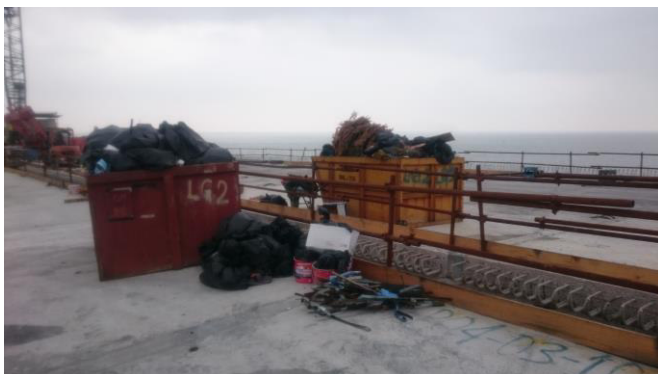
Ref No: 170202-R02

Parameters	Date	Observations and Recommendations	Follow-up
<i>Water Quality</i>	170207-R02	Sand and debris near the site boundary of P69 should be cleared.	Rectification/improvement was observed during the follow-up audit session on 14 February 2017.
	170221-R05	Contaminated sand near the site boundary at P55 should be cleared to prevent muddy discharge into sea.	Rectification/improvement was observed during the follow-up audit session on 28 February 2017.
<i>Ecology</i>	N/A ⁽¹⁾	N/A ⁽¹⁾	N/A ⁽¹⁾
<i>Air Quality</i>	170214-R01	Dusty material at P54 should be cleared.	Rectification/improvement was observed during the follow-up audit session on 28 February 2017.
	170221-R03	Dusty material along P54-58 should be cleared.	Rectification/improvement was observed during the follow-up audit session on 28 February 2017.
<i>Noise</i>	170207-R04	NRMM label should be provided to the plant at P76.	Rectification/improvement was observed during the follow-up audit session on 14 February 2017.

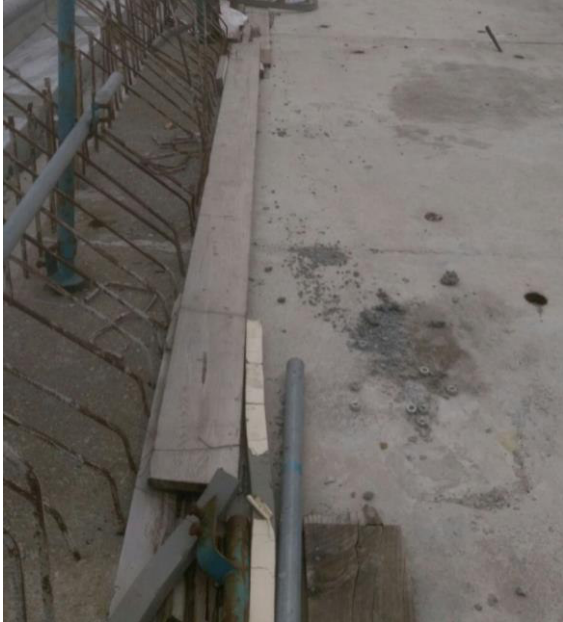
Ref No: 170202-R01

<i>Waste / Chemical Management</i>	170202-R01	Oil stain should be cleared at P11 and Portion C.	Rectification/improvement was observed during the follow-up audit session on 14 February 2017.
	170202-R02	Accumulated waste at P10 should be cleared.	Rectification/improvement was observed during the follow-up audit session on 7 February 2017.
	170202-R03	Drip tray should be provided to the chemical containers at P11 and the plant at Portion C.	Rectification/improvement was observed during the follow-up audit session on 14 February 2017.
	170202-R04	Chemical container at P57 should be provided with chemical label.	Rectification/improvement was observed during the follow-up audit session on 7 February 2017.
	170207-R01	Chemical containers at P69 should be provided with drip trays.	Rectification/improvement was observed during the follow-up audit session on 14 February 2017.
	170207-R03	Oil stain at P69, 75, 76 should be cleared.	Rectification/improvement was observed during the follow-up audit session on 14 February 2017.
