Contract No. HY/2011/09
Hong Kong-Zhuhai-Macao Bridge
Hong Kong Link Road – Section between HKSAR Boundary and Scenic Hill

Submission under Environmental Permit (EP-352/2009/D – Condition 4.4)
Monthly EM&A Report – June 2017

**Contract No. HY/2011/09 HZMB Hong Kong Link Road –
Section between HKSAR Boundary and Scenic Hill
Revised Monthly EM&A Report for June 2017 (EP-352/2009/D)**

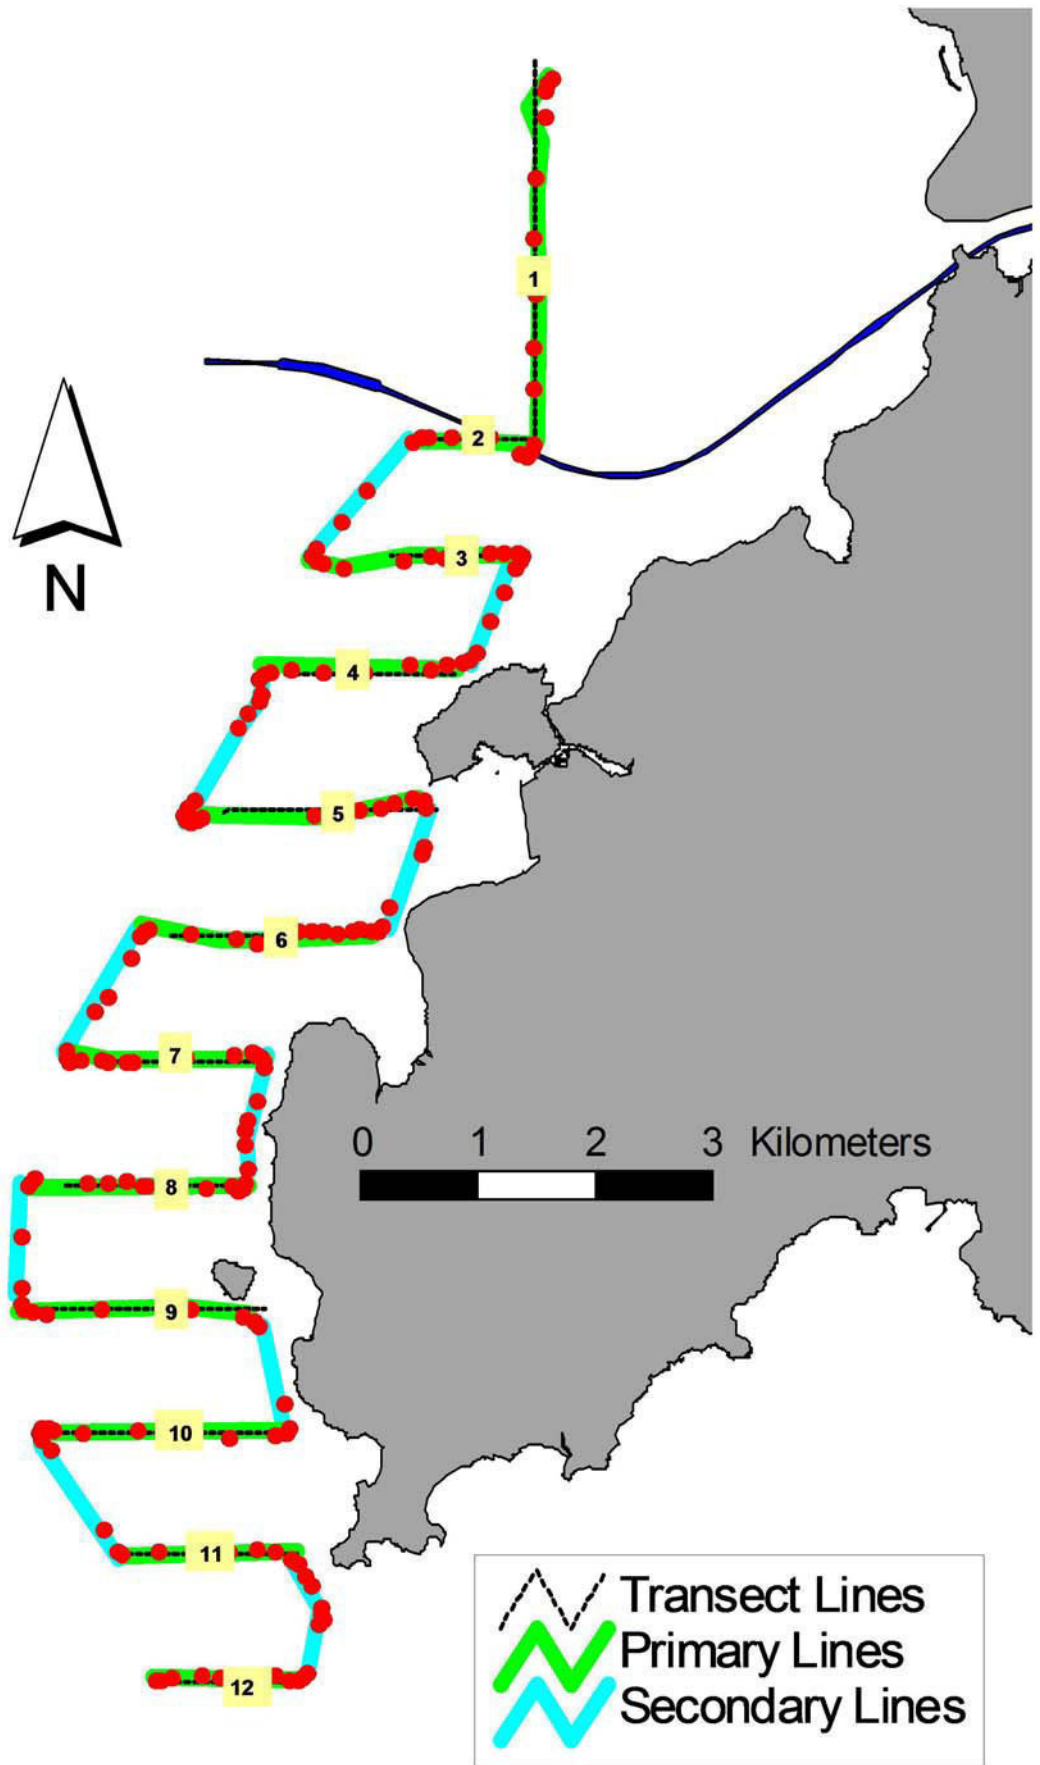
Figure 2. Survey Route on June 9th, 2017 (note: red dots represent the tracked positions of survey boat logged continuously by GPS throughout the course of the survey)

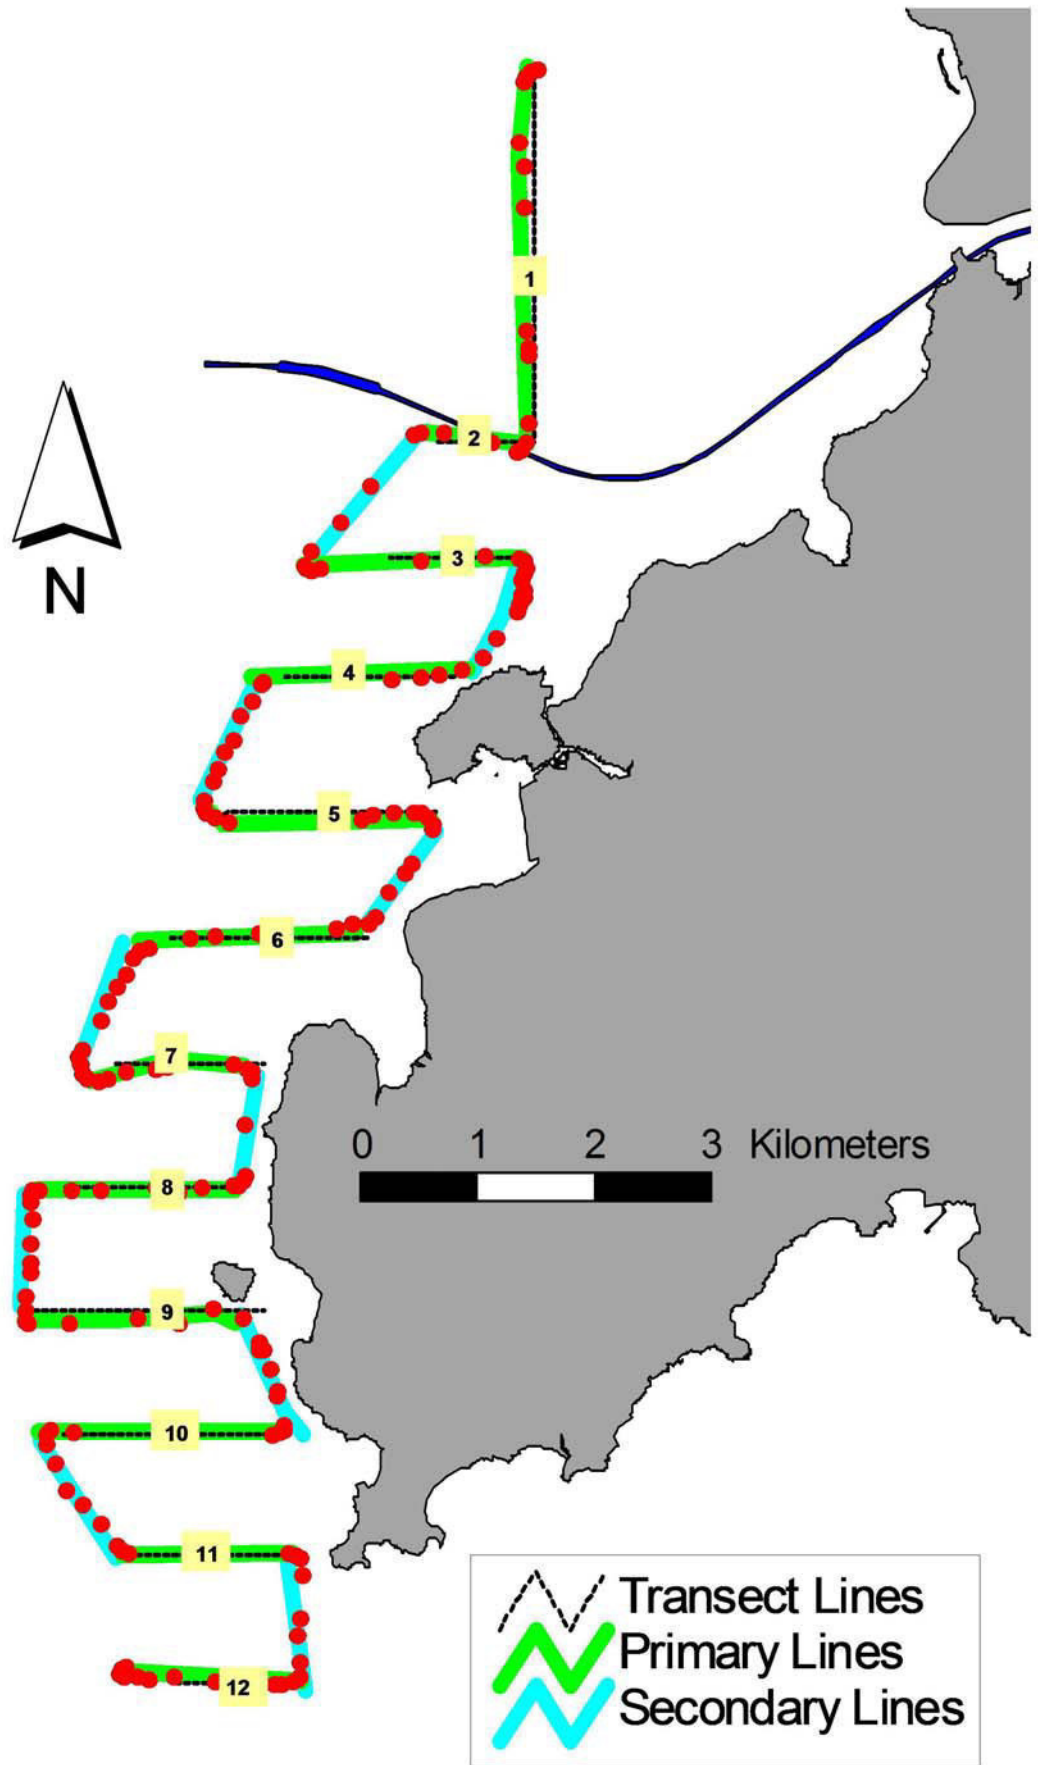
Figure 3. Survey Route on June 21st, 2017 (note: red dots represent the tracked positions of survey boat logged continuously by GPS throughout the course of the survey)

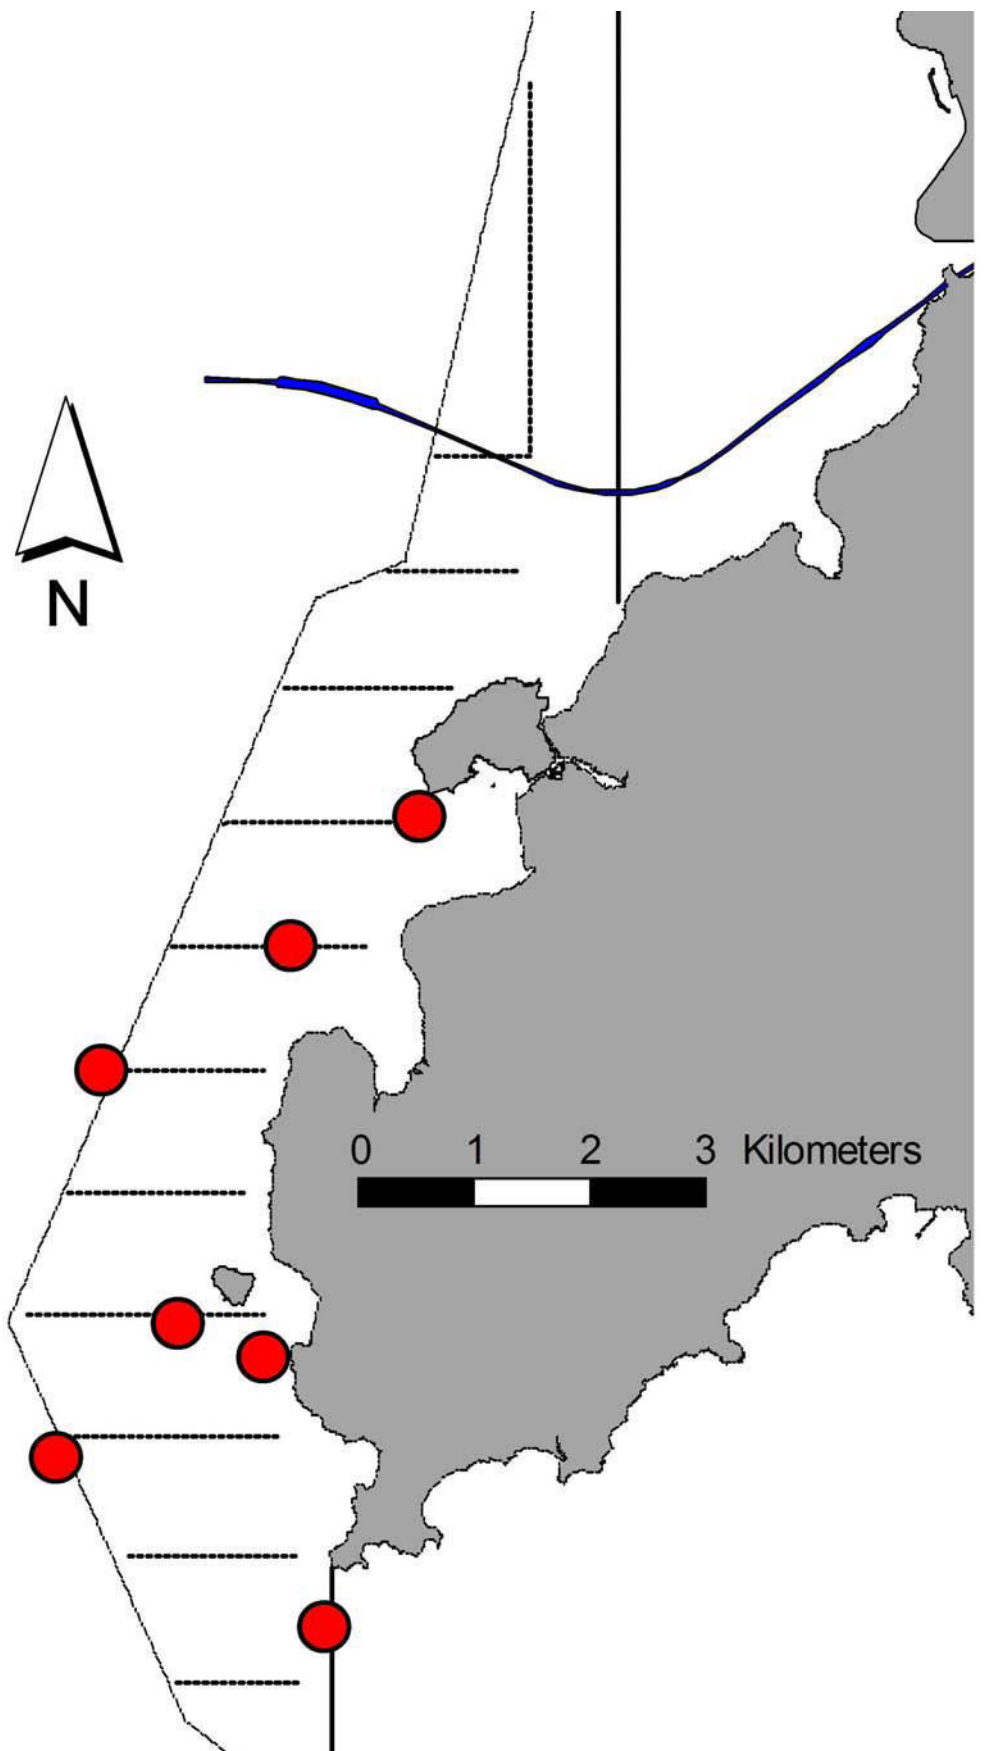
Figure 4. Distribution of Chinese White Dolphin Sighting during June 2017 HKLR09 Monitoring Surveys

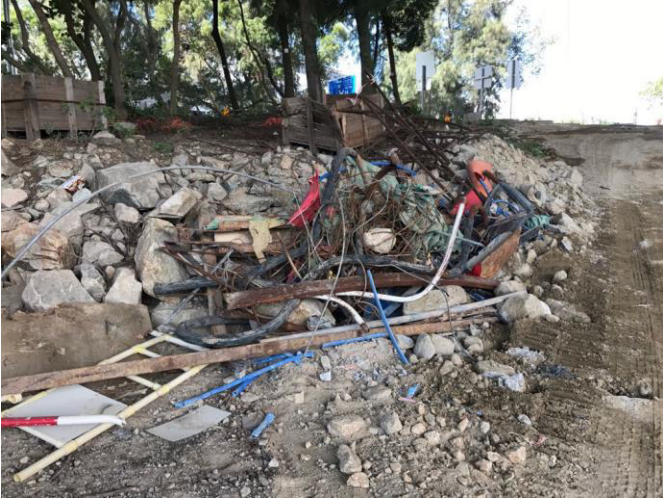
<p>Ref No: 170606-R01</p> <p>Impact: Waste / Chemical Management (F4i)</p> <p>Details: Accumulated construction waste at P92 should be removed.</p>

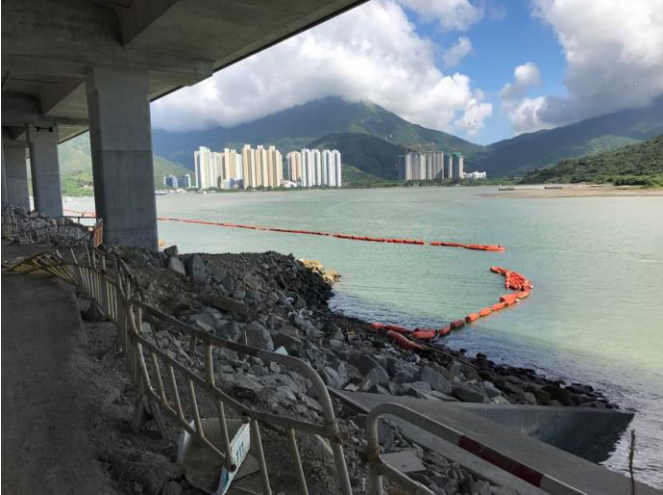
<p>Ref No: 170606-R02</p> <p>Impact: Water Quality (B25)</p> <p>Details: Silt curtain at P98 should be properly maintained.</p>

Parameters	Date	Observations and Recommendations	Follow-up
<i>Water Quality</i>	170606-R02	Silt curtain at P98 should be properly maintained.	Rectification/improvement was observed during the follow-up audit session on 15 June 2017.
<i>Ecology</i>	N/A ⁽¹⁾	N/A ⁽¹⁾	N/A ⁽¹⁾
<i>Air Quality</i>	170627-R01	NRMM and NEL labels should be provided to the equipment at P60.	Rectification/improvement will be reported in next reporting month.
	170627-R03	Dusty material should be covered by impervious sheet or removed at P68.	Rectification/improvement will be reported in next reporting month.
<i>Noise</i>	170627-R01	NRMM and NEL labels should be provided to the equipment at P60.	Rectification/improvement will be reported in next reporting month.
<i>Waste / Chemical Management</i>	170606-R01	Accumulated construction waste at P92 should be removed.	Rectification/improvement will be reported in next reporting month.

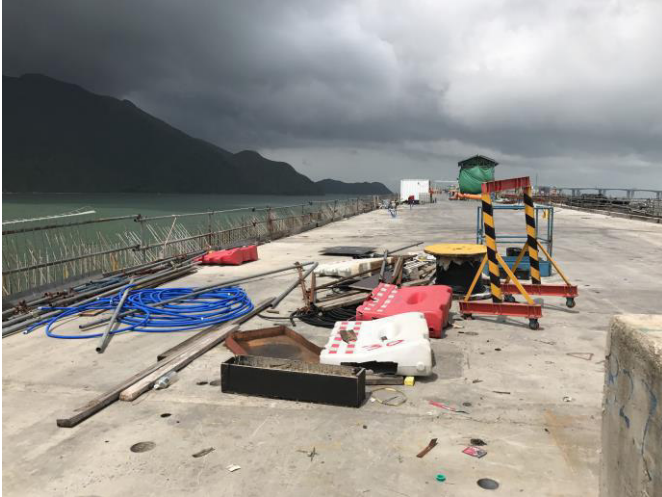
Ref No: 170615-R01

170615-R01	Housekeeping at P48, 55 should be enhanced.	Rectification/improvement was observed during the follow-up audit session on 27 June 2017.
	170615-R02	Drip tray at P51 should be plugged and oil stain should be removed as chemical waste.	Rectification/improvement was observed during the follow-up audit session on 27 June 2017.
	170615-R03	Chemical containers at P50 should be provided with proper chemical label and with drip tray.	Rectification/improvement was observed during the follow-up audit session on 27 June 2017.
	170622-R01	Proper chemical label should be provided to the chemical containers at P57.	Rectification/improvement will be reported in next reporting month.
	170622-R02	The chemical should be stored in proper container with chemical label and provided with drip tray at P57.	Rectification/improvement was observed during the follow-up audit session on 27 June 2017.
	170622-R03	The drip trays along P58-60 should be plugged to avoid oily water leakage.	Rectification/improvement will be reported in next reporting month.

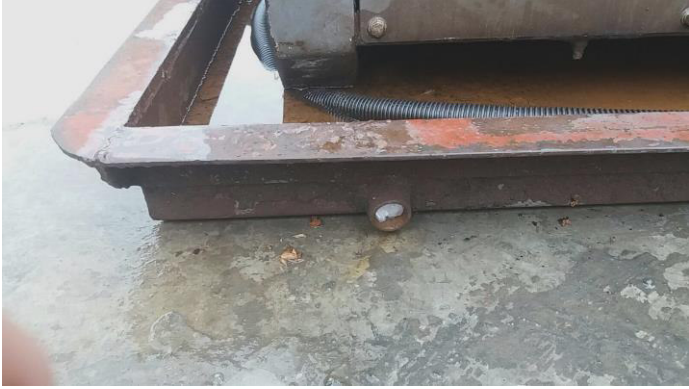
<p>Ref No: 170615-R02</p> <p>Impact: Waste / Chemical Management (F8,9)</p> <p>Details: Drip tray at P51 should be plugged and oil stain should be removed as chemical waste.</p> <p>Follow-up: Drip tray at P51 was plugged and oil stain was removed.</p>

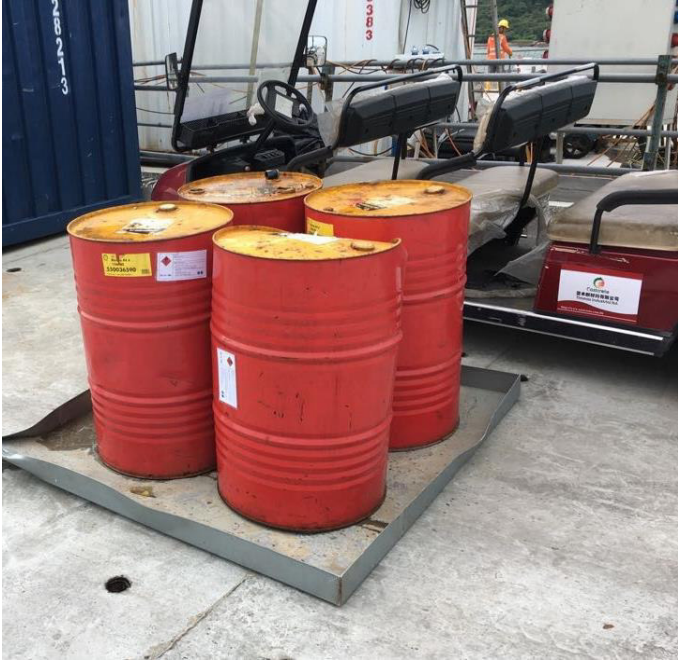
<p>Ref No: 170615-R03</p> <p>Impact: Waste / Chemical Management (F8,9)</p> <p>Details: Chemical containers at P50 should be provided with proper chemical label and with drip tray.</p> <p>Follow-up: Chemical containers at P50 was provided with proper chemical label and with drip tray.</p>
