Contract No. HY/2011/09
Hong Kong-Zhuhai-Macao Bridge
Hong Kong Link Road – Section between HKSAR Boundary and Scenic Hill

Submission under Environmental Permit (EP-352/2009/D – Condition 4.4)
Monthly EM&A Report – July 2017

Contract HY/2011/09
Hong Kong-Zhuhai-Macao Bridge
Hong Kong Link Road-Section between
HKSAR Boundary and Scenic Hill
Monthly EM&A Report

July 2017
(Version 1.0)

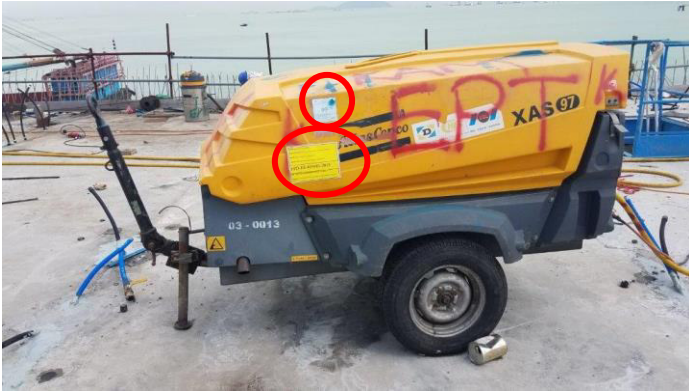
<p>Ref No: 170627-R01</p> <p>Impact: Air Quality (D26); Noise (E8)</p> <p>Details: NRMM and NEL labels should be provided to the equipment at P60.</p> <p>Follow-up: NRMM and NEL labels were provided to the equipment at P60.</p>

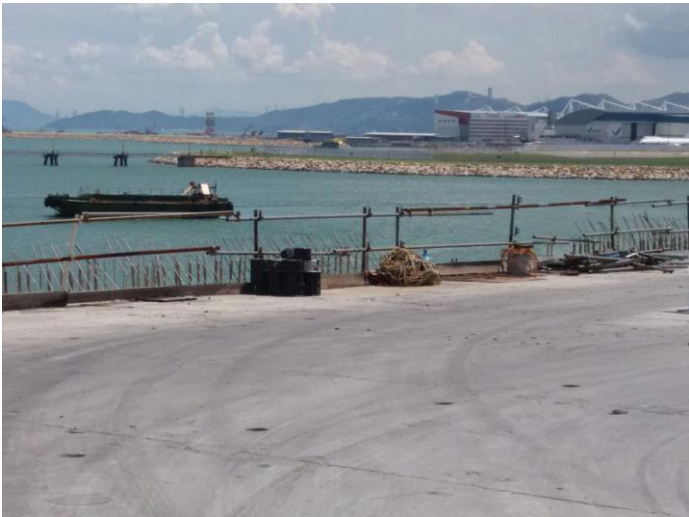
<p>Ref No: 170627-R03</p> <p>Impact: Air Quality (D7)</p> <p>Details: Dusty material should be covered by impervious sheet or removed at P68.</p> <p>Follow-up: Dusty material at P68 was removed.</p>

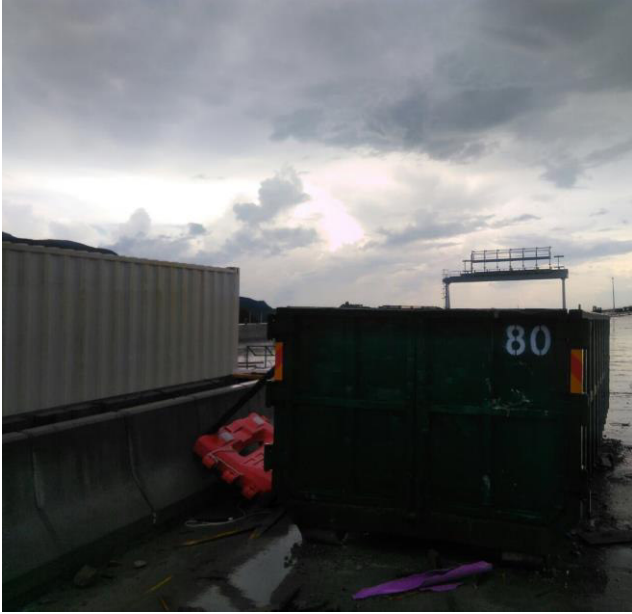
<p>Ref No: 170704-R01</p> <p>Impact: Waste / Chemical Management (F4ii)</p> <p>Details: Housekeeping should be enhanced at P35 to avoid accumulated construction waste.</p> <p>Follow-up: Accumulated construction waste at P35 was cleared.</p>

Noise	N/A ⁽¹⁾	N/A ⁽¹⁾	N/A ⁽¹⁾
Waste / Chemical Management	170704-R01	Housekeeping should be enhanced at P35 to avoid accumulated construction waste.	Rectification/improvement was observed during the follow-up audit session on 11 July 2017.
	170704-R03	Drip tray at P47, 57 should be plugged.	Rectification/improvement was observed during the follow-up audit session on 11 July 2017.
	170711-R02	Chemical containers at P44, 51, 53 should be provided with proper chemical label, drip tray and with proper chemical container.	Rectification/improvement was observed during the follow-up audit session on 25 July 2017.
	170711-R03	Housekeeping at P50, 53 and Portion A P82 should be enhanced.	Rectification/improvement was observed during the follow-up audit session on 25 July 2017.
	170718-R01	Housekeeping at P82-83 should be enhanced.	Rectification/improvement was observed during the follow-up audit session on 25 July 2017.
