Contract No. HY/2011/09

Hong Kong-Zhuhai-Macao Bridge

Hong Kong Link Road – Section between HKSAR Boundary and Scenic Hill

**Submission under Environmental Permit (EP-352/2009/D – Condition 4.4)
Monthly EM&A Report – August 2017**

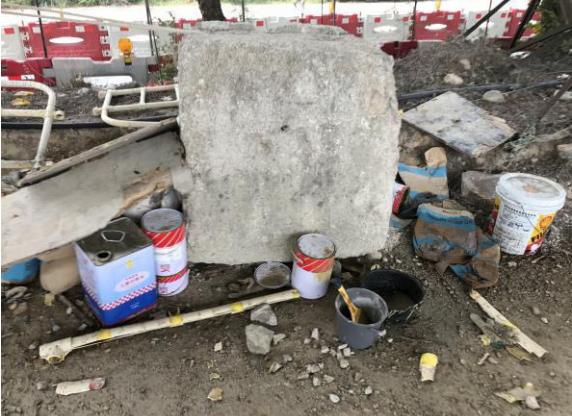
A photograph showing a construction site area. In the foreground, there is a concrete wall and various construction materials, including several blue and white chemical drums, buckets, and tools, scattered on the ground. In the background, there are red safety barriers and some greenery.	<p>Ref No: 170801-R02</p> <p>Impact: Waste / Chemical Management (F2i,2ii)</p> <p>Details: Chemical containers at P97 should be removed as chemical waste.</p>

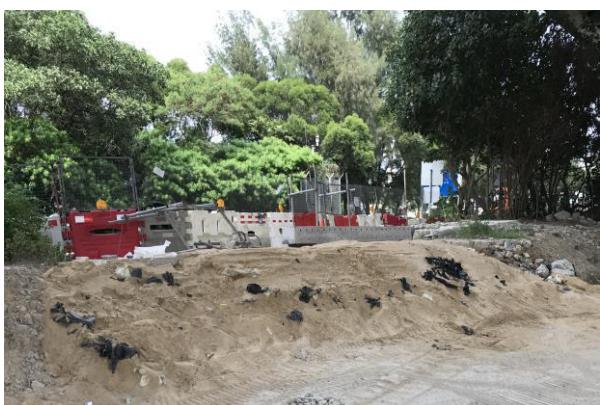
A photograph showing a construction site area. The foreground is dominated by a large pile of dusty, light-colored material, possibly sand or aggregate, with some dark debris scattered on top. In the background, there are red safety barriers, a concrete structure, and dense green trees under a clear sky.	<p>Ref No: 170801-R03</p> <p>Impact: Waste / Chemical Management (D7)</p> <p>Details: Dusty material at P91 should be removed or covered by impervious sheet.</p>

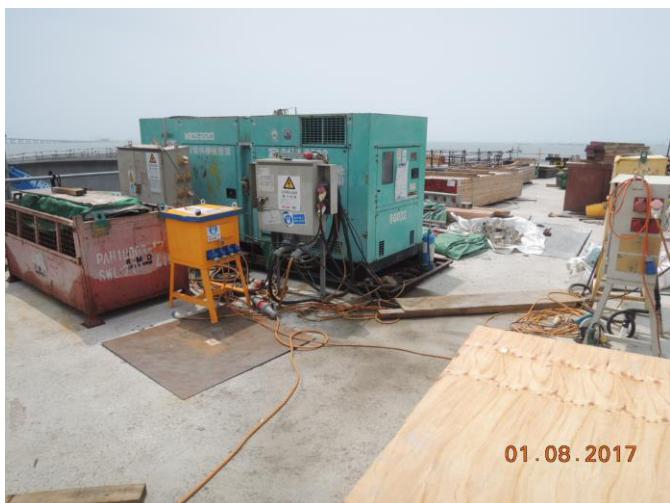
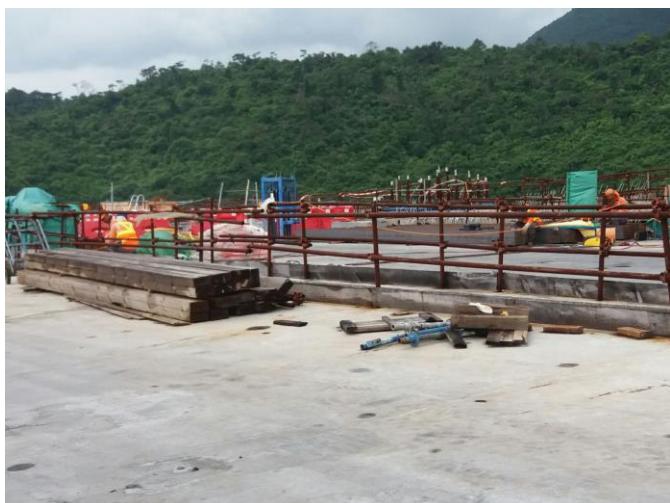
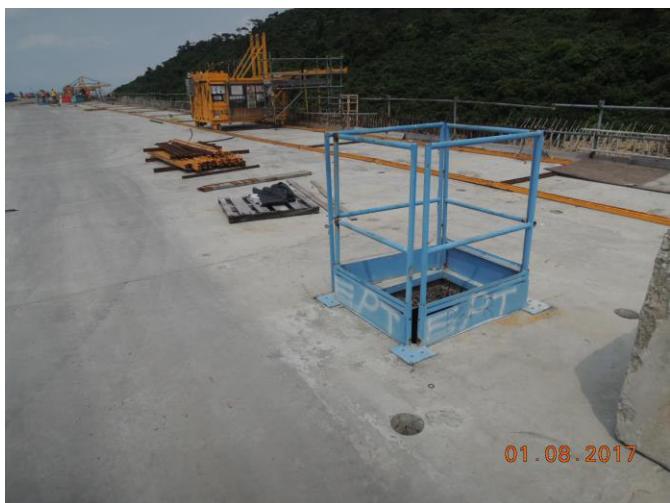
Ref No: 170725-R02

Waste / Chemical Management (F8,9)

Oil stain at P56, 59 and 65 should be cleared as chemical waste.

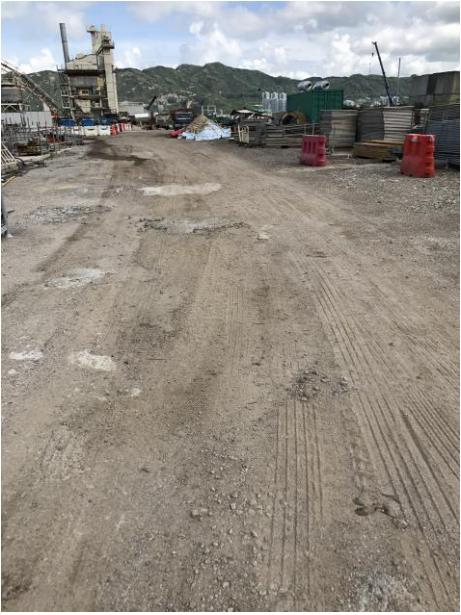
<p>Ref No: 170808-R01</p> <p>Impact: Air Quality (D5)</p> <p>Details: Haul road at WA4 should be sprayed with water for dust suppression.</p>

<p>Ref No: 170808-R01</p> <p>Impact: Air Quality (D5)</p> <p>Details: Haul road at WA4 should be sprayed with water for dust suppression.</p> <p>Follow-up: Haul road at WA4 was observed sprayed with water.</p>
--	---

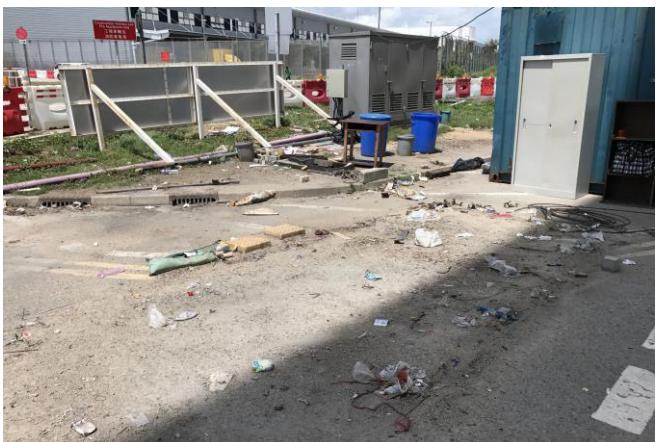
<p>Ref No: 170808-R02</p> <p>Impact: Waste / Chemical Management (F1iii)</p> <p>Details: Housekeeping at P82 should be enhanced at Portion A.</p>

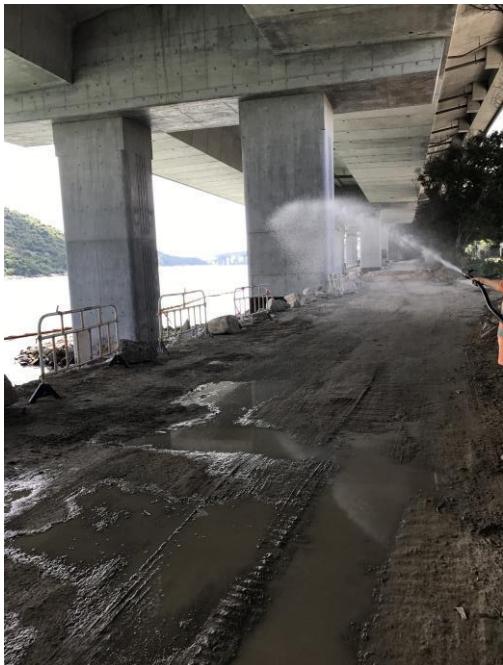
Ref No: 170808-R04

The water pipe should be repaired for water spraying during loading process and breaking work along P87-96 to suppress dust production.

The water pipe was repaired, water spraying was provided during loading process and breaking work along P87-96.

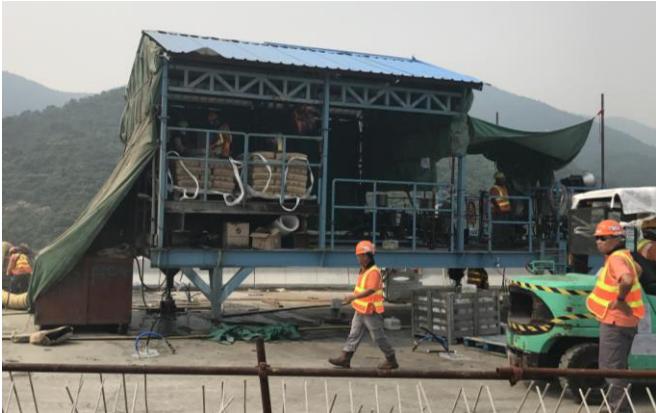
<p>Ref No: 170822-R01</p> <p>Impact: Air Quality (D13,14)</p> <p>Details: Cement mixing works at P83 should be done in proper three-side enclosed area and with water spraying.</p>

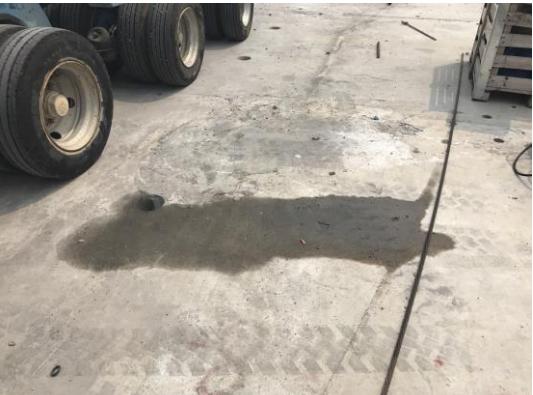
<p>Ref No: 170822-R02</p> <p>Impact: Waste / Chemical Management (F8,9)</p> <p>Details: Oil stain at P69 and P70 should be cleared and drip tray at P70 should be plugged to prevent oil leakage.</p>

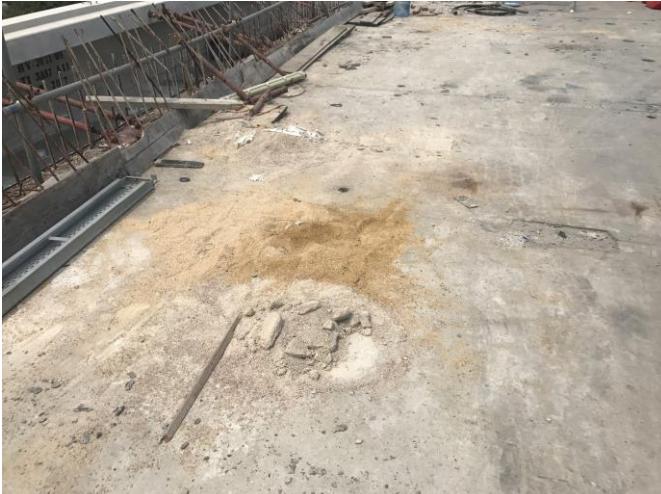
<p>Ref No: 170822-R03</p> <p>Impact: Air Quality (D7)</p> <p>Details: Dusty material at P72 should be covered with impervious sheet or removed.</p>

<p>Ref No: 170822-R03</p> <p>Impact: Air Quality (D7)</p> <p>Details: Dusty material at P72 should be covered with impervious sheet or removed.</p> <p>Follow-up: Dusty material at P72 was removed.</p>

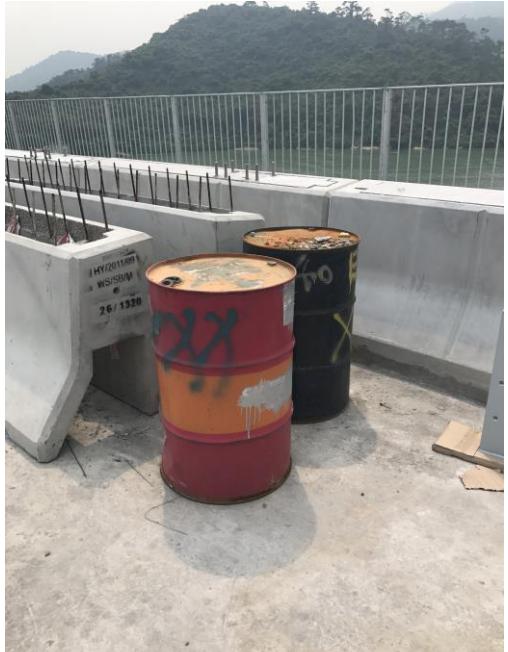
<p>Ref No: 170822-R04</p> <p>Impact: Waste / Chemical Management (F2iii,9)</p> <p>Details: Chemical containers at P72 should be with proper chemical label and provided with drip tray.</p>

<p>Ref No: 170822-R04</p> <p>Impact: Waste / Chemical Management (F2iii,9)</p> <p>Details: Chemical containers at P72 should be with proper chemical label and provided with drip tray.</p> <p>Follow-up: Chemical containers at P72 were removed.</p>
---	--

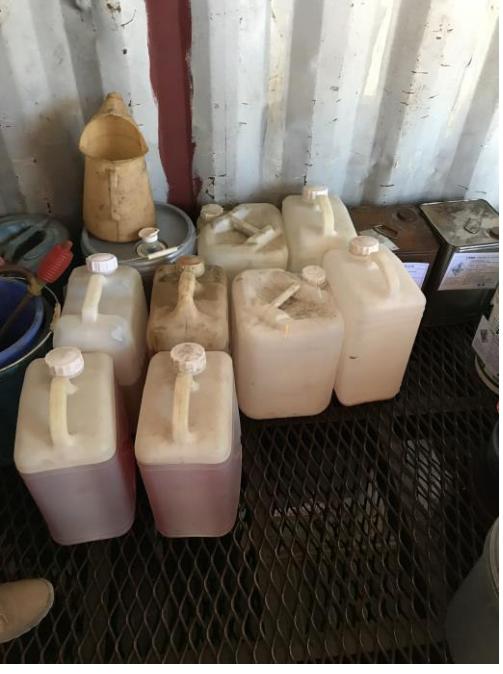
<p>Ref No: 170829-R01</p> <p>Impact: Waste / Chemical Management (F2iii)</p> <p>Details: Chemical waste in the chemical waste storage at WA4 should be provided with proper chemical label.</p>

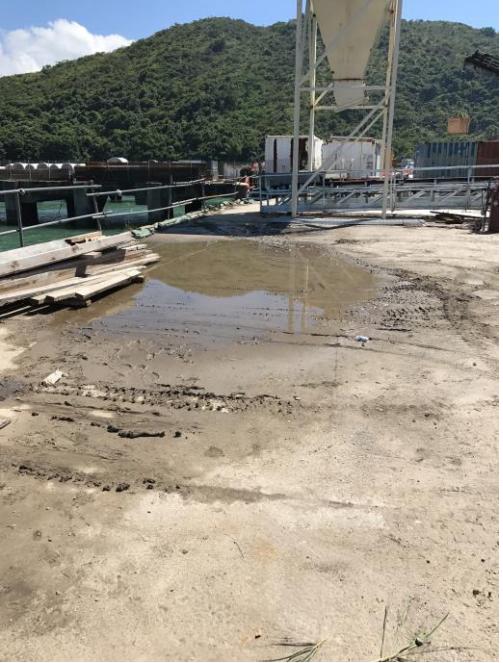
<p>Ref No: 170829-R02</p> <p>Impact: Water Quality (B15)</p> <p>Details: Muddy material near the site boundary of WA4 should be cleared.</p>

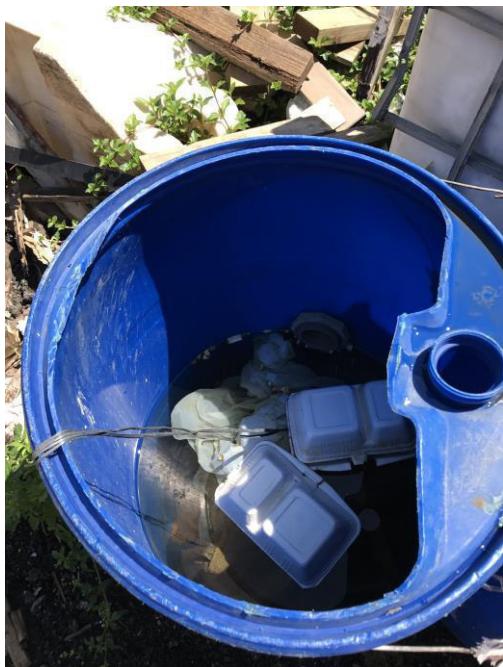
Ref No: 170829-R03

General waste and stand water in the container at WA4 should be removed.

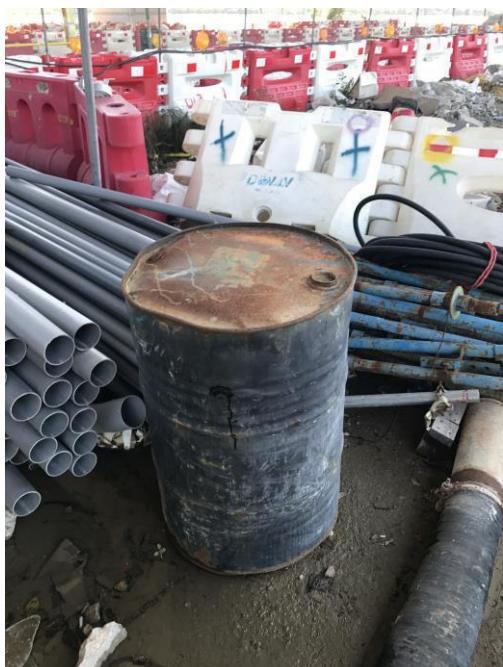
Ref No: 170829-R05

Chemical container at P106 Portion C should be provided with drip tray.

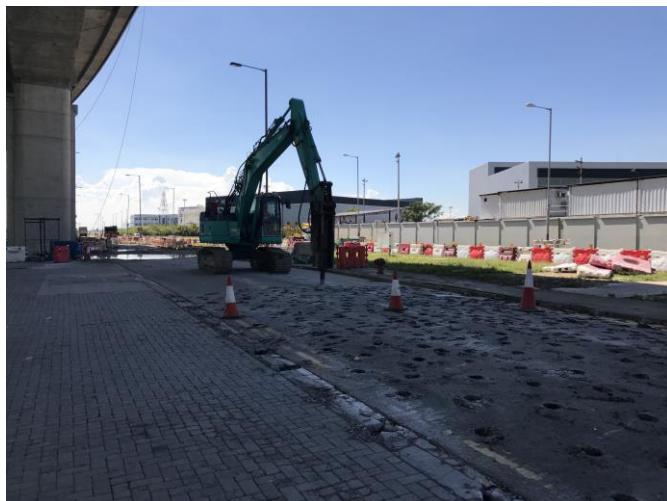
Ref No: 170829-R06

Water spraying should be provided during the breaking works at Portion a P82 and Portion C for dust suppression.

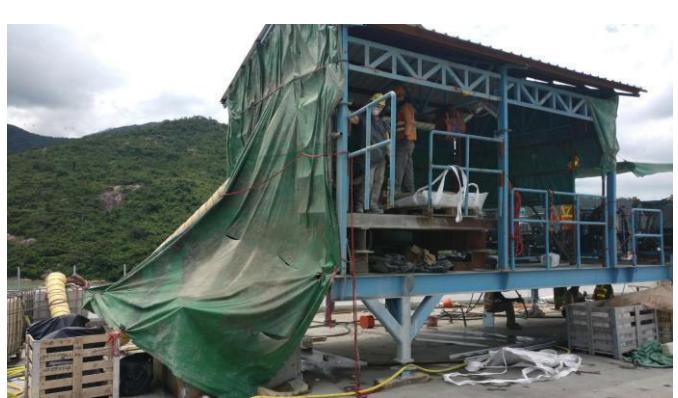
<p>Ref No: 170822-R01</p> <p>Impact: Air Quality (D13,14)</p> <p>Details: Cement mixing works at P83 should be done in proper three-side enclosed area and with water spraying.</p> <p>Follow-up: Cement mixing works area at P83 was with three-side enclosed area and with water spraying.</p>

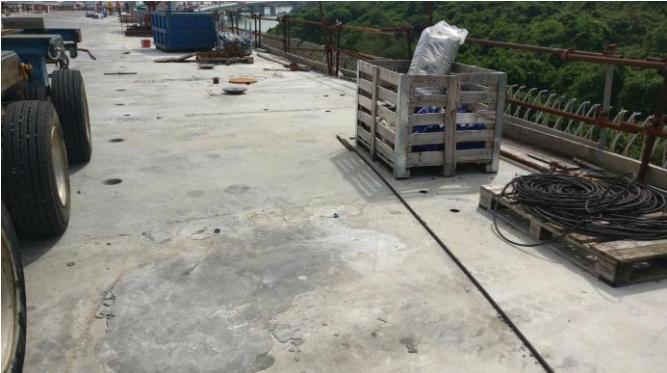
<p>Ref No: 170822-R02</p> <p>Impact: Waste / Chemical Management (F8,9)</p> <p>Details: Oil stain at P69 and P70 should be cleared and drip tray at P70 should be plugged to prevent oil leakage.</p> <p>Follow-up: Oil stain at P69 and P70 was cleared and drip tray at P70 was plugged to prevent oil leakage.</p>
