Contract No. HY/2011/09
Hong Kong-Zhuhai-Macao Bridge
Hong Kong Link Road – Section between HKSAR Boundary and Scenic Hill

Submission under Environmental Permit (EP-352/2009/D – Condition 4.4)
Monthly EM&A Report – September 2017

**Contract No. HY/2011/09 HZMB Hong Kong Link Road –
Section between HKSAR Boundary and Scenic Hill
Revised Monthly EM&A Report for September 2017 (EP-352/2009/D)**

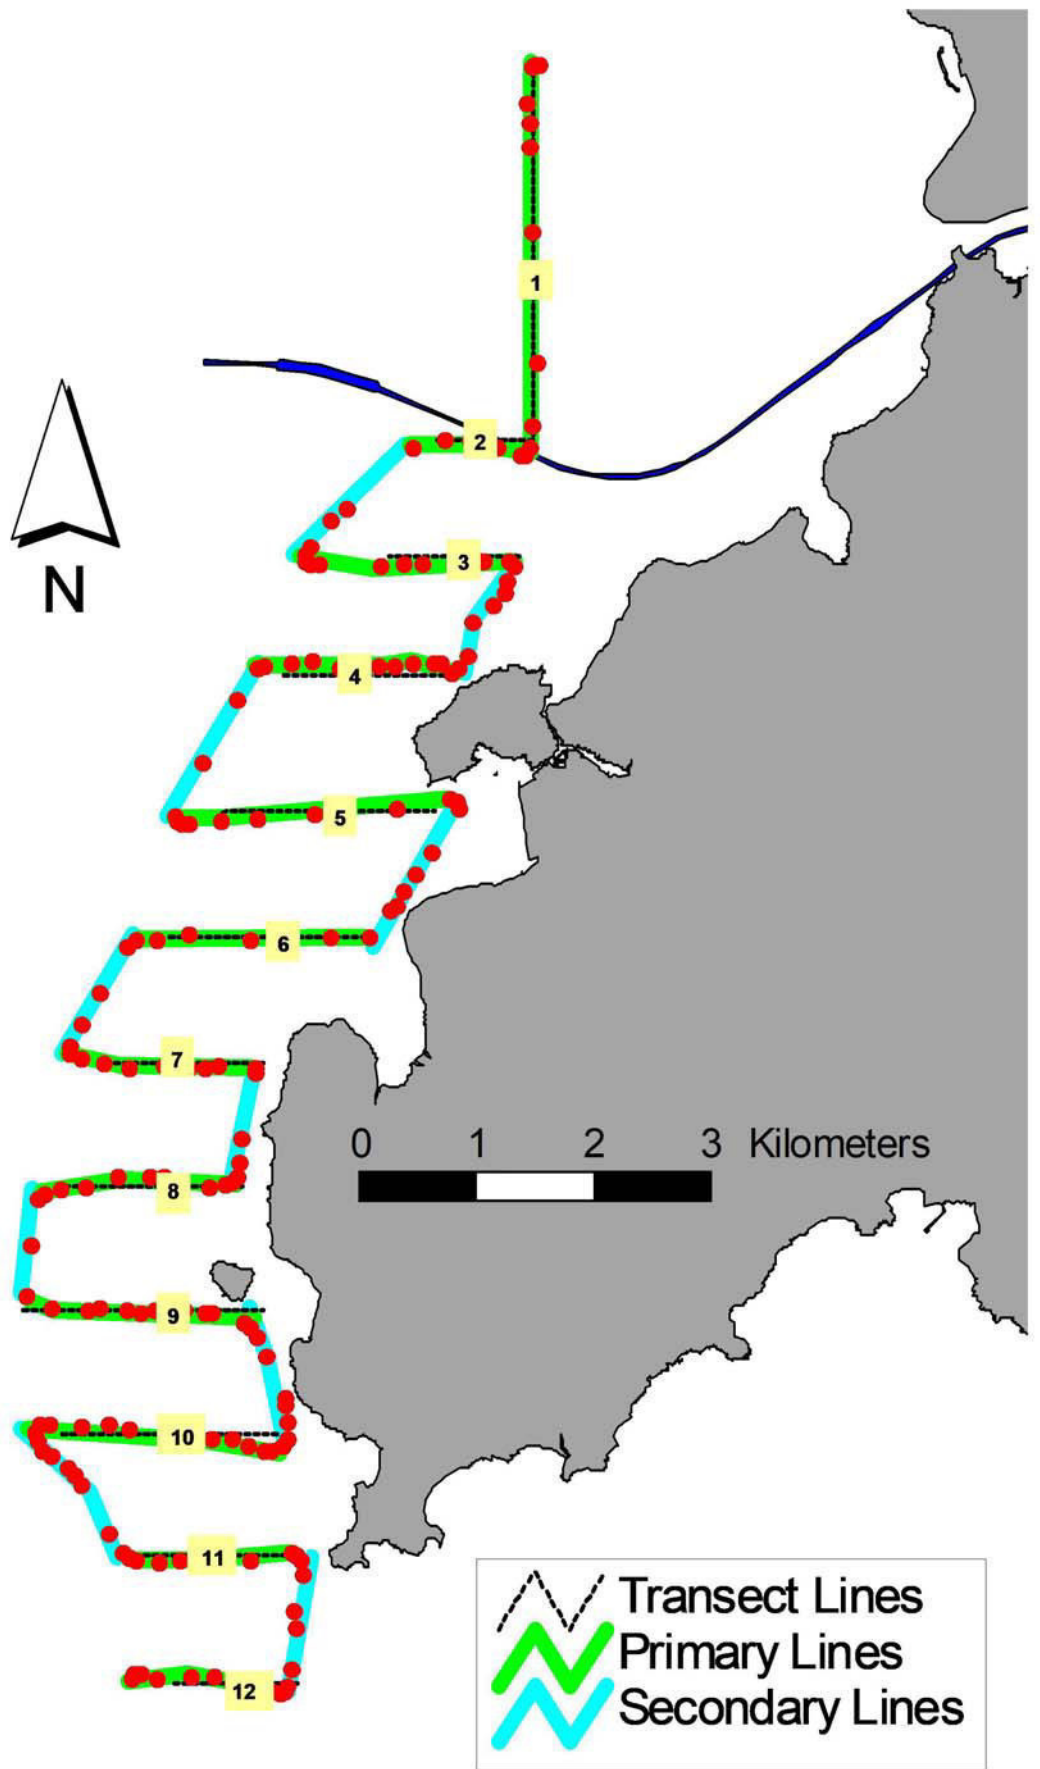
Figure 2. Survey Route on September 7th, 2017 (note: red dots represent the tracked positions of survey boat logged continuously by GPS throughout the course of the survey)

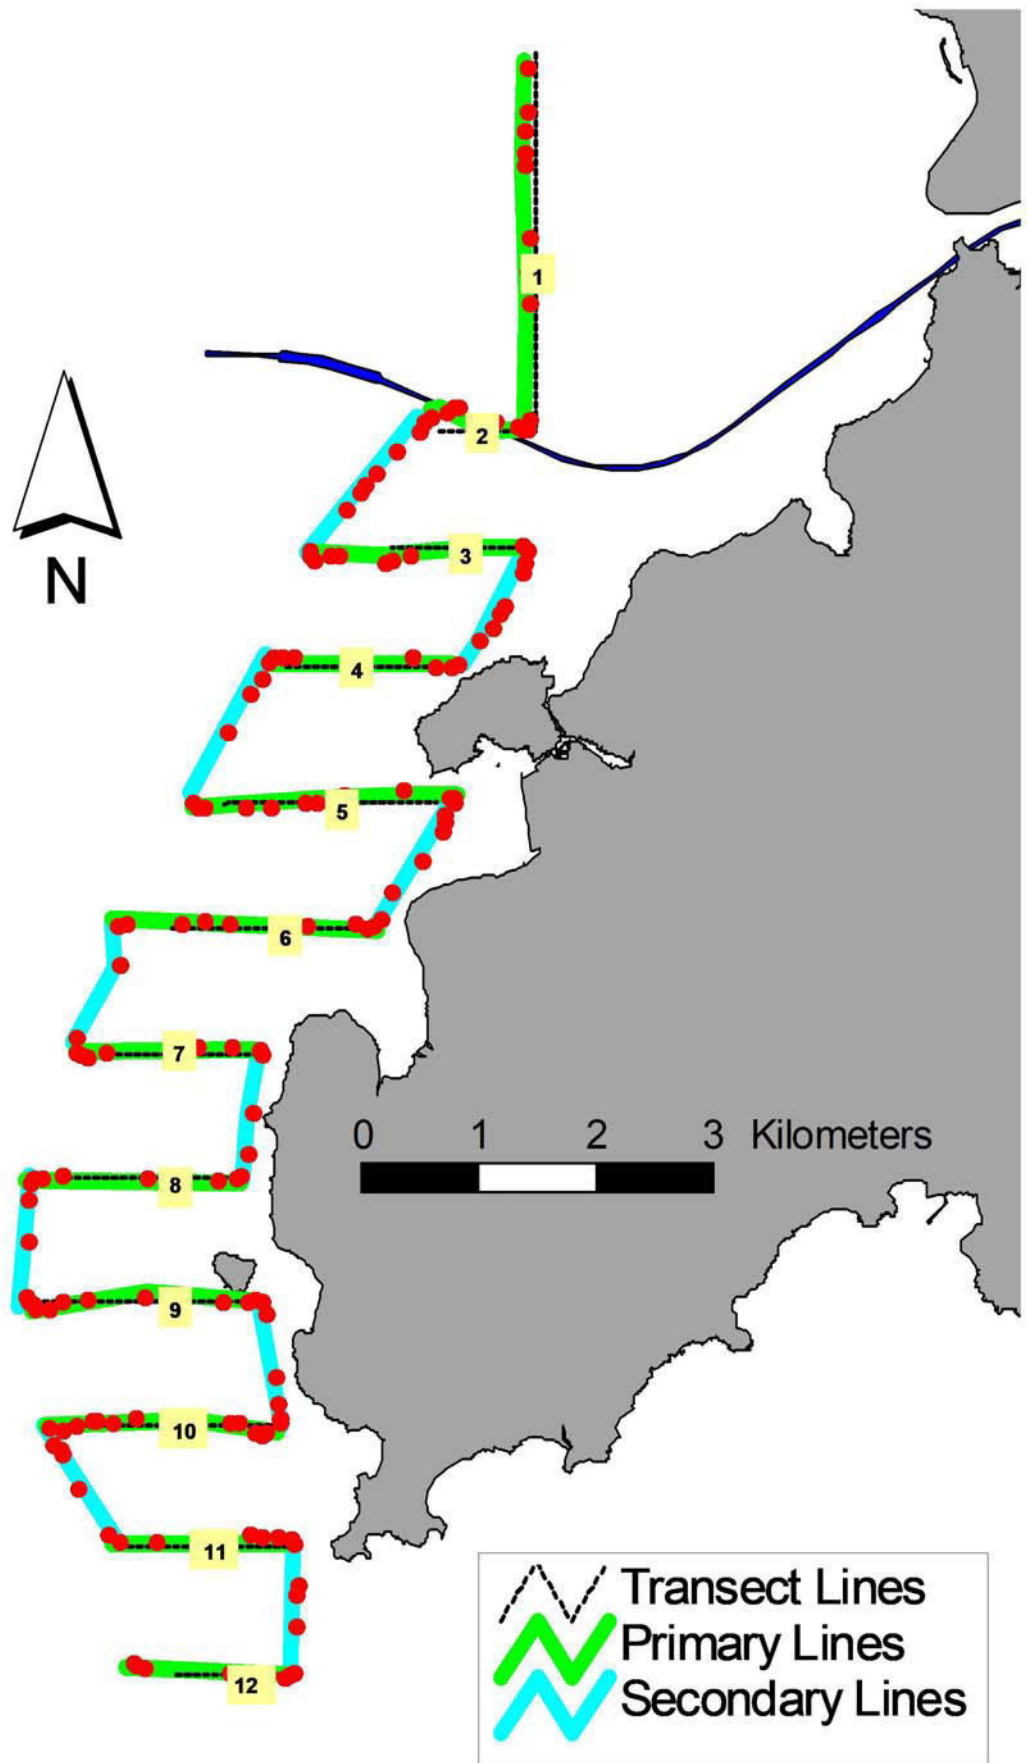
Figure 3. Survey Route on September 13th, 2017 (note: red dots represent the tracked positions of survey boat logged continuously by GPS throughout the course of the survey)

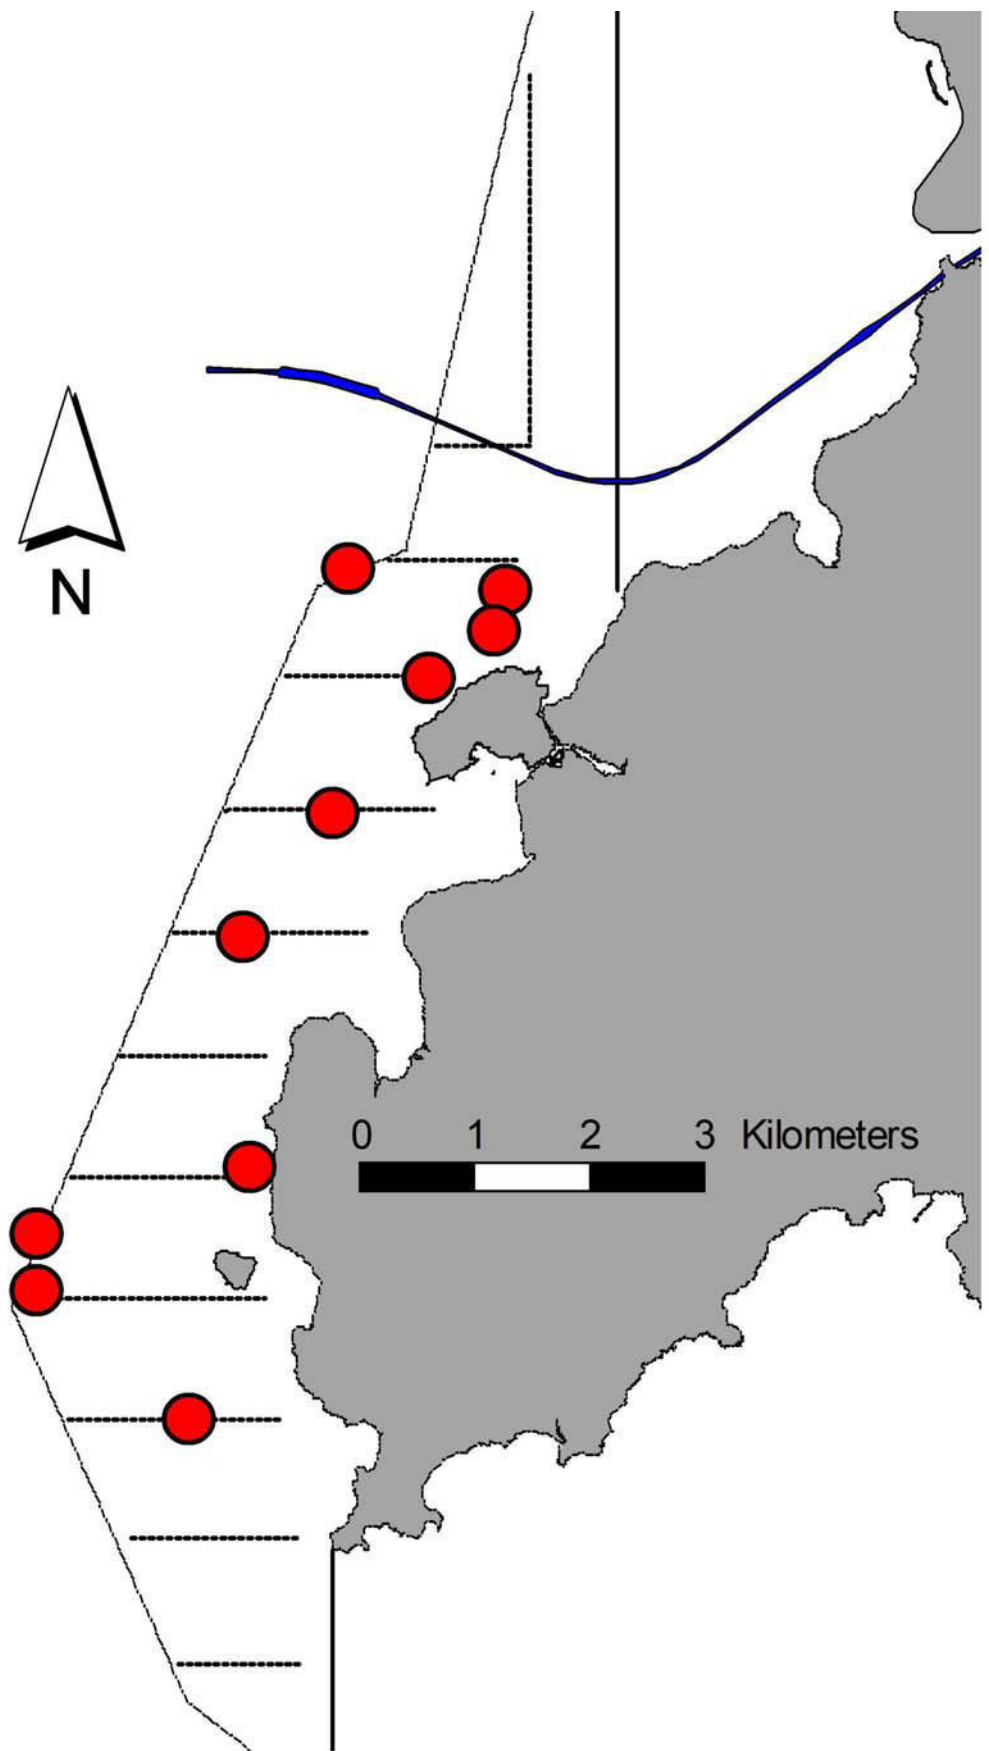
Figure 4. Distribution of Chinese White Dolphin Sighting during September 2017 HKLR09 Monitoring Surveys

- 5.12 Half of the dolphin groups were small in size with only 1-3 animals per group, while there were four medium-sized groups of 5-6 animals respectively.
- 5.13 During this month of dolphin monitoring, no major marine construction activities was conducted and no adverse impact on Chinese white dolphins was noticeable from general observations.
- 5.14 Evaluation of impacts on dolphins due to construction work will be conducted in the quarterly EM&A report.
- 5.15 Detailed monitoring methodology and results can be found in **Appendix I**.

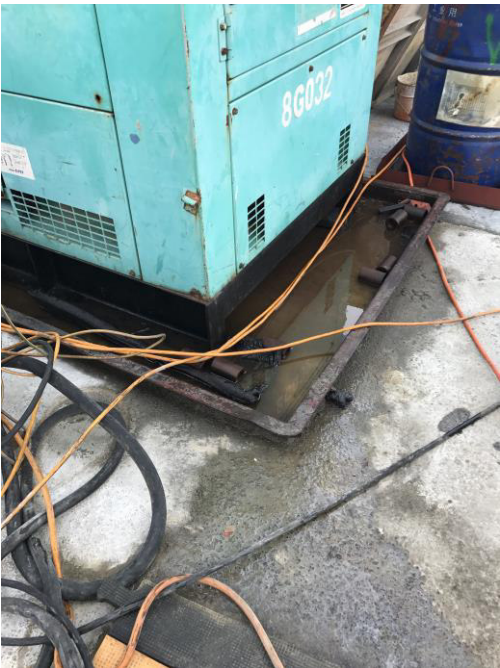
<p>Ref No: 170926-R02</p> <p>Impact: Waste / Chemical Management (F8,9)</p> <p>Details: The drip tray at P56 should be plugged and oily water and oil stain should be cleared as chemical waste.</p>

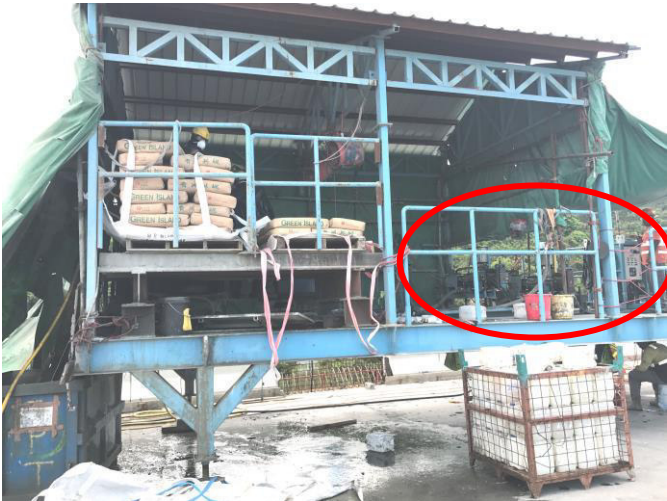
<p>Ref No: 170926-R03</p> <p>Impact: Air Quality (D13)</p> <p>Details: Grout mixing plant at P70 should be fully enclosed by three sides enclosure.</p>

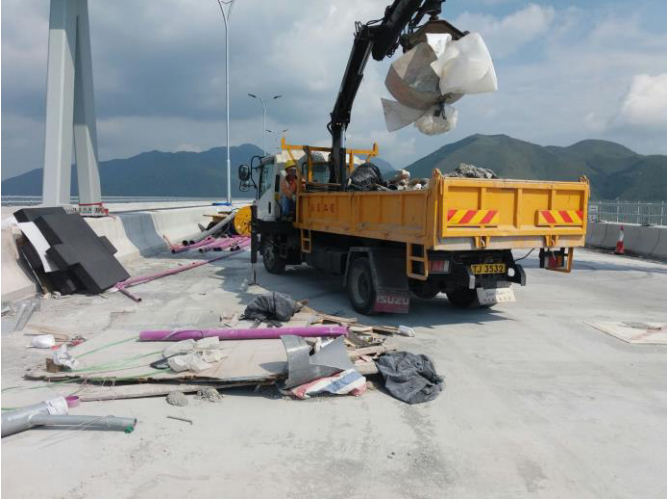
<p>Ref No: 170919-R01</p> <p>Impact: Air Quality (D7) Waste / Chemical Management (F1i,1iii,4ii)</p> <p>Details: Dusty material and accumulated waste at P13 should be removed.</p> <p>Follow-up: Dusty material and accumulated waste at P13 was being removed.</p>

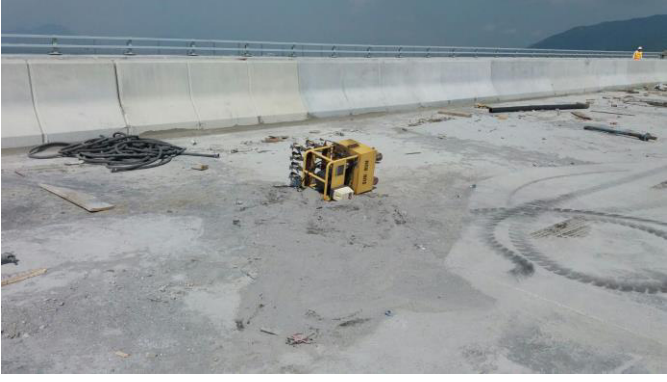
<p>Ref No: 170919-R02</p> <p>Impact: Waste / Chemical Management (F6,8)</p> <p>Details: Oil stain at P6 and Portion C P112 should be cleared.</p> <p>Follow-up: Oil stain at P6 and Portion C P112 was cleared.</p>
