**Contract No. HY/2011/09**  
**Hong Kong-Zhuhai-Macao Bridge**  
**Hong Kong Link Road – Section between HKSAR Boundary and Scenic Hill**

**Submission under Environmental Permit (EP-352/2009/D – Condition 4.4)**  
**Quarterly EM&A Report – September 2017 to November 2017**

**Contract No. HY/2011/09 HZMB Hong Kong Link Road –  
Section between HKSAR Boundary and Scenic Hill  
Quarterly EM&A Report No. 19 for September to November 2017**

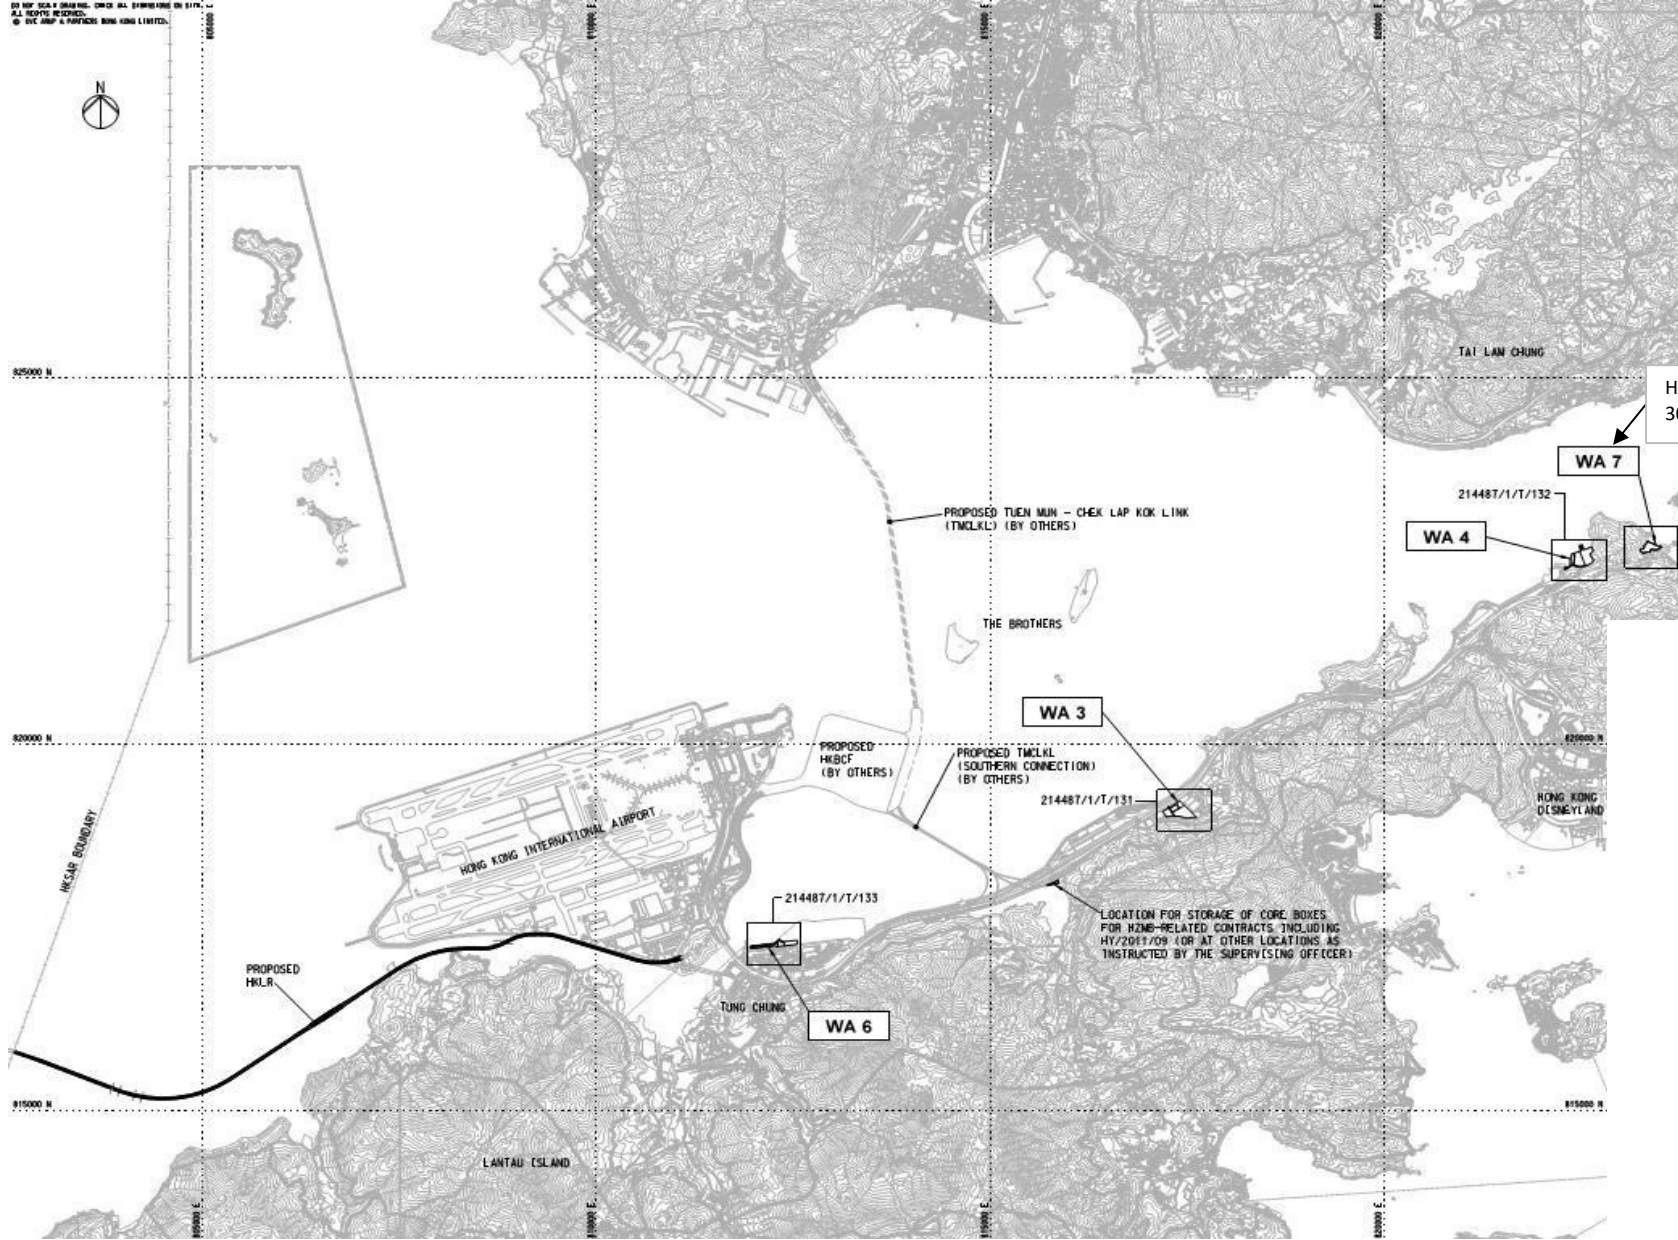
Title	Contract No. HY/2011/09 Hong Kong-Zhuhai-Macao Bridge Hong Kong Link Road – Section between HKSAR Boundary and Scenic Hill Site Layout Plan (WA3, WA4, WA6 and WA7)		Scale	N.T.S	Propose No.	MA12014
	Date	Jul-16	Figure	1a

- 2.5 **Figure 1a-d** shows the layout of the Contract and the scope of the Contract works comprises the following major items:
  - a dual 3-lane carriageway in the form of viaduct from the HKSAR boundary (connecting with the HZMB Main Bridge) to the Scenic Hill (connecting with the tunnel under separate Contract No. HY/2011/03), of approximately 9.4km in length with a hard shoulder for each bound of carriageway and a utilities trough on the outer edge of each bound of viaducts;

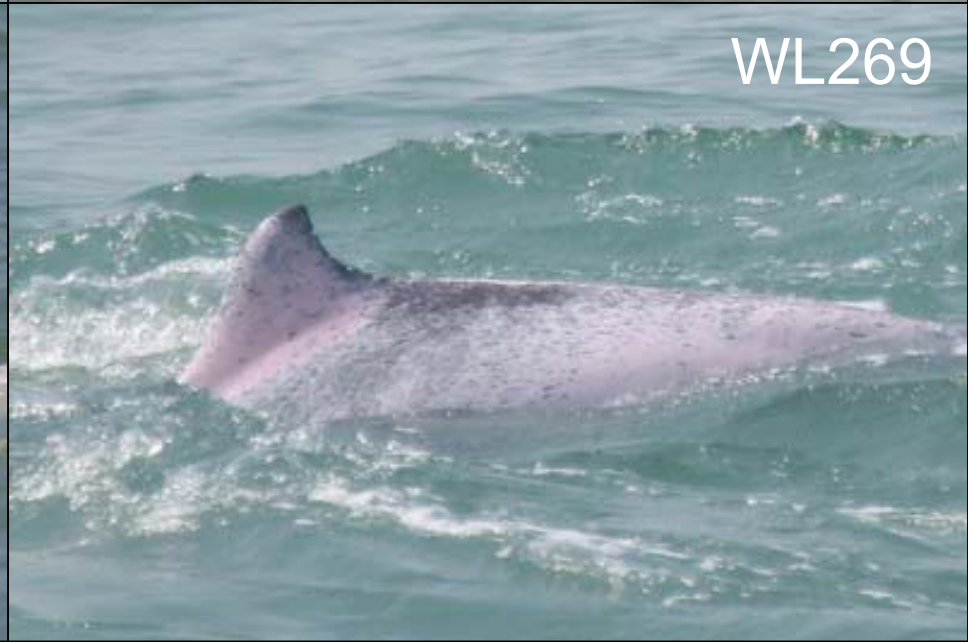
WL269

Appendix V. Ranging patterns (95% kernel ranges) of 40 individual dolphins that were sighted during HKLR09 impact phase monitoring period (note: yellow dots indicate sightings made in September – November 2017 during HKLR09 and HKLR03 monitoring surveys; yellow dots with red circles indicate the ones made during HKBCF monitoring surveys)
