Contract No. HY/2011/09
Hong Kong-Zhuhai-Macao Bridge
Hong Kong Link Road – Section between HKSAR Boundary and Scenic Hill

Submission under Environmental Permit (EP-352/2009/D – Condition 4.4)
Monthly EM&A Report – October 2017

**Contract No. HY/2011/09 HZMB Hong Kong Link Road –
Section between HKSAR Boundary and Scenic Hill
Revised Monthly EM&A Report for October 2017 (EP-352/2009/D)**

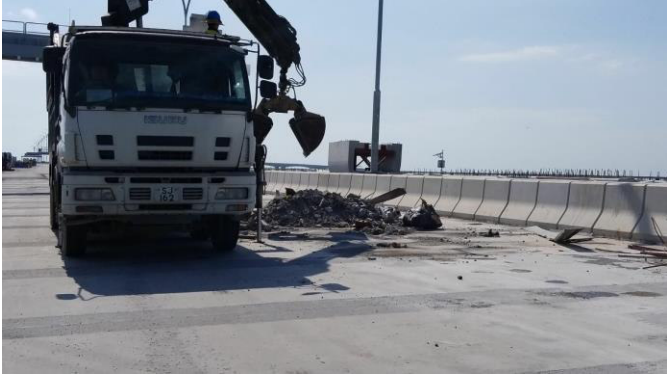
<p>Ref No: 171010-R01</p> <p>Impact: Waste / Chemical Management (F4ii)</p> <p>Details: Housekeeping should be enhanced at P43.</p> <p>Follow-up: Housekeeping was observed enhanced at P43.</p>
 	<p>Ref No: 171010-R02</p> <p>Impact: Air Quality (D15)</p> <p>Details: Water spraying should be provided to the scrubbling works along P47-50, contractor was reminded to provide water container at every working point.</p> <p>Follow-up: Water spraying was provided to the scrubbling works along P47-50.</p>

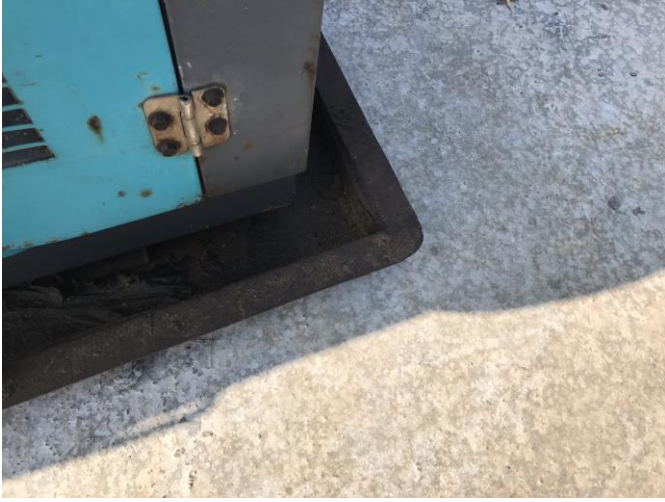
<p>Ref No: 171024-R02</p> <p>Impact: Waste / Chemical Management (F8,9)</p> <p>Details: Oily water in the drip tray should be cleared at P56.</p> <p>Follow-up: Oily water in the drip tray at P56 was cleared.</p>
