Contract No. HY/2011/09
Hong Kong-Zhuhai-Macao Bridge
Hong Kong Link Road – Section between HKSAR Boundary and Scenic Hill

Submission under Environmental Permit (EP-352/2009/D – Condition 4.4)
Monthly EM&A Report – November 2017

**Contract No. HY/2011/09 HZMB Hong Kong Link Road –
Section between HKSAR Boundary and Scenic Hill
Revised Monthly EM&A Report for November 2017 (EP-352/2009/D)**

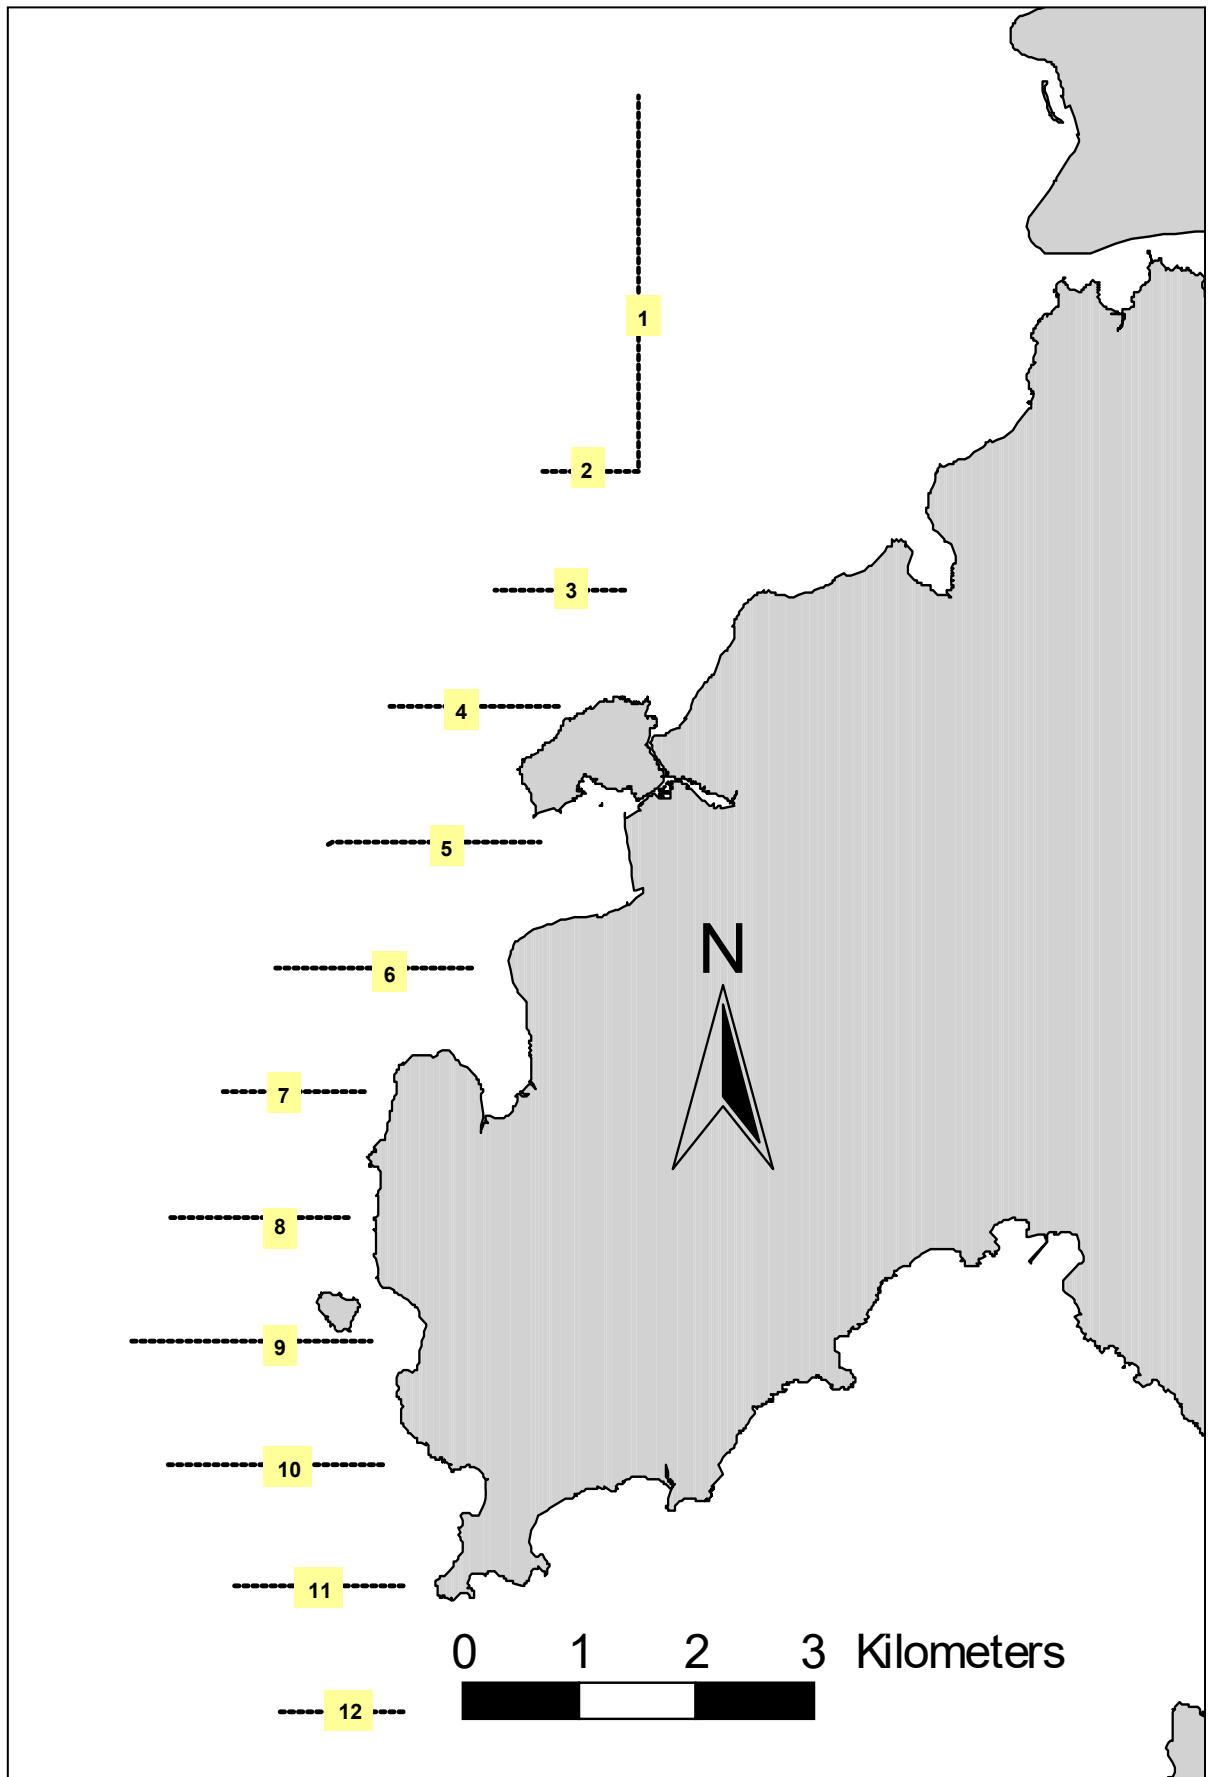
Figure 1. Transect Line Layout in West Lantau Survey Areas

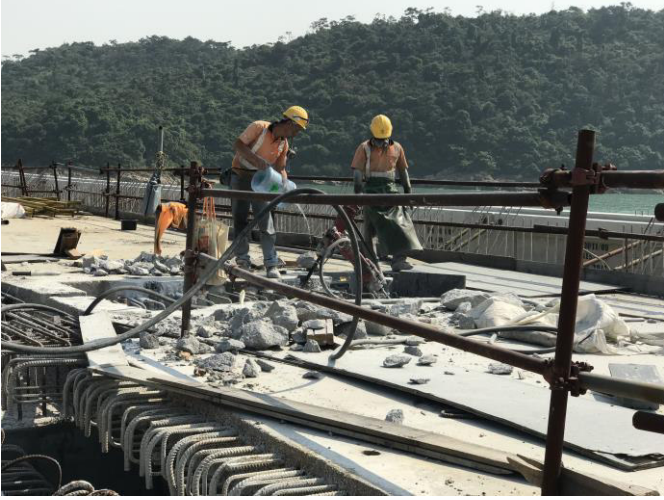
<p>Ref No: 171031-R01</p> <p>Impact: Air Quality (D15)</p> <p>Details: Breaking works at P59 should be provided with water spraying for dust suppression.</p> <p>Follow-up: Water spraying was provided to the breaking works at P59.</p>

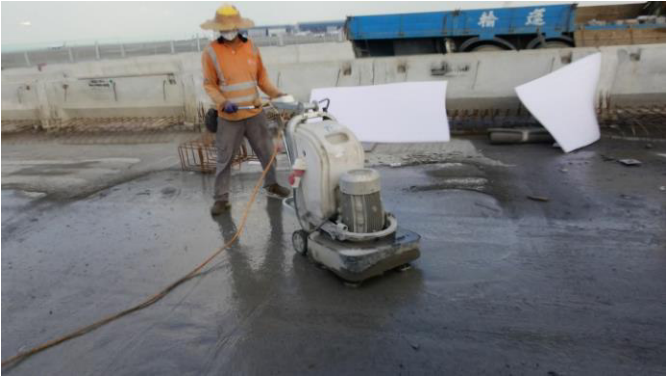
<p>Ref No: 171107-R01</p> <p>Impact: Air Quality (D15)</p> <p>Details: Water spraying should be provided to the scrubbling works along P67-68, contractor was reminded to provide water container at every working point.</p> <p>Follow-up: Water spraying was provided to the scrubbling works along P67-68.</p>

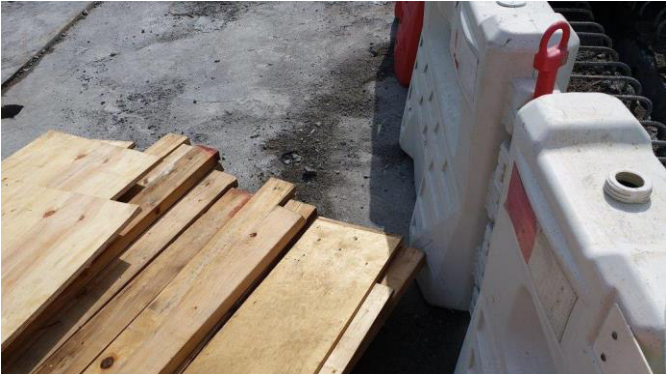
<p>Ref No: 171107-R03</p> <p>Impact: Waste / Chemical Management (F6)</p> <p>Details: Oil stain at P59 should be cleared as chemical waste.</p> <p>Follow-up: Oil stain at P59 was removed.</p>

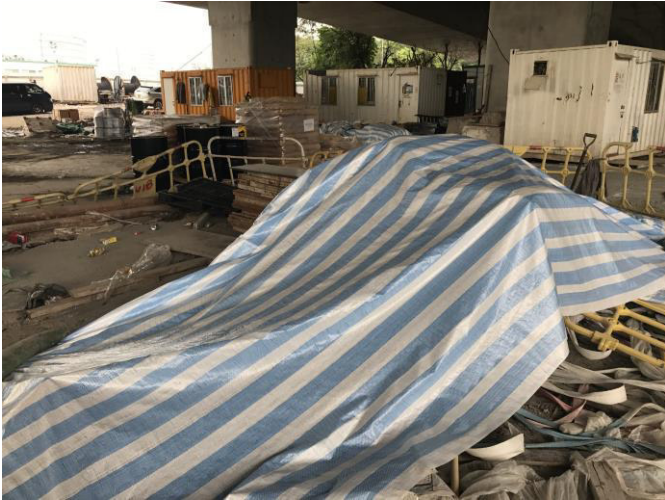
<p>Ref No: 171114-R01</p> <p>Impact: Air Quality (D20)</p> <p>Details: Cement bags at Portion C P113 should be covered by impervious sheet.</p> <p>Follow-up: Cement bags at Portion C P113 was covered by impervious sheet.</p>
