Contract No. HY/2011/09
Hong Kong-Zhuhai-Macao Bridge
Hong Kong Link Road – Section between HKSAR Boundary and Scenic Hill

Submission under Environmental Permit (EP-352/2009/D – Condition 4.4)
Quarterly EM&A Report – December 2017 to February 2018

**Contract No. HY/2011/09 HZMB Hong Kong Link Road –
Section between HKSAR Boundary and Scenic Hill
Quarterly EM&A Report No. 20 for December 2017 to February 2018**

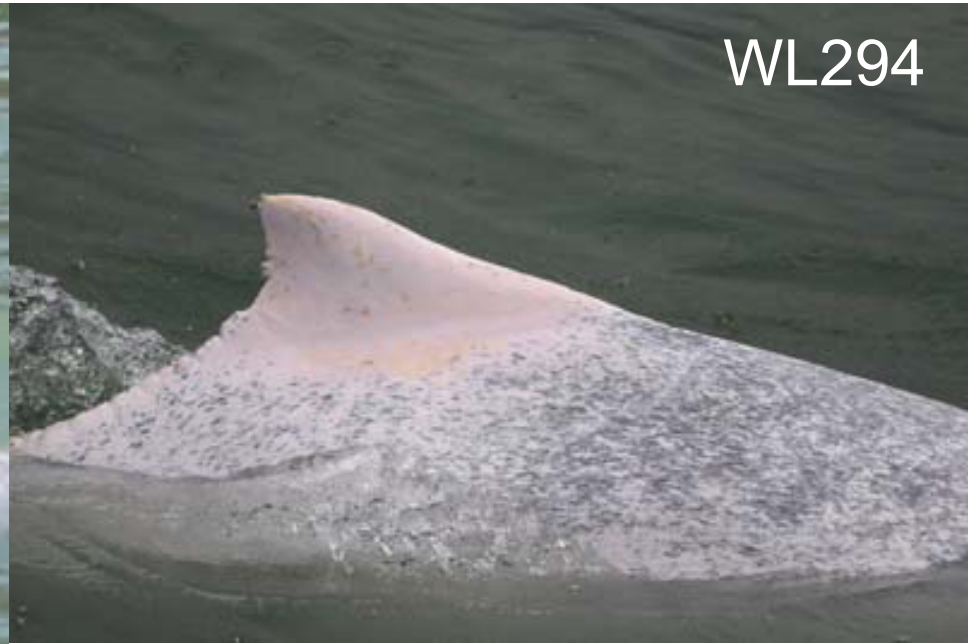
Appendix V. Ranging patterns (95% kernel ranges) of 26 individual dolphins that were sighted during HKLR09 impact phase monitoring period (note: yellow dots indicate sightings made in December 2017-February 2018 during HKLR09 and HKLR03 monitoring surveys; yellow dots with red circles indicate the ones made during HKBCF monitoring surveys)
