Contract No. HY/2011/09
Hong Kong-Zhuhai-Macao Bridge
Hong Kong Link Road – Section between HKSAR Boundary and Scenic Hill

Submission under Environmental Permit (EP-352/2009/D – Condition 4.4)
Monthly EM&A Report – January 2018

**Contract No. HY/2011/09 HZMB Hong Kong Link Road –
Section between HKSAR Boundary and Scenic Hill
Revised Monthly EM&A Report for January 2018 (EP-352/2009/D)**

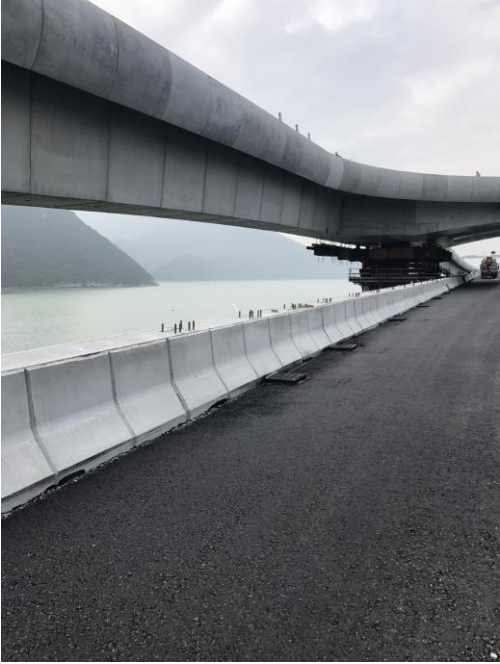
<p>Ref No: 171227-R01</p> <p>Impact: Waste / Chemical Management (F4ii)</p> <p>Details: Housekeeping at P56 should be enhanced.</p> <p>Follow-up: Housekeeping at P56 was enhanced.</p>

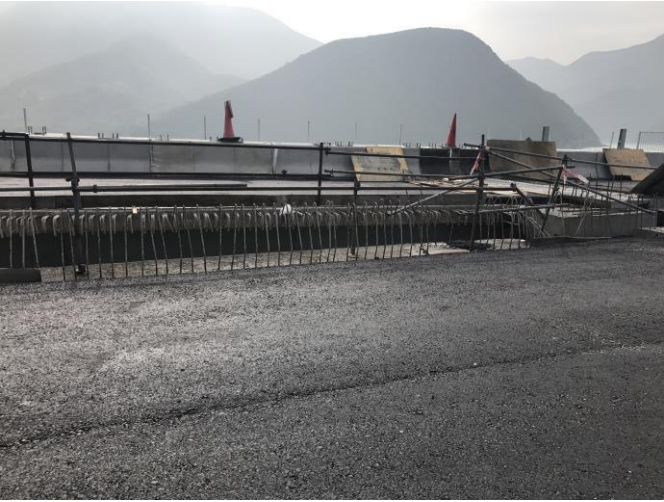
<p>Ref No: 171227-R02</p> <p>Impact: Air Quality (D7)</p> <p>Details: Dusty material at P55 should be covered by impervious sheet or removed.</p> <p>Follow-up: Dusty material at P55 was removed.</p>

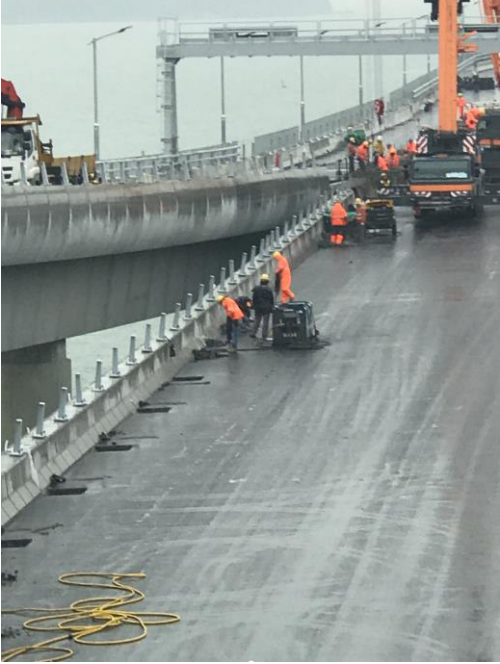
<p>Ref No: 180102-R01</p> <p>Impact: Waste / Chemical Management (F4ii)</p> <p>Details: Housekeeping at P55 should be enhanced.</p> <p>Follow-up: Housekeeping at P55 was enhanced.</p>
