**Contract No. HY/2011/09**  
**Hong Kong-Zhuhai-Macao Bridge**  
**Hong Kong Link Road – Section between HKSAR Boundary and Scenic Hill**

**Submission under Environmental Permit (EP-352/2009/D – Condition 4.4)**  
**Monthly EM&A Report – February 2018**

**Contract No. HY/2011/09 HZMB Hong Kong Link Road –  
Section between HKSAR Boundary and Scenic Hill  
Revised Monthly EM&A Report for February 2018 (EP-352/2009/D)**

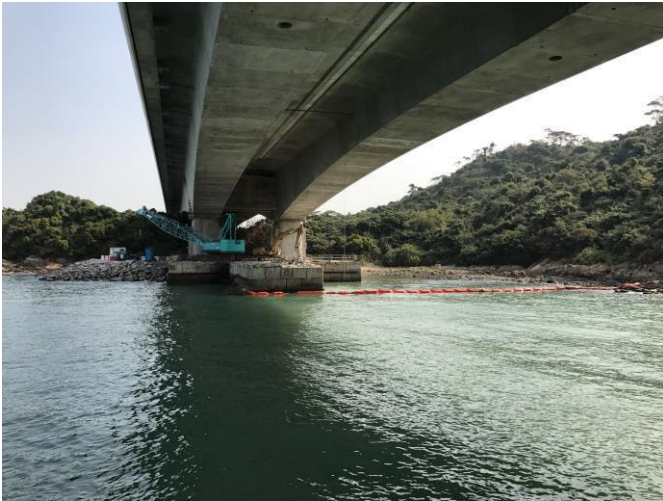
**Ref No:** 180206-R01

**Impact:**  
Water Quality (B24)

**Details:**  
Silt curtain at P68 should be surrounded properly around P68 during dismantling works.

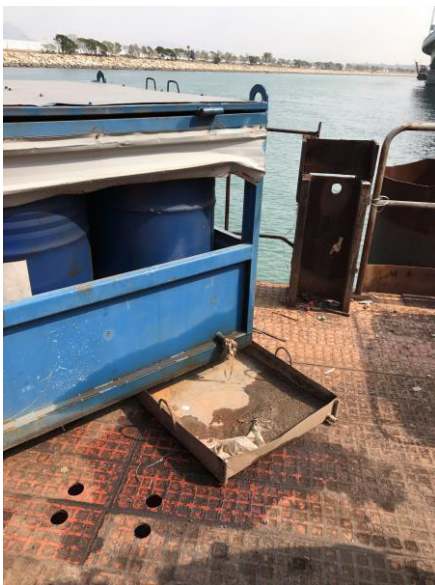
**Ref No:** 180206-R02

**Impact:**  
Waste / Chemical Management (F8,9)

**Details:**  
Drip tray at P70 should be plugged.

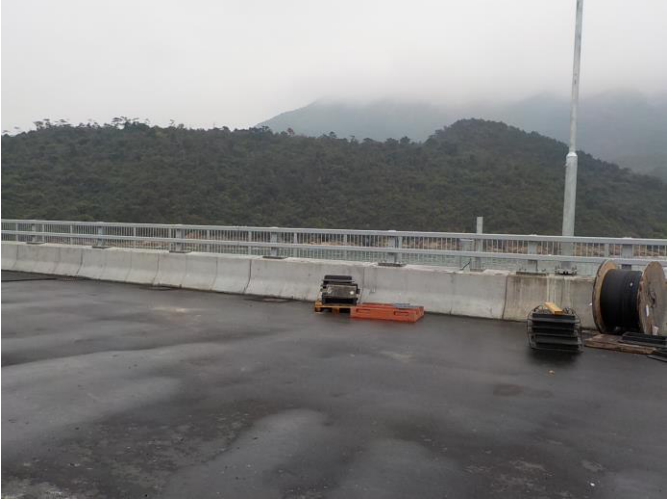
<p><b>Ref No:</b> 180130-R01</p> <p><b>Impact:</b> Waste / Chemical Management (F1i,1iii,4ii)</p> <p><b>Details:</b> Housekeeping at P56 should be enhanced.</p> <p><b>Follow-up:</b> Housekeeping at P56 was enhanced.</p>

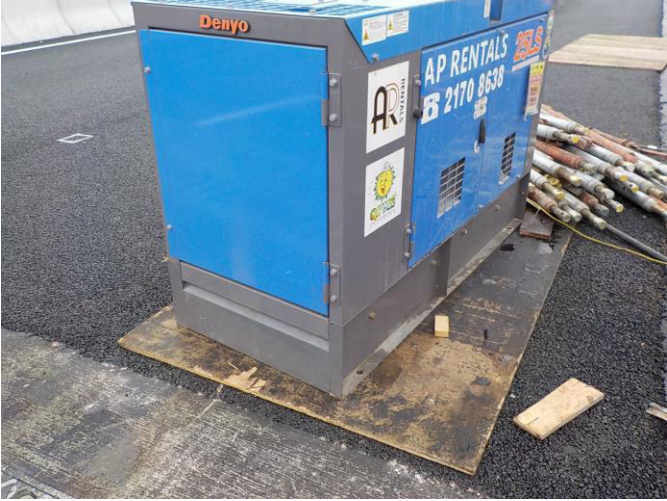
<p><b>Ref No:</b> 180130-R02</p> <p><b>Impact:</b> Waste / Chemical Management (F2iii,9)</p> <p><b>Details:</b> Chemical containers should be provided with proper chemical labels and drip tray at P56.</p> <p><b>Follow-up:</b> Chemical containers at P56 was removed.</p>

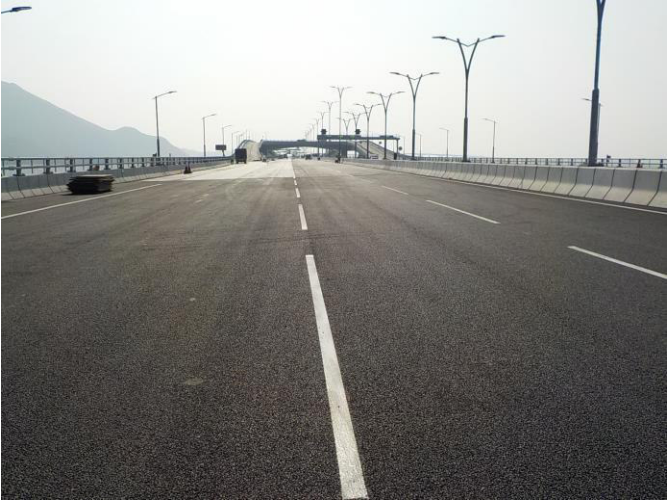
<p><b>Ref No:</b> 180130-R03</p> <p><b>Impact:</b> Waste / Chemical Management (F6)</p> <p><b>Details:</b> Oil stain at P56 should be cleared as chemical waste.</p> <p><b>Follow-up:</b> Oil stain at P56 was cleared.</p>

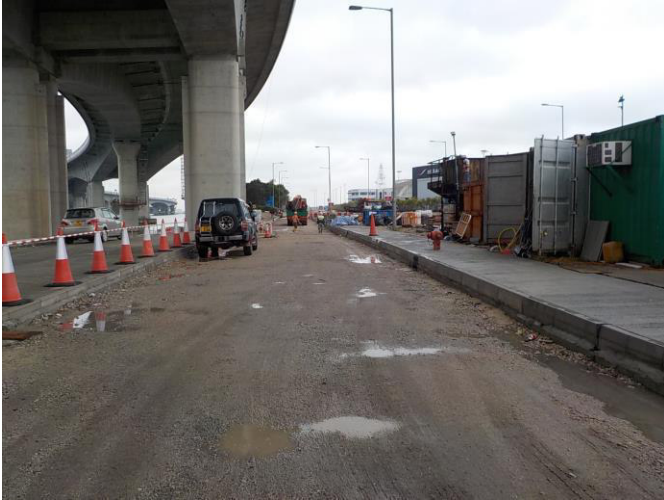
**Ref No:** 180123-R01

**Impact:**  
Air Quality (D26)

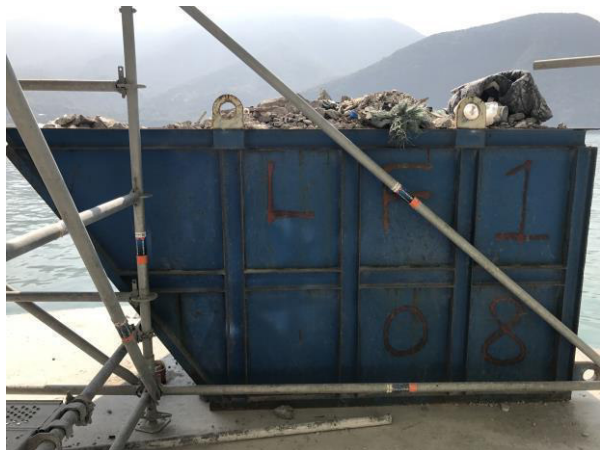
**Ref No:** 180213-R01

**Impact:**  
Waste / Chemical Management (F4ii)

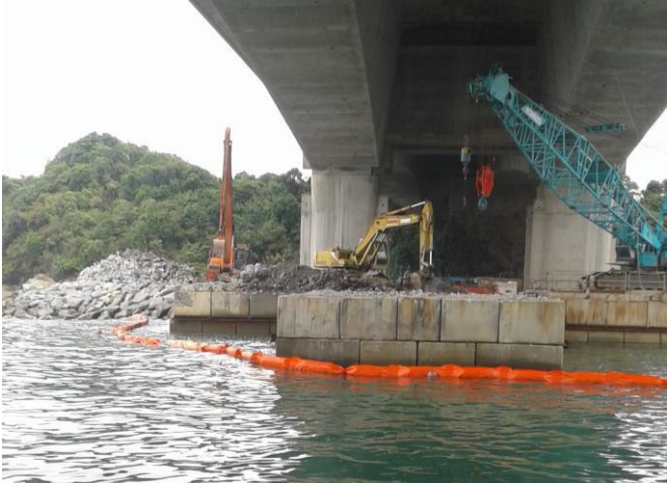
<p><b>Ref No:</b> 180206-R01</p> <p><b>Impact:</b> Water Quality (B24)</p> <p><b>Details:</b> Silt curtain at P68 should be surrounded properly around P68 during dismantling works.</p> <p><b>Follow-up:</b> Silt curtain at P68 was properly surrounded around P68 during dismantling works.</p>

Parameters	Date	Observations and Recommendations	Follow-up
<i>Water Quality</i>	06/02/2018	Silt curtain at P68 should be surrounded properly around P68 during dismantling works.	Rectification/improvement was observed during the follow-up audit session on 13 February 2018.
<i>Ecology</i>	N/A <sup>(1)</sup>	N/A <sup>(1)</sup>	N/A <sup>(1)</sup>
<i>Air Quality</i>	N/A <sup>(1)</sup>	N/A <sup>(1)</sup>	N/A <sup>(1)</sup>
<i>Noise</i>	N/A <sup>(1)</sup>	N/A <sup>(1)</sup>	N/A <sup>(1)</sup>
<i>Waste / Chemical Management</i>	06/02/2018	Drip tray at P70 should be plugged.	Rectification/improvement was observed during the follow-up audit session on 13 February 2018.
	13/02/2018	Housekeeping should be enhanced at P52.	Rectification/improvement was observed during the follow-up audit session on 27 February 2018.
	20/02/2018	Chemical at P56 should be stored in proper chemical container with chemical label and drip tray.	Rectification/improvement was observed during the follow-up audit session on 27 February 2018.

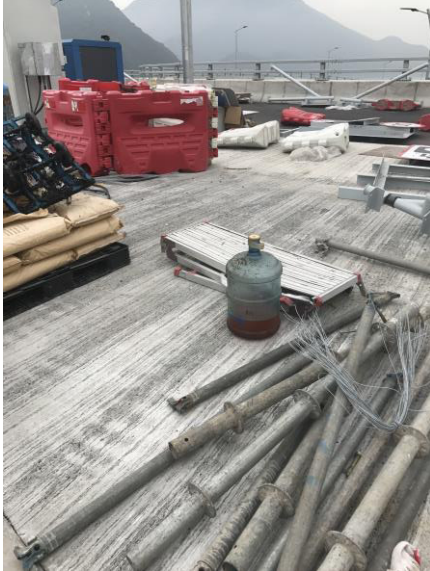
**Ref No:** 180220-R01

Chemical at P56 should be stored in proper chemical container with chemical label and drip tray.

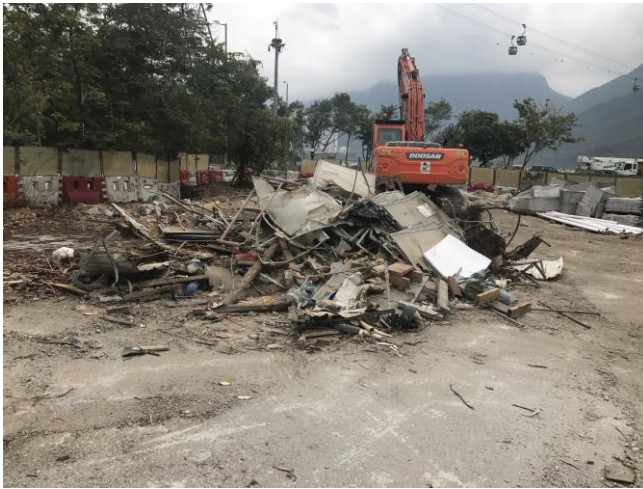
**Ref No:** 180220-R02

Housekeeping at P113 should be enhanced.

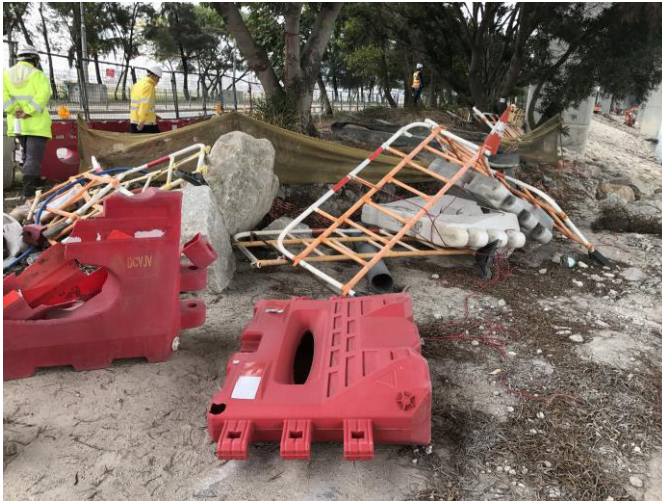
**Ref No:** 180227-R01

Housekeeping should be enhanced at P84 (portion A) and accumulation of waste nearby sea should be avoided.

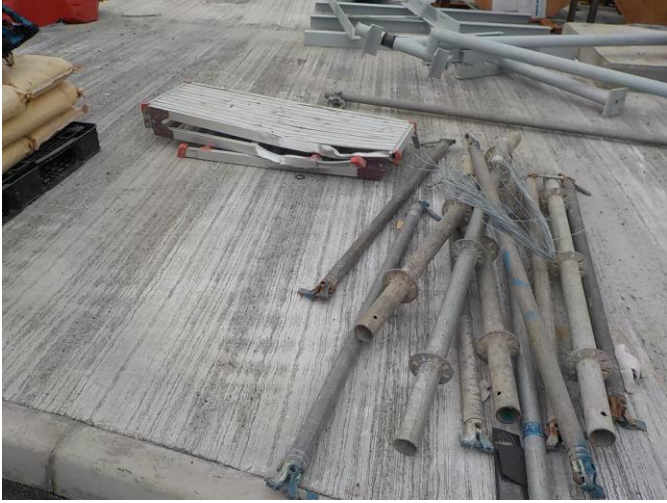
<p><b>Ref No:</b> 180220-R01</p> <p><b>Impact:</b> Waste / Chemical Management (F2i,2iii,8)</p> <p><b>Details:</b> Chemical at P56 should be stored in proper chemical container with chemical label and drip tray.</p> <p><b>Follow-up:</b> Chemical at P56 was removed.</p>

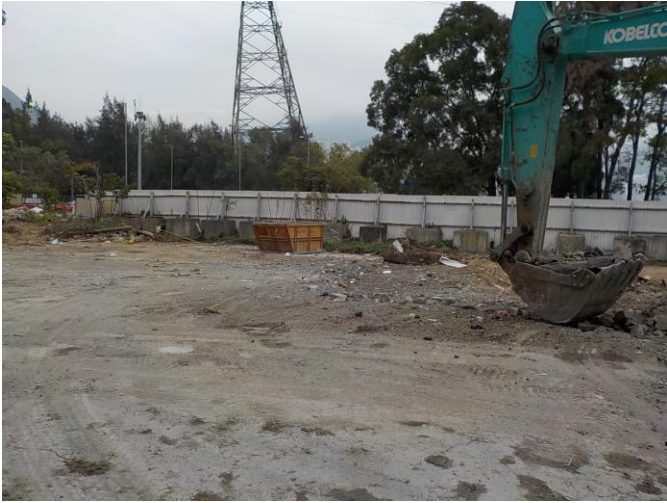
<p><b>Ref No:</b> 180220-R02</p> <p><b>Impact:</b> Waste / Chemical Management (F1i,1iii,4ii)</p> <p><b>Details:</b> Housekeeping at P113 should be enhanced.</p> <p><b>Follow-up:</b> Housekeeping at P113 was enhanced.</p>
