Contract No. HY/2011/09
Hong Kong-Zhuhai-Macao Bridge
Hong Kong Link Road – Section between HKSAR Boundary and Scenic Hill

Submission under Environmental Permit (EP-352/2009/D – Condition 4.4)
Monthly EM&A Report – March 2018

**Contract No. HY/2011/09 HZMB Hong Kong Link Road –
Section between HKSAR Boundary and Scenic Hill
Revised Monthly EM&A Report for March 2018 (EP-352/2009/D)**

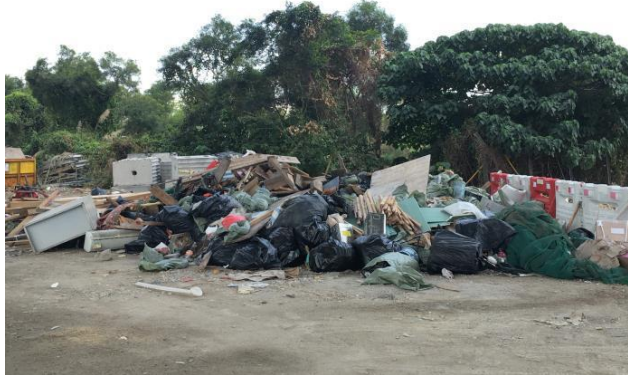
<p>Ref No: 180313-F04</p> <p>Impact: Waste / Chemical Management (F1i,1iii,4ii)</p> <p>Details: Housekeeping should be enhanced at P82 (portion A) and P109 (Portion C).</p>

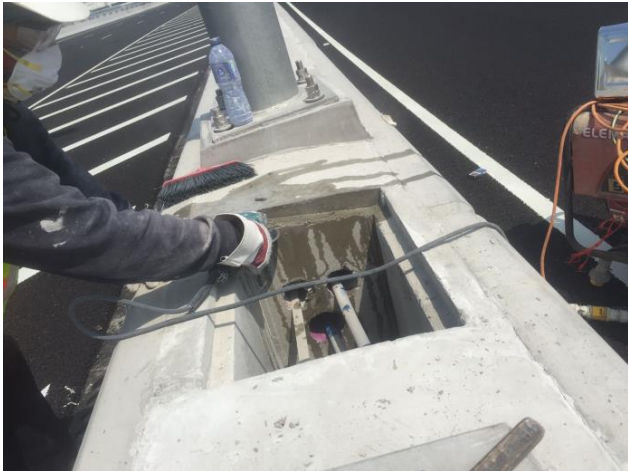
<p>Ref No: 180320-R02</p> <p>Impact: Air Quality (D 15)</p> <p>Details: Dust was observed from grinding works at P72. The Contractor was reminded to apply suitable mitigation measure.</p> <p>Follow-up: Suitable mitigation measure was applied during grinding works.</p>

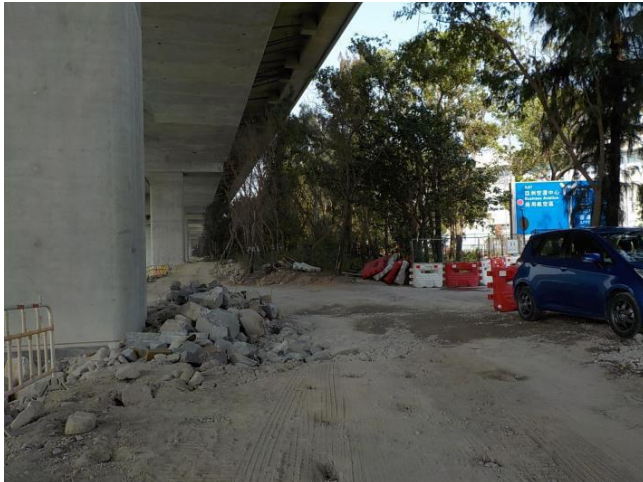
<p>Ref No: 180320-F03</p> <p>Impact: Air Quality (D 13, 15)</p> <p>Details: Dust was observed during the mechanical breaking operation at P100 (Portion A). The Contractor was reminded to spray water for dust suppression.</p> <p>Follow-up: No mechanical breaking operation at P100 (Portion A) was observed.</p>

Parameters	Date	Observations and Recommendations	Follow-up
<i>Water Quality</i>	N/A ⁽¹⁾	N/A ⁽¹⁾	N/A ⁽¹⁾
<i>Ecology</i>	N/A ⁽¹⁾	N/A ⁽¹⁾	N/A ⁽¹⁾
<i>Air Quality</i>	13/03/2018	Dust was observed during the mechanical breaking operation at P100 (Portion A). The Contractor was reminded to spray water for dust suppression.	Rectification/improvement was observed during the follow-up audit session on 27 March 2018.
	20/03/2018	An opened cement bag was observed without appropriate cover at P0.	Rectification/improvement was observed during the follow-up audit session on 27 March 2018.
	20/03/2018	Dust was observed from grinding works at P72. The Contractor was reminded to apply suitable mitigation measure.	Rectification/improvement was observed during the follow-up audit session on 27 March 2018.
<i>Noise</i>	N/A ⁽¹⁾	N/A ⁽¹⁾	N/A ⁽¹⁾
<i>Waste / Chemical Management</i>	06/03/2018	Housekeeping should be enhanced at P82 (Portion A) and P109(Portion C)	Rectification/improvement was observed during the follow-up audit session on 20 March 2018.
