Contract No. HY/2011/09
Hong Kong-Zhuhai-Macao Bridge
Hong Kong Link Road – Section between HKSAR Boundary and Scenic Hill

Submission under Environmental Permit (EP-352/2009/D – Condition 4.4)
Quarterly EM&A Report – March 2018 to May 2018

**Contract No. HY/2011/09 HZMB Hong Kong Link Road –
Section between HKSAR Boundary and Scenic Hill
Quarterly EM&A Report No. 21 for March to May 2018**

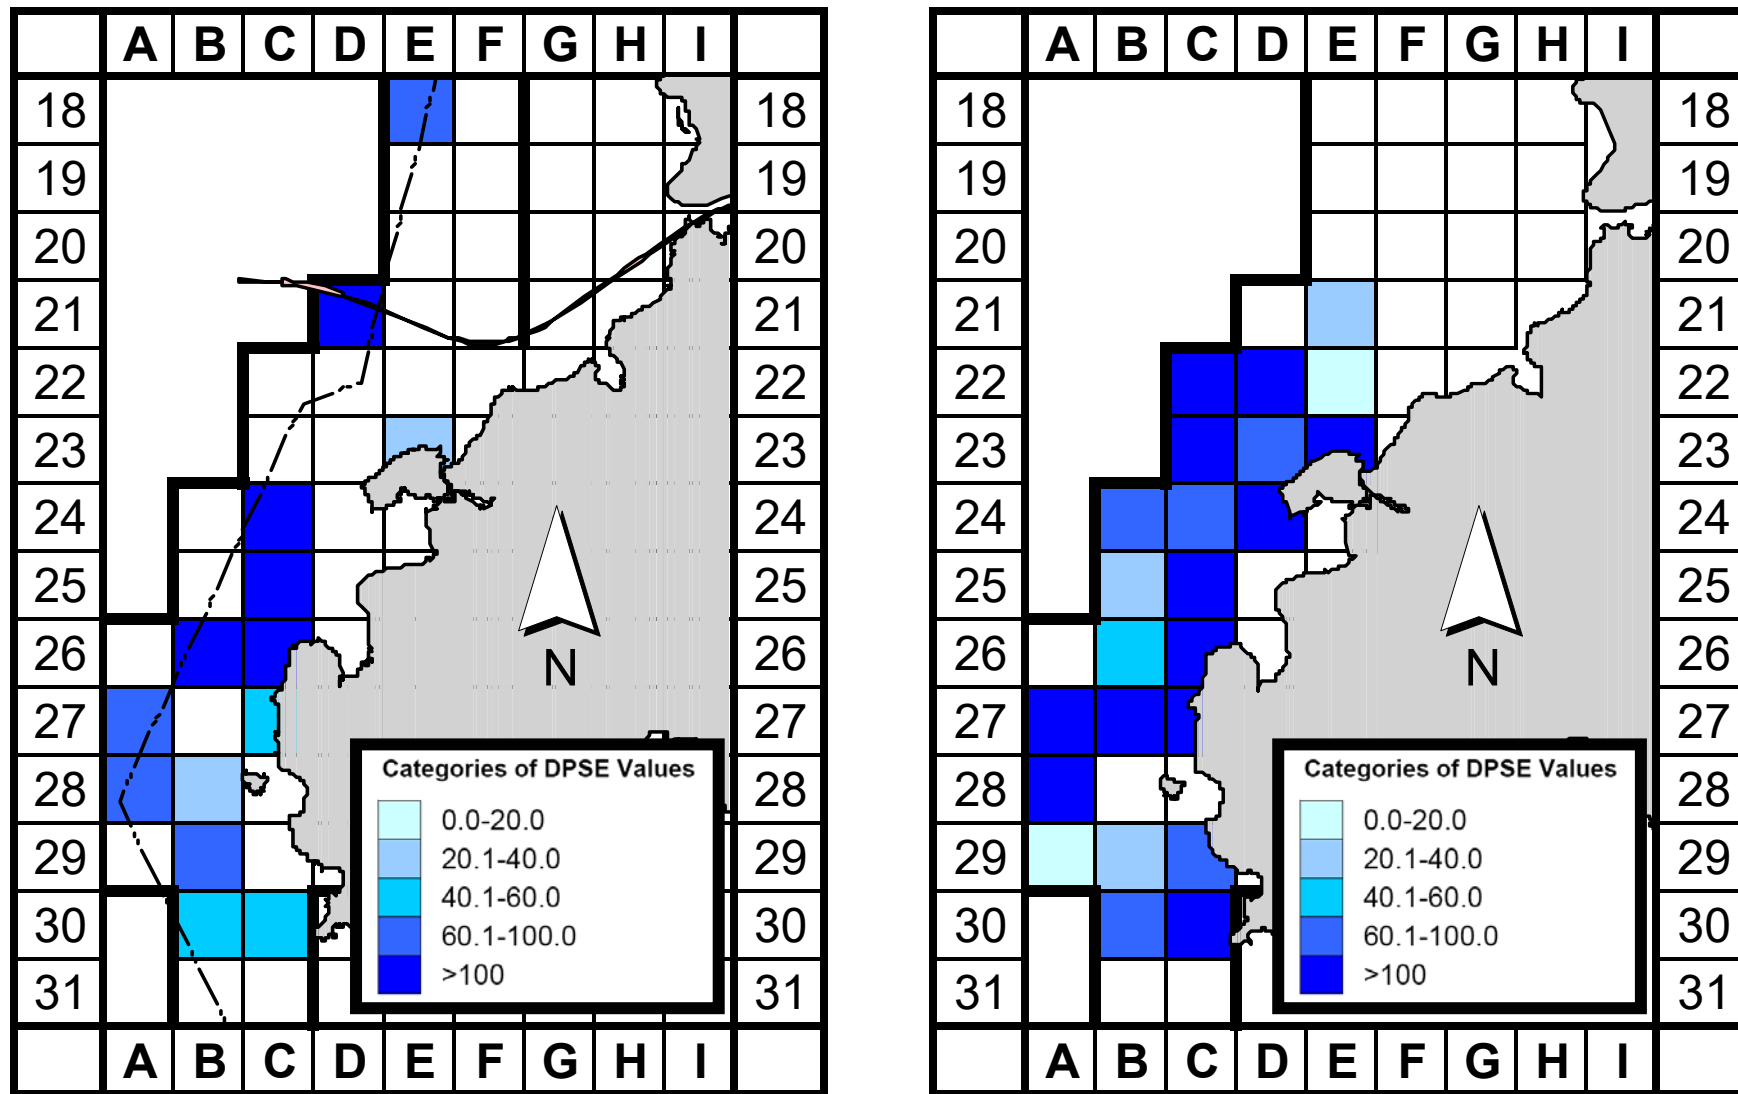
Figure 6. Comparison of density of Chinese white dolphins with corrected survey effort per km² in West Lantau survey area between the impact monitoring period (March-May 2018; left) and baseline monitoring period (September-November 2011; right) (DPSE = no. of dolphins per 100 units of survey effort)
