Contract No. HY/2011/09
Hong Kong-Zhuhai-Macao Bridge
Hong Kong Link Road – Section between HKSAR Boundary and Scenic Hill

Submission under Environmental Permit (EP-352/2009/D – Condition 4.4)
Monthly EM&A Report – June 2018

Contract HY/2011/09
Hong Kong-Zhuhai-Macao Bridge
Hong Kong Link Road-Section between
HKSAR Boundary and Scenic Hill
Monthly EM&A Report

June 2018
(Version 2.0)

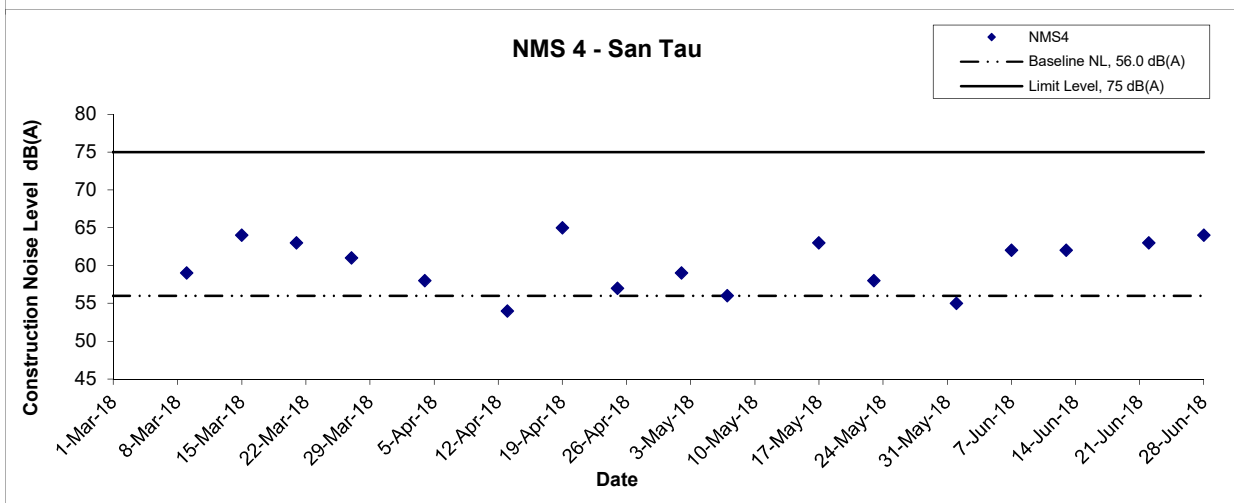
Noise Levels

Title Contract HY/2011/09 Hong Kong-Zhuhai-Macao Bridge Hong Kong Link Road-Section between HKSAR Boundary and Scenic Hill Graphical Presentation of Construction Noise Monitoring Results	Scale N.T.S	Project No. MA12014	
	Jun-18	Appendix G

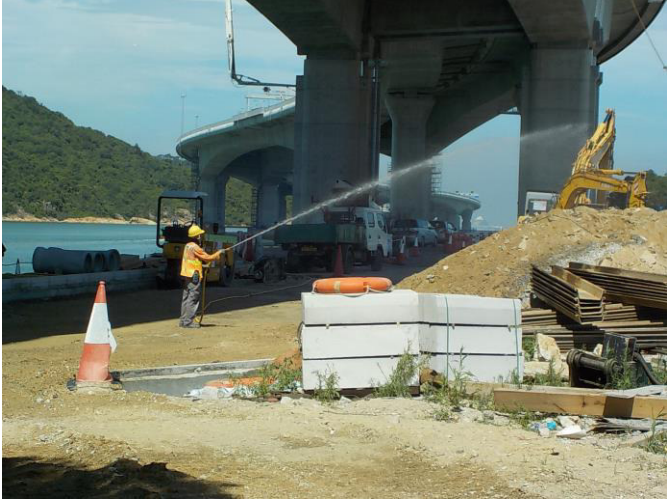
<p>Ref No: 180529-R01</p> <p>Impact: Air Quality (D 6)</p> <p>Details: To provide dust mitigation measures (e.g. water spraying) for the unpaved site area at near P81-P83.</p> <p>Follow-up: Water spraying was provided.</p>

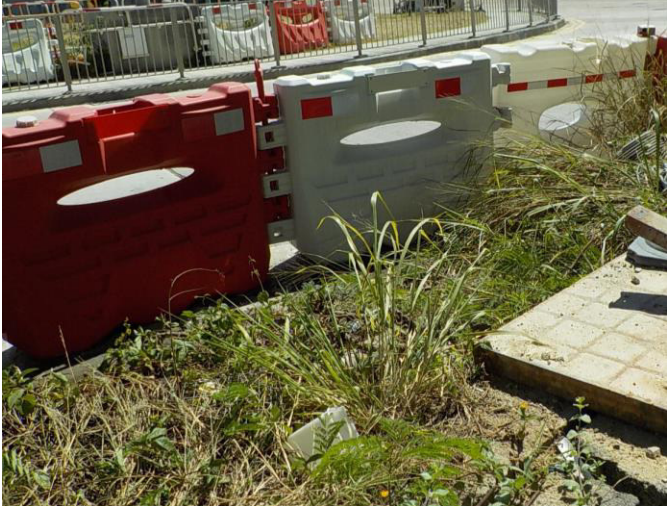
<p>Ref No: 180529-R02</p> <p>Impact: Waste/Chemical Management (F 1i, 1iii and 4ii)</p> <p>Details: To clear the damaged traffic barrier at P83.</p> <p>Follow-up: The damaged traffic barrier was cleared.</p>

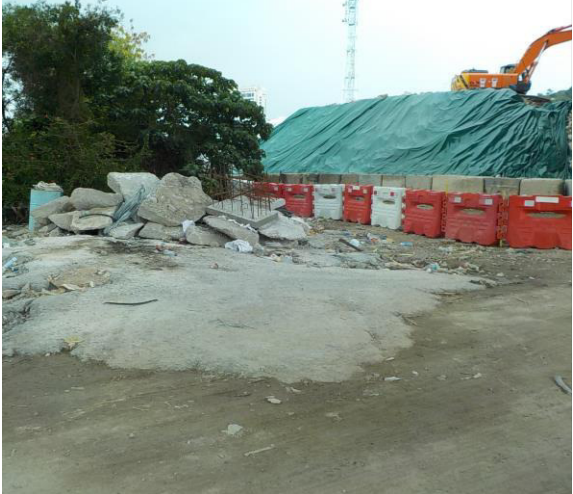
<p>Ref No: 180605-R01</p> <p>Impact: Waste/Chemical Management (F 1i, 1iii and 4ii)</p> <p>Details: To clear the accumulated waste at P109 (Portion C).</p> <p>Follow-up: The accumulated waste was cleared.</p>
---	--

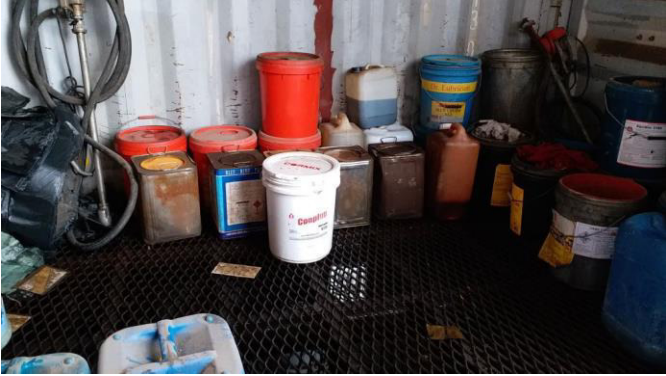
<p>Ref No: 180612-R01</p> <p>Impact: Waste/Chemical Management (F 8 and 9)</p> <p>Details: Provide drip tray for the chemical container at WA4.</p> <p>Follow-up: Secondary spill containment was provided.</p>

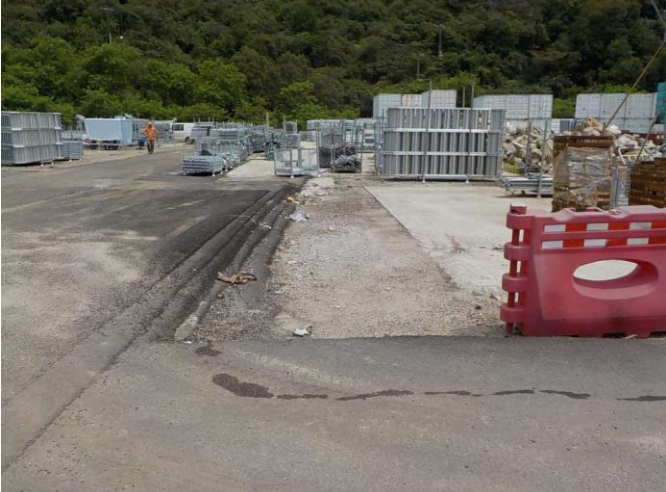
<p>Ref No: 180612-R02</p> <p>Impact: Waste/Chemical Management (F 1iii)</p> <p>Details: Clear the damaged traffic barrier at WA4.</p> <p>Follow-up: The damaged traffic barrier was cleared.</p>
