Contract No. HY/2011/09
Hong Kong-Zhuhai-Macao Bridge
Hong Kong Link Road – Section between HKSAR Boundary and Scenic Hill

Submission under Environmental Permit (EP-352/2009/D – Condition 4.4)
Monthly EM&A Report – July 2018

**Contract No. HY/2011/09 HZMB Hong Kong Link Road –
Section between HKSAR Boundary and Scenic Hill
Monthly EM&A Report for July 2018 (EP-352/2009/D)**

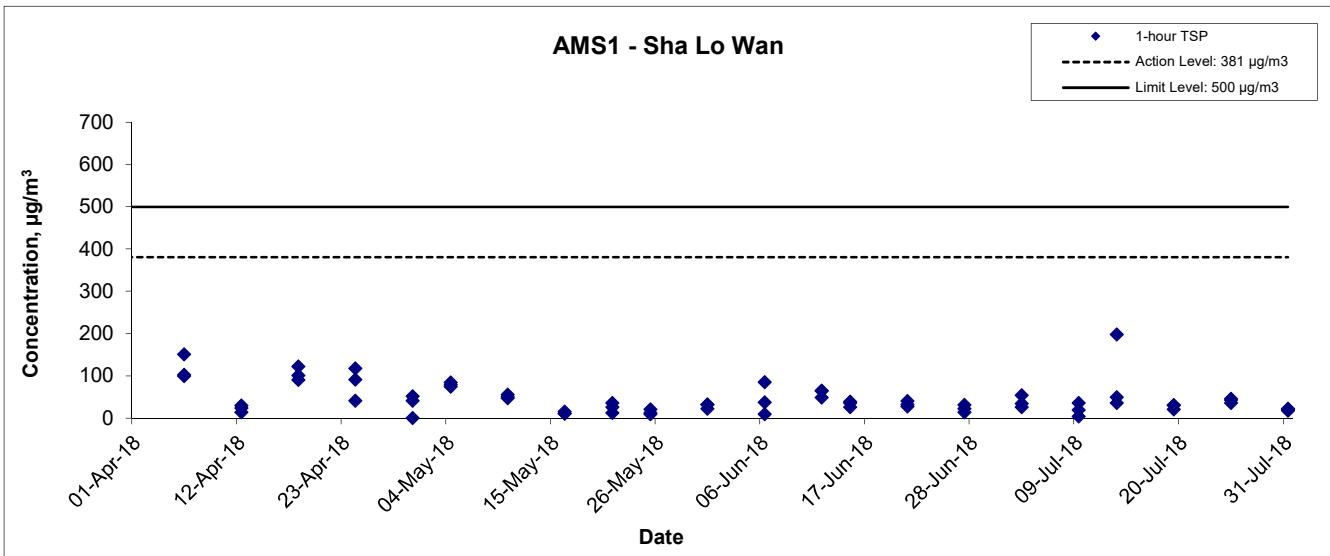
1-hour TSP Concentration Levels

Title Contract No. HY/2011/09 Hong Kong-Zhuhai-Macao Bridge Hong Kong Link Road – Section between HKSAR Boundary and Scenic Hill Graphical Presentation of 1-hour TSP Monitoring Results	Scale N.T.S	Project No. MA12014	
	Date Jul 18	Appendix E

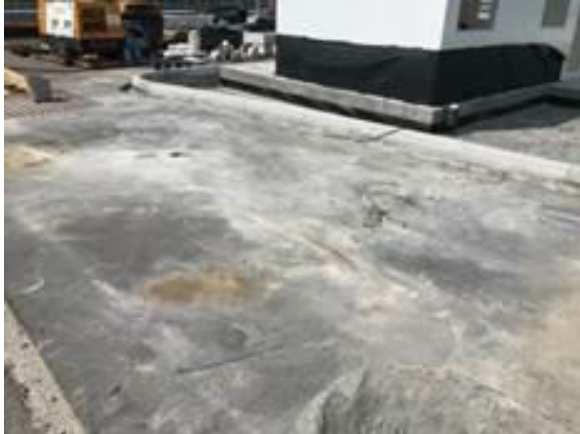
<p>Ref No: 180703-F04</p> <p>Impact: Waste/Chemical Management (F 8)</p> <p>Details: To clear the oil stain as chemical waste at P56.</p> <p>Follow-up: The oil stain was cleared.</p>

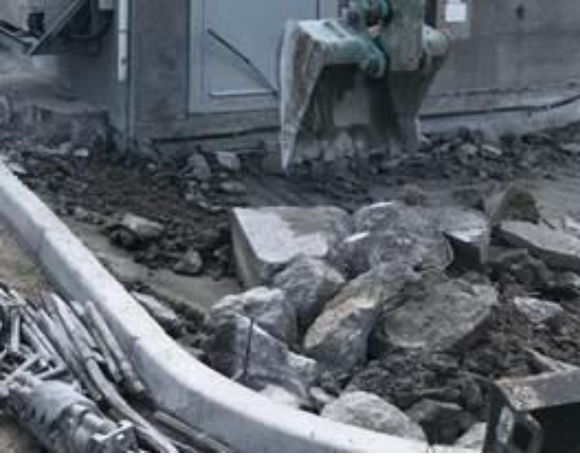
<p>Ref No: 180703-F05</p> <p>Impact: Air Quality (D 15)</p> <p>Details: To provide sufficient water spray before breaking works at P56 to avoid dust generation.</p> <p>Follow-up: Sufficient water spray was provided before breaking works.</p>

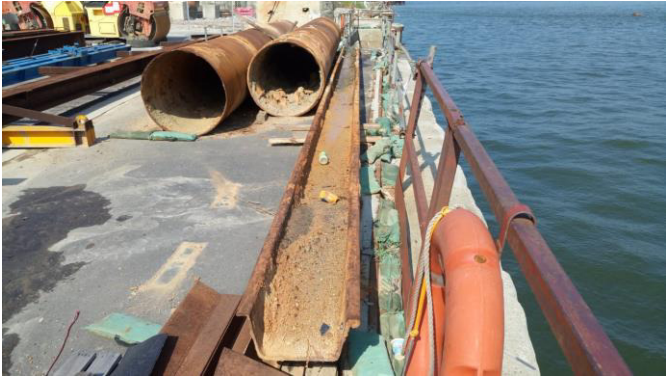
<p>Ref No: 180710-R01</p> <p>Impact: Waste/Chemical Management (F 1i & iii)</p> <p>Details: To clear the accumulated waste on the sheet pile at WA4.</p> <p>Follow-up: The accumulated waste was clear.</p>

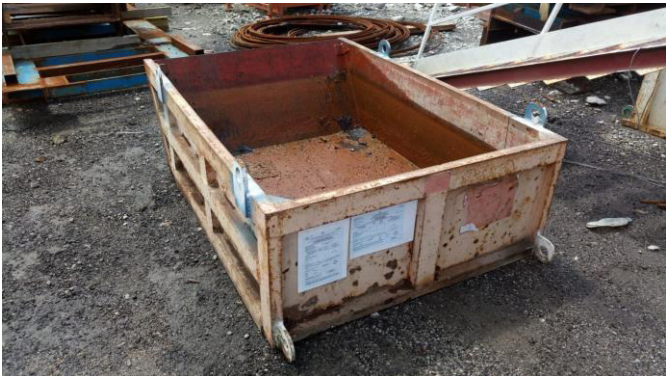
<p>Ref No: 180710-R02</p> <p>Impact: Water Quality (B 8)</p> <p>Details: Ponding water should be avoided at WA4.</p> <p>Follow-up: No ponding water was observed.</p>

Parameters	Date	Observations and Recommendations	Follow-up
<i>Water Quality</i>	10/7/2018	Ponding water should be avoided at WA4.	Rectification/improvement was observed during the follow-up audit session on 17 July 2018.
<i>Ecology</i>	N/A ⁽¹⁾	N/A ⁽¹⁾	N/A ⁽¹⁾
<i>Air Quality</i>	24/7/2018	NRMM labels should be provided for the generator and the air compressor at P56.	Rectification/improvement was observed during the follow-up audit session on 31 July 2018.
<i>Noise</i>	N/A ⁽¹⁾	N/A ⁽¹⁾	N/A ⁽¹⁾
<i>Waste / Chemical Management</i>	03/7/2018	To provide drip tray for the chemical containers at near P82.	Rectification/improvement was observed during the follow-up audit session on 10 July 2018.
	03/7/2018	To clear the damaged traffic barriers at near P82 and Portion C.	Rectification/improvement was observed during the follow-up audit session on 10 July 2018.
	10/7/2018	To clear the accumulated waste on the sheet pile at WA4.	Rectification/improvement was observed during the follow-up audit session on 17 July 2018.
