**Contract No. HY/2011/09**  
**Hong Kong-Zhuhai-Macao Bridge**  
**Hong Kong Link Road – Section between HKSAR Boundary and Scenic Hill**

**Submission under Environmental Permit (EP-352/2009/D – Condition 4.4)**  
**Monthly EM&A Report – August 2018**

**Contract No. HY/2011/09 HZMB Hong Kong Link Road –  
Section between HKSAR Boundary and Scenic Hill  
Monthly EM&A Report for August 2018 (EP-352/2009/D)**

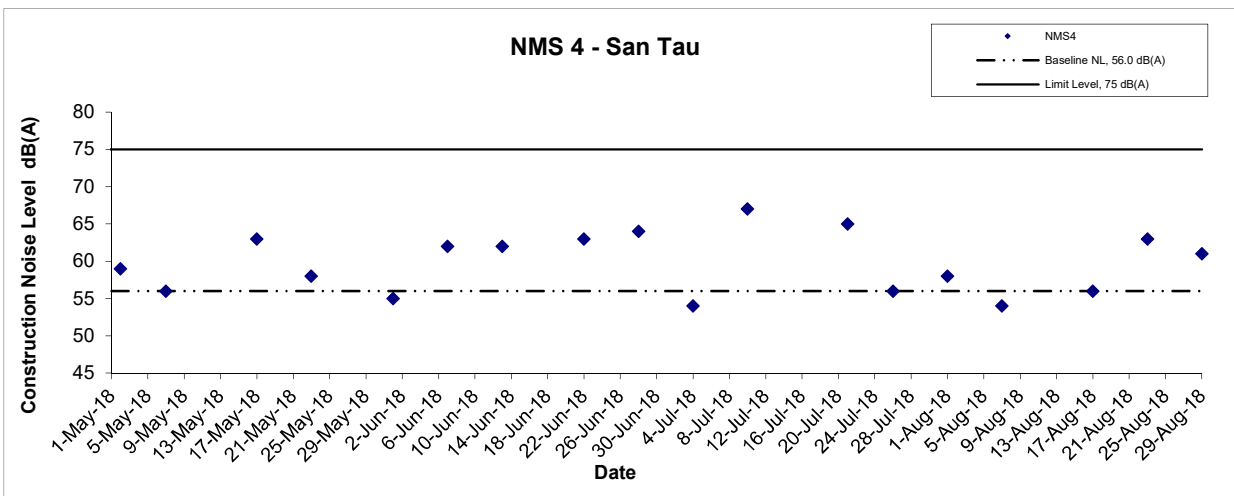
## Noise Levels

Title    Contract HY/2011/09 Hong Kong-Zhuhai-Macao Bridge Hong Kong Link Road-Section between HKSAR Boundary and Scenic Hill Graphical Presentation of Construction Noise Monitoring Results	Scale	Project No.	CINOTECH
	N.T.S	MA12014	
	Aug-18	Appendix G

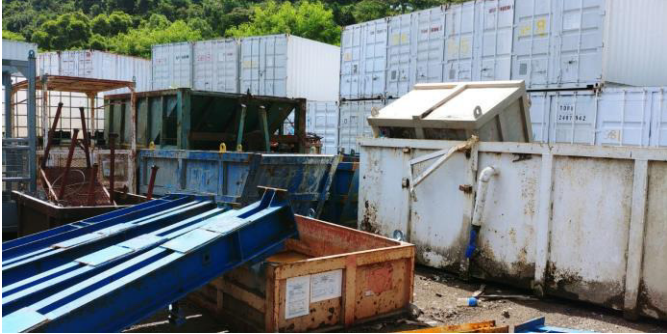
<p><b>Ref No:</b> 180807-R01</p> <p><b>Impact:</b> Waste/Chemical Management (F 1i &amp; 1iii)</p> <p><b>Details:</b> To clear the accumulated waste at WA4.</p> <p><b>Follow-up:</b> Accumulated waste was cleared.</p>

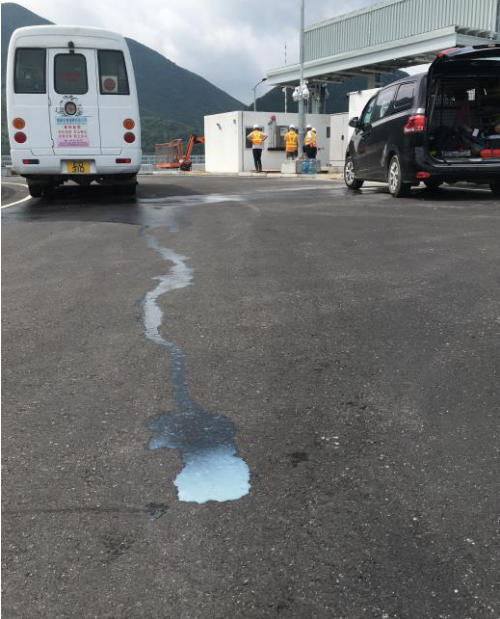
<p><b>Ref No:</b> 180828-R01</p> <p><b>Impact:</b> Waste/Chemical Management (F 6)</p> <p><b>Details:</b> To clear the unknown liquid on the ground as chemical waste at P56.</p>

14/8/2018	Regular clear the construction wastes at P109 to avoid accumulation.	Rectification/improvement was observed during the follow-up audit session on 21 August 2018.
	28/8/2018	To clear the unknown liquid on the ground as chemical waste at P56.	Rectification/improvement was observed during the follow-up audit session on 4 September 2018.
	28/8/2018	To provide drip tray for the chemical container at P56.	Rectification/improvement was observed during the follow-up audit session on 4 September 2018.
<i>Landscape &amp; Visual Impact</i>	N/A <sup>(1)</sup>	N/A <sup>(1)</sup>	N/A <sup>(1)</sup>
<i>Permits/Licences</i>	N/A <sup>(1)</sup>	N/A <sup>(1)</sup>	N/A <sup>(1)</sup>
<i>Other</i>	N/A <sup>(1)</sup>	N/A <sup>(1)</sup>	N/A <sup>(1)</sup>
<i>Cultural Heritage (Sha Lo Wan (West) Archaeological Site)</i>	19/6/2018	N/A <sup>(1)</sup>	N/A <sup>(1)</sup>

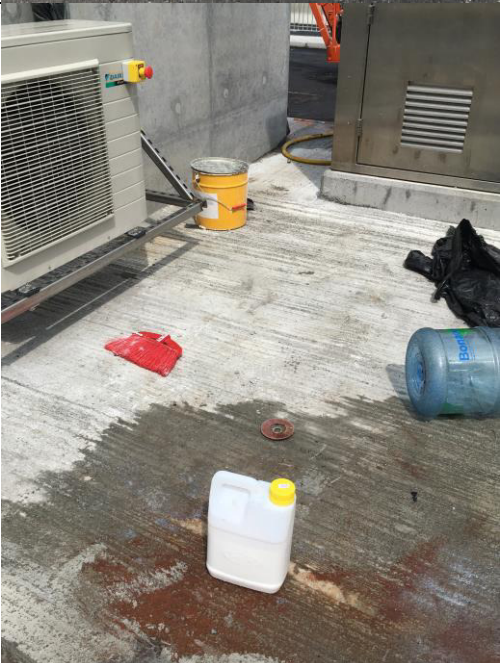
<p><b>Ref No:</b> 180828-R02</p> <p><b>Impact:</b> Waste/Chemical Management (F 8)</p> <p><b>Details:</b> To provide drip tray for the chemical container at P56.</p>
