Contract No. HY/2011/09
Hong Kong-Zhuhai-Macao Bridge
Hong Kong Link Road – Section between HKSAR Boundary and Scenic Hill

Submission under Environmental Permit (EP-352/2009/D – Condition 4.4)
Monthly EM&A Report – September 2018

**Contract No. HY/2011/09 HZMB Hong Kong Link Road –
Section between HKSAR Boundary and Scenic Hill
Monthly EM&A Report for September 2018 (EP-352/2009/D)**

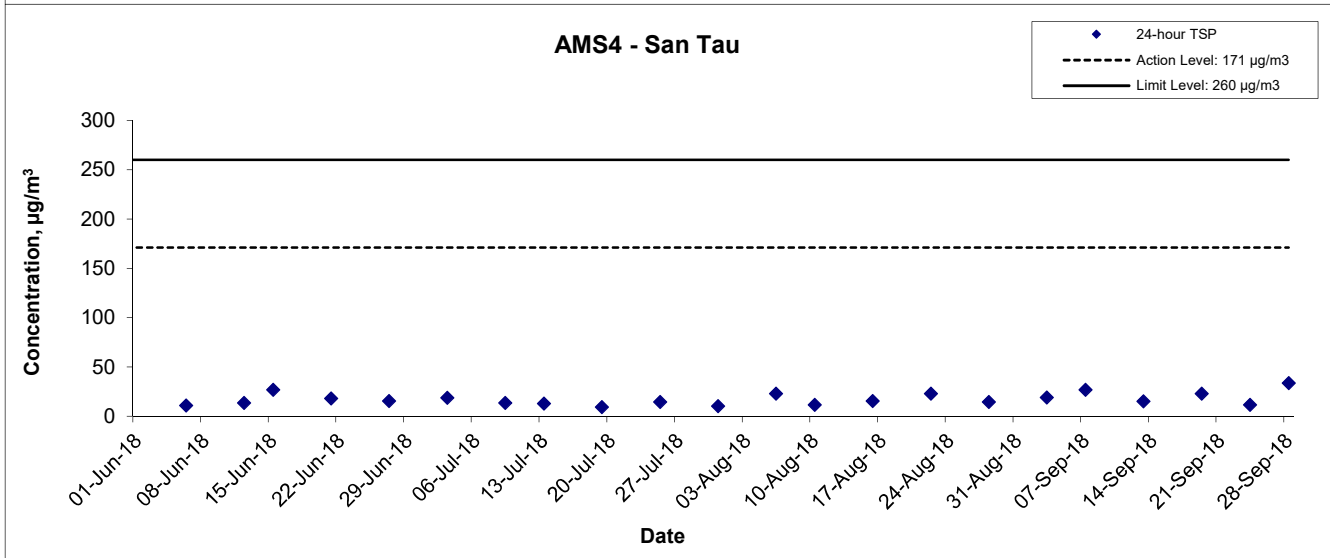
Title Contract No. HY/2011/09 Hong Kong-Zhuhai-Macao Bridge Hong Kong Link Road – Section between HKSAR Boundary and Scenic Hill Graphical Presentation of 24-hour TSP Monitoring Results	Scale N.T.S	Project No. MA12014	CINOTECH
	Date Sep 18	Appendix F

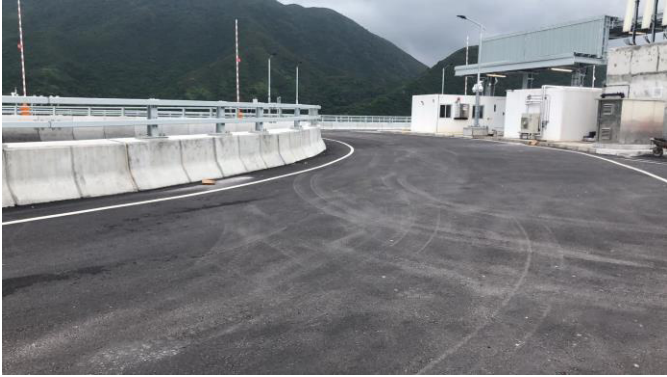
<p>Ref No: 180828-R01</p> <p>Impact: Waste/Chemical Management (F 6)</p> <p>Details: To clear the unknown liquid on the ground as chemical waste at P56.</p> <p>Follow-up: The unknown liquid was cleared.</p>

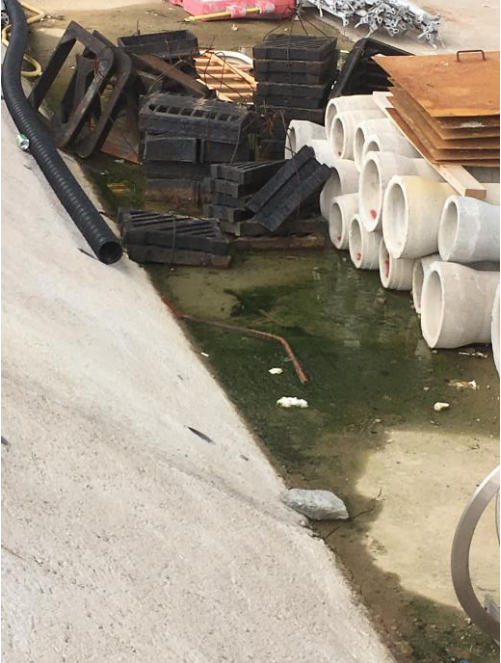
<p>Ref No: 180926-R01</p> <p>Impact: Water Quality (B 8)</p> <p>Details: Clear the muddy water at near P82.</p>

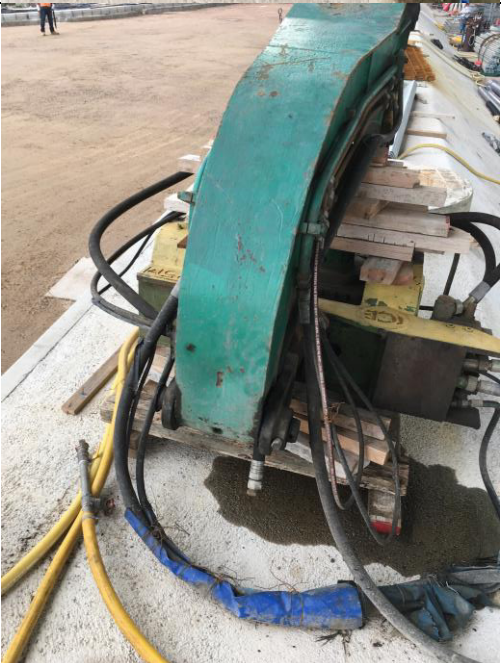
<p>Ref No: 180926-R02</p> <p>Impact: Waste/ Chemical Management (F 8)</p> <p>Details: Clear the oil stain properly at near P82.</p>

18/9/2018	To provide drip tray for the chemical container at near P82.	Rectification/improvement was observed during the follow-up audit session on 26 September 2018.
	26/9/2018	Clear the oil stain properly at near P82.	Rectification/improvement was observed during the follow-up audit session on 2 October 2018.
<i>Landscape & Visual Impact</i>	N/A ⁽¹⁾	N/A ⁽¹⁾	N/A ⁽¹⁾
<i>Permits/Licences</i>	N/A ⁽¹⁾	N/A ⁽¹⁾	N/A ⁽¹⁾
<i>Other</i>	N/A ⁽¹⁾	N/A ⁽¹⁾	N/A ⁽¹⁾
<i>Cultural Heritage (Sha Lo Wan (West) Archaeological Site)</i>	19/9/2018	N/A ⁽¹⁾	N/A ⁽¹⁾
