# **Dragages -China Harbour-VSL JV**

**Contract HY/2011/09**  
**Hong Kong-Zhuhai-Macao Bridge**  
**Hong Kong Link Road-Section between**  
**HKSAR Boundary and Scenic Hill**

**Quarterly EM&A Report**  
**September to November 2018**

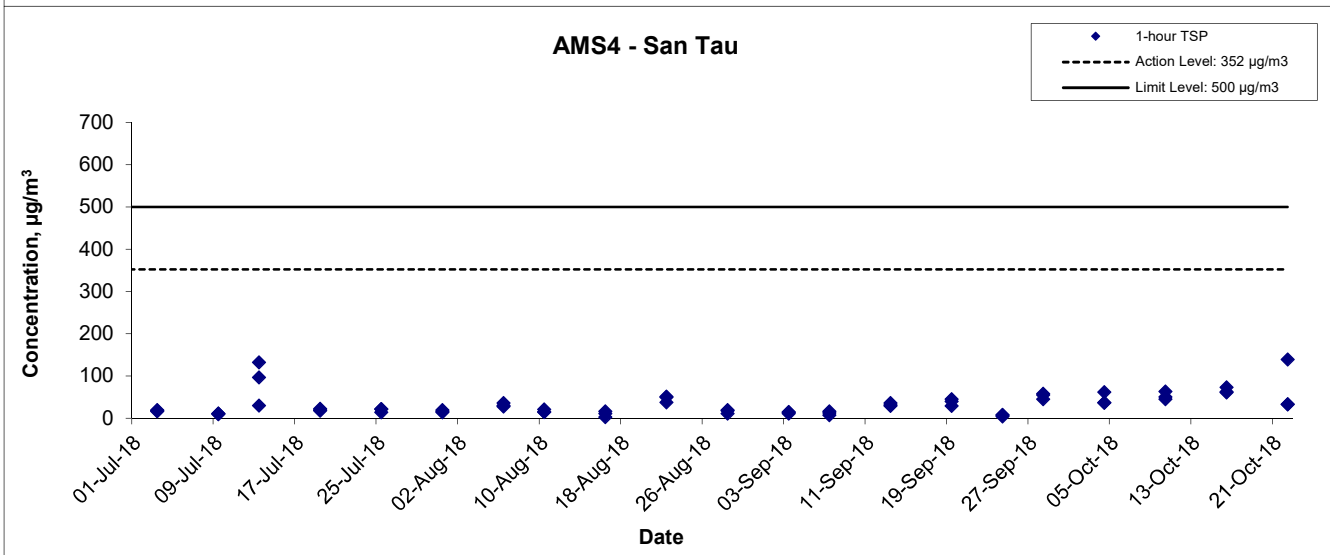
Title Contract No. HY/2011/09 Hong Kong-Zhuhai-Macao Bridge Hong Kong Link Road – Section between HKSAR Boundary and Scenic Hill  Graphical Presentation of 1-hour TSP Monitoring Results	Scale N.T.S	Project No. MA12014	
	Date Oct 18	Appendix E

### 1-hour TSP Concentration Levels
