Agreement No. HMWSD 1/2019 (EP)
Post-Construction Monitoring of Chinese
White Dolphin (Line-transect Vessel
Surveys) for the Hong Kong-Zhuhai-Macao
Bridge Hong Kong Link Road at West
Lantau Waters – Investigation

Monthly EM&A Report – July 2020

Monthly EM&A Report for July 2020

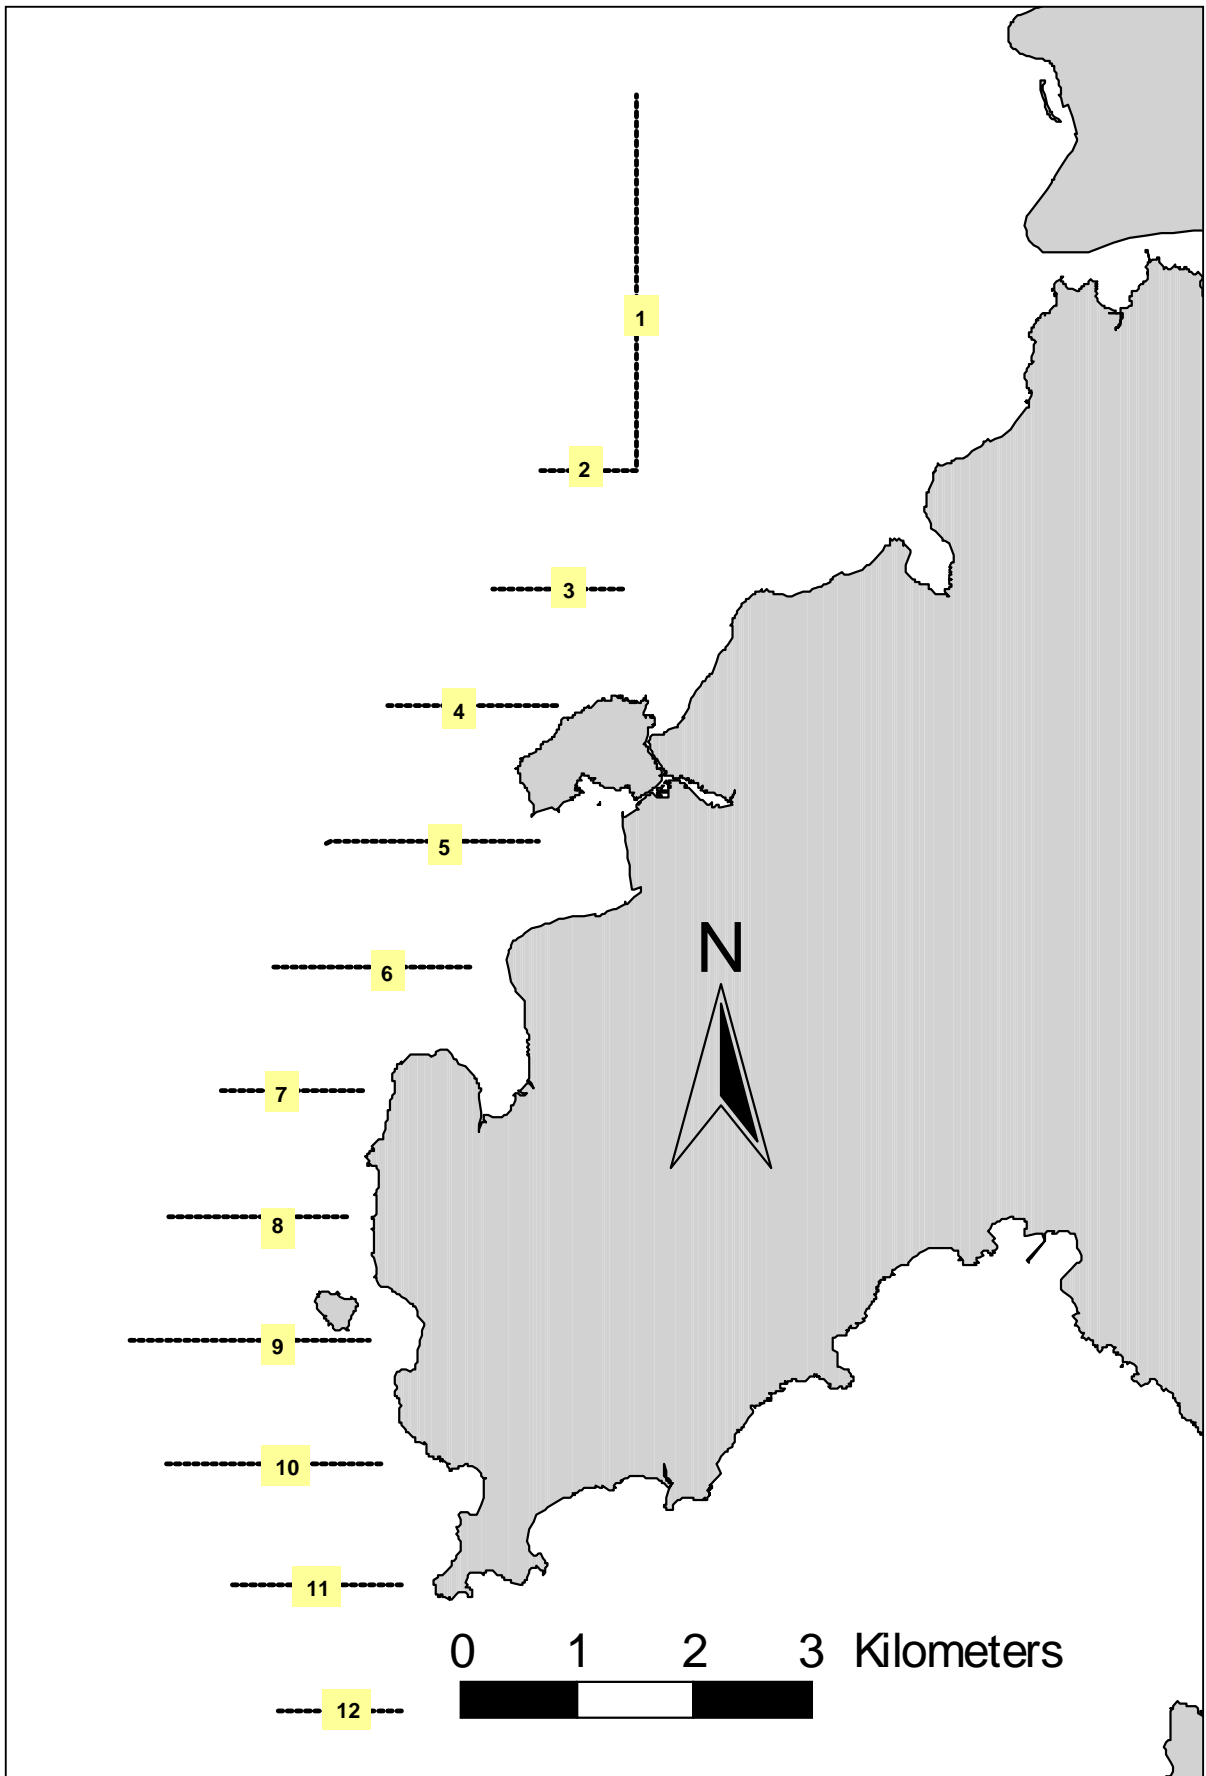
Figure 1. Transect Line Layout in West Lantau Survey Areas

- 2.1.1. According to the requirement of the updated EM&A manual, the dolphin monitoring programme should cover all transect lines in WL survey area (see Figure 1) twice per month throughout the entire post-construction period. The co-ordinates of all transect lines are shown in Table 1.

- 2.1.7. Survey effort being conducted along the parallel transect lines that were perpendicular to the coastlines (as indicated in Figure 1) was labeled as “primary” survey effort, while the survey effort being conducted along the connecting lines between parallel lines was labeled as “secondary” survey effort. According to HKCRP long-term dolphin monitoring data, encounter rates of Chinese White Dolphins deduced from effort and sighting data collected along primary and secondary lines have been similar in survey areas around Lantau Island. Therefore, both primary and secondary survey effort would be presented as on-effort survey effort.

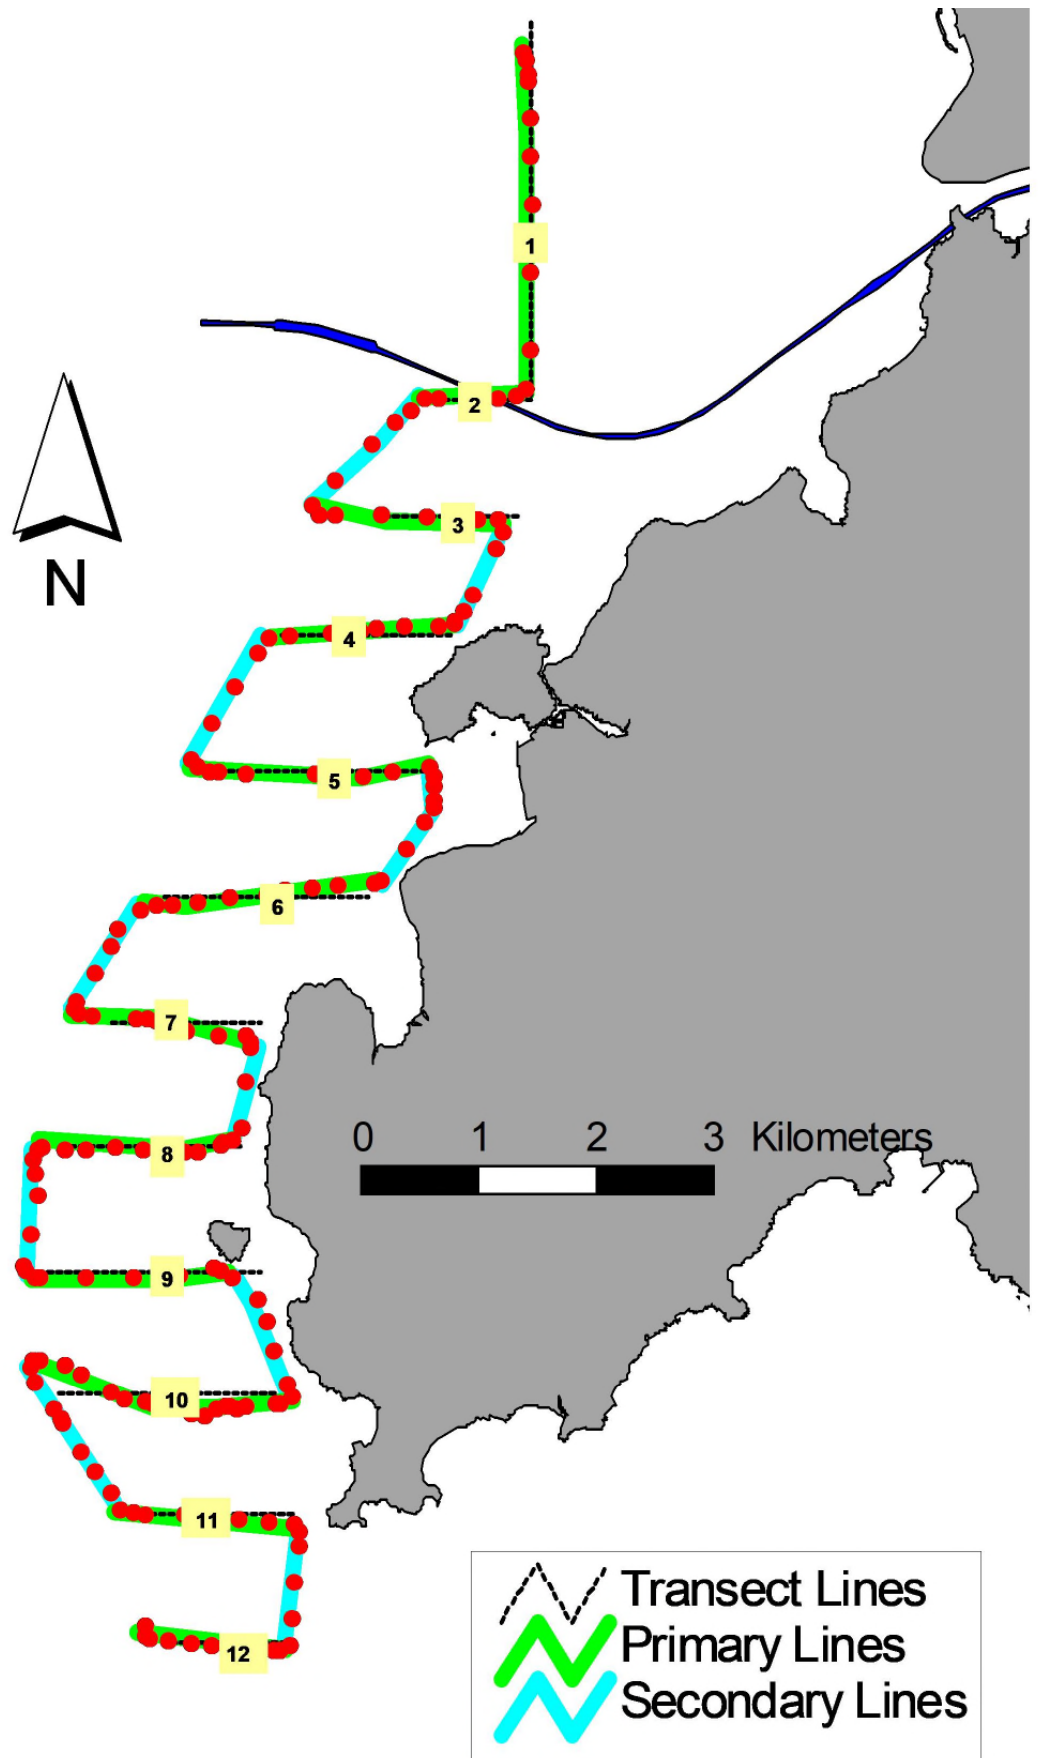
Figure 2. Survey Route on July 6th, 2020 (note: red dots represent the tracked positions of survey boat logged continuously by GPS throughout the course of the survey)

Two sets of systematic line-transect vessel surveys were conducted on 6 and 13 July 2020, to cover all transect lines in WL survey area twice. The survey routes of each survey day are presented in Figures 2 to 3 of **Appendix B**.

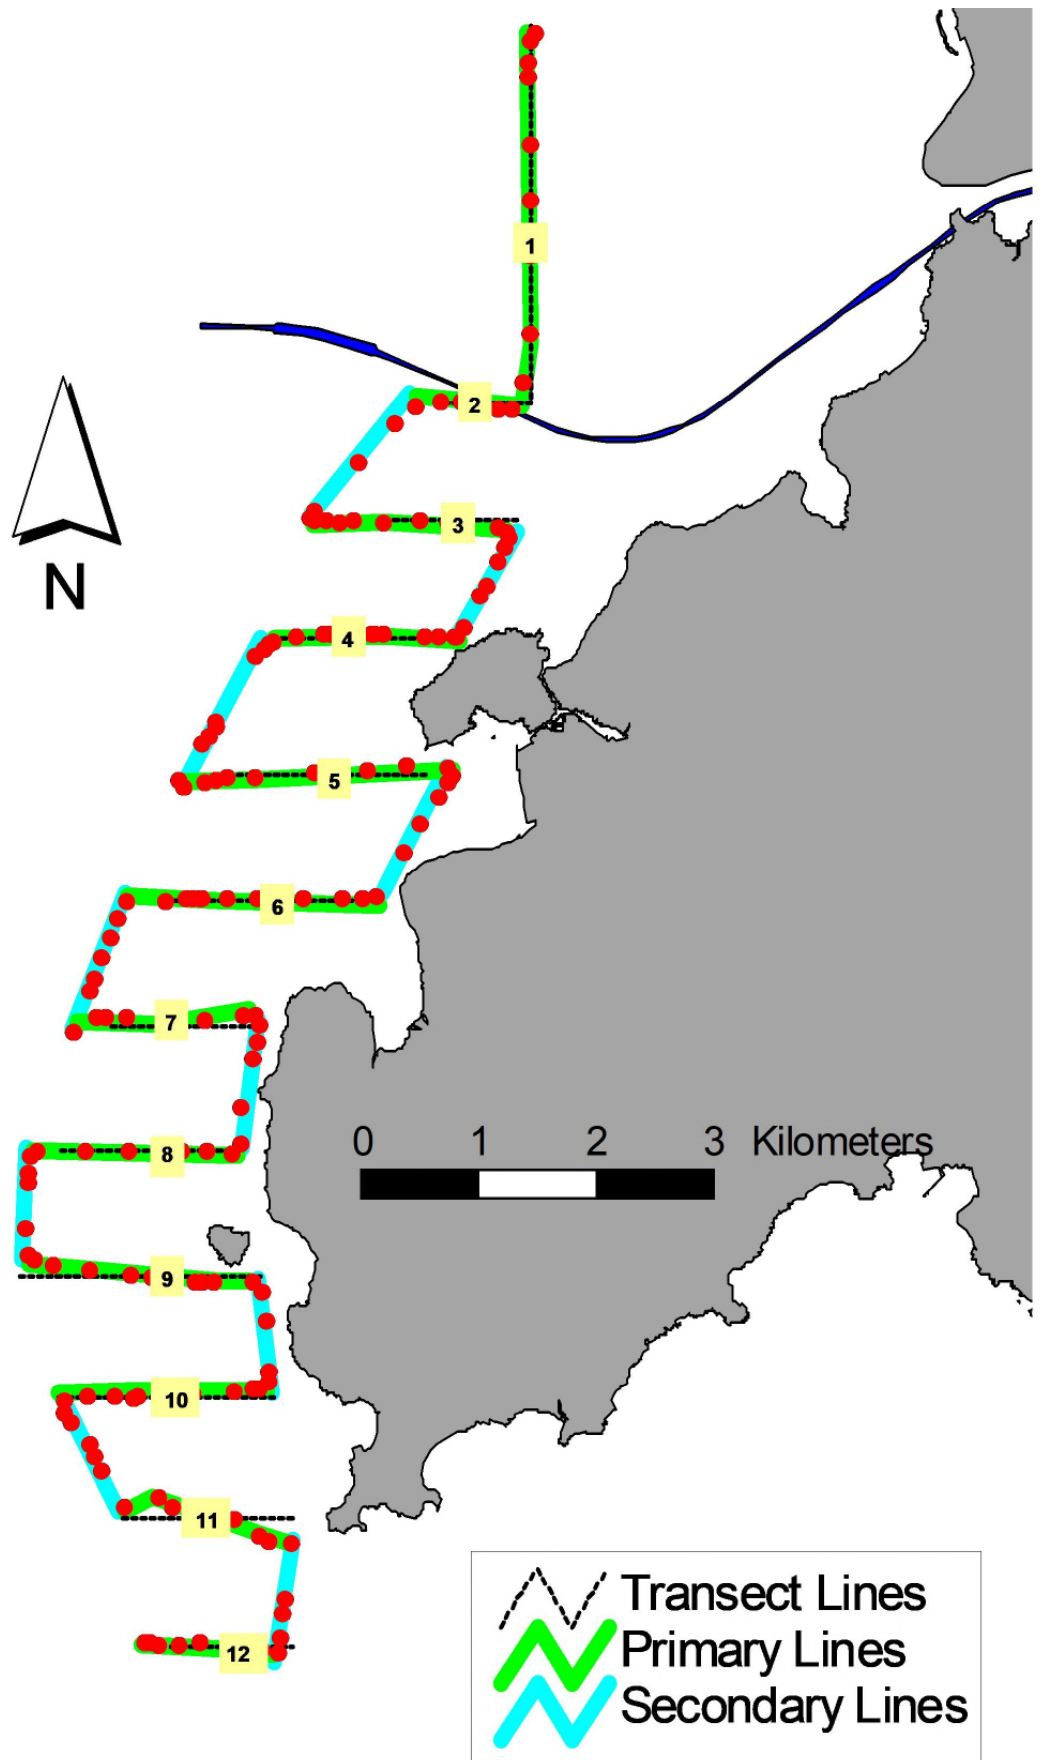
Figure 3. Survey Route on July 13th, 2020 (note: red dots represent the tracked positions of survey boat logged continuously by GPS throughout the course of the survey)

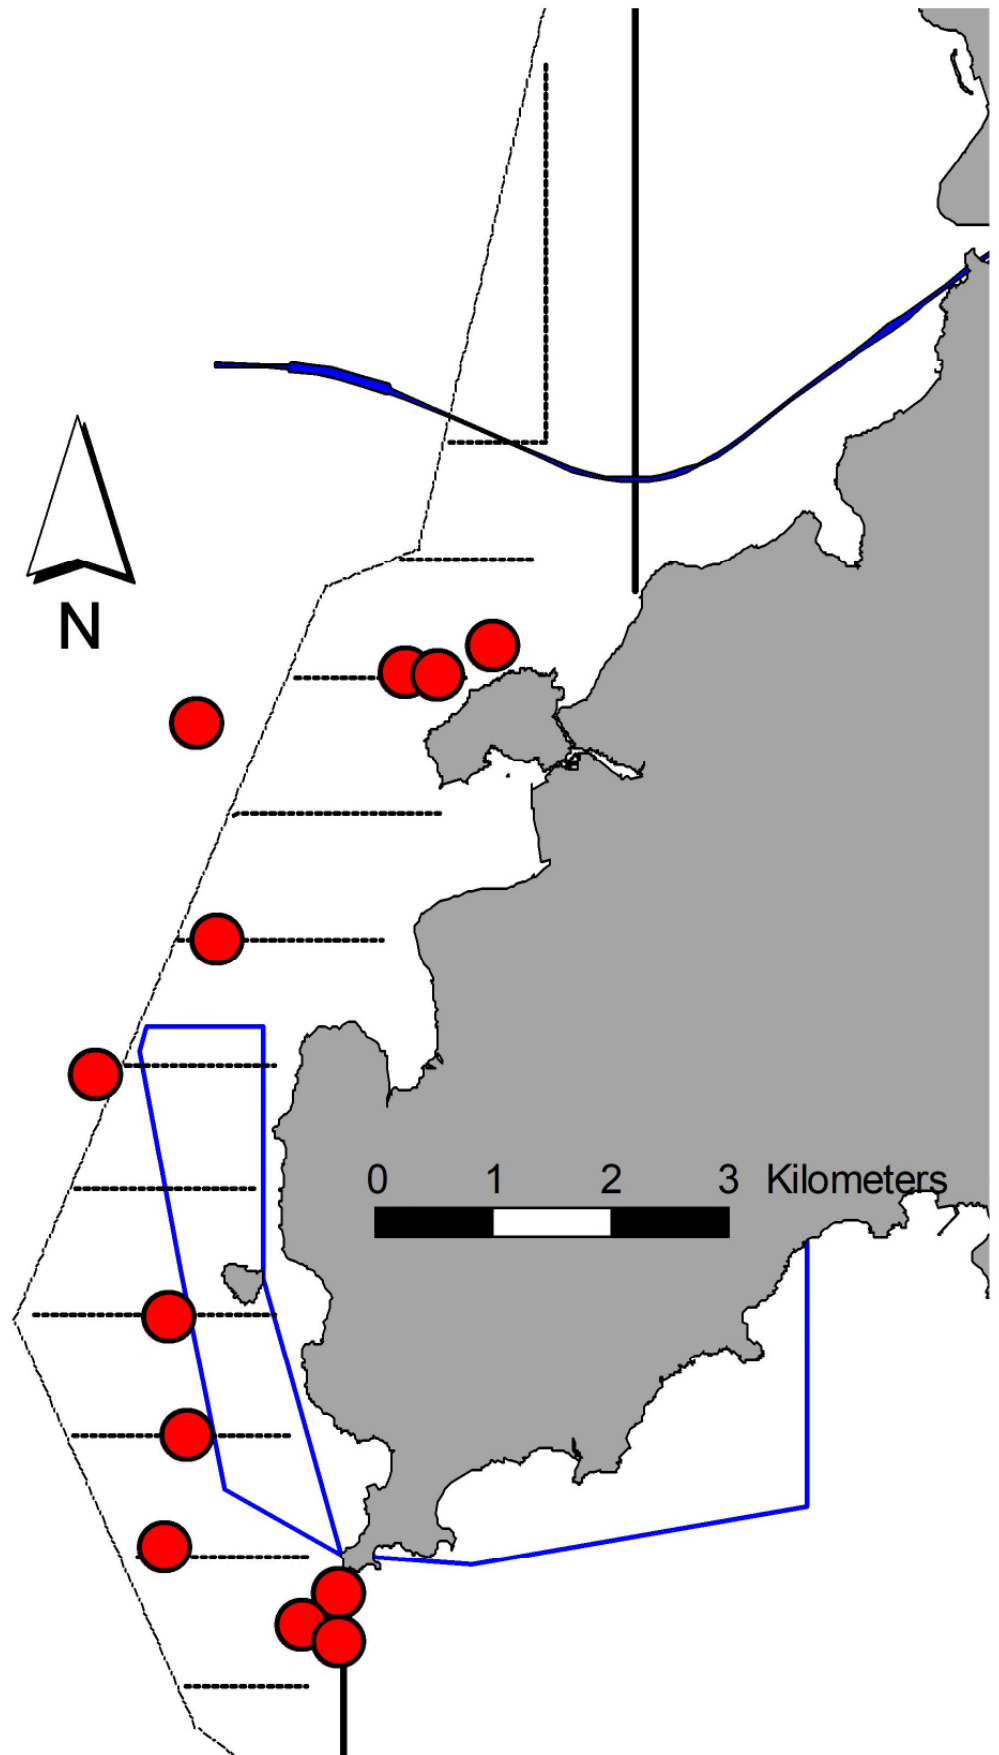
Figure 4. Distribution of Chinese White Dolphin sightings during the monitoring surveys conducted in July 2020

Distribution of the dolphin sightings made in the reporting period is shown in Figure 4 of **Appendix B**. The sightings were all recorded in the central and southern portions of the WL survey area, with slightly higher concentrations near Tai O Peninsula and Fan Lau Peninsula. None of them were sighted in the proximity of the HKLR alignment.
