Contract No. HY/2011/03

**Hong Kong-Zhuhai-Macao Bridge Hong Kong Link Road
Section between Scenic Hill and Hong Kong Boundary Crossing
Facilities**

Monthly EM&A Report No.144 (September 2024)

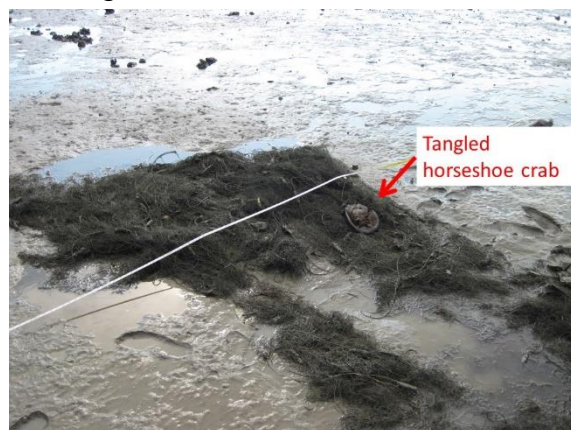
A tangled horseshoe crab on a trash net (record in June 2017)

- 6.3.2 Since the field survey of June 2016, increasing number of trashes and even big trashes (**Figure 2.3 of Appendix I**) were found in every sampling zone. It raised a concern about the solid waste dumping and current-driven waste issues in Tung Chung Wan. Respective measures (e.g., manual clean-up) should be implemented by responsible governmental agency units.

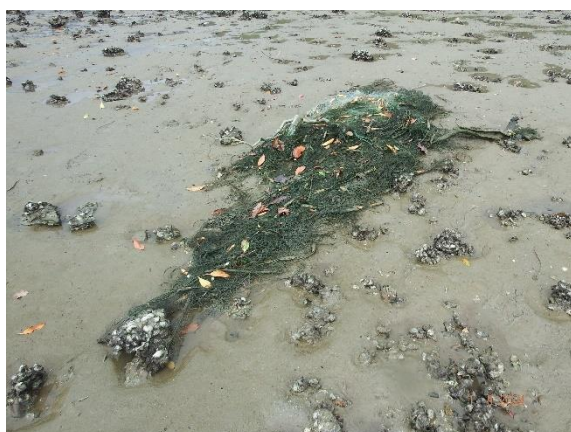
Trash gill net (recorded in September 2024)

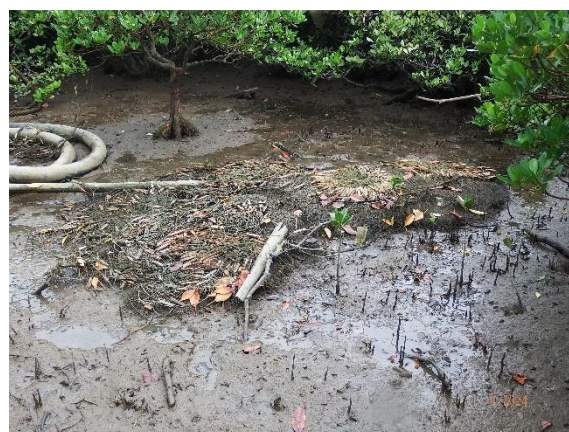
Trash nets deposited at ST for several years, where horseshoe crab occasionally tangled on them (record in September 2024)
