**Re: Agreement No. CE 48/2011 (EP)
Environmental Project Office for the
HZMB Hong Kong Link Road, HZMB Hong Kong Boundary Crossing
Facilities, and Tuen Mun-Chek Lap Kok Link – Investigation**

**Contract No. HY/2011/09 HZMB Hong Kong Link Road –
Section between HKSAR Boundary and Scenic Hill
Quarterly EM&A Report No. 10 for June to August 2015**

**Contract HY/2011/09
Hong Kong-Zhuhai-Macao Bridge
Hong Kong Link Road-Section between
HKSAR Boundary and Scenic Hill**

Quarterly EM&A Report

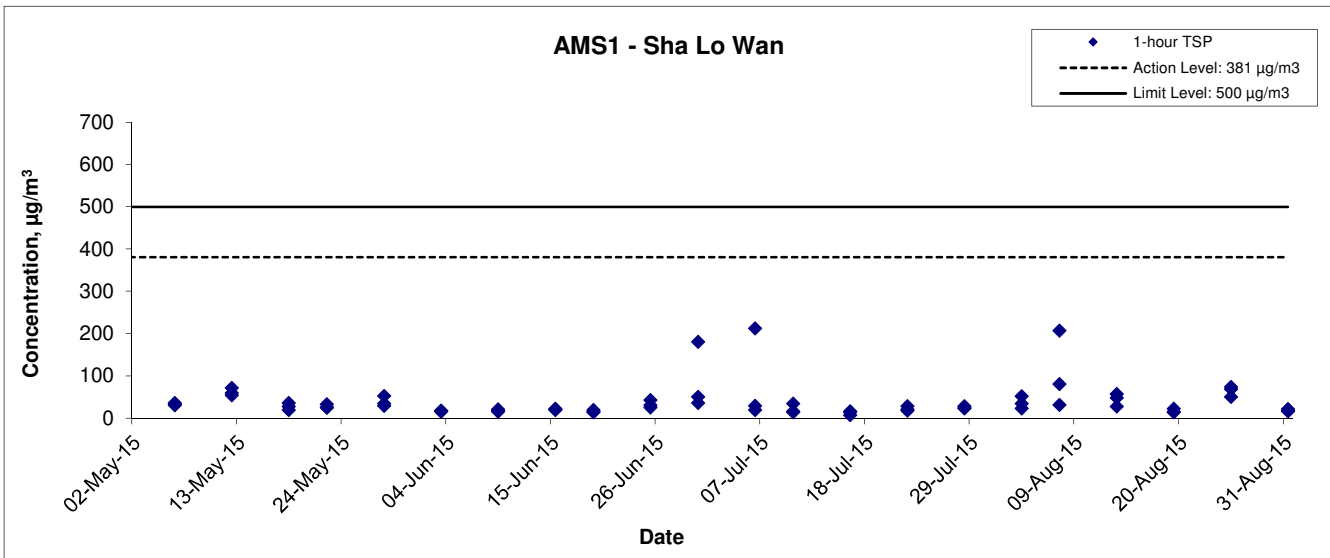
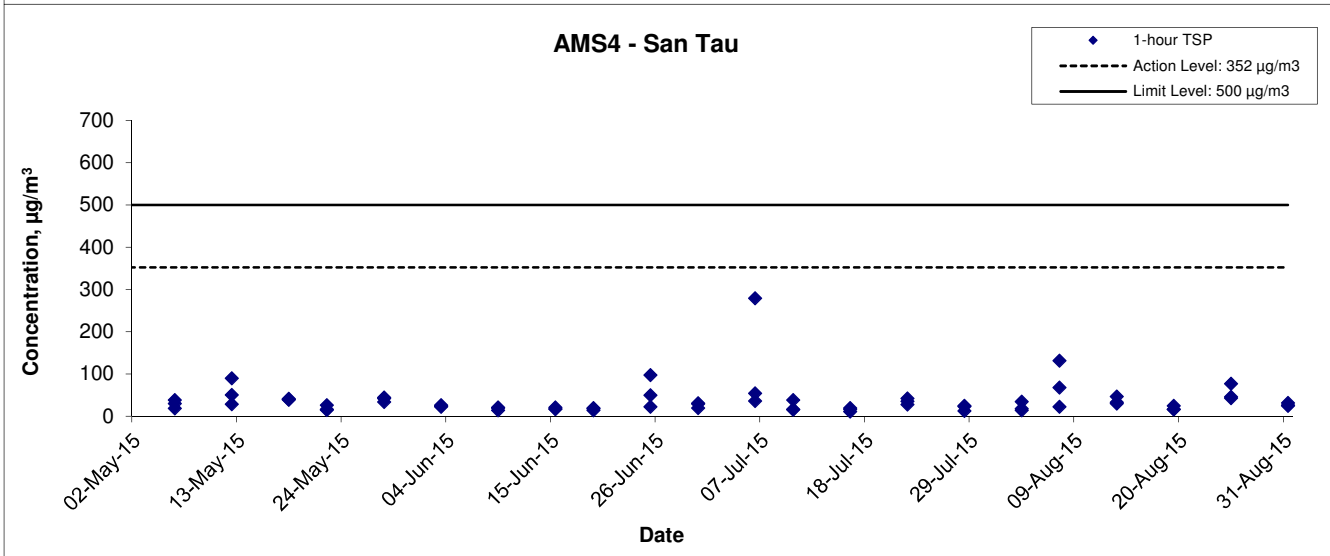
Title Contract No. 11/2011/03 Hong Kong-Zhuhai-Macao Bridge Hong Kong Link Road – Section between HKSAR Boundary and Scenic Hill Graphical Presentation of 1-hour TSP Monitoring Results	Scale N.T.S	Project No. MA12014	
	Date Aug 15	Appendix B

1-hour TSP Concentration Levels

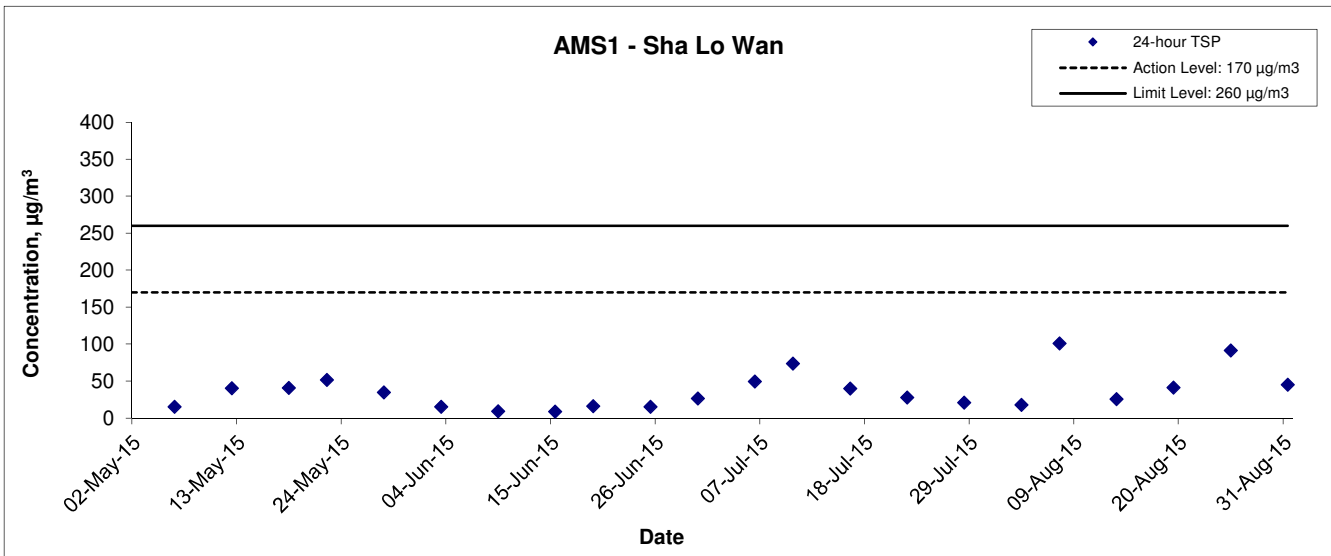
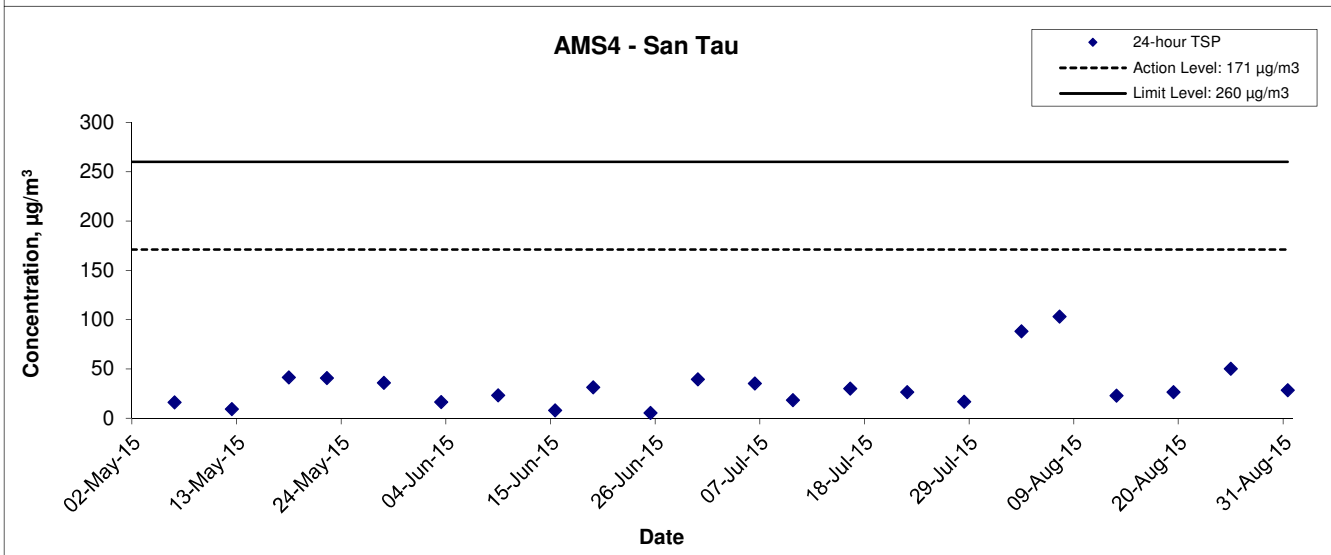
Title Contract No. 11/2011/03 Hong Kong-Zhuhai-Macao Bridge Hong Kong Link Road – Section between HKSAR Boundary and Scenic Hill Graphical Presentation of 24-hour TSP Monitoring Results	Scale N.T.S	Project No. MA12014	CINOTECH
	Date Aug 15	Appendix C

24-hour TSP Concentration Levels

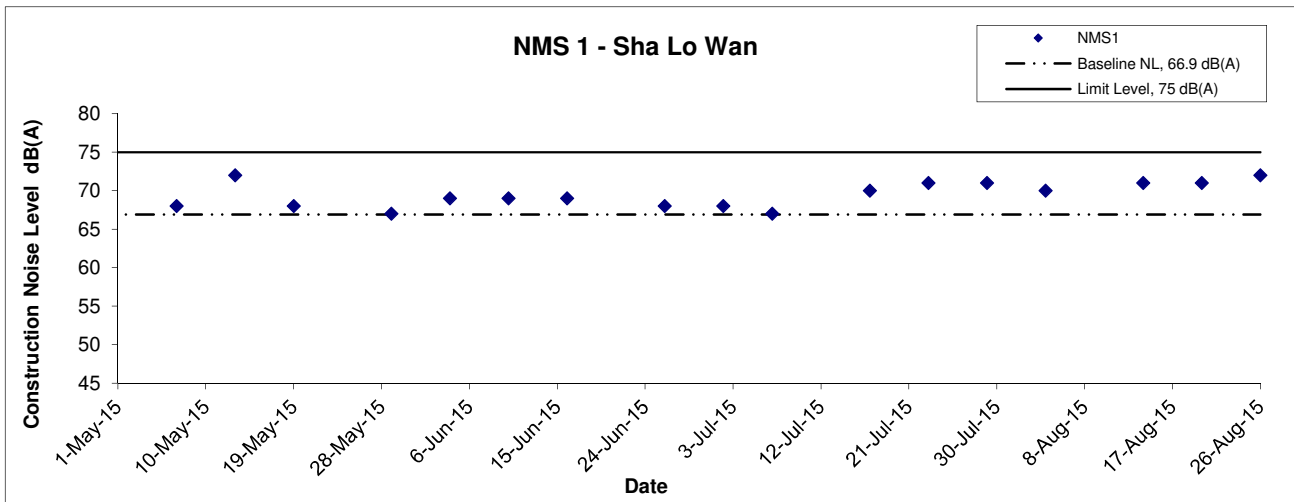
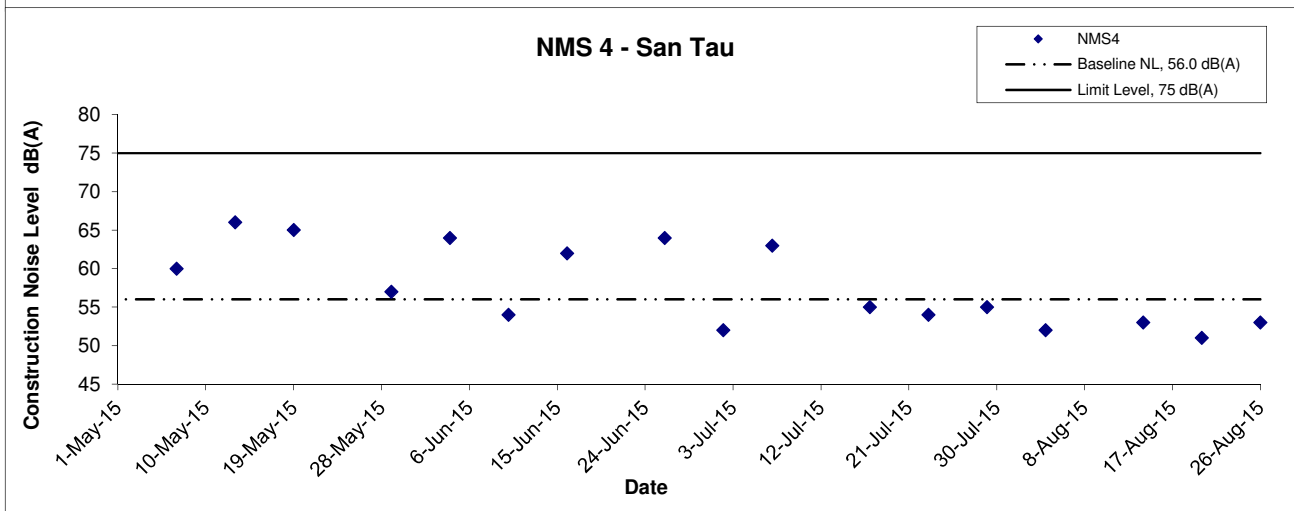
Title Contract HY/2011/09 Hong Kong-Zhuhai-Macao Bridge Hong Kong Link Road-Section between HKSAR Boundary and Scenic Hill Graphical Presentation of Construction Noise Monitoring Results	Scale	N.T.S	Project No.	MA12014	CINOTECH
	Date	Aug 15	Appendix	D

Noise Levels

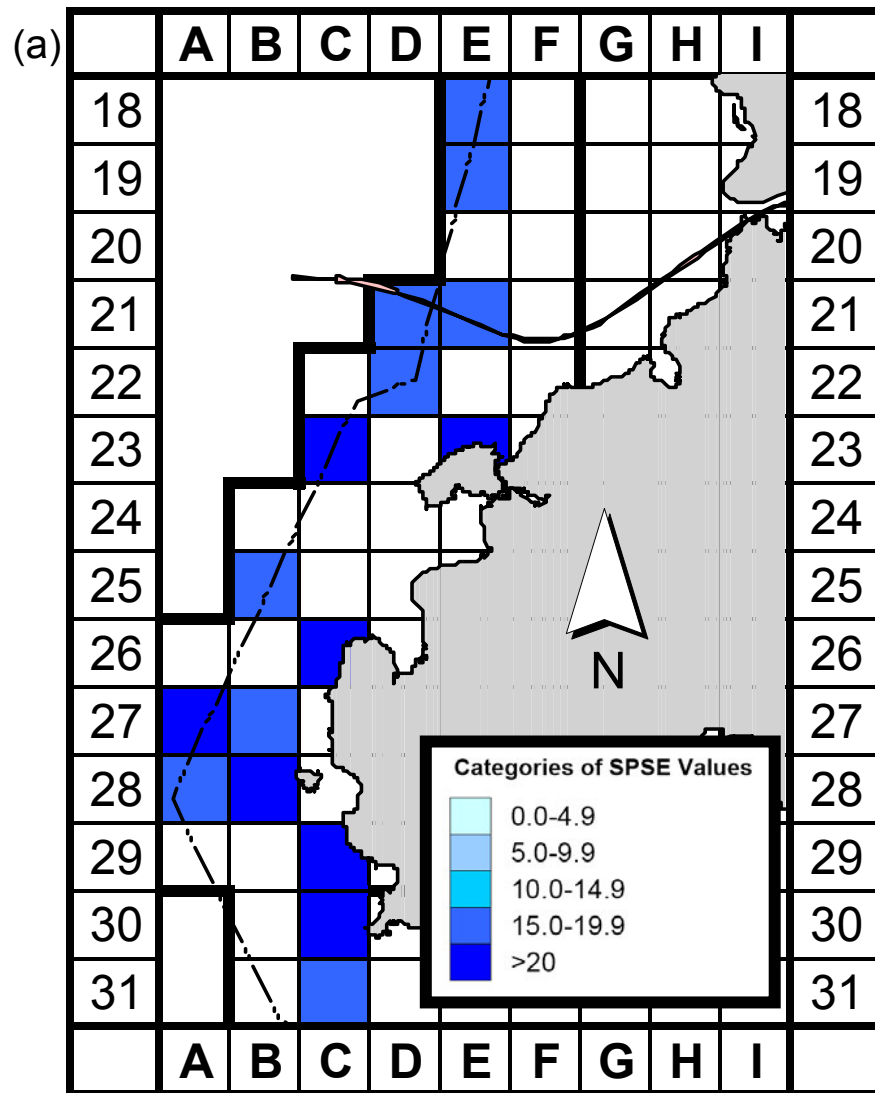
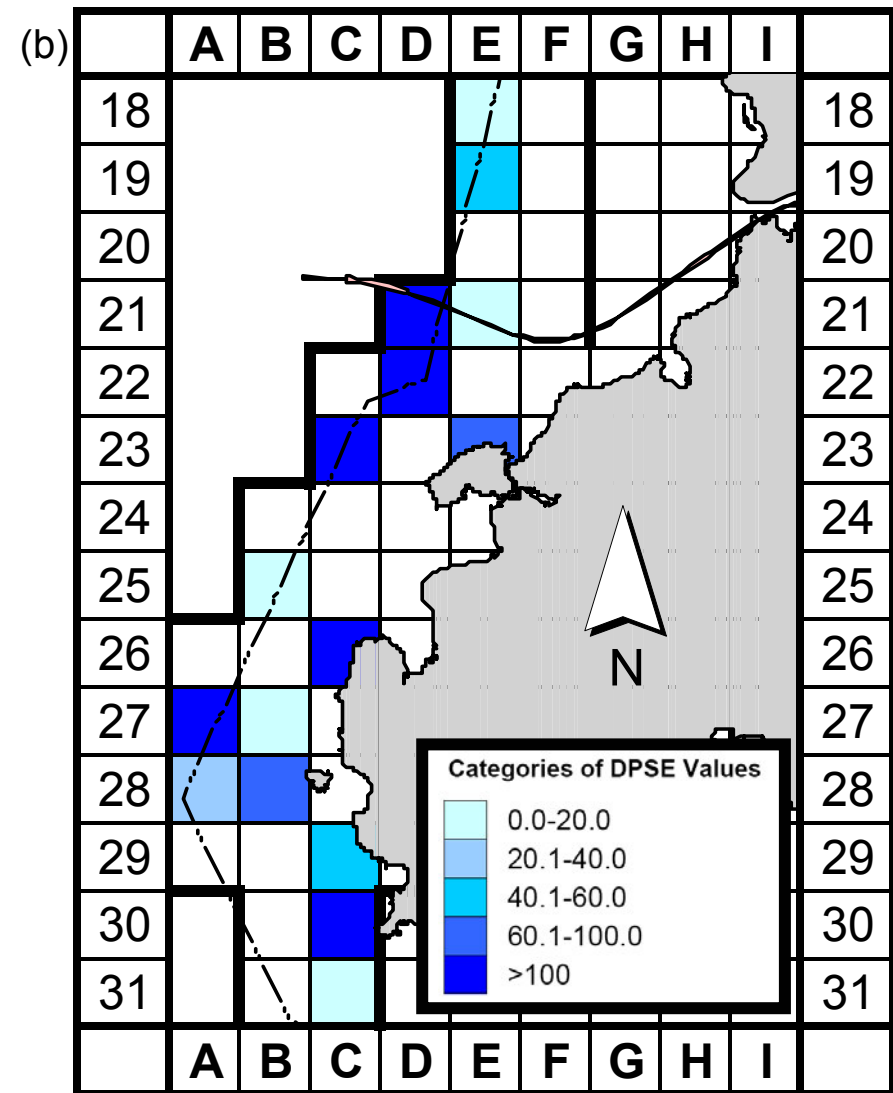
Figure 5a. Sighting density of Chinese white dolphins with corrected survey effort per km² in West Lantau survey area, using data collected during HKLR09 impact monitoring period (Jun-Aug 15) (SPSE = no. of on-effort sightings per 100 units of survey effort)

- 4.21 From June to August 2015, the most heavily utilized habitats by the dolphins were mainly found near Tai O Peninsula, Kai Kung Shan and Fan Lau, which is similar to the previous monitoring quarters (**Figures 5a and 5b of Appendix F**). However, it should be cautioned that the amount of survey effort collected in each grid during the three-month period was fairly low (6 units of survey effort for most grids), and therefore the habitat use pattern derived from the three-month dataset should be treated with caution. A more complete picture of dolphin habitat use pattern will be presented when more survey effort for each grid will be collected throughout the impact phase monitoring programme.

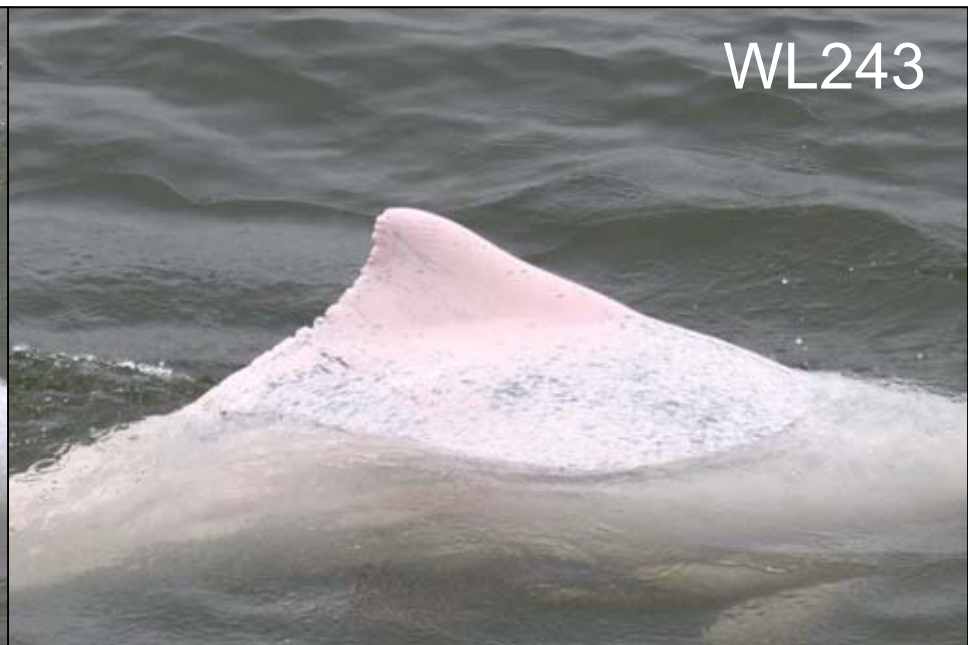
Appendix V. Ranging patterns (95% kernel ranges) of 64 individual dolphins that were sighted during HKLR09 impact phase monitoring period (note: yellow dots indicates sightings made in June – August 2015)

- 4.31 Ranging patterns of the 64 individuals identified during the three-month study period were determined by fixed kernel method, and are shown in **Appendix V of Appendix F**.
- 4.32 Notably, a number of individual dolphins (NL136, NL210, NL242, NL261, NL280, NL284, NL295 and WL11) that primarily centered their range use in North Lantau were found extending their ranges to the southern part of West Lantau waters, further expanding their range use away from North Lantau waters (**Appendix V of Appendix F**).
- 4.33 On the contrary, most individuals that primarily centered their range use in West Lantau were sighted within their normal range during the present quarterly period **Appendix V of Appendix F**).
