# Contract No. EP/SP/61/10 Organic Resources Recovery Centre (Phase 1)

One Hundred and Twelfth Monthly  
EM&A Report (September 2024)

**Organic Resources Recovery Centre,  
Phase I**

Monthly EM&A Report  
(1 September 2024 – 30 September 2024)

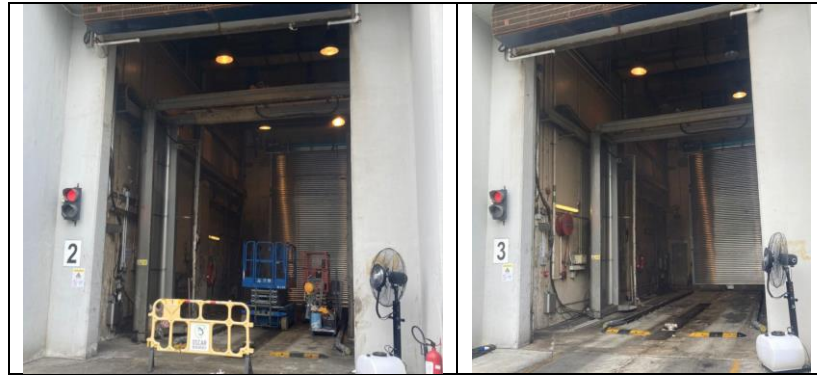
6. As advised by the Contractor on 5 September 2024, the inner doors of both Bay #2 and Bay #3 had been repaired, with photos as below:

7. As advised by the Contractor on 12 September 2024, all remaining maintenance work (including all exterior door replacements) is expected to be completed within October 2024.

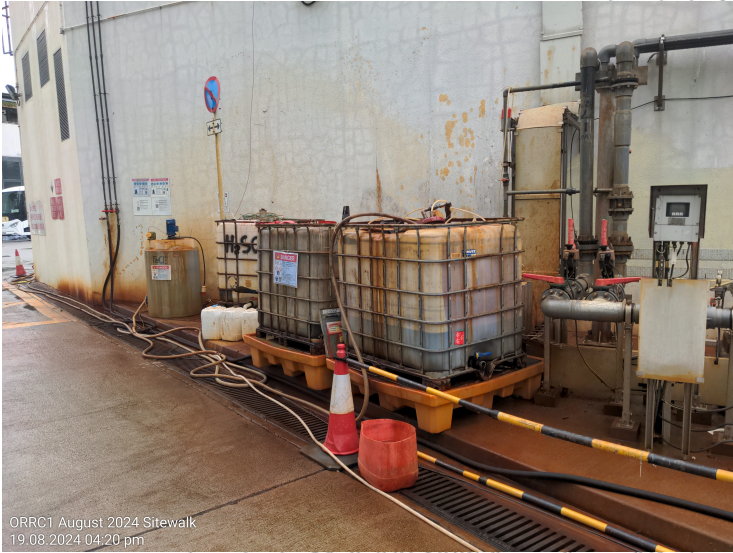
**Figure 3 - Site Layout**

ORRC1 August 2024 Sitewalk  
19.08.2024 04:20 pm
