Central Police Station Conservation
and Revitalisation Project:
98th Monthly EM&A Report
(1 April to 30 April 2024)

**Block 4 Investigation, Removal and the Associated Alteration Works –
Heritage Checker Monthly Site Audit Checklist for Cultural Heritage**

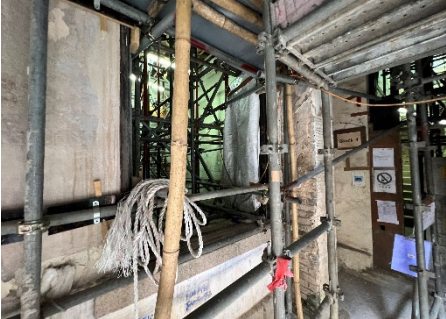
<p>Protections to existing timber windows.</p>

<p>Condition of the scaffolding on 24th April.</p>	<p>[Inspections dated 2nd, 9th, 16th, 24th and 30th April 2024] Protections to existing timber windows and doors on G/F were generally found sufficient during all visits but with signs of deterioration. Contractor was reminded to maintain sufficient protection to the portion that are to be retained.</p> <p>[Inspections dated 2nd, 9th, 16th, 24th and 30th April 2024] The hoarding construction in Sergeants Yard, which was originally completed in early October, was found to be generally clean and tidy during all site visits.</p> <p>[Inspections dated 2nd, 9th, 16th, 24th and 30th April 2024] The scaffolding was found well maintained during all site visits. Modifications were made at the lower level of the scaffold to suit the ongoing demolition works. The contractor was however reminded to provide warning measures and protection to any exposed sharp edges.</p>

- Protection to existing timber windows and doors on G/F had signs of deterioration during all site visits. The Contractor was reminded to maintain sufficient protection to the portion that are to be retained.

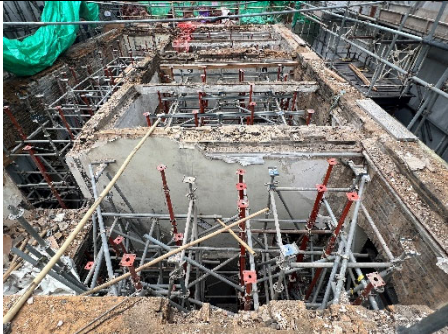
<p>Floor removal in Floor Zone I dated 30th April.</p>

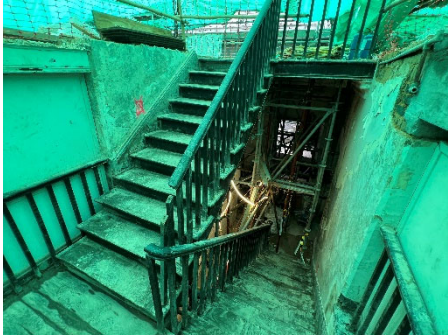
<p>Completed removal of protection to ST02 from 1/F to 2/F for 3D scanning.</p>

<p>Installation of tarpaulin covers dated 30th April.</p>	<p>[Inspections dated 30th April 2024] Protection to ST02 from 1/F to 2/F was removed for 3D scanning which was subsequently carried out on 30th April. The contractor was reminded to reinstate the protection following the scanning and until the upcoming salvaging works commence.</p>
--	--	--	---

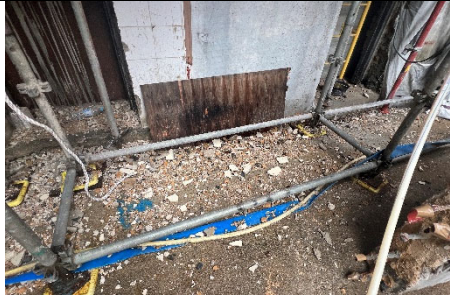
<p>Debris from demolition works found on ground level.</p>

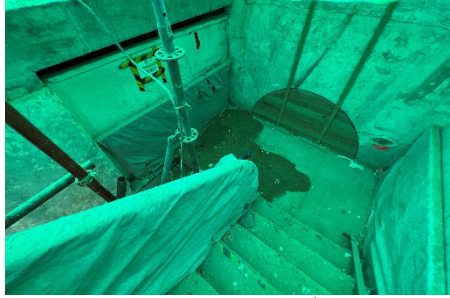
<p>No debris were found on 19th April.</p>

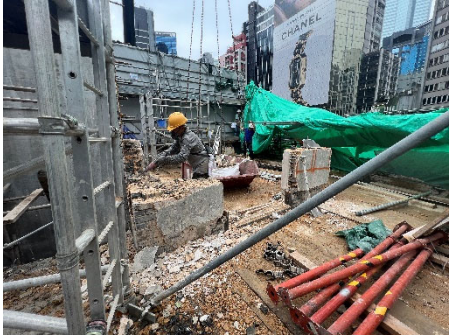
<p>Demolition works follow the approved sequence.</p>	<p>[Inspections dated 2nd, 9th, 16th, 24th and 30th April 2024] The mobile crane was observed during all 5 site inspections with the area fenced off.</p> <p>During this reporting period, AMO has been further reminded about the previously reported termite infestation issue (note: first reported on 8th March 2024).</p> <p>At the time of publishing this report, the treatment of the affected timber members remain under discussion and an instruction to the contractor remains pending.</p>

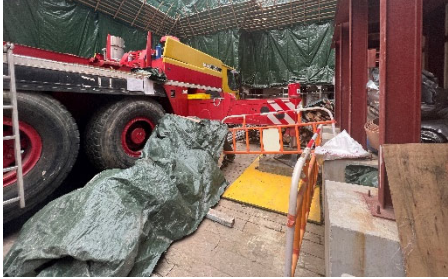
<p>Working area has been fenced off.</p>

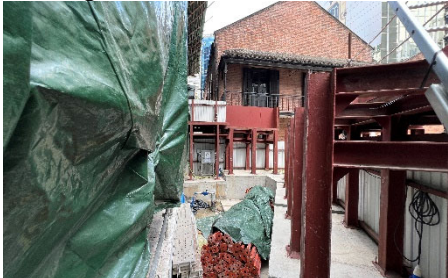
<p>Hoarding condition near Blk 6&7</p>
