# Central Police Station Conservation and Revitalisation Project

Monthly EM&A Report No. 99  
(1 May to 31 May 2024)

**Block 4 Investigation, Removal and the Associated Alteration Works –  
Heritage Checker Monthly Site Audit Checklist for Cultural Heritage**

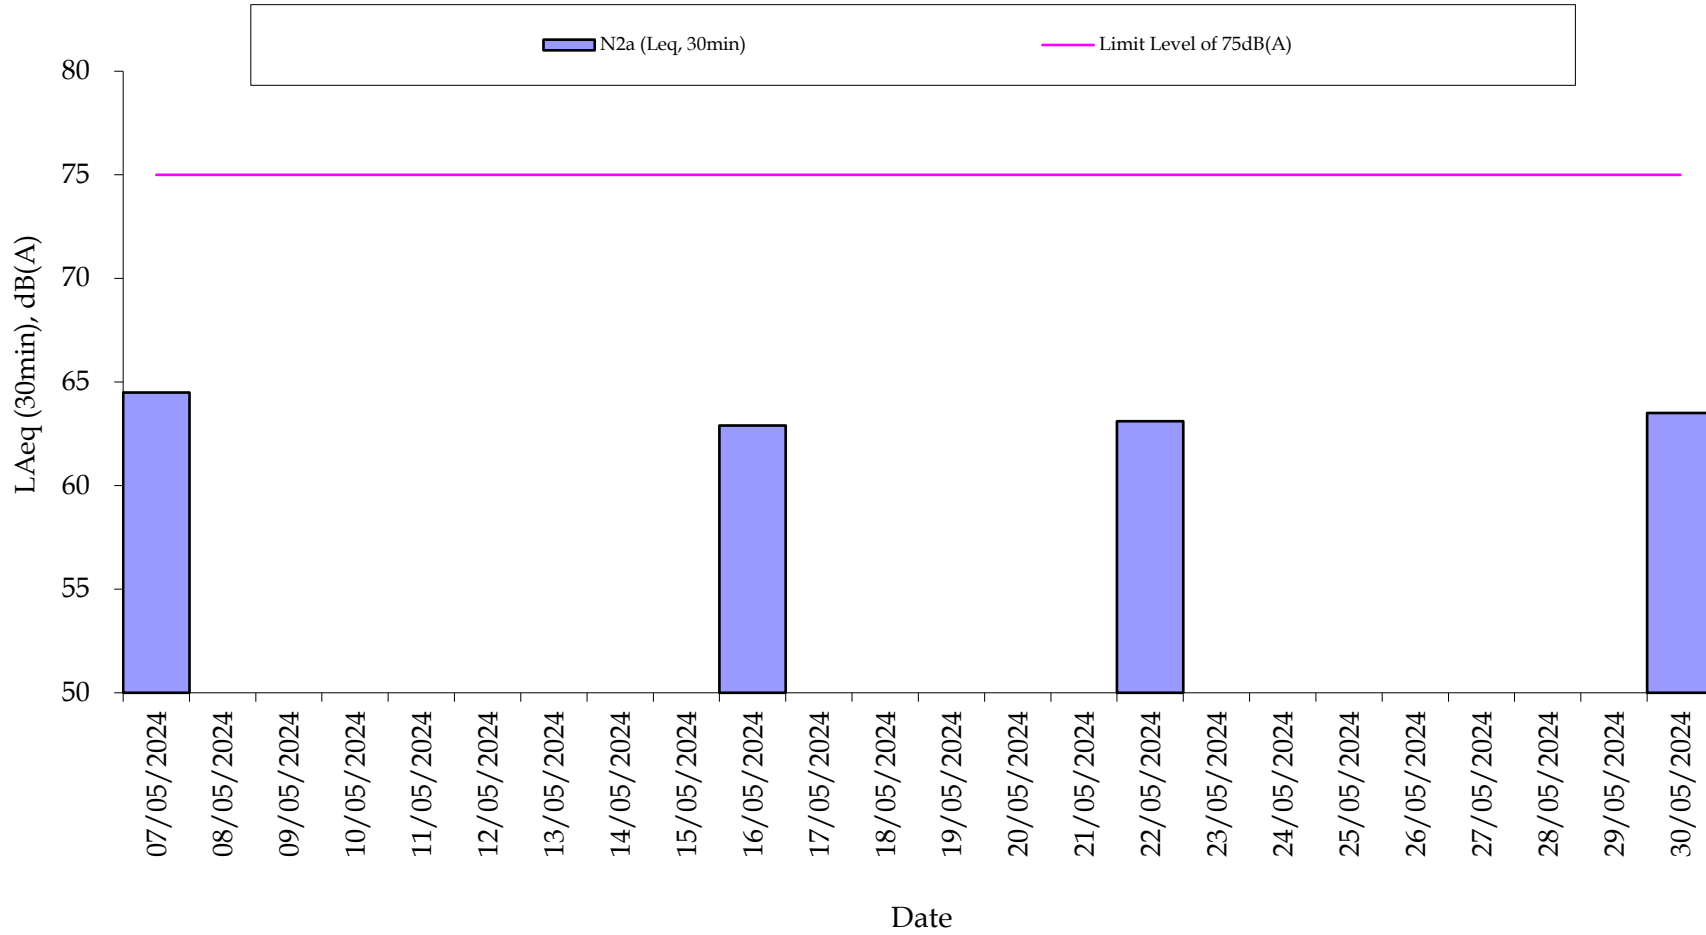
Normal Weekdays Noise Monitoring Results at 2nd Floor of Block 3 at Tai Kwun (N2a) (Leq, 30min)

Remark:  
- 75dB(A) was adopted as the Limit Level during normal weekdays in the reporting period

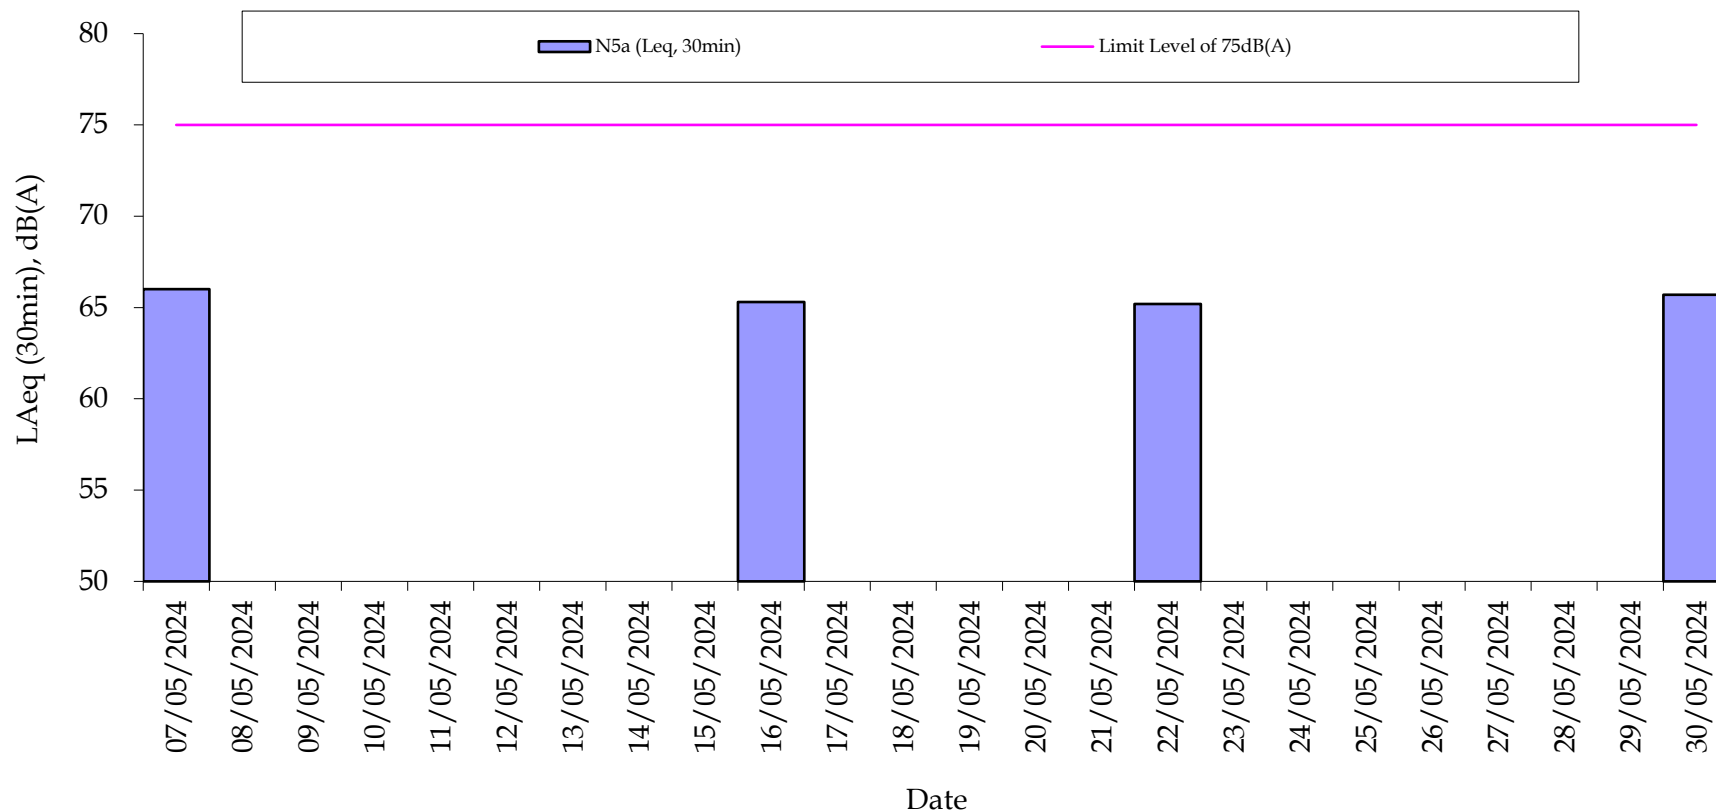
Normal Weekdays Noise Monitoring Results Outside of Boundary Wall of Tai Kwun at Chancery Lane (N5a) (Leq, 30min)

- 75dB(A) was adopted as the Limit Level during normal weekdays in the reporting period.
- Correction of +3dB(A) was added to the monitoring data for free-field measurement.

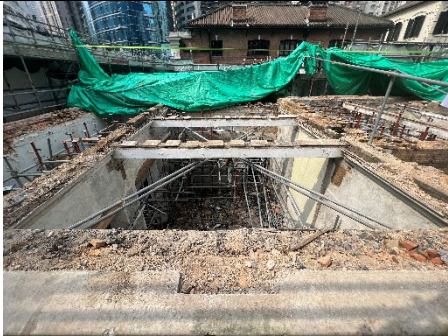
<p>Site condition dated 7<sup>th</sup> May.</p>

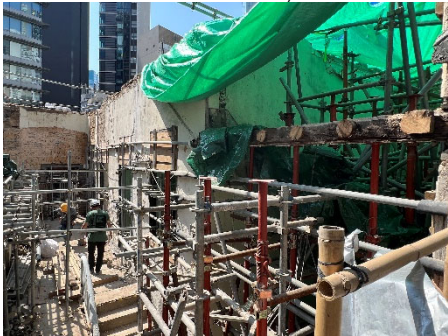
<p>Condition of Wall Zone 1 on I/F dated 14<sup>th</sup> May.</p>

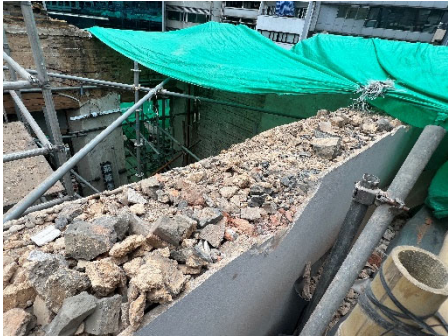
<p>Removal in Wall Zone 5 dated 29<sup>th</sup> May.</p>	<p>[Inspections dated 7<sup>th</sup>, 14<sup>th</sup>, 22<sup>nd</sup> and 29<sup>th</sup> May 2024]</p> <p>The Stage 2 and 3 removal works have continued on site since late February. During this reporting period, I/F walls in zone 1 to 4 and partially in zone 5 have been demolished as per the approved demolition plan and methodology.</p> <p>Based on the observation on site, the work sequence and methodology have followed the approved method statement(s).</p> <p>Selected CDEs have been salvaged during the period. These have subsequently been protected and placed in the temporary storage space at ground level. These items are awaiting transfer by the contractor to the offsite storage.</p>
--	--	--	--

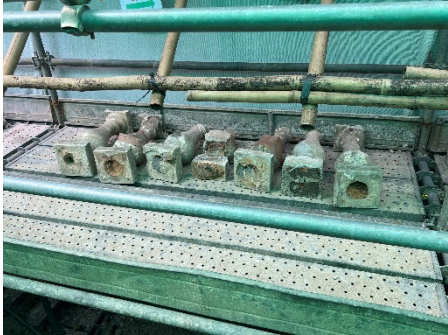
<p>Photo showing the salvaged bottle baluster before packing and relocation on 29<sup>th</sup> May.</p>

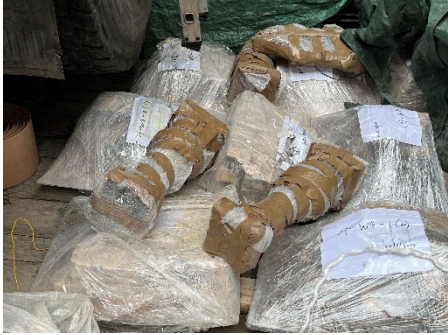
<p>Condition of the salvaged CDEs stored on site dated 29<sup>th</sup> May.</p>	<p>[Inspections dated 29<sup>th</sup> May 2024] The salvaged CDEs that are stored temporarily on site and protected by tarpaulin, have been checked with no sign of water ingress.</p>
--	--	---	--

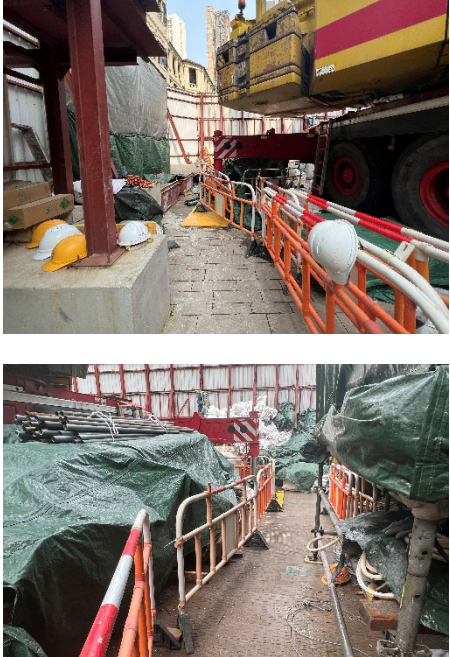
4.2	Is the site kept reasonably tidy?	6/10

<p data-bbox="947 1283 1323 1310">The site is generally being kept tidy.</p>	[Inspections dated 7 <sup>th</sup> , 14 <sup>th</sup> , 22 <sup>nd</sup> and 29 <sup>th</sup> May 2024] The overall site tidiness has been improved. As observed during the site inspections, there is now less loose laying debris at G/F.  The contractor was reminded to maintain site tidiness as well as ensuring sufficient protection is provided to the full extent of the fabric to be retained.

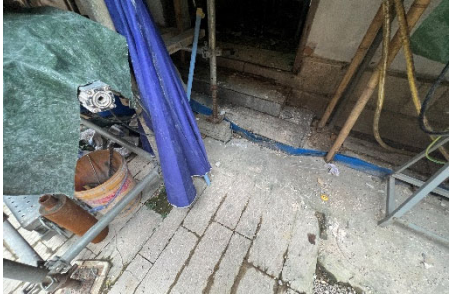
<p>No debris were found on 19<sup>th</sup> April.</p>

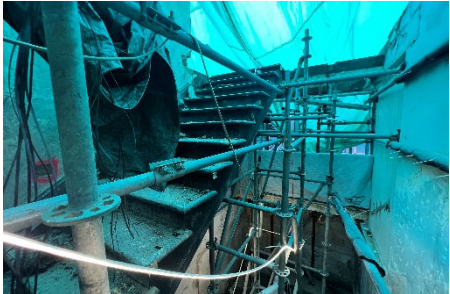
<p>Condition of the first flight from 1/F to 2/F at ST02 on 29<sup>th</sup> May.</p>	<p>[Inspections dated 7<sup>th</sup>, 14<sup>th</sup>, 22<sup>nd</sup> and 29<sup>th</sup> May 2024] Following the reporting of debris found on ST02 landing between 1/F and 2/F in the previous report No.19, as observed in the site inspections, the tidiness of the timber staircase has been improved prior to and during the salvaging works that commenced on 27<sup>th</sup> May.</p>

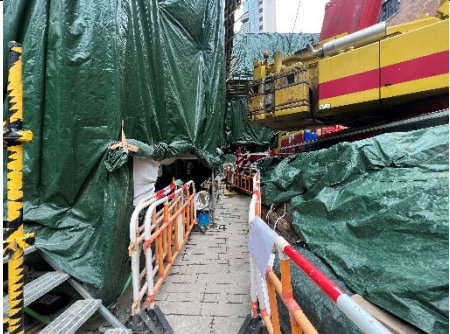
<p>Mobile crane on site with working area fenced off.</p>	<p>[Inspections dated 7<sup>th</sup>, 14<sup>th</sup>, 22<sup>nd</sup> and 29<sup>th</sup> May 2024] The mobile crane was observed during all site inspections with the area fenced off.</p> <p>Following AMO's letter dated 3 May 2024 stating no adverse comment on the proposed treatment of termite infested timbers, these timber elements have now been disposed from site.</p>

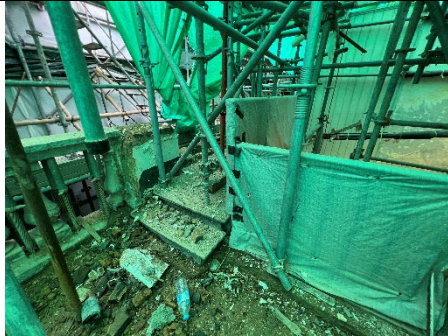
<p>Demolition works follow the approved sequence.</p>	
4.4	Are site rules applied effectively?	9/10		<p>[Inspections dated 7<sup>th</sup>, 14<sup>th</sup>, 22<sup>nd</sup> and 29<sup>th</sup> May 2024] There was no evidence of smoking happening onsite during all site inspections.</p> <p>The site-based staff were all observed to be wearing the required Personal Protective Equipment (PPE), including being clipped on to the fall arrest line.</p>
4.5	Are the temporary site facilities properly maintained?	8/10

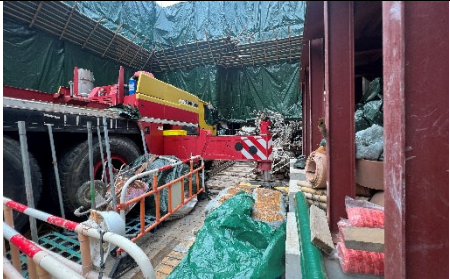
<p>Working area has been fenced off.</p>

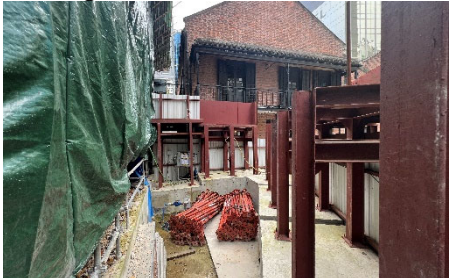
<p>Hoarding condition near Blk 6&amp;7</p>

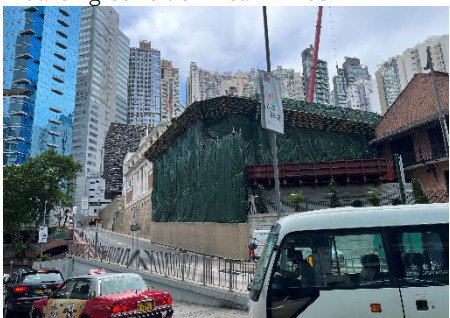
<p>Scaffolding and hoarding arrangement are maintained along Arbutnot Road</p>	No adverse comments.
<b>Sub-Total</b>		<b>47/60</b>
