# Central Police Station Conservation and Revitalisation Project

Monthly EM&A Report No. 103  
(1 September to 30 September 2024)

<p>3.5</p>	<p>Is protection of the existing building adequate and effective?</p>	<p>8/10</p>

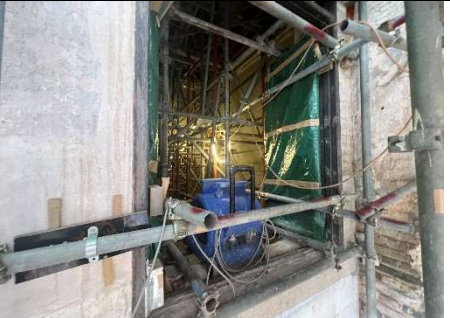
<p>Protections to existing timber windows.</p>

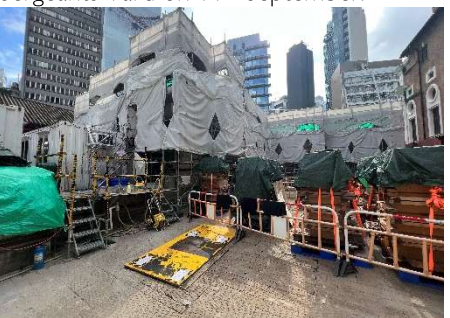
<p>Condition of the scaffolding on 5<sup>th</sup> September</p>	<p>[Inspections dated 5<sup>th</sup>, 11<sup>th</sup>, 16<sup>th</sup> and 25<sup>th</sup> Sep 2024] Protection to existing timber window on G/F was found sufficient. Contractor was reminded to maintain sufficient protection over the entire extent of fabric to be retained as well as being alert to changing weather conditions and needing to adapt the protection in the event of any typhoon or heavy rain.</p> <p>[Inspections dated 5<sup>th</sup>, 11<sup>th</sup>, 16<sup>th</sup> and 25<sup>th</sup> Sep 2024] The hoarding construction in Sergeants Yard, which was originally completed in early October 2023, was found to be generally clean and tidy during all site visits.</p> <p>[Inspections dated 5<sup>th</sup>, 11<sup>th</sup>, 16<sup>th</sup> and 25<sup>th</sup> Sep 2024] The scaffolding was found well maintained during all site visits.</p> <p>Ahead of typhoon Yagi, the contractors undertook the necessary precautionary measures and those stipulated under contract provisions as appropriate for site safety to minimize adverse weather impact. This included replacing the old green tarpaulin covering with air-permeable netting, opening up and tying back the scaffold netting throughout the duration of the typhoon from 4<sup>th</sup> to 7<sup>th</sup> September.</p>

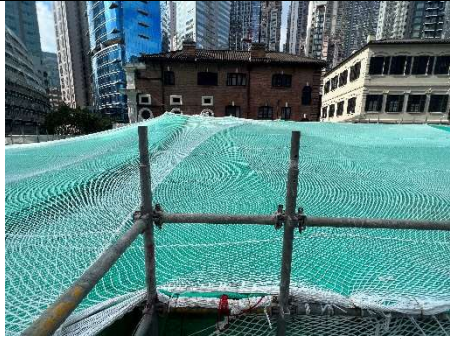
3.4	Do the works comply with the contract documents?	17/20		No non-compliance notice was issued during the reporting period.  The contractor was reminded to maintain the weathertightness of the roof tarpaulin over the retained structure and salvaging loose historic fabric that is stored in the site area so to avoid water ingress. The contractor is also reminded to be alert to changing weather conditions and needing to adapt the protection in the event of any typhoon or heavy rain.  The contractor was reminded to maintain the condition of historic fabrics by regularly inspecting and removing any sprouting vegetation and mold growth, as well as ensuring the intactness of all protective measures to CDEs.

<p>Condition of roof protection dated 5<sup>th</sup> September.</p>

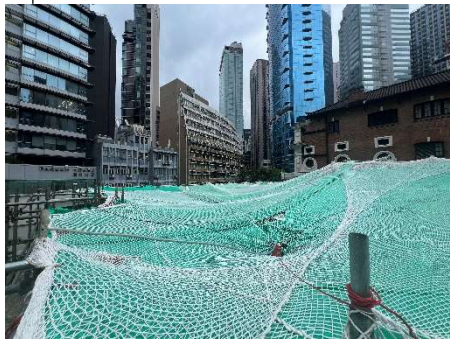
<p>Condition of roof protection dated 25<sup>th</sup> September.</p>

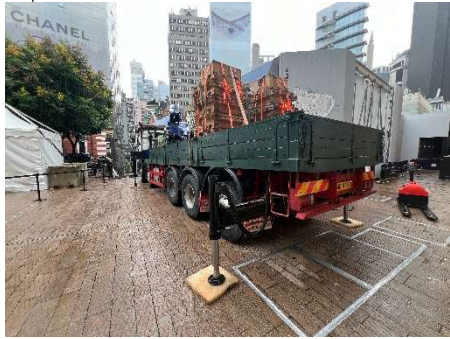
<p>Delivery of pier samples to offsite laboratory dated 25<sup>th</sup> September.</p>	<p>[Inspections dated 5<sup>th</sup>, 11<sup>th</sup>, 16<sup>th</sup> and 25<sup>th</sup> Sep 2024] The project is currently at pause period with no construction works on site.</p> <p>The roof tarpaulin and netting were observed in good condition during this reporting period. Automatic pumps were provided so that any ponding water can be pumped away promptly.</p> <p>During the inspection on 25<sup>th</sup> September, due to the minor damage in the roof tarpaulin, water ingress to ST02 was observed. Contractor was notified accordingly and the rectification work is in progress when this report is prepared.</p> <p>2nos. masonry pier samples were delivered to the offsite laboratory on 25<sup>th</sup> September.</p>

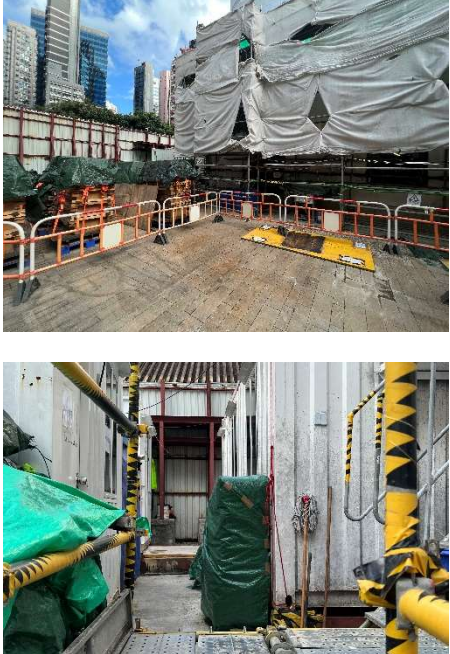
<p data-bbox="947 1185 1321 1217">The site is generally being kept tidy.</p>	[Inspections dated 5 <sup>th</sup> , 11 <sup>th</sup> , 16 <sup>th</sup> and 25 <sup>th</sup> Sep 2024] The site is kept in tidy condition during this reporting period. The contractor was reminded to maintain site tidiness as well as ensuring sufficient protection is provided to the full extent of the fabric to be retained, whether within the building, or those salvaged loose historic fabric being stored in the site area.

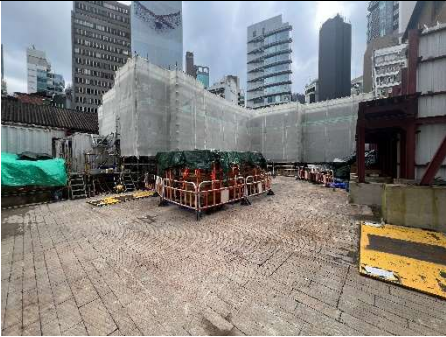
<p>Site condition dated 11<sup>th</sup> September with storage space fenced off.</p>

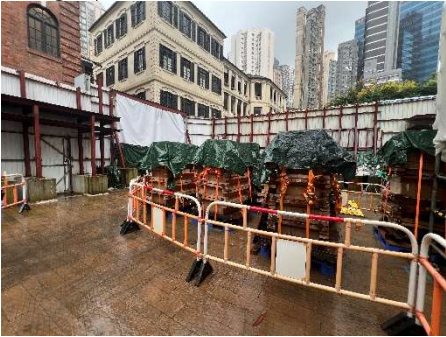
<p>Site condition dated 25<sup>th</sup> September with storage space fenced off.</p>	<p>[Inspections dated 5<sup>th</sup>, 11<sup>th</sup>, 16<sup>th</sup> and 25<sup>th</sup> Sep 2024] Salvaged loose historic fabric (CDEs) were well protected and fenced off before being relocated to the offsite storage on 13<sup>th</sup> and 14<sup>th</sup> August.</p>
4.4	Are site rules applied effectively?	9/10		<p>[Inspections dated 5<sup>th</sup>, 11<sup>th</sup>, 16<sup>th</sup> and 25<sup>th</sup> Sep 2024] There was no evidence of smoking happening onsite during all site inspections.</p>

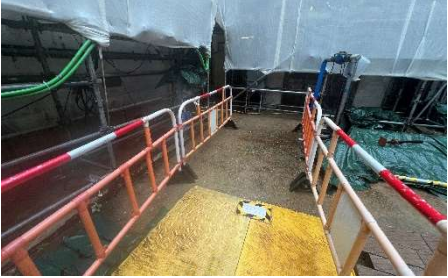
<p>Working area has been fenced off.</p>   <p>Hoarding condition near Blk 6&amp;7</p>	No adverse comments.
