Development at West Kowloon Cultural District

Monthly Environmental Monitoring and Audit (EM&A) Report

for July 2024

**Part-2: EM&A for ELS Works for The
Integrated Basement and
Underground Road in Zones 2A, 2B
& 2C**

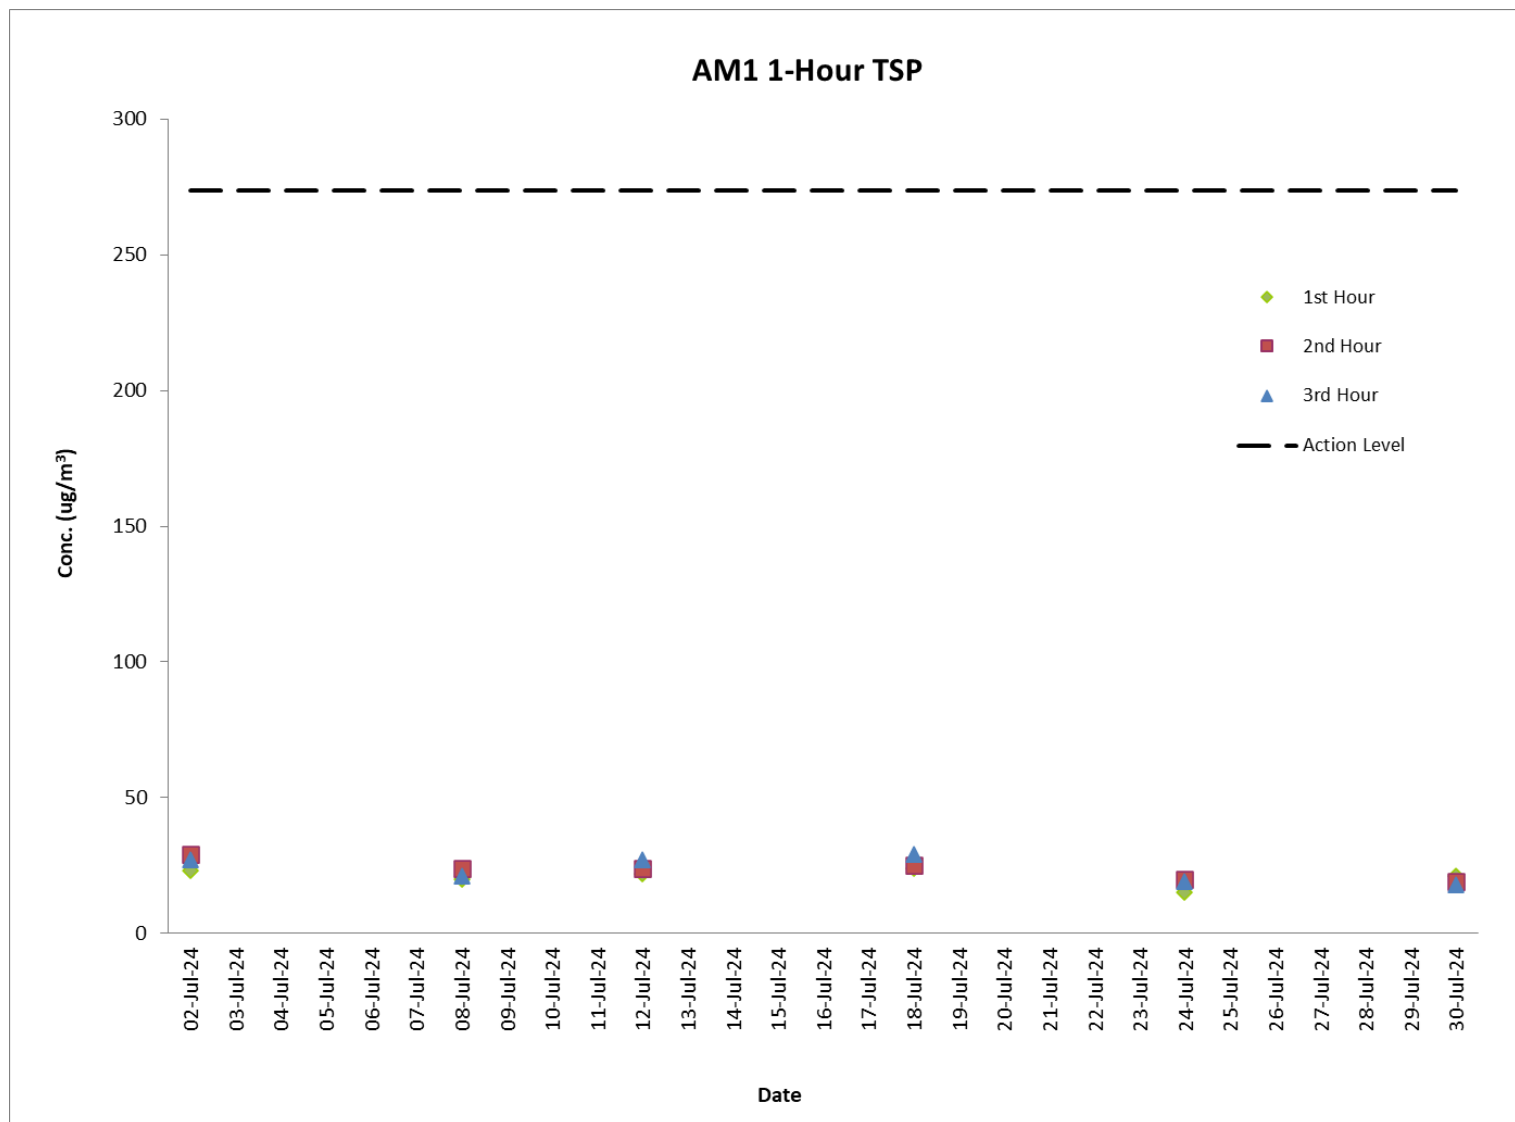
Graphical Presentation of Air Quality Monitoring Result at Station AM1 (1-hour TSP)

Date	Weather Condition	Time	Conc. ($\mu\text{g}/\text{m}^3$)			Action Level ($\mu\text{g}/\text{m}^3$)	Limit Level ($\mu\text{g}/\text{m}^3$)
			1 st Hour	2 nd Hour	3 rd Hour		
2-Jul-24	Cloudy	8:23 - 11:23	23	29	27	273.7	500
8-Jul-24	Sunny	8:23 - 11:23	20	24	21	273.7	500
12-Jul-24	Fine	8:33 - 11:33	22	24	27	273.7	500
18-Jul-24	Fine	8:32 - 11:32	24	25	29	273.7	500
24-Jul-24	Cloudy	8:27 - 11:27	15	20	19	273.7	500
30-Jul-24	Cloudy	8:23 - 11:23	21	19	18	273.7	500

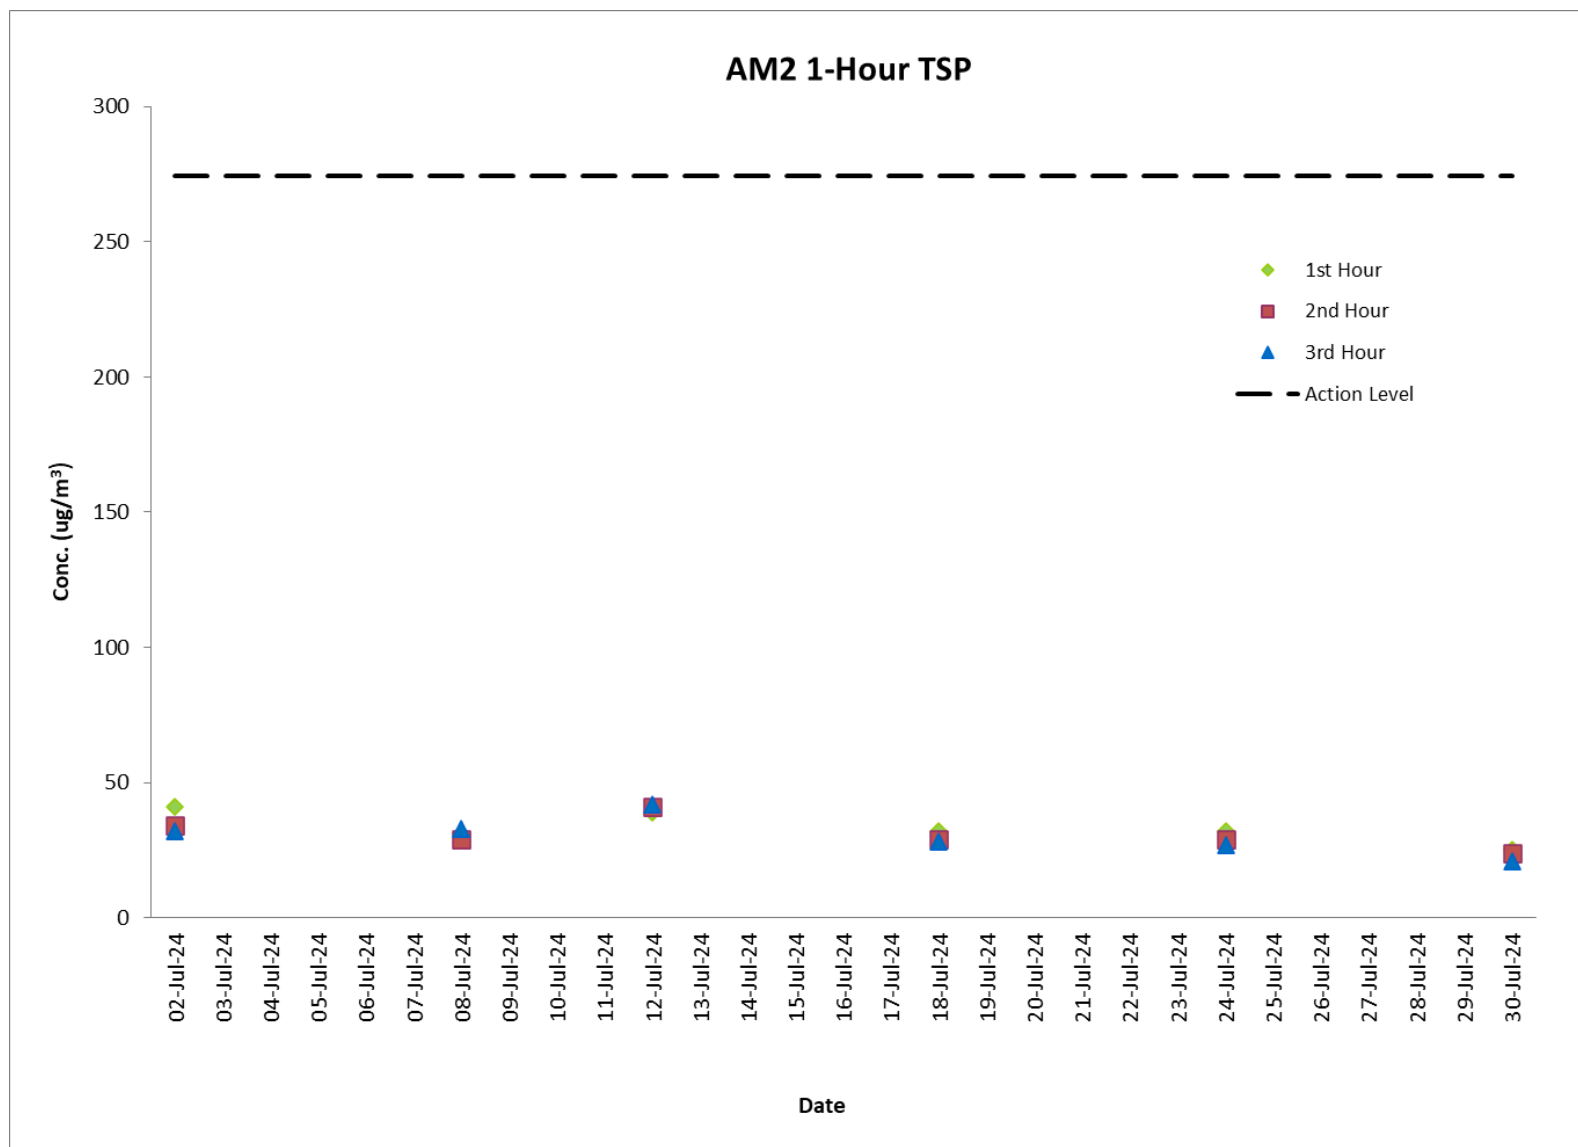
Graphical Presentation of Air Quality Monitoring Result at Station AM2 (1-hour TSP)

Date	Weather Condition	Time	Conc. ($\mu\text{g}/\text{m}^3$)			Action Level ($\mu\text{g}/\text{m}^3$)	Limit Level ($\mu\text{g}/\text{m}^3$)
			1 st Hour	2 nd Hour	3 rd Hour		
2-Jul-24	Cloudy	8:38 - 11:38	41	34	32	274.2	500
8-Jul-24	Sunny	8:37 - 11:37	31	29	33	274.2	500
12-Jul-24	Fine	8:47 - 11:47	39	41	42	274.2	500
18-Jul-24	Fine	8:47 - 11:47	32	29	28	274.2	500
24-Jul-24	Cloudy	8:43 - 11:43	32	29	27	274.2	500
30-Jul-24	Cloudy	8:38 - 11:38	25	24	21	274.2	500

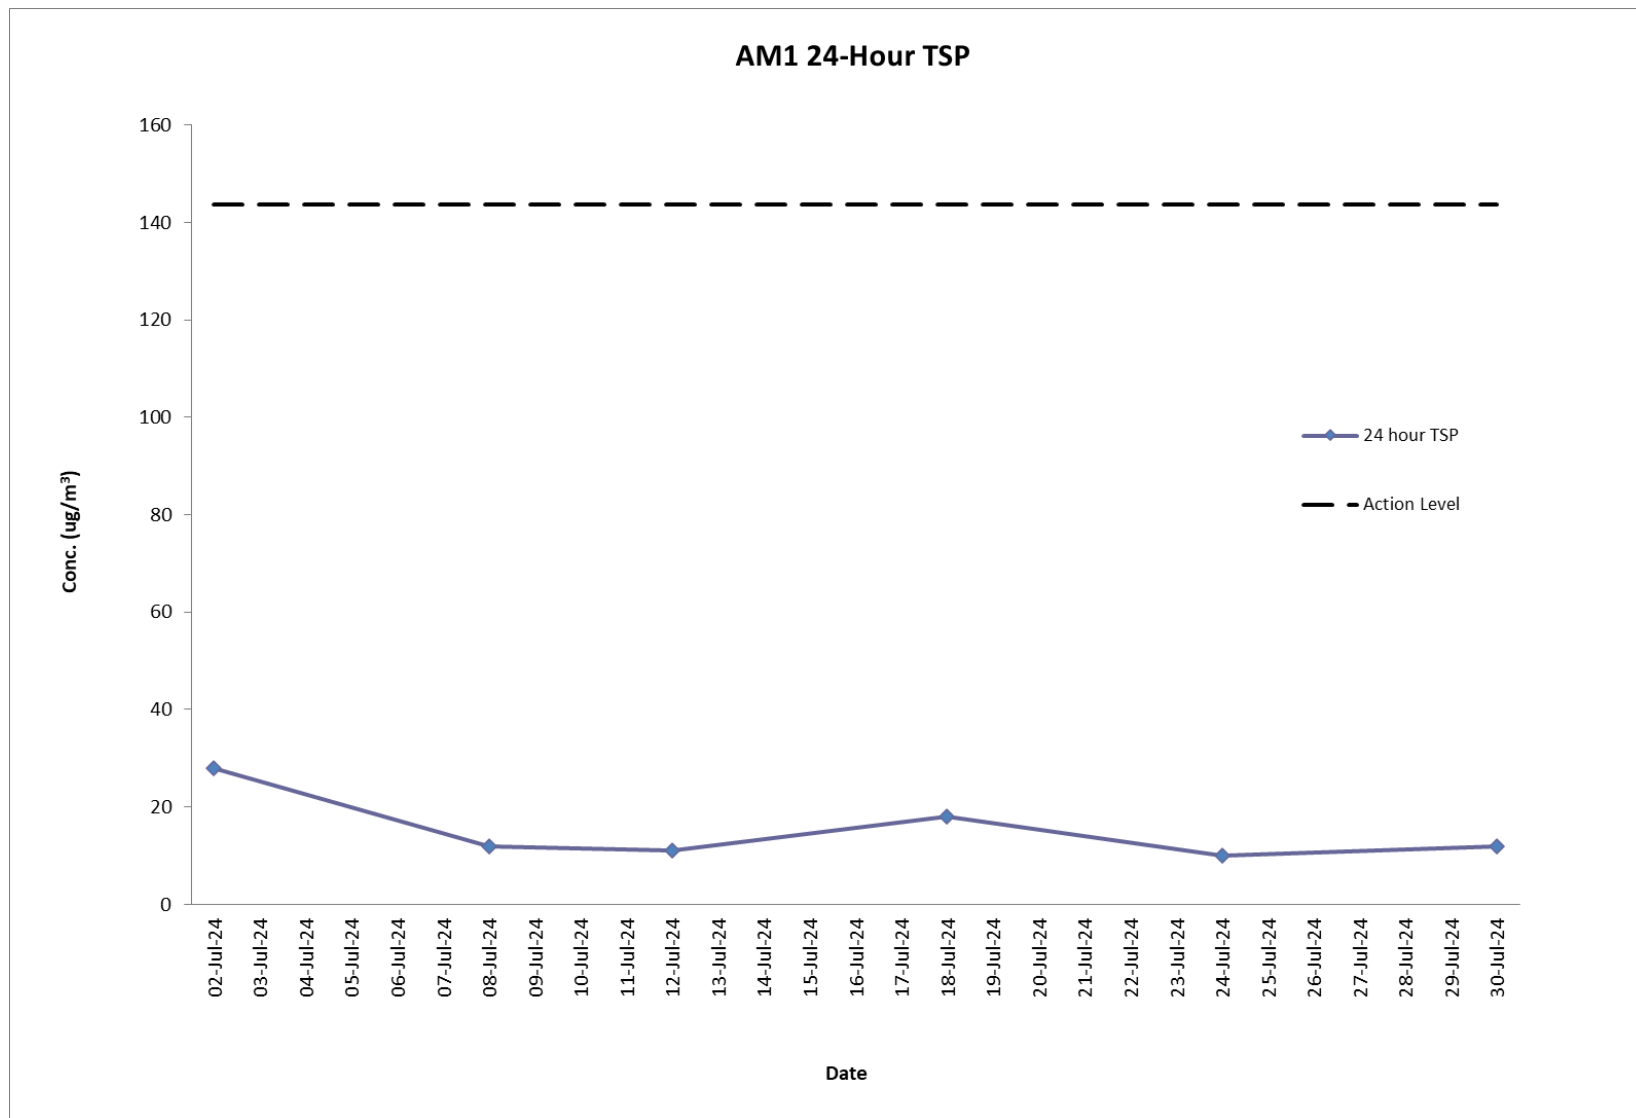
Graphical Presentation of Air Quality Monitoring Result at Station AM1 (24-hour TSP)

Start		Finish		Filter Weight (g)		Elapsed Time Reading		Sampling Time (hrs)	Flow Rate (m ³ /min)			Conc. (µg/m ³)	Weather Condition	Action Level	Limit Level
Date	Time	Date	Time	Initial	Final	Initial	Final		Initial	Final	Average				
2-Jul-24	8:20	3-Jul-24	8:20	2.8127	2.8613	28324.38	28348.38	24	1.2	1.2	1.2	28	Cloudy	143.6	260
8-Jul-24	8:20	9-Jul-24	8:20	2.7967	2.8195	28348.38	28372.38	24	1.27	1.27	1.27	12	Sunny	143.6	260
12-Jul-24	8:30	13-Jul-24	8:30	2.7995	2.8197	28372.38	28396.38	24	1.27	1.27	1.27	11	Fine	143.6	260
18-Jul-24	8:30	19-Jul-24	8:30	2.8028	2.8350	28396.38	28420.38	24	1.27	1.27	1.27	18	Fine	143.6	260
24-Jul-24	8:25	25-Jul-24	8:25	2.8046	2.8228	28420.38	28444.38	24	1.27	1.27	1.27	10	Cloudy	143.6	260
30-Jul-24	8:20	31-Jul-24	8:20	2.8084	2.8297	28444.38	28468.38	24	1.27	1.27	1.27	12	Cloudy	143.6	260

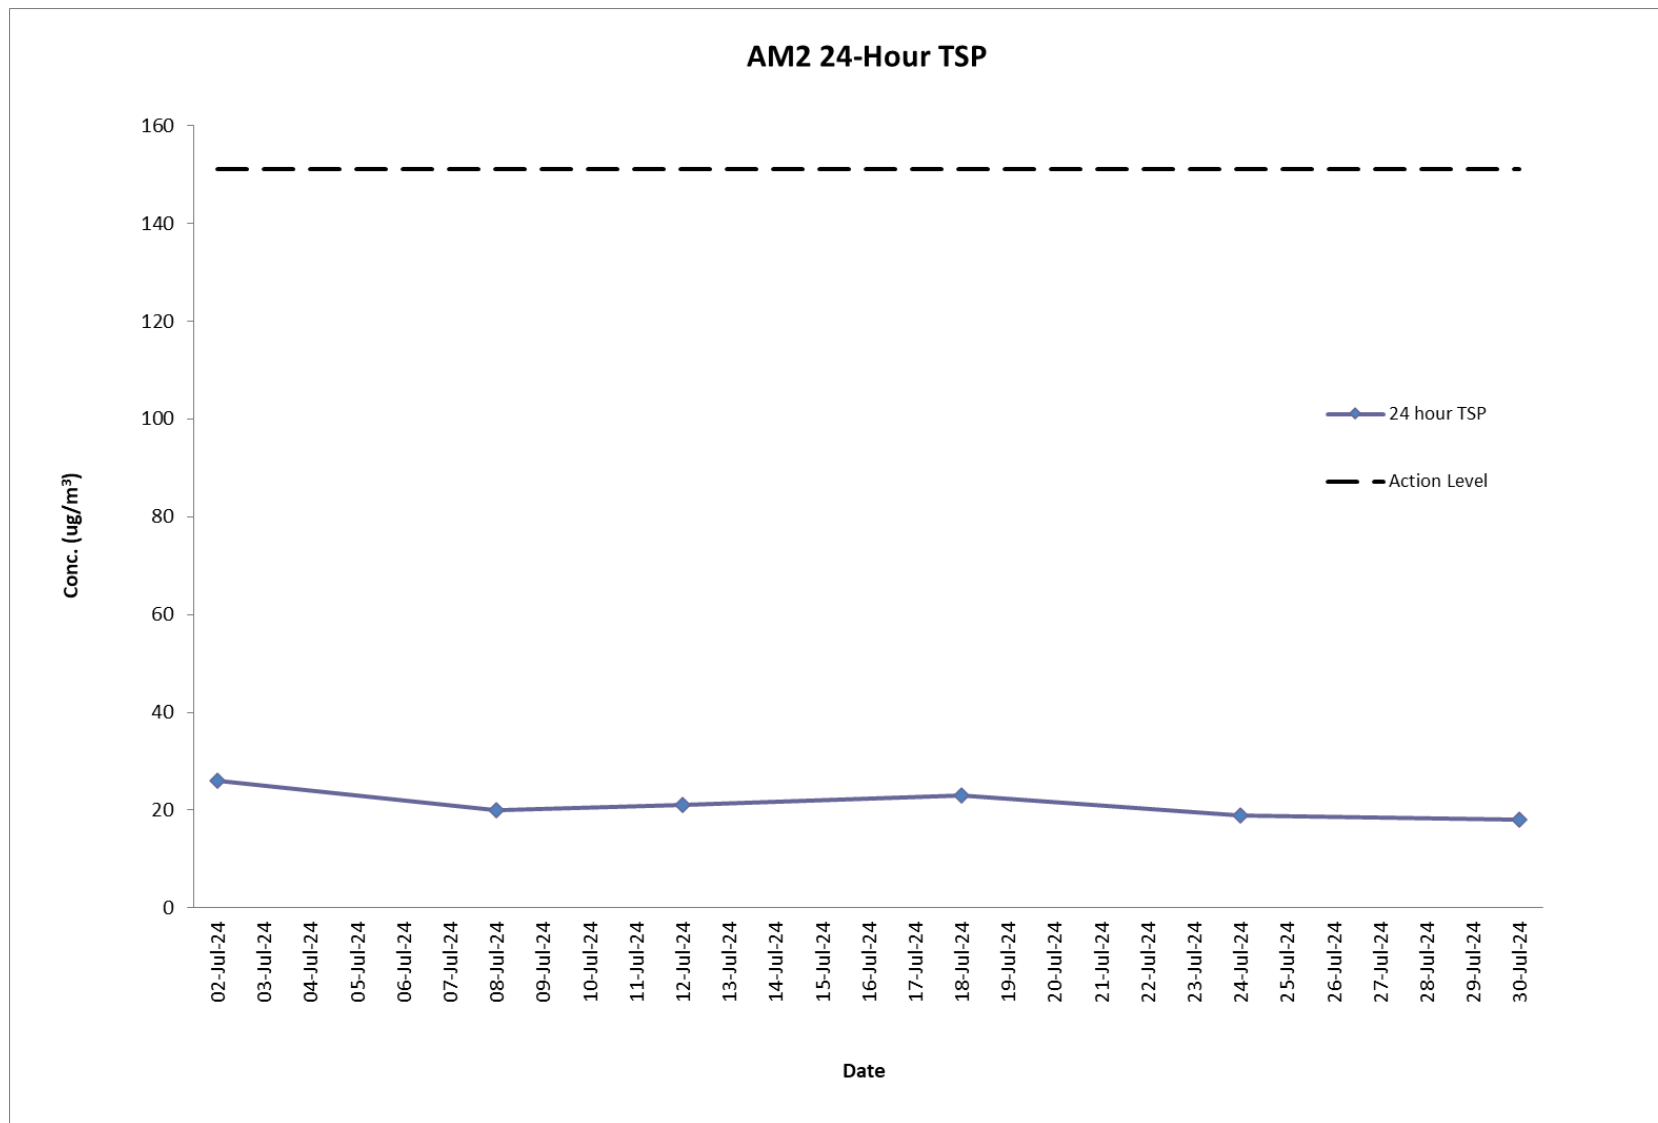
Graphical Presentation of Air Quality Monitoring Result at Station AM2 (24-hour TSP)

Start		Finish		Sampling Time (hrs)	Conc. ($\mu\text{g}/\text{m}^3$)	Weather Condition	Action Level	Limit Level
Date	Time	Date	Time					
2-Jul-24	8:35	3-Jul-24	8:35	24	26	Cloudy	151.1	260
8-Jul-24	8:35	9-Jul-24	8:35	24	20	Sunny	151.1	260
12-Jul-24	8:45	13-Jul-24	8:45	24	21	Fine	151.1	260
18-Jul-24	8:44	19-Jul-24	8:44	24	23	Fine	151.1	260
24-Jul-24	8:40	25-Jul-24	8:40	24	19	Cloudy	151.1	260
30-Jul-24	8:35	31-Jul-24	8:35	24	18	Cloudy	151.1	260

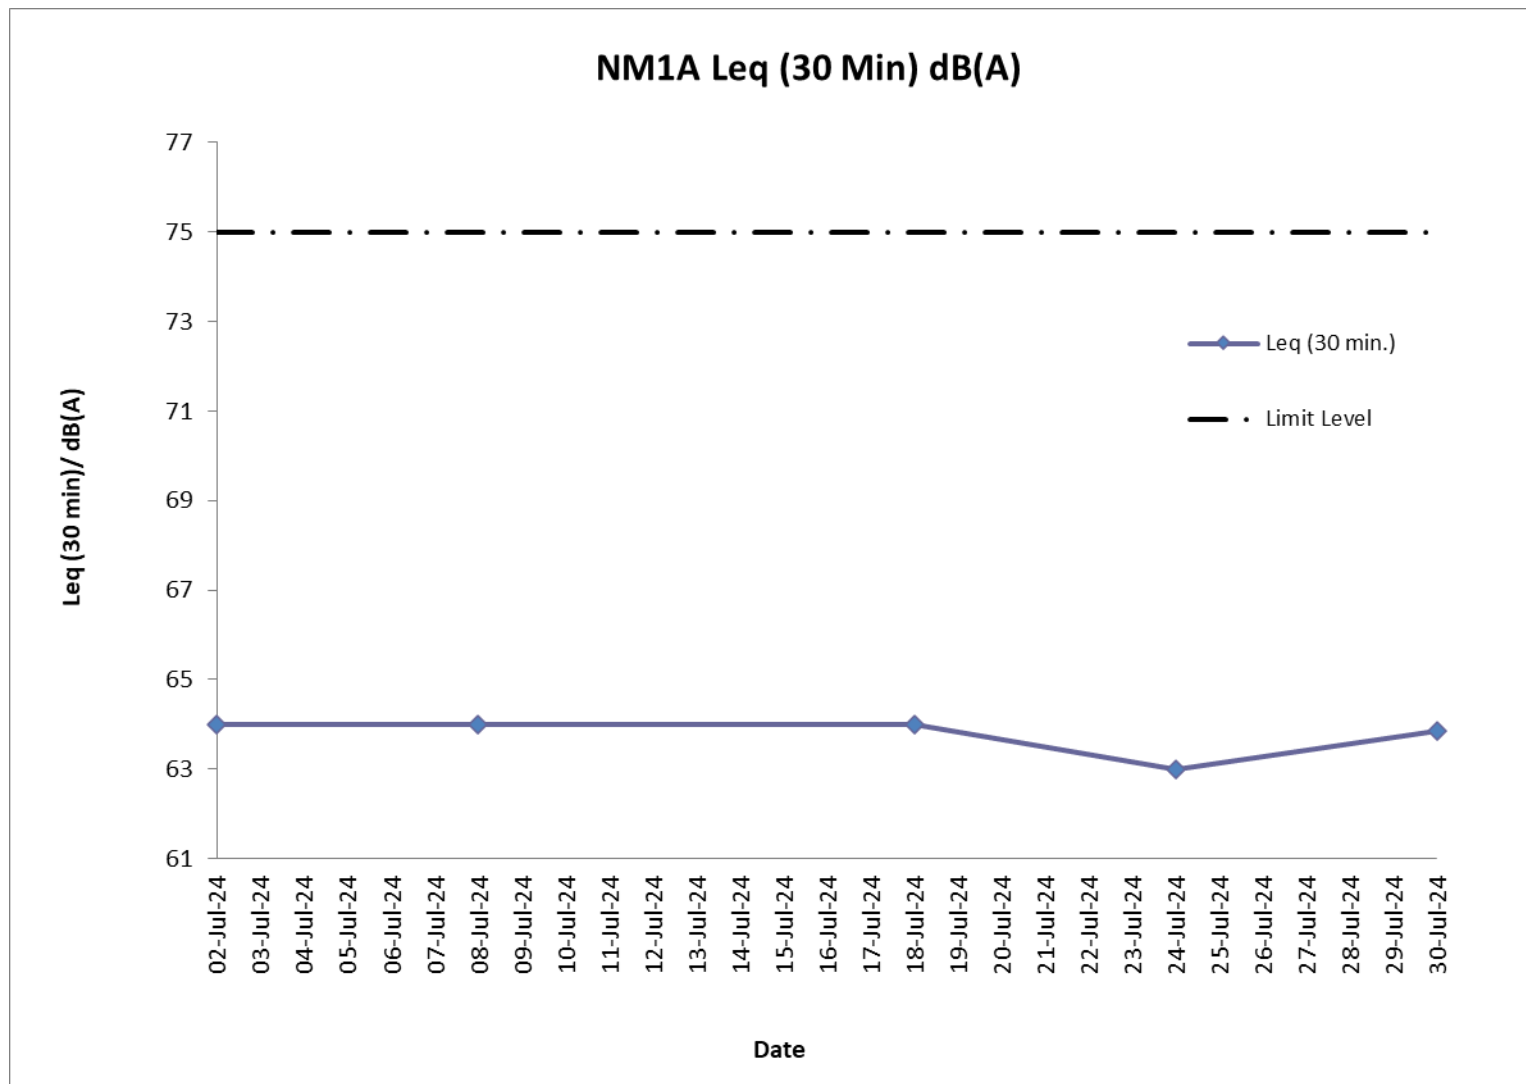
Graphical Presentation Noise Monitoring Result at Station NM1A

Date	Time	Measured L ₁₀ , dB(A)	Measured L ₉₀ , dB(A)	L _{eq} (30 min.)*, dB(A)
2-Jul-24	9:26	63.0	59.2	64
2-Jul-24	9:31	62.3	58.6	
2-Jul-24	9:36	63.5	59.9	
2-Jul-24	9:41	63.8	59.0	
2-Jul-24	9:46	62.6	58.4	
2-Jul-24	9:51	64.7	60.6	
8-Jul-24	9:21	63.0	59.2	64
8-Jul-24	9:26	62.6	58.8	
8-Jul-24	9:31	62.7	58.0	
8-Jul-24	9:36	63.4	59.7	
8-Jul-24	9:41	63.5	59.5	
8-Jul-24	9:46	62.9	58.2	
18-Jul-24	9:30	63.0	59.2	64
18-Jul-24	9:35	62.6	58.5	
18-Jul-24	9:40	63.4	59.8	
18-Jul-24	9:45	64.9	60.0	
18-Jul-24	9:50	62.7	58.6	
18-Jul-24	9:55	63.6	59.7	
24-Jul-24	9:26	62.7	58.2	63
24-Jul-24	9:31	61.0	57.5	
24-Jul-24	9:36	61.4	57.8	
24-Jul-24	9:41	63.9	59.0	
24-Jul-24	9:46	62.1	58.7	
24-Jul-24	9:51	62.2	58.9	
30-Jul-24	9:23	63.0	59.2	64
30-Jul-24	9:28	64.9	60.5	
30-Jul-24	9:33	62.4	58.8	
30-Jul-24	9:38	62.7	58.7	
30-Jul-24	9:43	61.4	57.6	
30-Jul-24	9:48	62.6	58.0

The station set-up of a free-field measurement at Station NM1A.

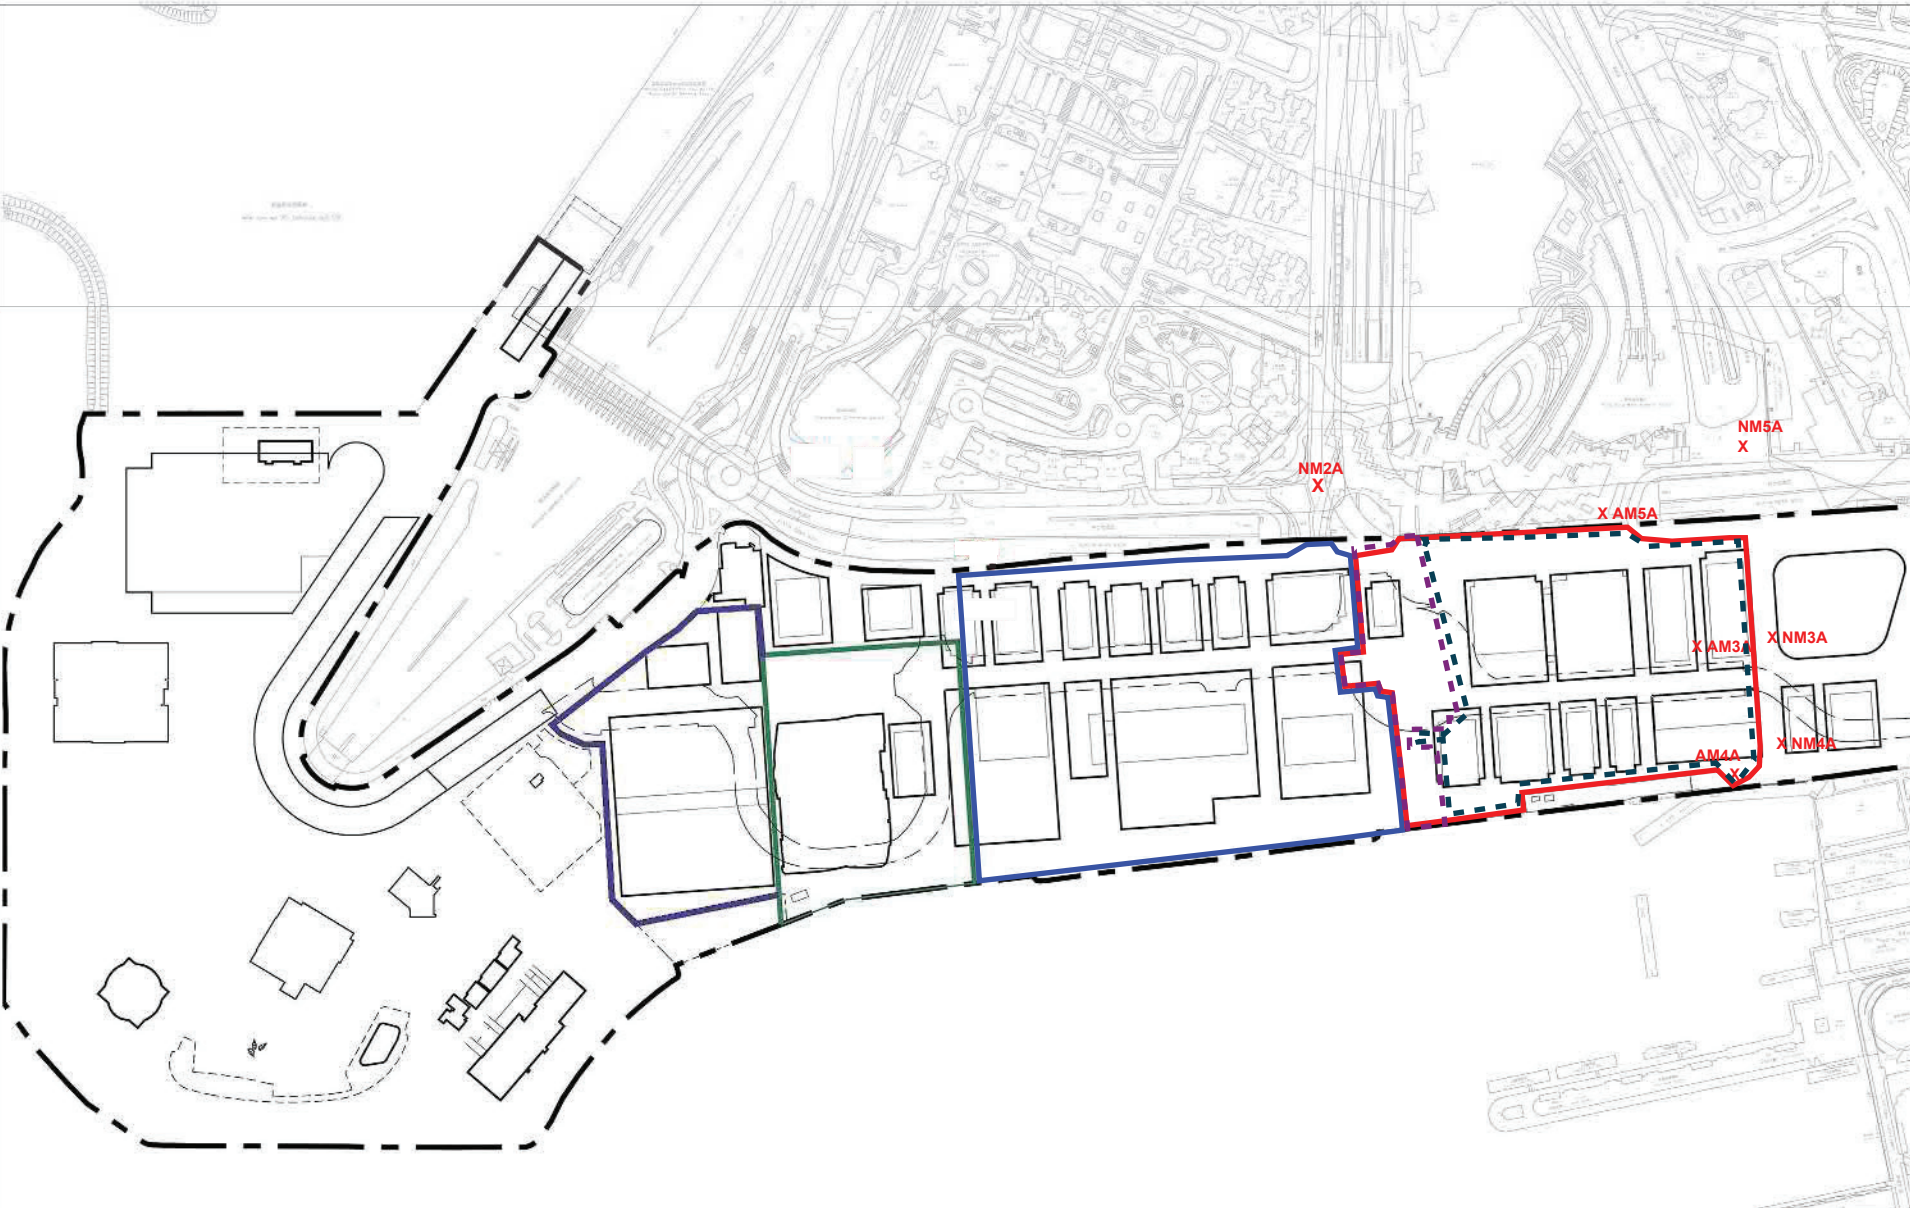
REMARKS:
 THE AIR MONITORING STATION AM2A HAS BEEN RELOCATED TO THE ALTERNATIVE MONITORING STATION AM2B AT 1ST FLOOR OF GAMMON'S SITE OFFICE ON 26 FEBRUARY 2019.

- Zone 2A Boundary
- Zone 2B & 2C Boundary
- Under Management by Zone 2B & 2C Contractor Starting from 20 Dec 2022
- No Construction Work and Only Maintenance Work is Carried Out by Zone 2B & 2C Contractor Starting from 01 April 2023

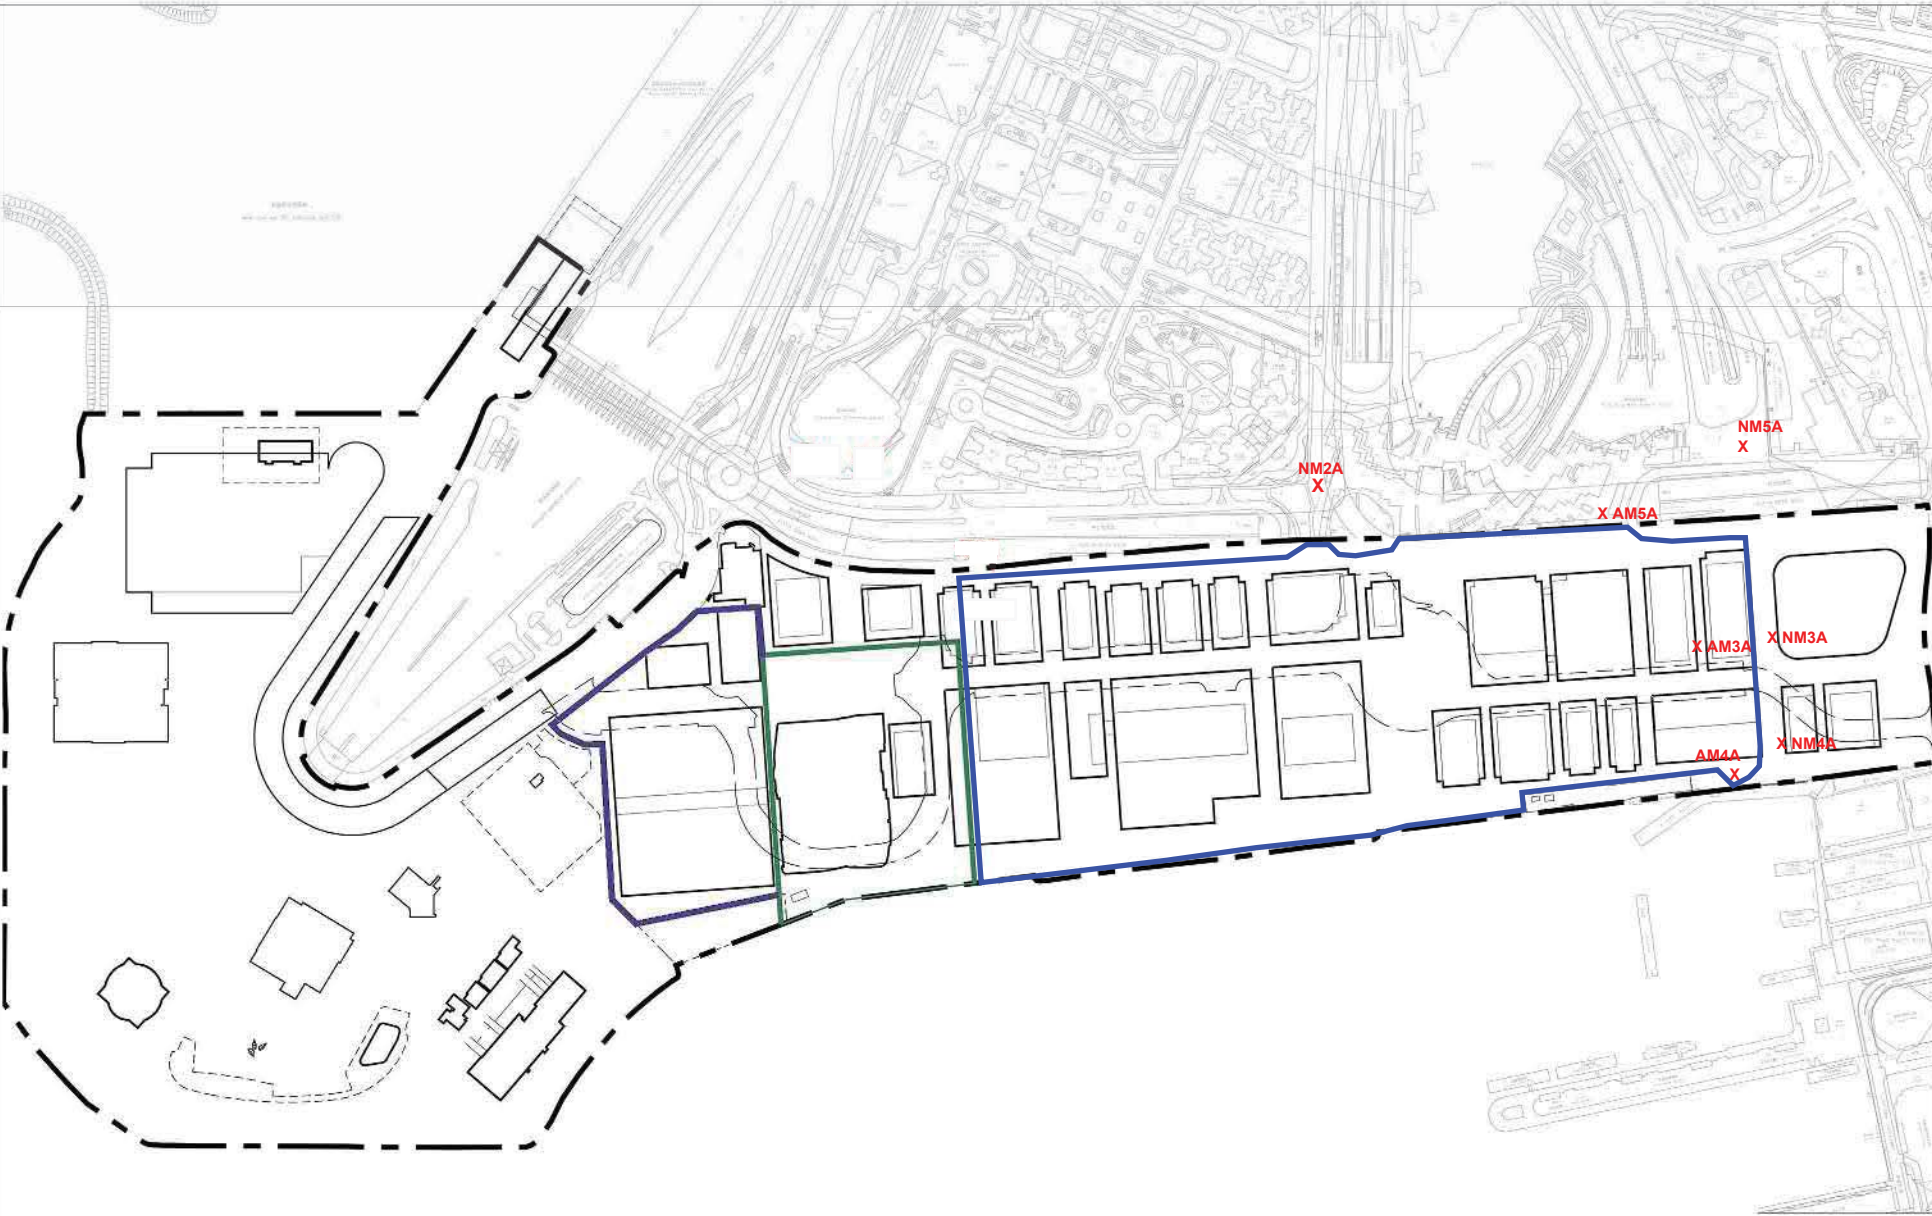
REMARKS:
THE AIR MONITORING STATION AM2A HAS BEEN RELOCATED TO THE ALTERNATIVE MONITORING STATION AM2B AT 1ST FLOOR OF GAMMON'S SITE OFFICE ON 26 FEBRUARY 2019.

—— Zones 2A, 2B & 2C Boundary (Contract No.: CC/2023/2B/095)

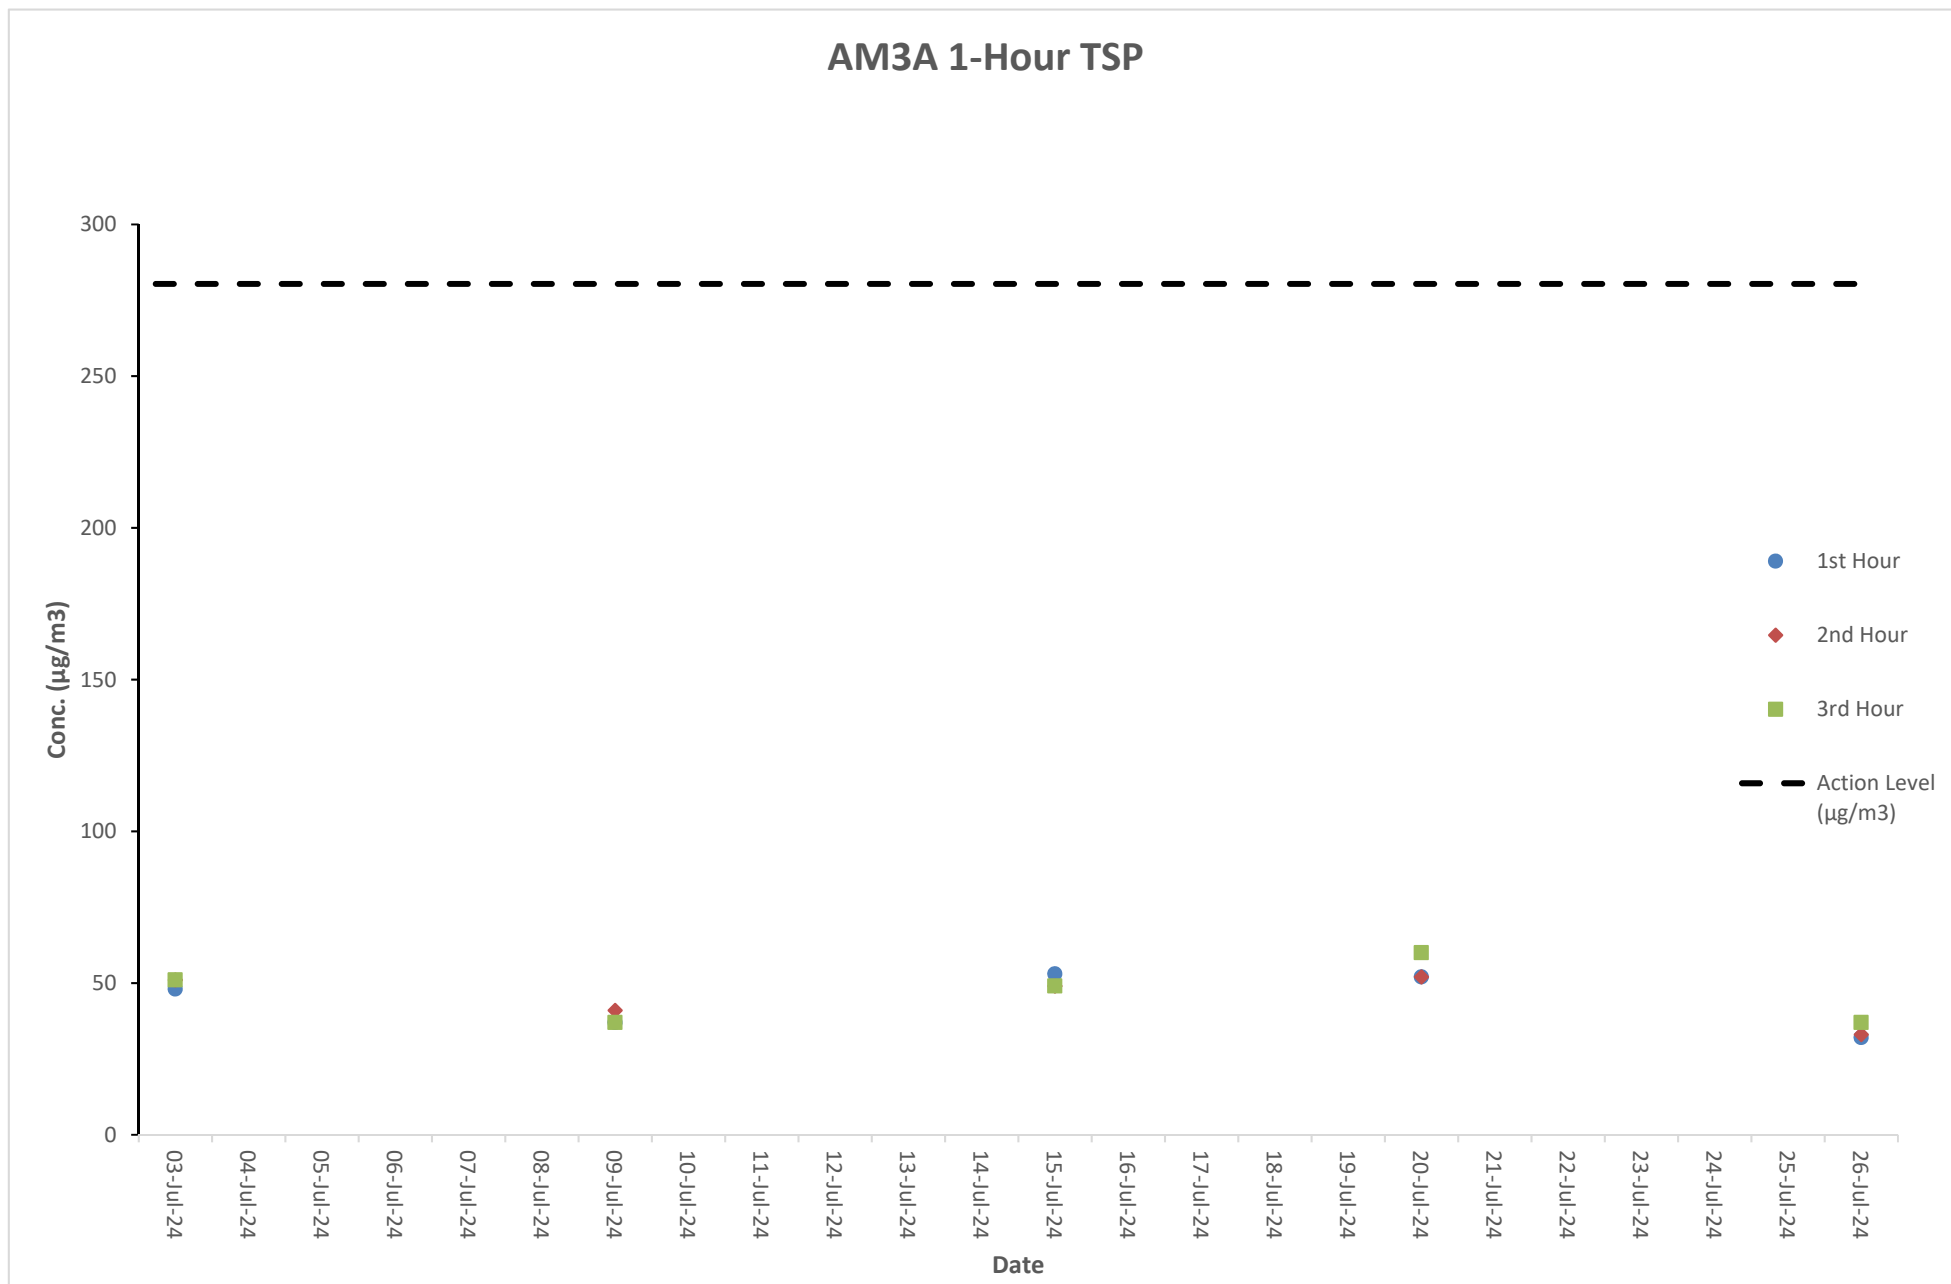
Graphical Presentation of Air Quality Monitoring Result at Station AM3A (1-hour TSP)

Date	Weather Condition	Time		Conc. ($\mu\text{g}/\text{m}^3$)			Action Level	Limit Level
		Start	Finish	1st Hour	2nd Hour	3rd Hour		
03-Jul-24	Fine	08:01	11:01	48	51	51	280.4	500
09-Jul-24	Cloudy	14:05	17:05	37	41	37	280.4	500
15-Jul-24	Cloudy	08:06	11:06	53	49	49	280.4	500
20-Jul-24	Cloudy	14:07	17:07	52	52	60	280.4	500
26-Jul-24	Cloudy	08:09	11:09	32	33	37	280.4	500

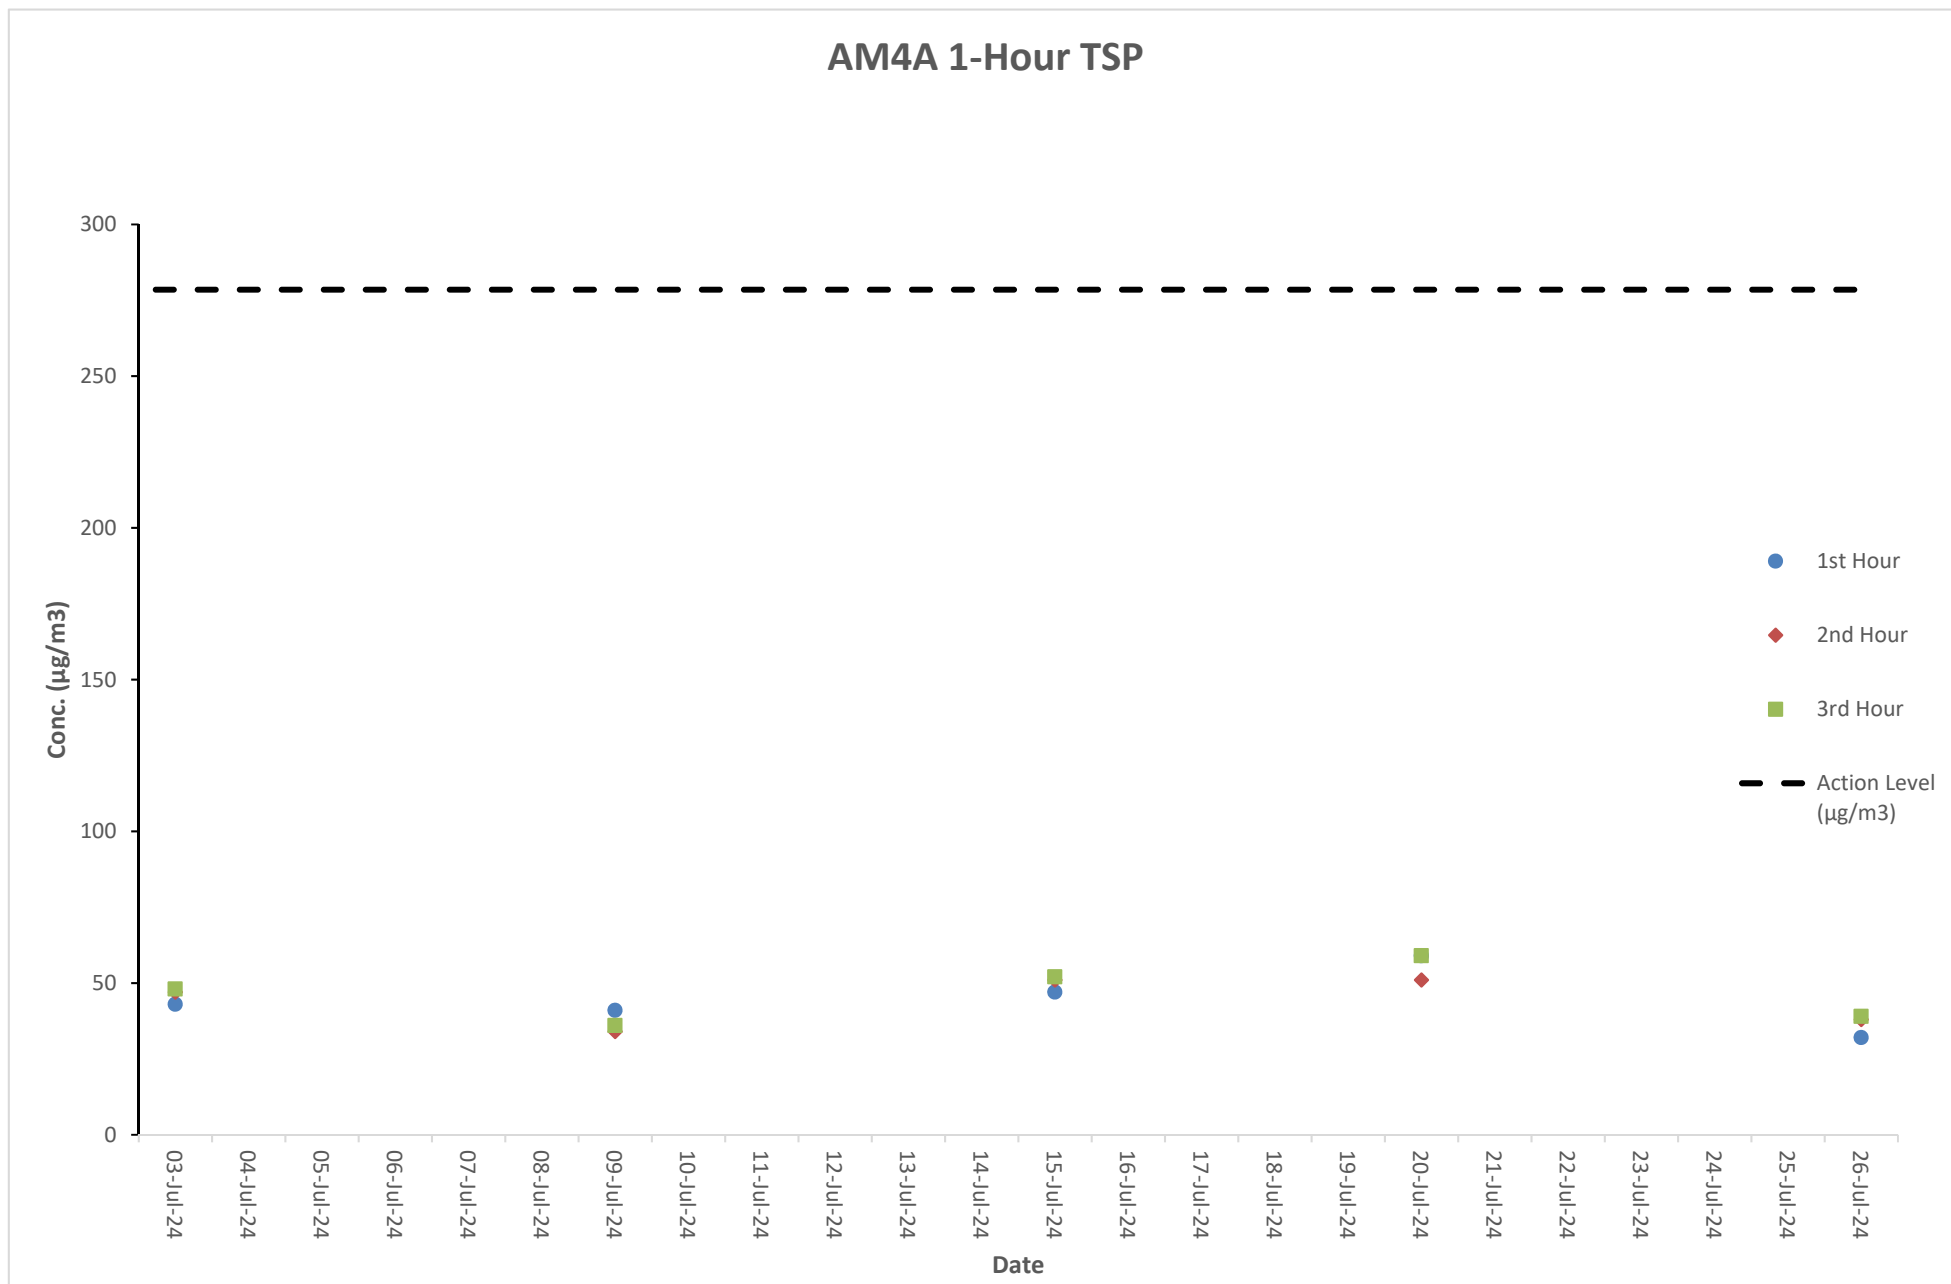
Graphical Presentation of Air Quality Monitoring Result at Station AM4A (1-hour TSP)

Date	Weather Condition	Time		Conc. ($\mu\text{g}/\text{m}^3$)			Action Level	Limit Level
		Start	Finish	1st Hour	2nd Hour	3rd Hour		
03-Jul-24	Fine	08:09	11:09	43	47	48	278.5	500
09-Jul-24	Cloudy	14:13	17:13	41	34	36	278.5	500
15-Jul-24	Cloudy	08:14	11:14	47	51	52	278.5	500
20-Jul-24	Cloudy	14:15	17:15	59	51	59	278.5	500
26-Jul-24	Cloudy	08:17	11:17	32	38	39	278.5	500

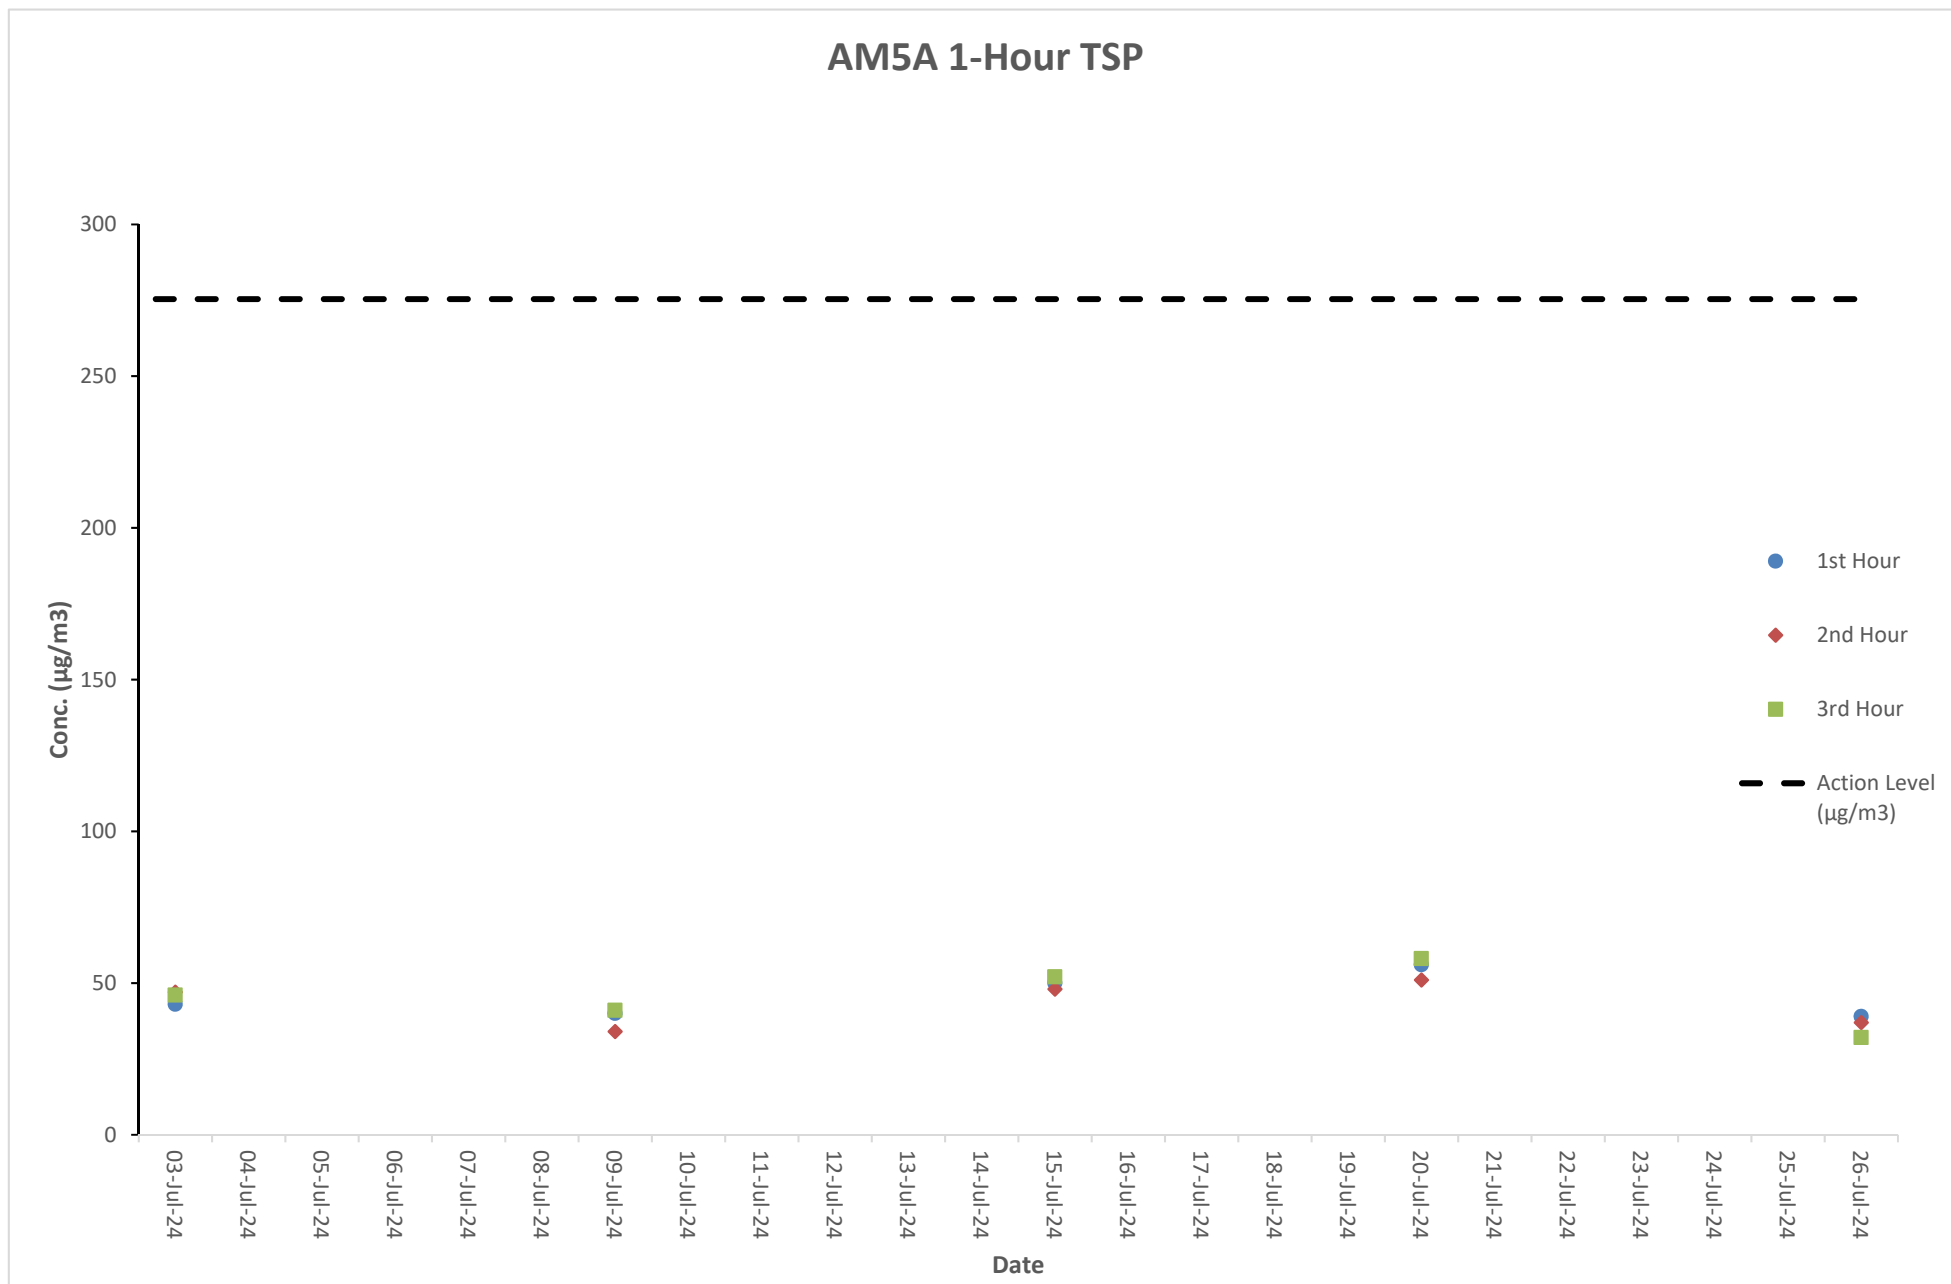
Graphical Presentation of Air Quality Monitoring Result at Station AM5A (1-hour TSP)

Date	Weather Condition	Time		Conc. ($\mu\text{g}/\text{m}^3$)			Action Level	Limit Level
		Start	Finish	1st Hour	2nd Hour	3rd Hour		
03-Jul-24	Fine	08:24	11:24	43	47	46	275.4	500
09-Jul-24	Cloudy	14:30	17:30	40	34	41	275.4	500
15-Jul-24	Cloudy	08:29	11:29	50	48	52	275.4	500
20-Jul-24	Cloudy	14:32	17:32	56	51	58	275.4	500
26-Jul-24	Cloudy	08:32	11:32	39	37	32	275.4	500
