Development at West Kowloon Cultural District

Monthly Environmental Monitoring and Audit (EM&A) Report

for July 2024

**Part-2: EM&A for ELS Works for The
Integrated Basement and
Underground Road in Zones 2A, 2B
& 2C**

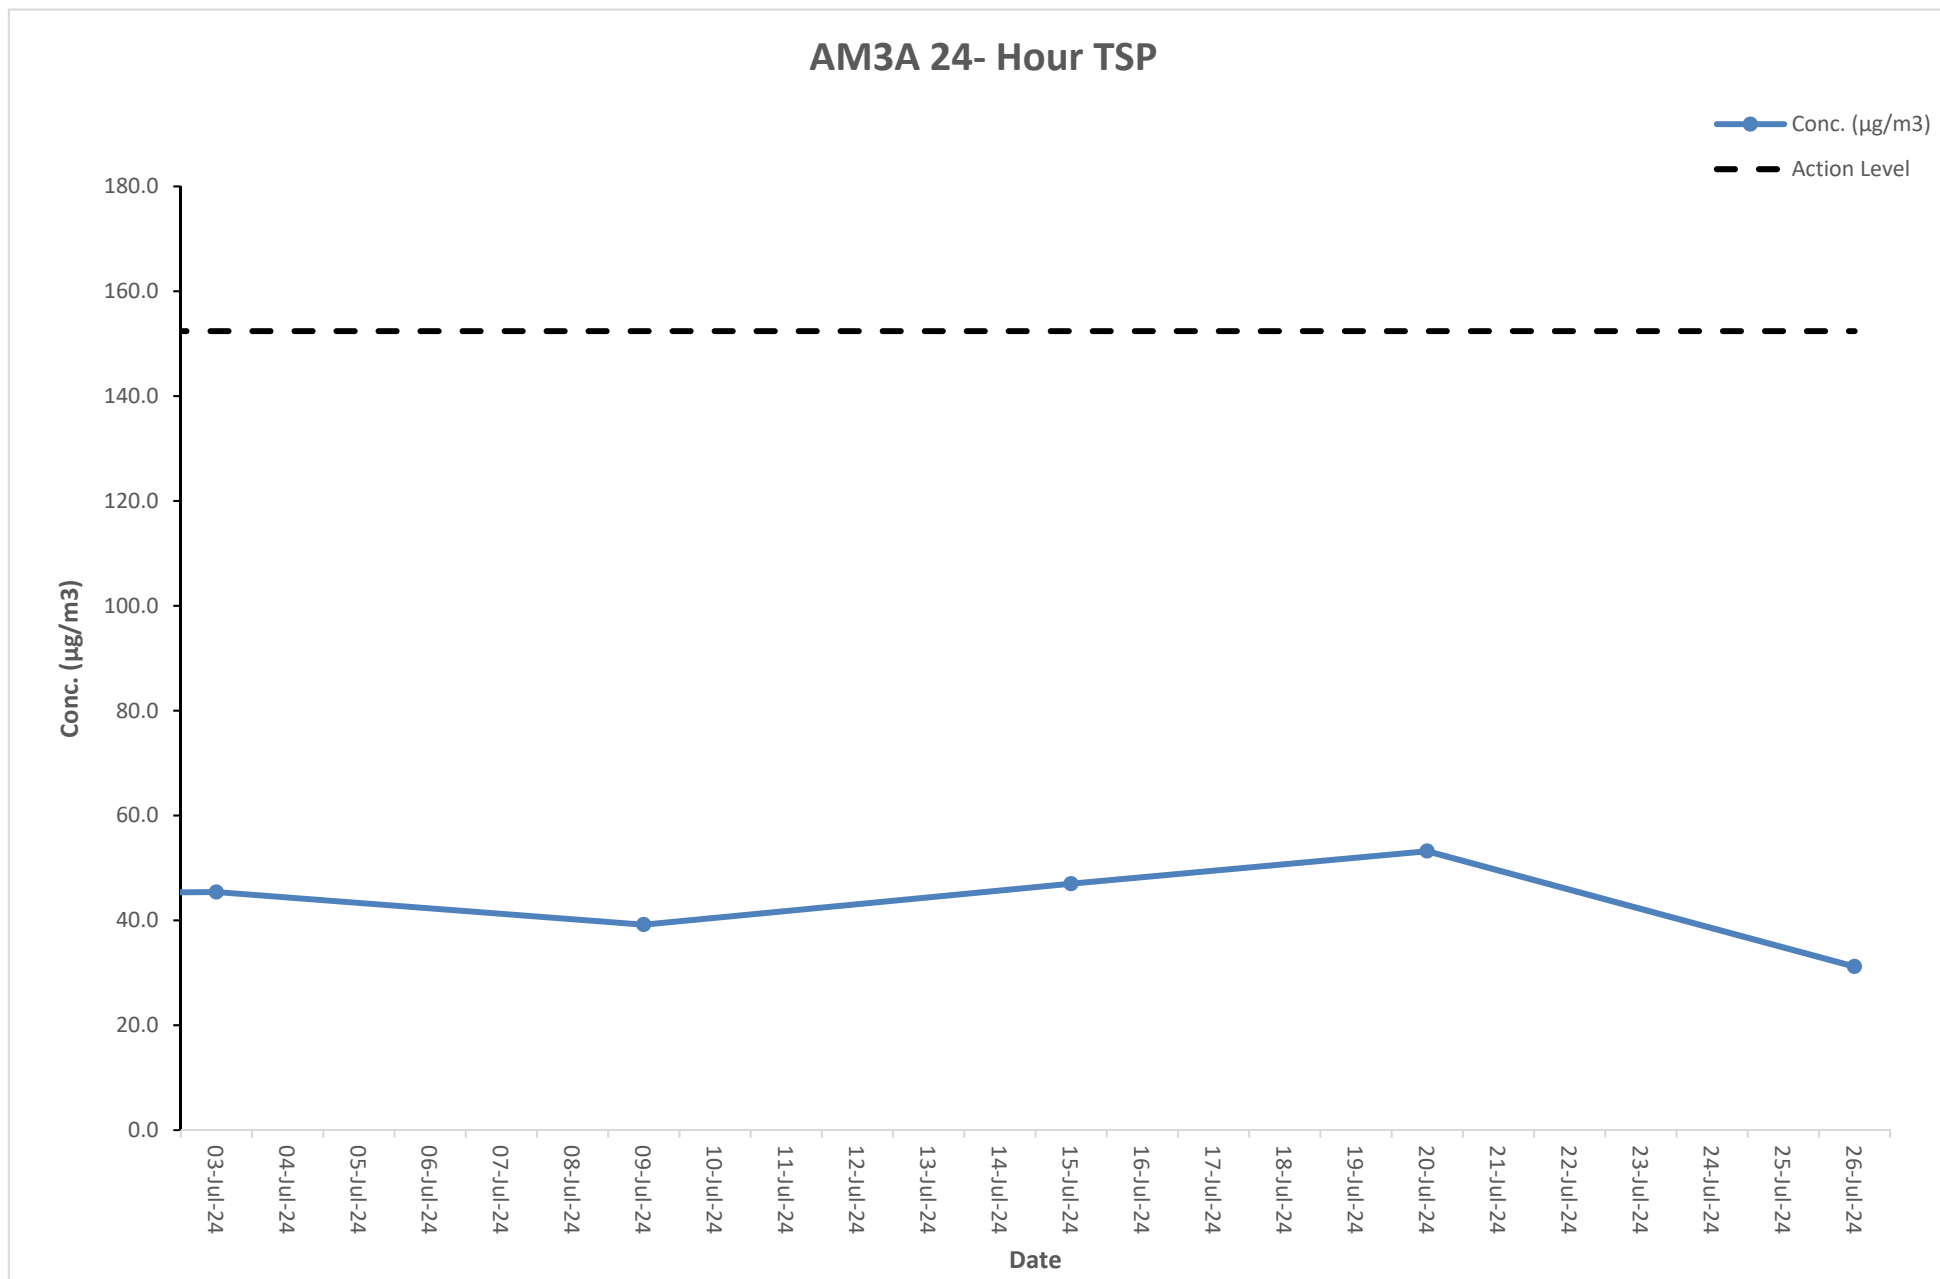
Graphical Presentation of Air Quality Monitoring Result at Station AM3A (24-hour TSP)

Start		Finish		Filter Weight (g)		Elapsed Time Reading		Sampling Time (hrs)	Flow Rate (m ³ /min)			Conc. (µg/m ³)	Weather Condition	Action Level	Limit Level
Date	Time	Date	Time	Initial	Final	Initial	Final		Initial	Final	Average				
03-Jul-24	10:00AM	04-Jul-24	10:00AM	2.8023	2.8753	6975.8	6999.8	24	1.12	1.12	1.12	45.4	Sunny	152.4	260
09-Jul-24	10:00AM	10-Jul-24	10:00AM	2.8035	2.8665	6999.8	7023.8	24	1.12	1.12	1.12	39.2	Cloudy	152.4	260
15-Jul-24	10:00AM	16-Jul-24	10:00AM	2.8068	2.8825	7023.8	7047.8	24	1.12	1.12	1.12	47.0	Rainy	152.4	260
20-Jul-24	10:00AM	21-Jul-24	10:00AM	2.8079	2.8935	7047.8	7071.8	24	1.12	1.12	1.12	53.2	Rainy	152.4	260
26-Jul-24	10:00AM	27-Jul-24	10:00AM	2.8053	2.8555	7071.8	7095.8	24	1.12	1.12	1.12	31.2	Rainy	152.4	260

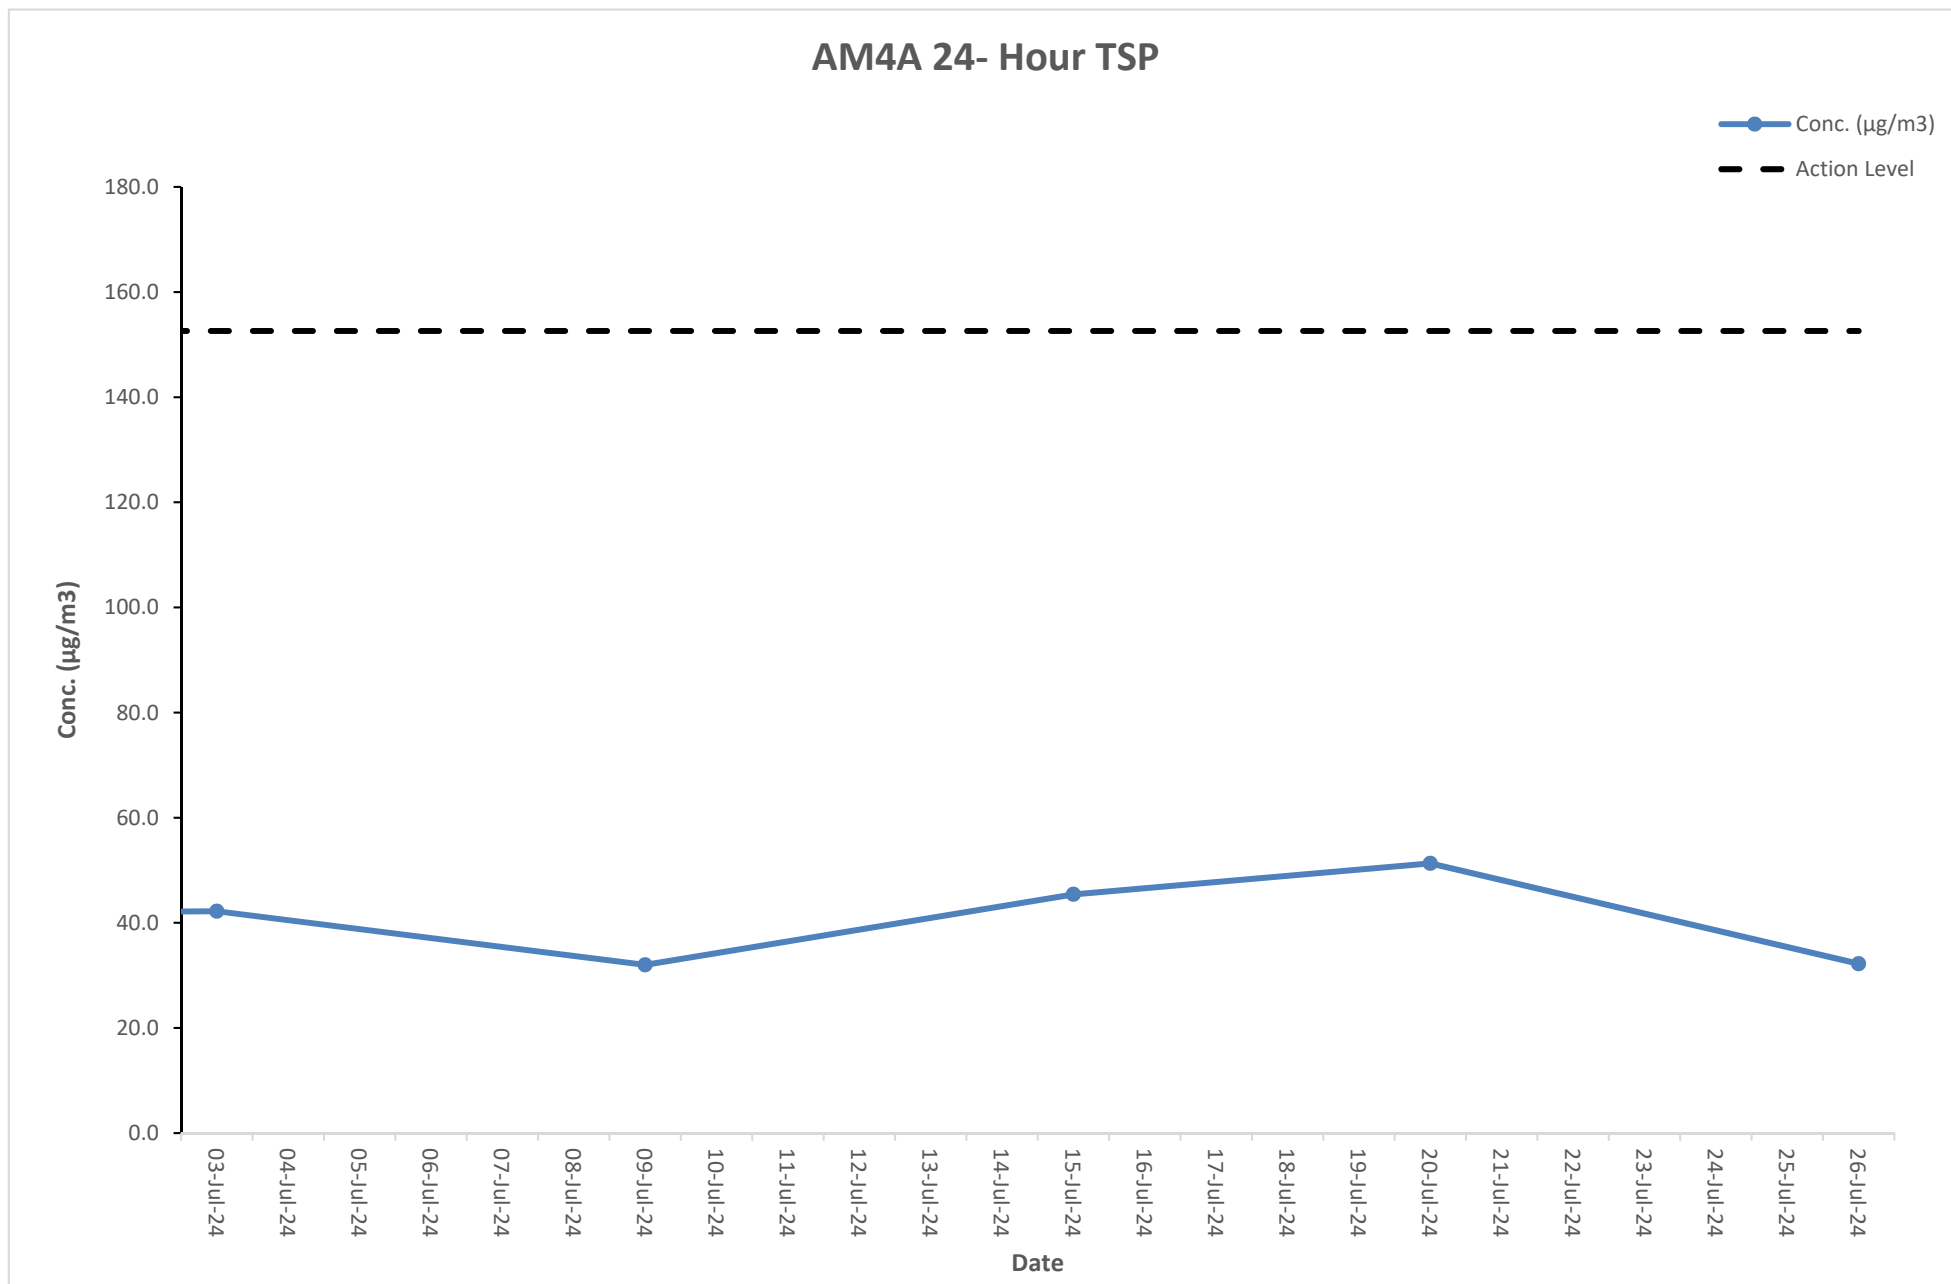
Graphical Presentation of Air Quality Monitoring Result at Station AM4A (24-hour TSP)

Start		Finish		Filter Weight (g)		Elapsed Time Reading		Sampling Time (hrs)	Flow Rate (m ³ /min)			Conc. (µg/m ³)	Weather Condition	Action Level	Limit Level
Date	Time	Date	Time	Initial	Final	Initial	Final		Initial	Final	Average				
03-Jul-24	10:00AM	04-Jul-24	10:00AM	2.8013	2.8693	7395.4	7419.4	24	1.12	1.12	1.12	42.2	Sunny	152.6	260
09-Jul-24	10:00AM	10-Jul-24	10:00AM	2.8014	2.8529	7419.4	7443.4	24	1.12	1.12	1.12	32.0	Cloudy	152.6	260
15-Jul-24	10:00AM	16-Jul-24	10:00AM	2.8048	2.8779	7443.4	7467.4	24	1.12	1.12	1.12	45.4	Rainy	152.6	260
20-Jul-24	10:00AM	21-Jul-24	10:00AM	2.8018	2.8844	7467.4	7491.4	24	1.12	1.12	1.12	51.3	Rainy	152.6	260
26-Jul-24	10:00AM	27-Jul-24	10:00AM	2.8061	2.8579	7491.4	7515.4	24	1.12	1.12	1.12	32.2	Rainy	152.6	260

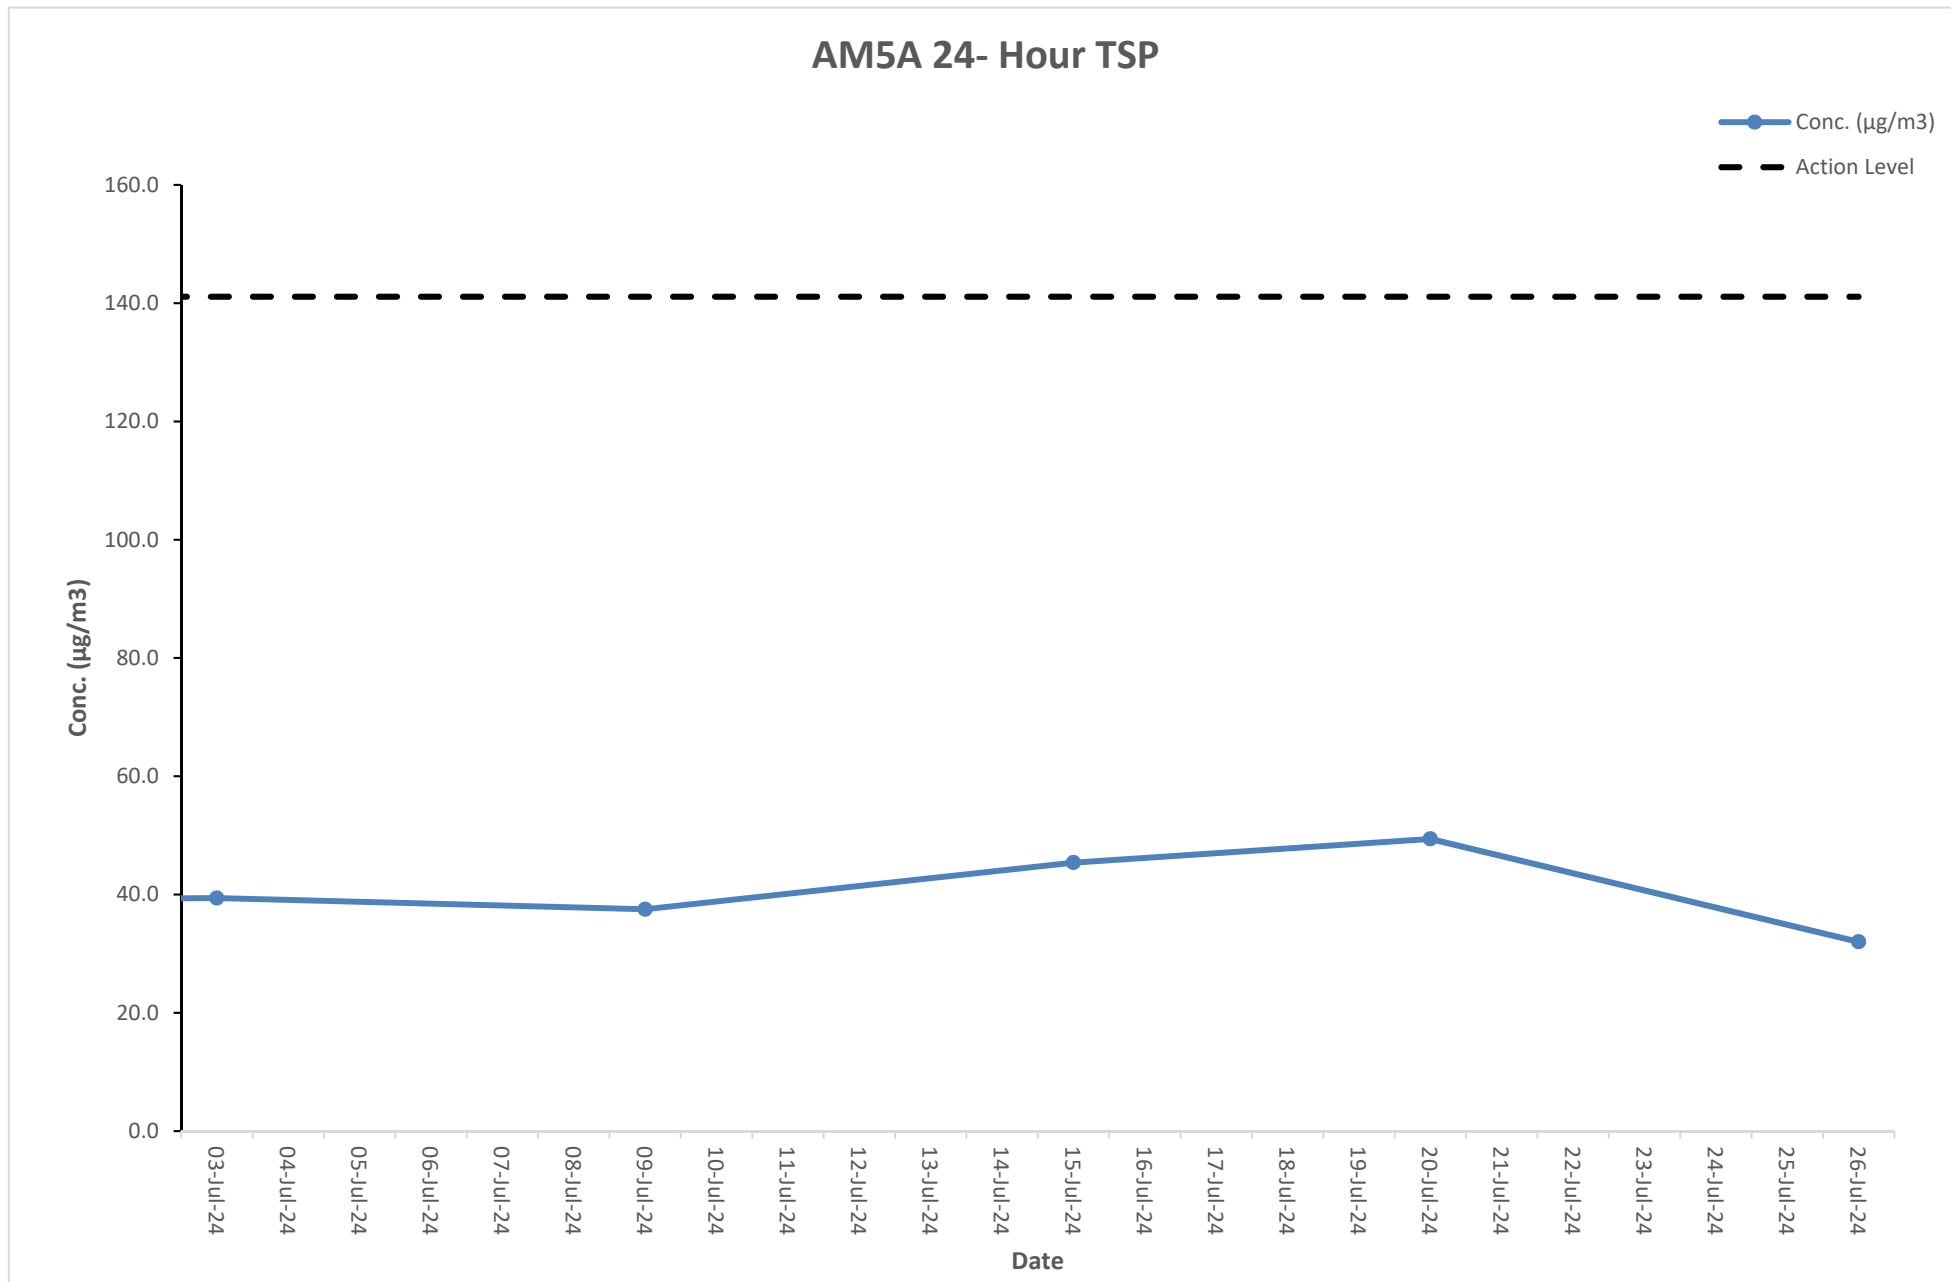
Graphical Presentation of Air Quality Monitoring Result at Station AM5A (24-hour TSP)

Start		Finish		Filter Weight (g)		Elapsed Time Reading		Sampling Time (hrs)	Flow Rate (m ³ /min)			Conc. (µg/m ³)	Weather Condition	Action Level	Limit Level
Date	Time	Date	Time	Initial	Final	Initial	Final		Initial	Final	Average				
03-Jul-24	10:00AM	04-Jul-24	10:00AM	2.8070	2.8703	7533.6	7557.6	24	1.12	1.12	1.12	39.4	Sunny	141.1	260
09-Jul-24	10:00AM	10-Jul-24	10:00AM	2.8021	2.8625	7557.6	7581.6	24	1.12	1.12	1.12	37.5	Cloudy	141.1	260
15-Jul-24	10:00AM	16-Jul-24	10:00AM	2.8014	2.8744	7581.6	7605.6	24	1.12	1.12	1.12	45.4	Rainy	141.1	260
20-Jul-24	10:00AM	21-Jul-24	10:00AM	2.8037	2.8832	7605.6	7629.6	24	1.12	1.12	1.12	49.4	Rainy	141.1	260
26-Jul-24	10:00AM	27-Jul-24	10:00AM	2.8063	2.8578	7629.6	7653.6	24	1.12	1.12	1.12	32.0	Rainy	141.1	260

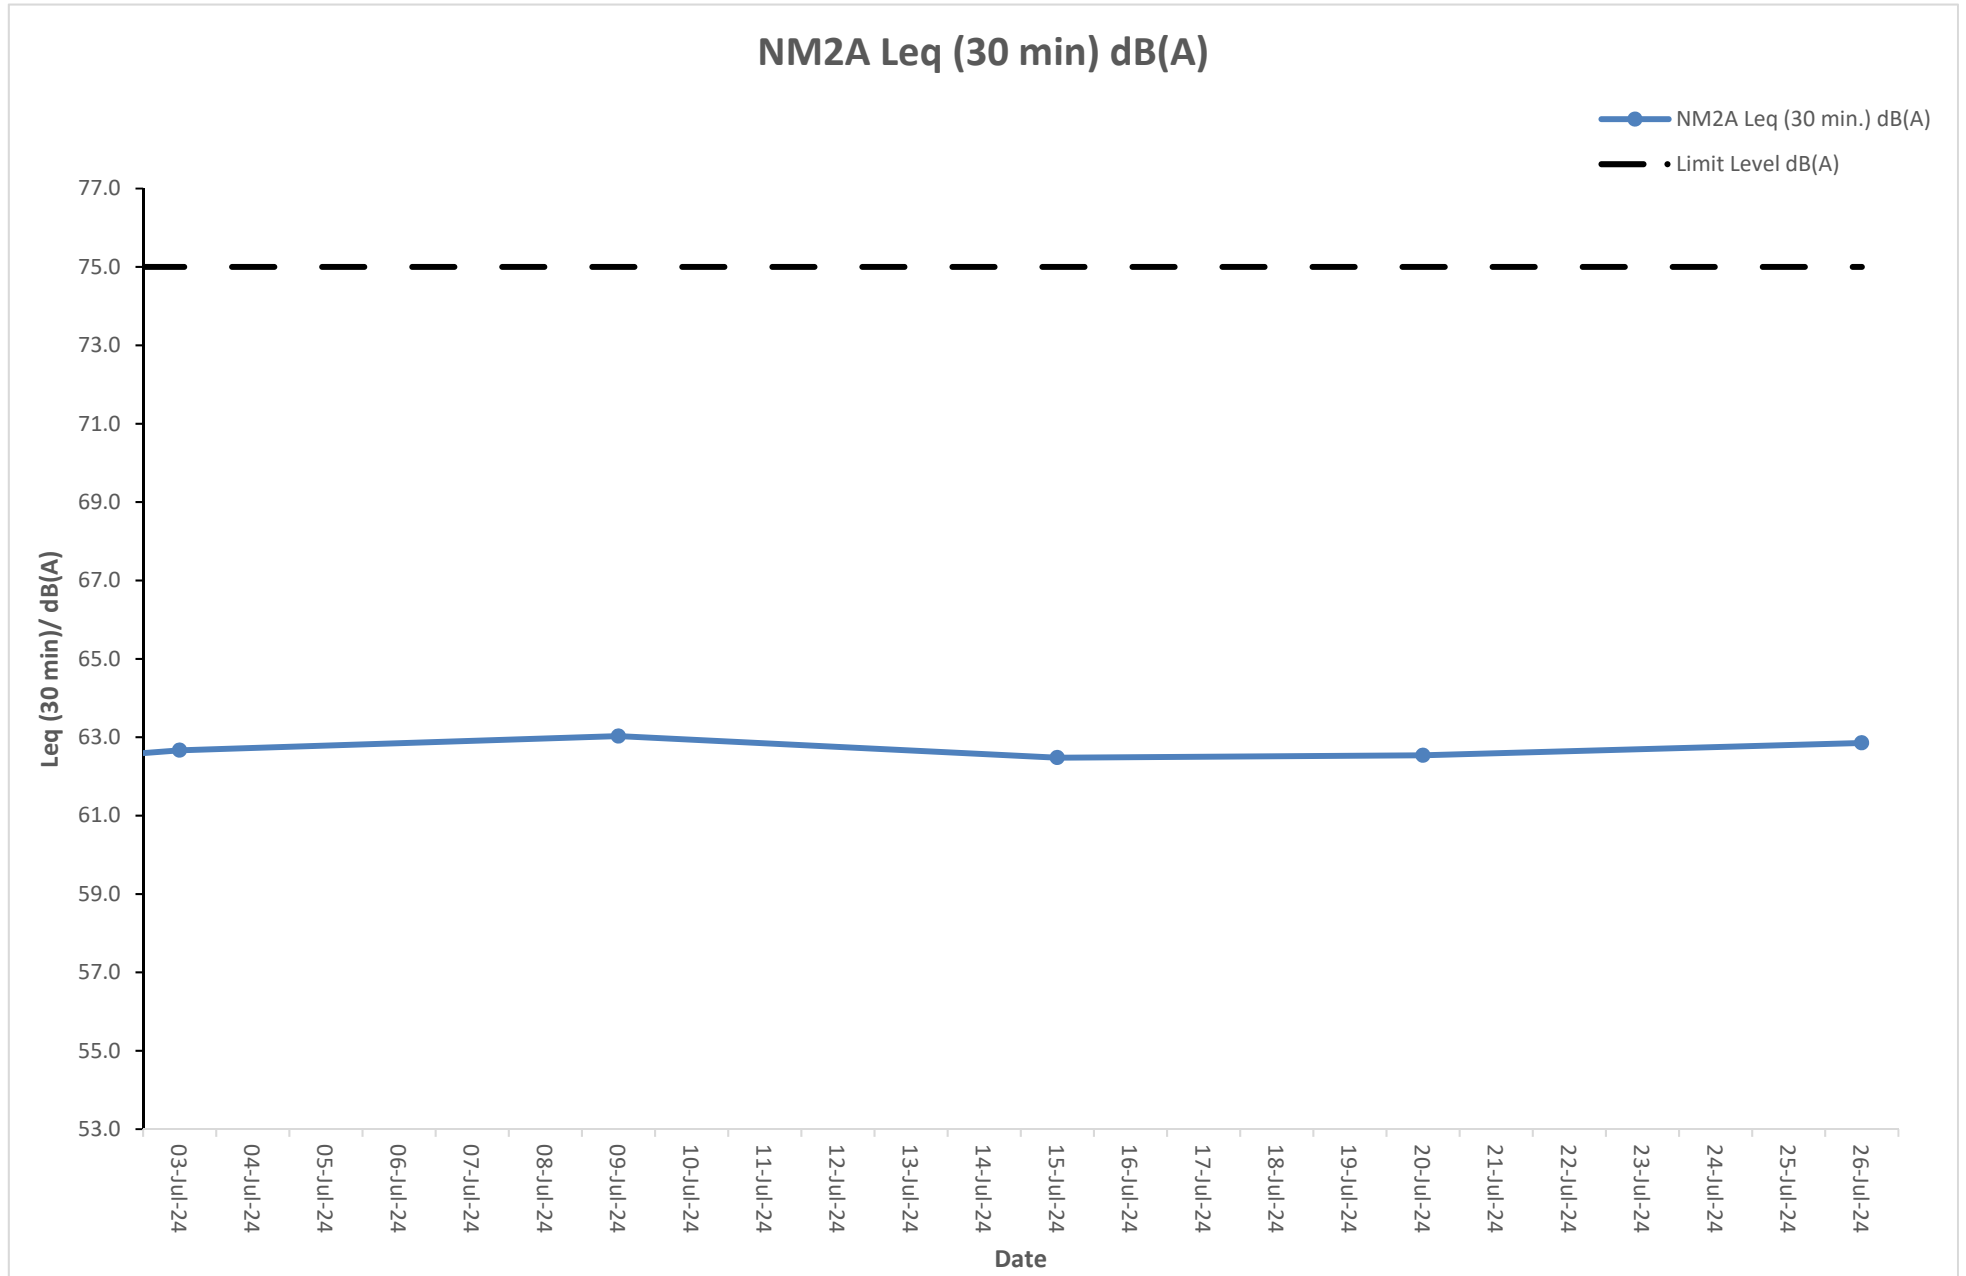
Graphical Presentation of Noise Monitoring Result at Station NM2A

Date	Time	Measured L10 dB(A)	Measured L90 dB(A)	Leq (30 min.) dB(A)
03-Jul-24	8:31	64.0	60.3	62.7
03-Jul-24	8:36	64.1	60.8	
03-Jul-24	8:41	64.4	61.4	
03-Jul-24	8:46	64.5	60.7	
03-Jul-24	8:51	64.0	61.0	
03-Jul-24	8:56	64.5	61.4	
09-Jul-24	14:35	63.9	61.6	63.0
09-Jul-24	14:40	63.7	60.6	
09-Jul-24	14:45	64.1	61.0	
09-Jul-24	14:50	63.6	60.4	
09-Jul-24	14:55	64.6	61.3	
09-Jul-24	15:00	64.9	61.3	
15-Jul-24	8:36	64.8	61.0	62.5
15-Jul-24	8:41	64.8	60.6	
15-Jul-24	8:46	64.4	61.2	
15-Jul-24	8:51	64.7	60.2	
15-Jul-24	8:56	64.8	60.2	
15-Jul-24	9:01	64.4	60.8	
20-Jul-24	14:37	64.3	60.7	62.5
20-Jul-24	14:42	64.2	61.0	
20-Jul-24	14:47	64.4	60.6	
20-Jul-24	14:52	64.3	61.4	
20-Jul-24	14:57	64.1	61.1	
20-Jul-24	15:02	65.0	60.8	
26-Jul-24	8:39	65.0	60.4	62.9
26-Jul-24	8:44	64.7	60.8	
26-Jul-24	8:49	64.4	61.0	
26-Jul-24	8:54	64.8	60.4	
26-Jul-24	8:59	64.5	60.5	
26-Jul-24	9:04	64.7	60.9

The station set-up of a façade measurement at station NM2A.

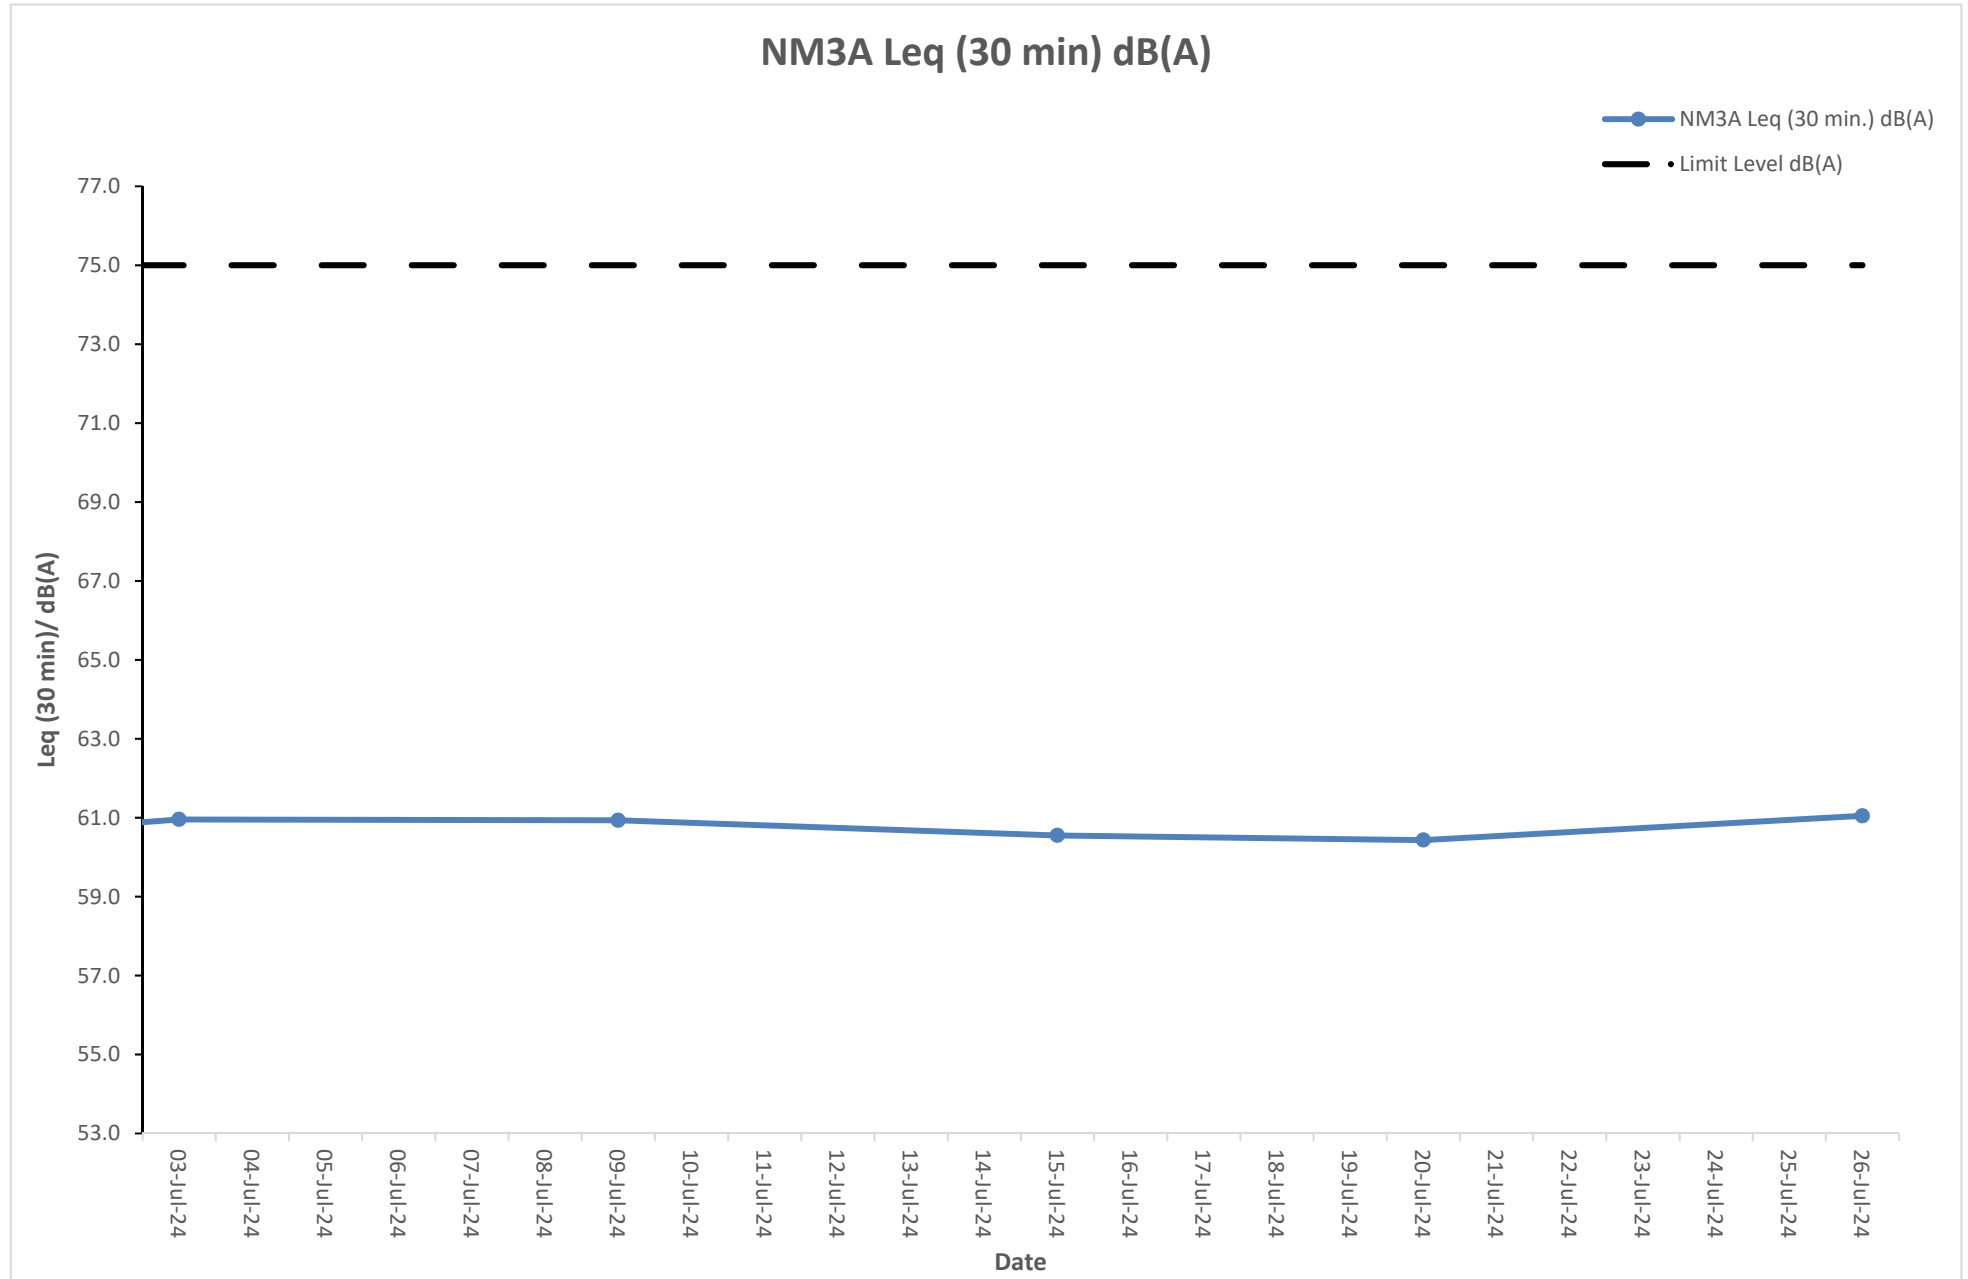
Graphical Presentation of Noise Monitoring Result at Station NM3A

Date	Time	Measured L10 dB(A)	Measured L90 dB(A)	Leq (30 min.) dB(A)
03-Jul-24	10:01	62.4	57.1	61.0
03-Jul-24	10:06	63.0	57.1	
03-Jul-24	10:11	61.9	56.8	
03-Jul-24	10:16	63.7	55.9	
03-Jul-24	10:21	63.4	57.5	
03-Jul-24	10:26	62.2	57.7	
09-Jul-24	16:08	63.6	57.8	60.9
09-Jul-24	16:13	62.1	55.9	
09-Jul-24	16:18	62.5	56.6	
09-Jul-24	16:23	63.5	56.9	
09-Jul-24	16:28	63.4	57.7	
09-Jul-24	16:33	63.5	56.2	
15-Jul-24	10:06	63.1	56.2	60.6
15-Jul-24	10:11	63.4	57.1	
15-Jul-24	10:16	62.9	57.6	
15-Jul-24	10:21	63.2	57.1	
15-Jul-24	10:26	62.5	55.9	
15-Jul-24	10:31	61.9	56.6	
20-Jul-24	16:10	63.7	56.8	60.4
20-Jul-24	16:15	63.7	57.0	
20-Jul-24	16:20	63.1	57.5	
20-Jul-24	16:25	63.4	55.9	
20-Jul-24	16:30	63.0	56.9	
20-Jul-24	16:35	62.3	57.8	
26-Jul-24	10:09	62.9	56.8	61.0
26-Jul-24	10:14	63.1	56.7	
26-Jul-24	10:19	62.7	56.8	
26-Jul-24	10:24	63.2	56.4	
26-Jul-24	10:29	63.4	57.7	
26-Jul-24	10:34	63.5	57.6

The station set-up of a façade measurement at station NM3A.

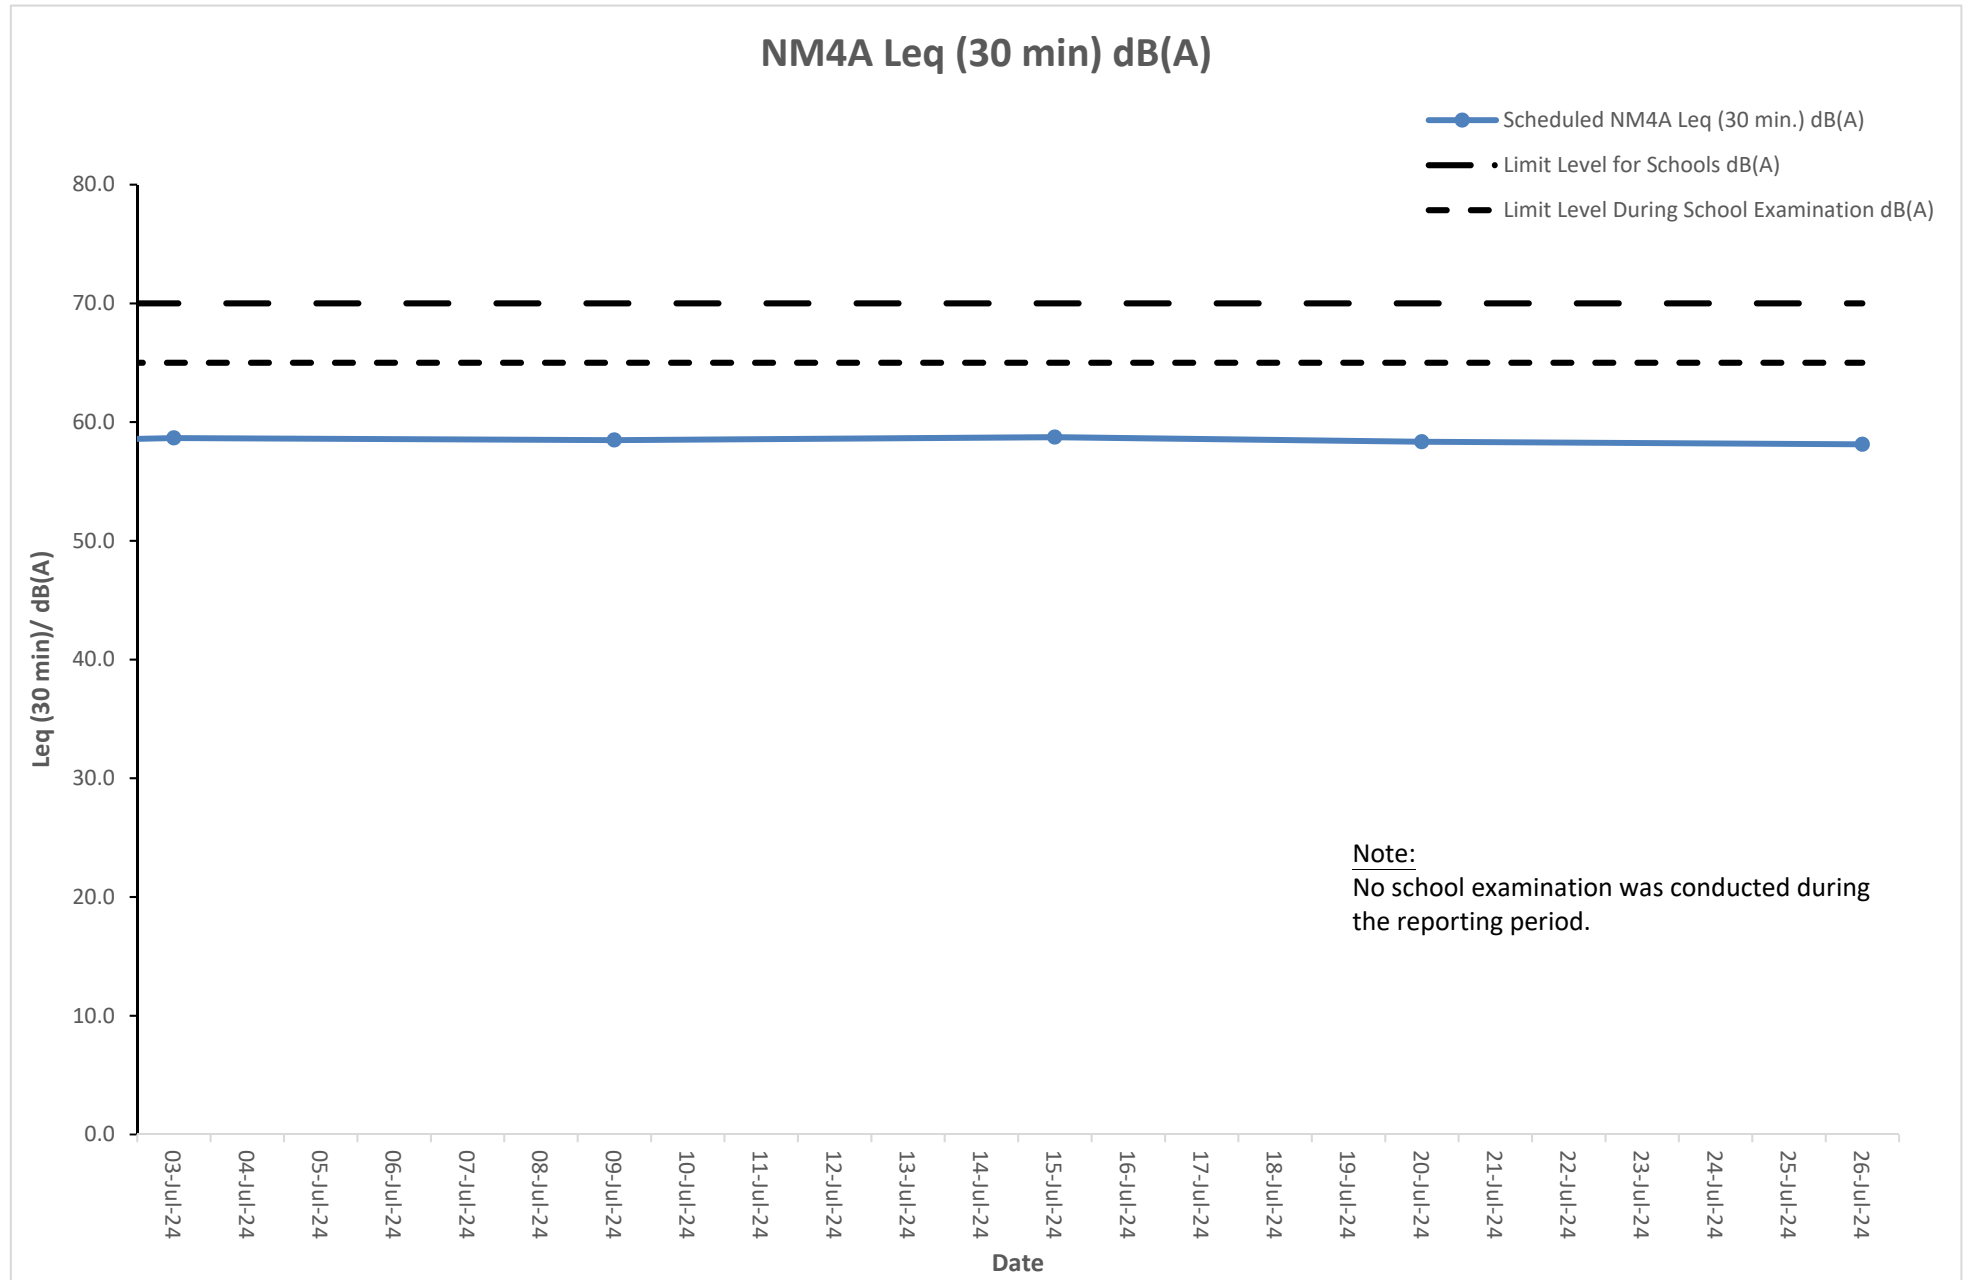
Graphical Presentation of Noise Monitoring Result at Station NM4A

Date	Time	Measured L10 dB(A)	Measured L90 dB(A)	Leq (30 min.) dB(A)
03-Jul-24	10:36	60.0	56.0	58.7
03-Jul-24	10:41	59.7	56.1	
03-Jul-24	10:46	60.3	57.1	
03-Jul-24	10:51	59.8	56.0	
03-Jul-24	10:56	59.8	55.8	
03-Jul-24	11:01	60.0	56.3	
09-Jul-24	16:43	60.4	56.3	58.5
09-Jul-24	16:48	60.0	55.9	
09-Jul-24	16:53	60.0	57.0	
09-Jul-24	16:58	60.3	56.8	
09-Jul-24	17:03	59.3	56.9	
09-Jul-24	17:08	59.9	56.1	
15-Jul-24	10:41	59.6	56.6	58.7
15-Jul-24	10:46	59.7	57.1	
15-Jul-24	10:51	60.2	56.8	
15-Jul-24	10:56	59.9	56.1	
15-Jul-24	11:01	59.3	56.1	
15-Jul-24	11:06	59.8	56.3	
20-Jul-24	16:45	60.4	55.8	58.3
20-Jul-24	16:50	60.0	56.4	
20-Jul-24	16:55	59.6	56.1	
20-Jul-24	17:00	60.6	55.9	
20-Jul-24	17:05	59.4	56.2	
20-Jul-24	17:10	60.3	56.1	
26-Jul-24	10:44	59.3	56.8	58.1
26-Jul-24	10:49	60.6	56.6	
26-Jul-24	10:54	60.6	56.8	
26-Jul-24	10:59	59.7	56.6	
26-Jul-24	11:04	59.4	56.5	
26-Jul-24	11:09	60.5	57.1

The station set-up of a façade measurement at station NM4A.

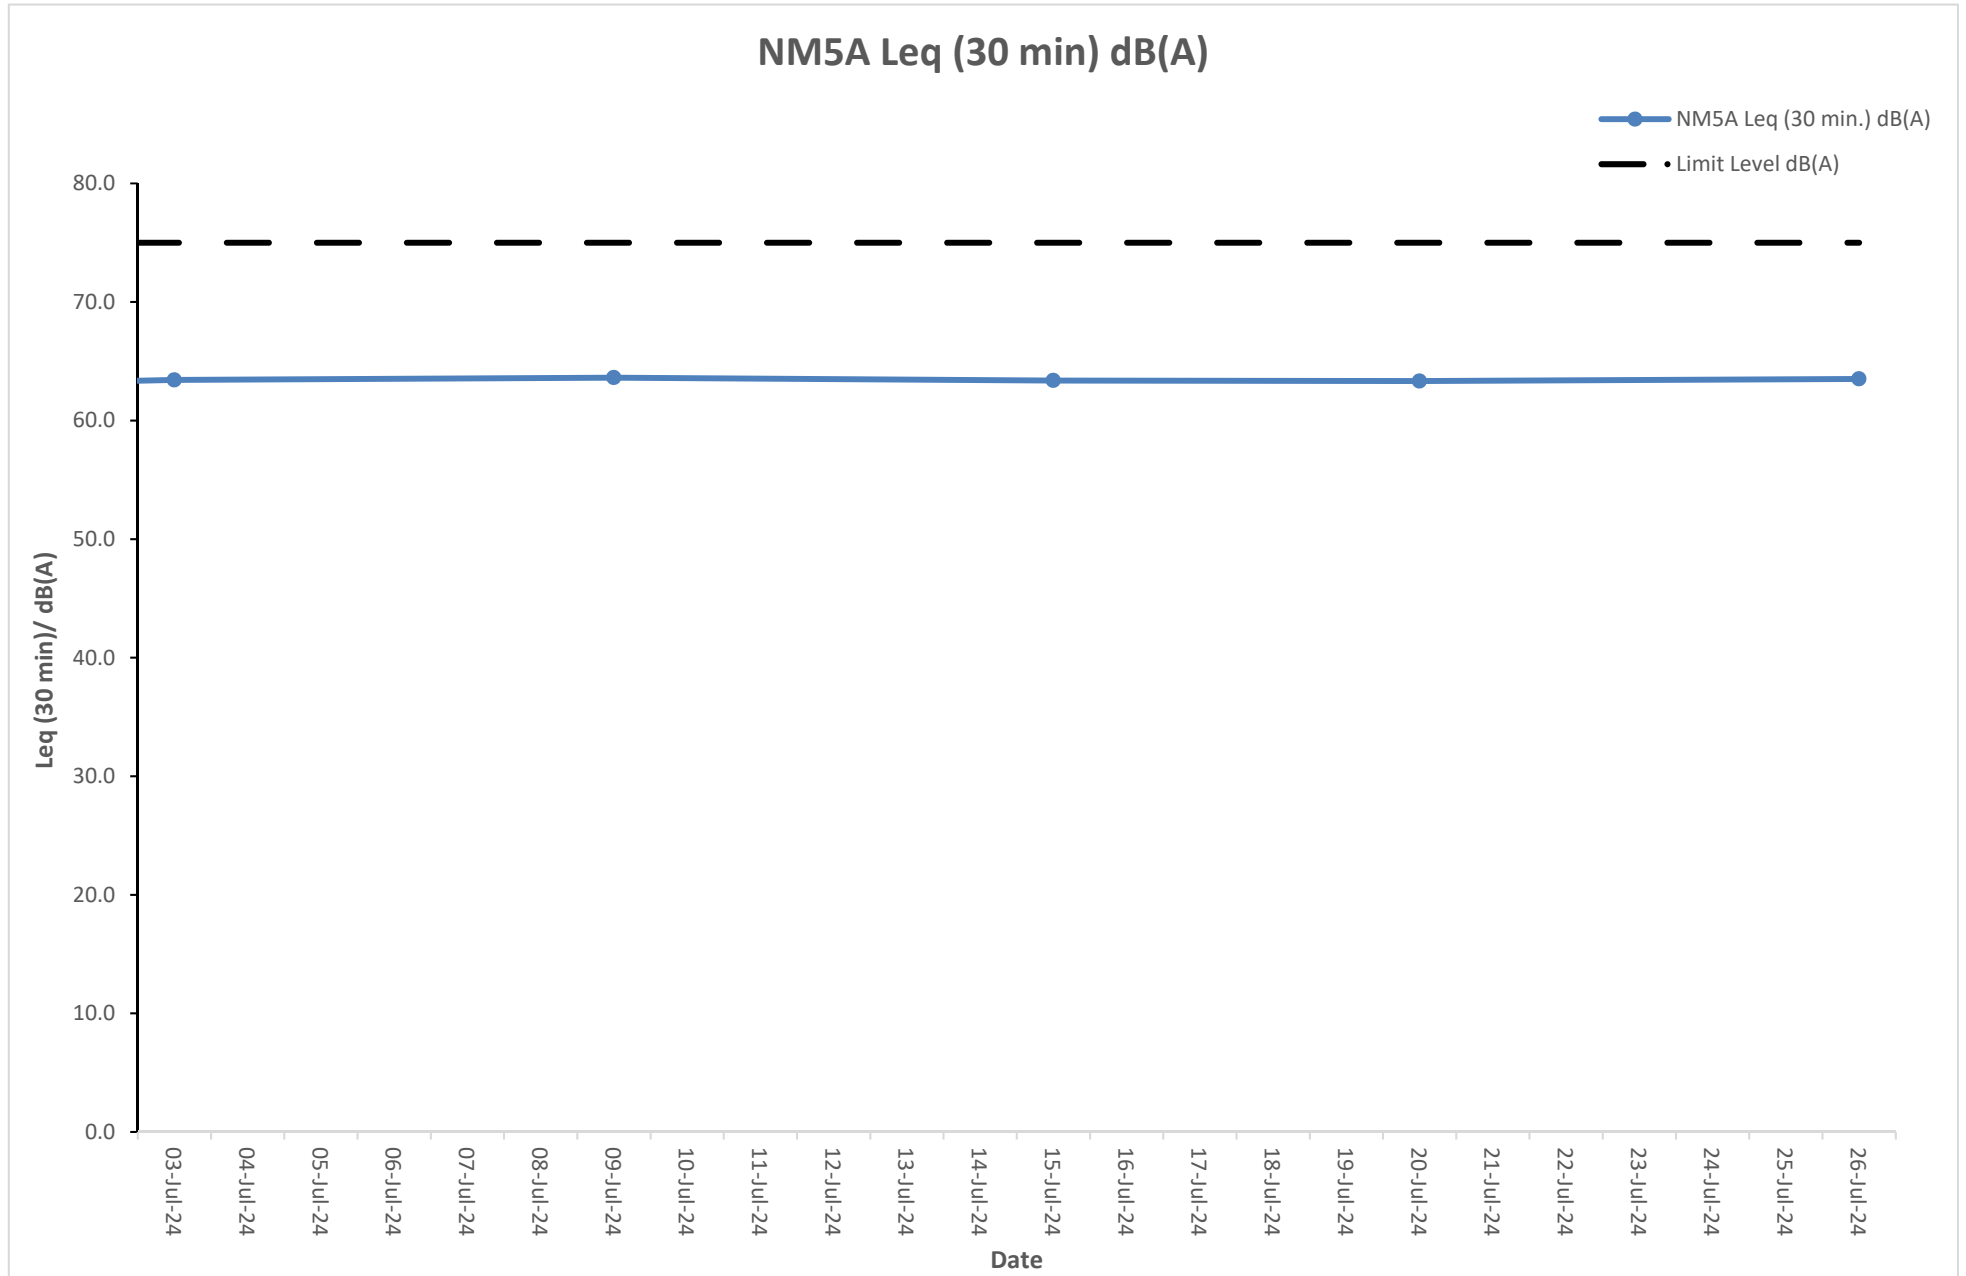
Graphical Presentation of Noise Monitoring Result at Station NM5A

Date	Time	Measured L10 dB(A)	Measured L90 dB(A)	Leq (30 min.) dB(A)	Leq (30 min.) +3 dB(A)
03-Jul-24	9:21	61.7	58.6	60.4	63.4
03-Jul-24	9:26	61.4	58.0		
03-Jul-24	9:31	62.1	58.7		
03-Jul-24	9:36	62.6	58.0		
03-Jul-24	9:41	62.2	58.8		
03-Jul-24	9:46	61.6	57.6		
09-Jul-24	15:27	61.8	57.7	60.6	63.6
09-Jul-24	15:32	62.8	59.1		
09-Jul-24	15:37	62.7	58.3		
09-Jul-24	15:42	61.4	59.0		
09-Jul-24	15:47	62.0	59.3		
09-Jul-24	15:52	62.5	59.1	60.4	63.4
15-Jul-24	9:26	61.5	58.3		
15-Jul-24	9:31	62.3	57.7		
15-Jul-24	9:36	61.4	59.0		
15-Jul-24	9:41	62.3	58.0		
15-Jul-24	9:46	62.5	57.9		
15-Jul-24	9:51	62.0	57.9	60.3	63.3
20-Jul-24	15:29	62.1	57.6		
20-Jul-24	15:34	61.8	58.3		
20-Jul-24	15:39	62.3	57.8		
20-Jul-24	15:44	62.7	59.2		
20-Jul-24	15:49	62.2	58.8		
20-Jul-24	15:54	62.3	58.9	60.5	63.5
26-Jul-24	9:29	62.3	58.3		
26-Jul-24	9:34	62.1	57.8		
26-Jul-24	9:39	62.3	59.0		
26-Jul-24	9:44	62.2	59.1		
26-Jul-24	9:49	62.2	58.2		
26-Jul-24	9:54	62.2	59.0

The station set-up of a free-field measurement at station NM5A.
