Development at West Kowloon Cultural District

Monthly Environmental Monitoring and Audit (EM&A) Report for August 2024

12 September 2024

Part-1: EM&A at Lyric Theatre Complex

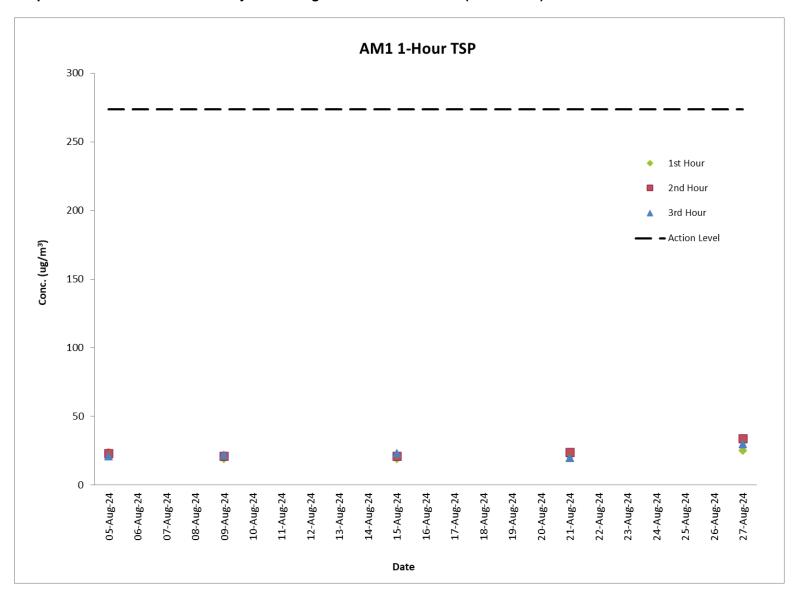
Graphical Presentation of Air Quality Monitoring Result at Station AM1 (1-hour TSP)

Weather		Conc. (µg/m³)			Action Level	Limit Level
Date	Condition	Time	1 st Hour	2 nd Hour	3 rd Hour	(μg/m³)	(μg/m³)
5-Aug-24	Sunny	8:24 - 11:24	24	23	21	273.7	500
9-Aug-24	Sunny	8:28 - 11:28	19	21	22	273.7	500
15-Aug-24	Fine	8:24 - 11:24	19	21	23	273.7	500
21-Aug-24	Cloudy	8:28 - 11:28	21	24	20	273.7	500
27-Aug-24	Fine	8:28 - 11:28	25	34	30	273.7	500

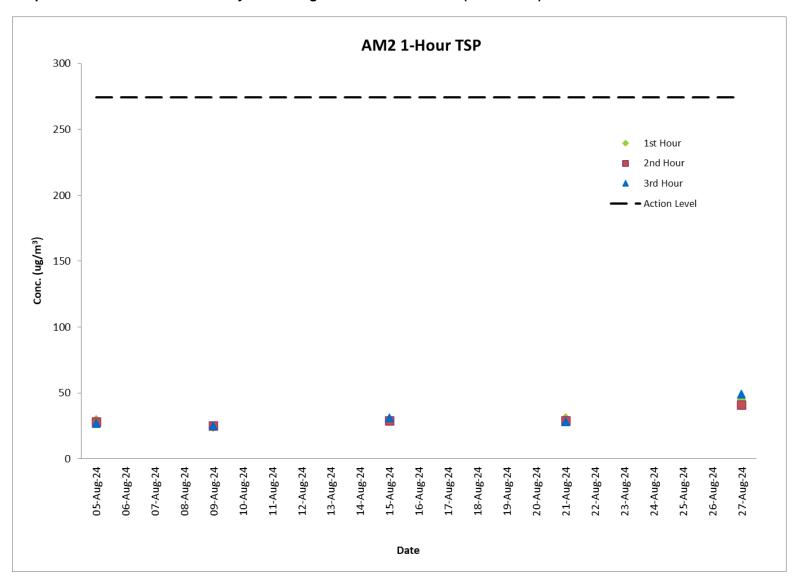
Graphical Presentation of Air Quality Monitoring Result at Station AM2 (1-hour TSP)

Weather			Conc. (µg/m³))	Action Level	Limit Level
Date	Condition	Time	1 st Hour	2 nd Hour	3 rd Hour	(μg/m³)	(μg/m³)
5-Aug-24	Sunny	8:39 - 11:39	30	28	27	274.2	500
9-Aug-24	Sunny	8:43 - 11:43	24	25	25	274.2	500
15-Aug-24	Fine	8:39 - 11:39	28	29	31	274.2	500
21-Aug-24	Cloudy	8:42 - 11:42	31	29	28	274.2	500
27-Aug-24	Fine	8:43 - 11:43	45	41	49	274.2	500

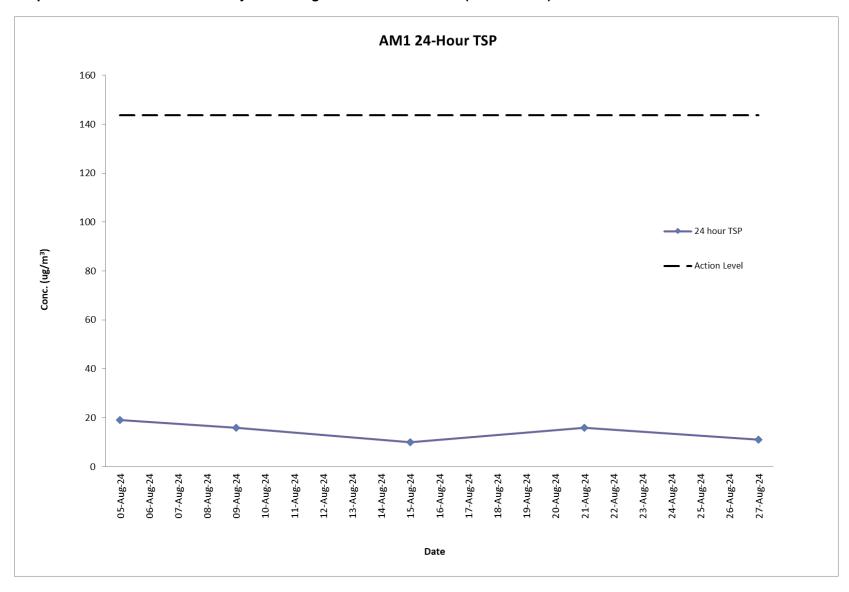
Graphical Presentation of Air Quality Monitoring Result at Station AM1 (24-hour TSP)

Sta	rt	Finis	sh	Filter W	eight (g)		d Time ding	Sampling	Flow	Rate (m³/mir	1)	Conc.	Weather	Action	Limit
Date	Time	Date	Time	Initial	Final	Initial	Final	Time (hrs)	Initial	Final	Average	(µg/m ³)	Condition	Level	Level
5-Aug-24	8:21	6-Aug-24	8:21	2.7989	2.8337	28468.38	28492.38	24	1.27	1.27	1.27	19	Sunny	143.6	260
9-Aug-24	8:25	10-Aug-24	8:25	2.8004	2.8290	28492.38	28516.38	24	1.27	1.27	1.27	16	Sunny	143.6	260
15-Aug-24	8:21	16-Aug-24	8:21	2.8066	2.8240	28516.38	28540.38	24	1.27	1.27	1.27	10	Fine	143.6	260
21-Aug-24	8:25	22-Aug-24	8:25	2.8059	2.8353	28540.38	28564.38	24	1.27	1.27	1.27	16	Cloudy	143.6	260
27-Aug-24	8:25	28-Aug-24	8:25	2.8045	2.8252	28564.38	28588.38	24	1.27	1.27	1.27	11	Fine	143.6	260

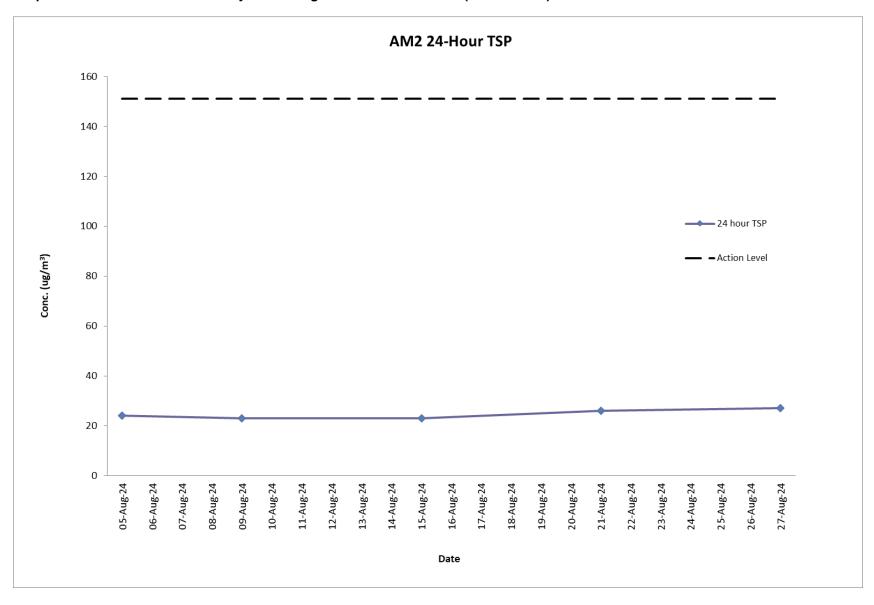
Graphical Presentation of Air Quality Monitoring Result at Station AM2 (24-hour TSP)

Sta	rt	Finis	sh	Sampling	Conc.	Weather	Action	
Date	Time	Date	Time	Time (hrs)	(µg/m³)	Condition	Level	Limit Level
5-Aug-24	8:36	6-Aug-24	8:36	24	24	Sunny	151.1	260
9-Aug-24	8:40	10-Aug-24	8:40	24	23	Sunny	151.1	260
15-Aug-24	8:36	16-Aug-24	8:36	24	23	Fine	151.1	260
21-Aug-24	8:40	22-Aug-24	8:40	24	26	Cloudy	151.1	260
27-Aug-24	8:40	28-Aug-24	8:40	24	27	Fine	151.1	260

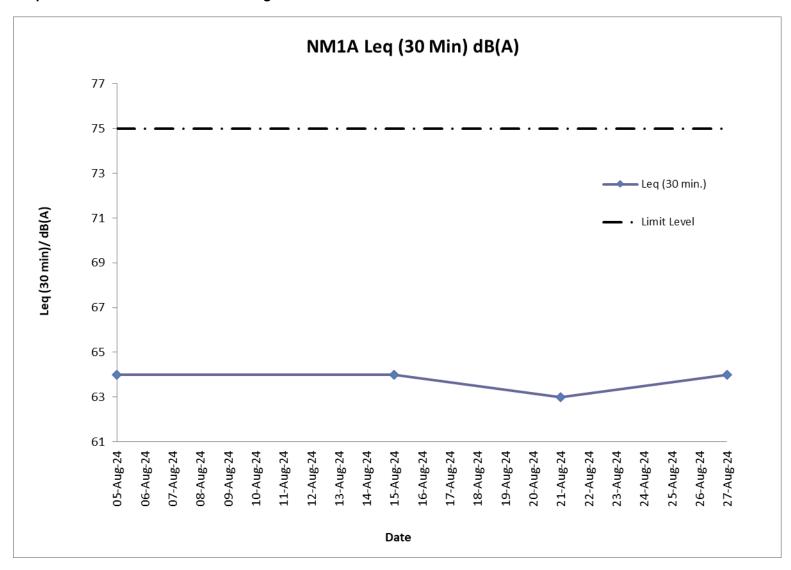
The station set-up of a free-field measurement at Station NM1A.

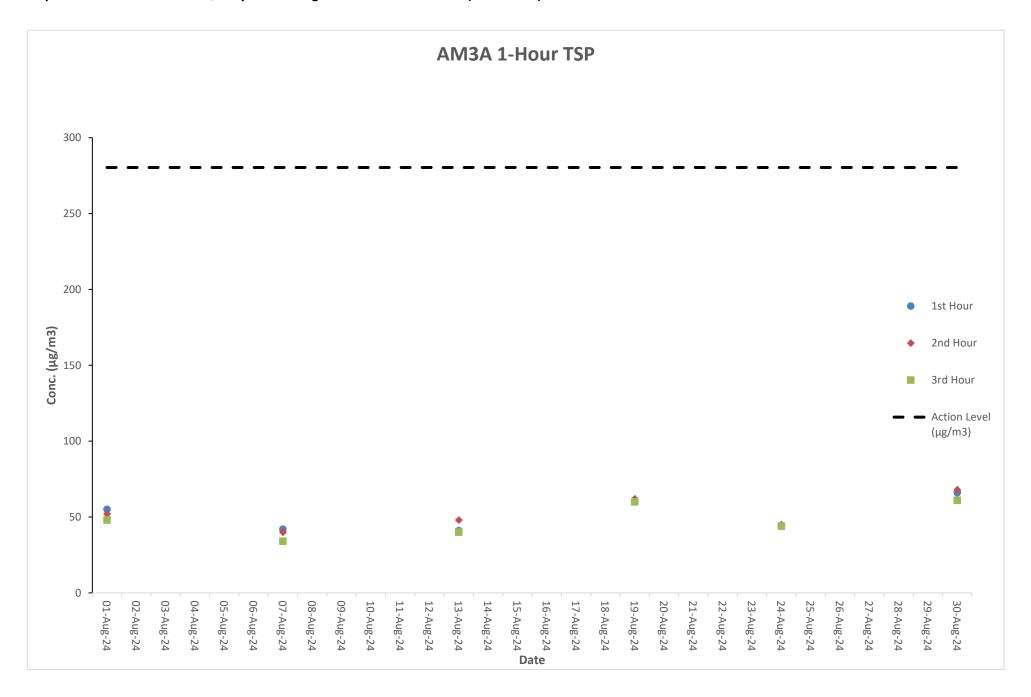
Air Quality Monitoring Result at Station AM3A (1-hour TSP)

Date	Weather	Time		C	onc. (µg/m3	Action	Limit	
Date	Condition	Start	Finish	1st Hour	2nd Hour	3rd Hour	Level	Level
01-Aug-24	Cloudy	14:04	17:04	55	52	48	280.4	500
07-Aug-24	Fine	08:09	11:09	42	40	34	280.4	500
13-Aug-24	Cloudy	14:05	17:05	41	48	40	280.4	500
19-Aug-24	Cloudy	08:01	11:01	60	62	60	280.4	500
24-Aug-24	Fine	14:00	17:00	44	45	44	280.4	500
30-Aug-24	Fine	08:09	11:09	66	68	61	280.4	500

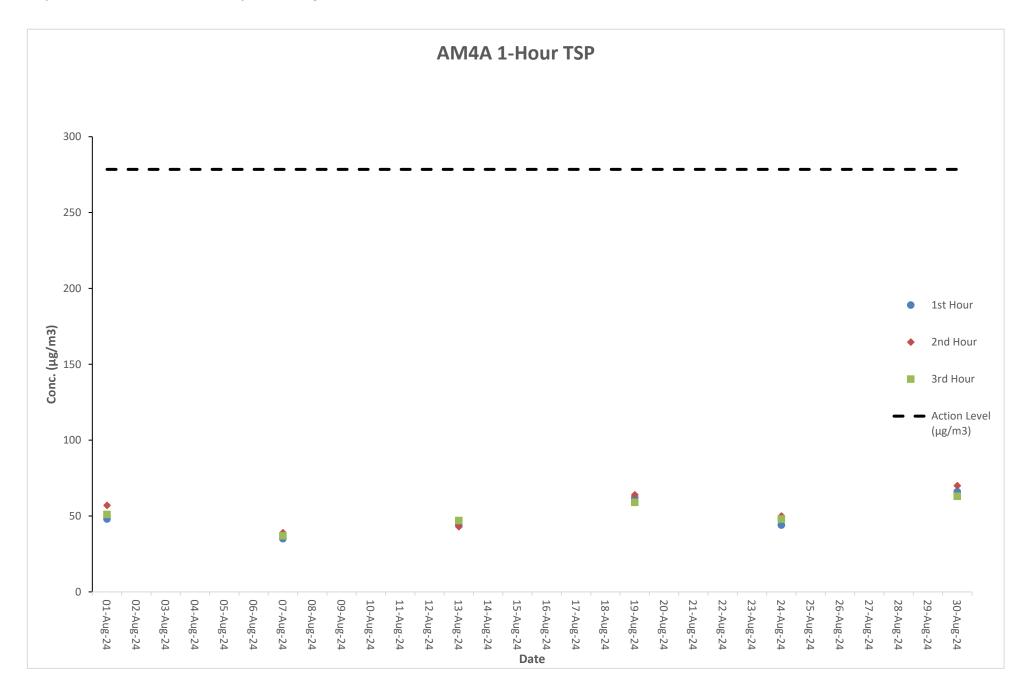
Air Quality Monitoring Result at Station AM4A (1-hour TSP)

Date	Weather	Tir	Time		onc. (µg/m3	Action	Limit	
Date	Condition	Start	Finish	1st Hour	2nd Hour	3rd Hour	Level	Level
01-Aug-24	Cloudy	14:12	17:12	48	57	51	278.5	500
07-Aug-24	Fine	08:17	11:17	35	39	37	278.5	500
13-Aug-24	Cloudy	14:13	17:13	44	43	47	278.5	500
19-Aug-24	Cloudy	08:09	11:09	62	64	59	278.5	500
24-Aug-24	Fine	14:08	17:08	44	50	48	278.5	500
30-Aug-24	Fine	08:17	11:17	66	70	63	278.5	500

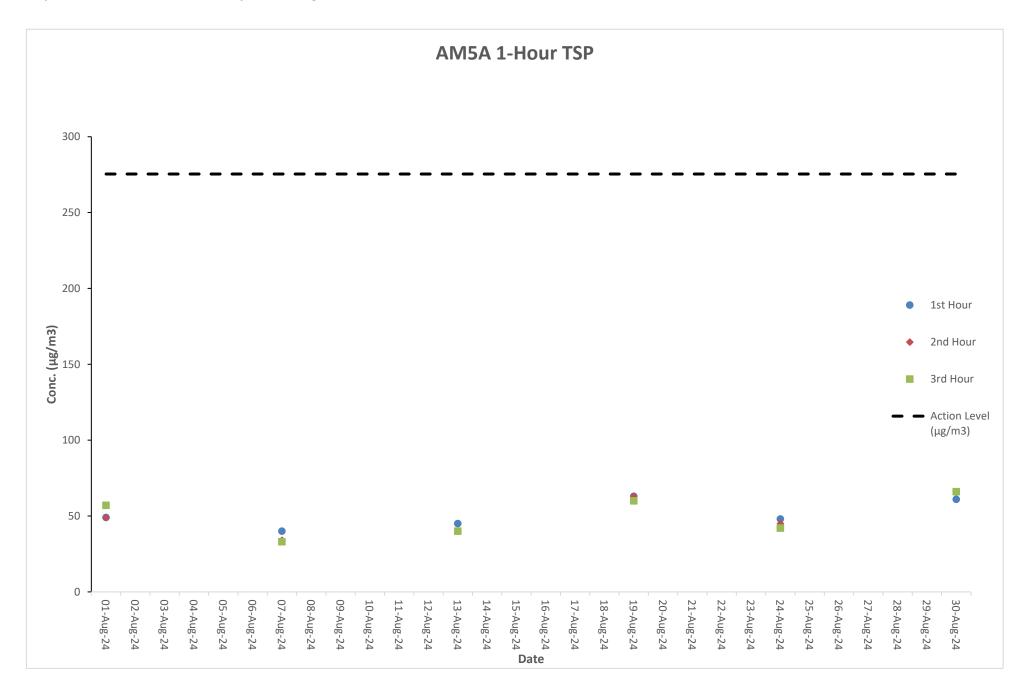
Air Quality Monitoring Result at Station AM5A (1-hour TSP)

Date	Weather	Time		C	onc. (µg/m3	Action	Limit	
Date	Condition	Start	Finish	1st Hour	2nd Hour	3rd Hour	Level	Level
01-Aug-24	Cloudy	14:27	17:27	49	49	57	275.4	500
07-Aug-24	Fine	08:34	11:34	40	34	33	275.4	500
13-Aug-24	Cloudy	14:28	17:28	45	40	40	275.4	500
19-Aug-24	Cloudy	08:26	11:26	63	63	60	275.4	500
24-Aug-24	Fine	14:23	17:23	48	45	42	275.4	500
30-Aug-24	Fine	08:34	11:34	61	66	66	275.4	500

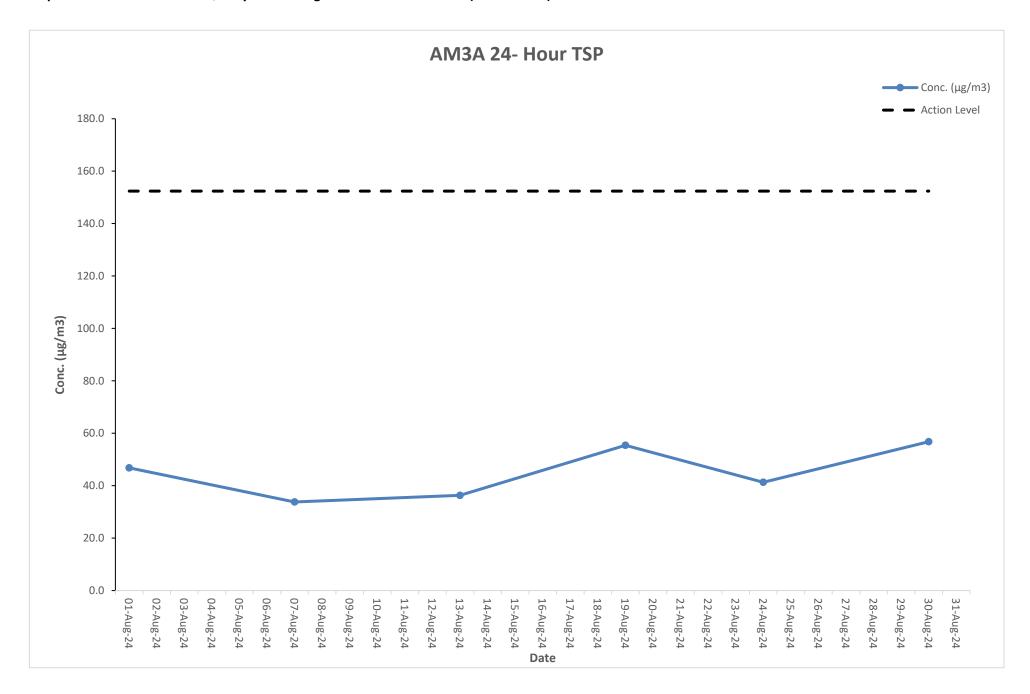
Air Quality Monitoring Result at Station AM3A (24-hour TSP)

21				=::. \	Elapsed Time				5	3,					
Star		Finis		Filter W			ding .	Sampling		v Rate (n	· · ·	Conc.	Weather	Action	Limit
Date	Time	Date	Time	Initial	Final	Initial	Final	Time (hrs)	Initial	Final	Average	(µg/m3)	Condition	Level	Level
01-Aug-24	10:00AM	02-Aug-24	10:00AM	2.8065	2.8819	7096.8	7120.8	24	1.12	1.12	1.12	46.8	Rainy	152.4	260
07-Aug-24	10:00AM	08-Aug-24	10:00AM	2.8026	2.8569	7120.8	7144.8	24	1.12	1.12	1.12	33.8	Cloudy	152.4	260
13-Aug-24	10:00AM	14-Aug-24	10:00AM	2.8022	2.8605	7144.8	7168.8	24	1.12	1.12	1.12	36.3	Rainy	152.4	260
19-Aug-24	10:00AM	20-Aug-24	10:00AM	2.8059	2.8952	7168.8	7192.8	24	1.12	1.12	1.12	55.4	Rainy	152.4	260
24-Aug-24	10:00AM	25-Aug-24	10:00AM	2.8045	2.8709	7192.8	7216.8	24	1.12	1.12	1.12	41.3	Sunny	152.4	260
30-Aug-24	10:00AM	31-Aug-24	10:00AM	2.8033	2.8946	7216.8	7240.8	24	1.12	1.12	1.12	56.8	Rainy	152.4	260

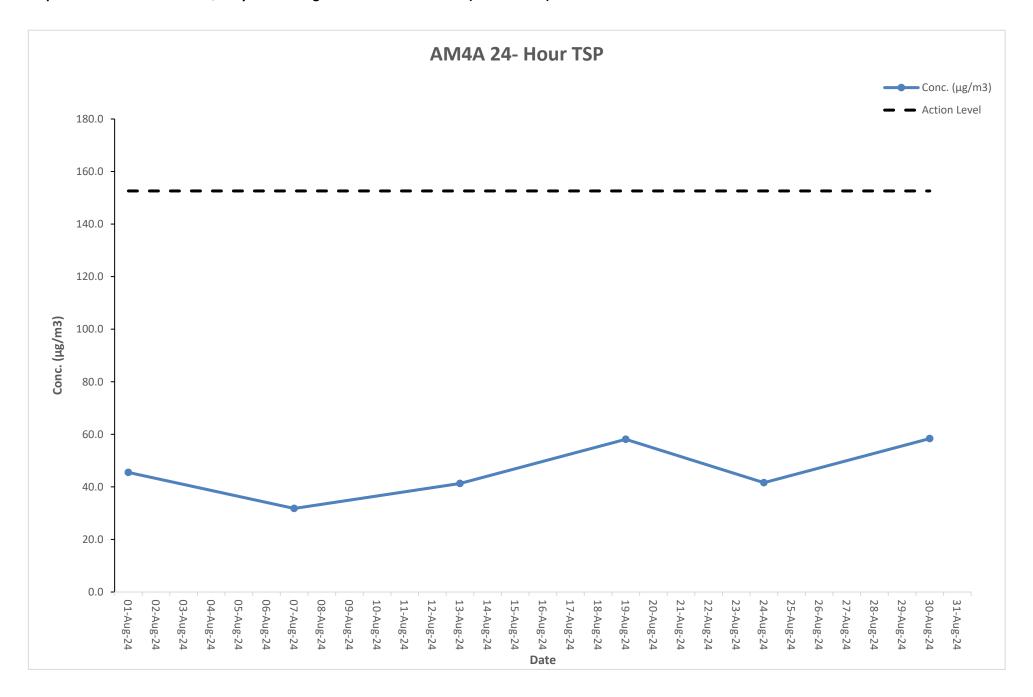
Air Quality Monitoring Result at Station AM4A (24-hour TSP)

Star	rt	Finis	h	Filter W	eight (g)		d Time ding	Sampling	Flov	v Rate (n	n ³ /min)	Conc.	Weather	Action	Limit
Date	Time	Date	Time	Initial	Final	Initial	Final	Time (hrs)	Initial	Final	Average	(µg/m3)	Condition	Level	Level
01-Aug-24	10:00AM	02-Aug-24	10:00AM	2.8057	2.8789	7516.4	7540.4	24	1.12	1.12	1.12	45.5	Rainy	152.6	260
07-Aug-24	10:00AM	08-Aug-24	10:00AM	2.8026	2.8537	7540.4	7564.4	24	1.12	1.12	1.12	31.8	Cloudy	152.6	260
13-Aug-24	10:00AM	14-Aug-24	10:00AM	2.8081	2.8745	7564.4	7588.4	24	1.12	1.12	1.12	41.3	Rainy	152.6	260
19-Aug-24	10:00AM	20-Aug-24	10:00AM	2.8063	2.8997	7588.4	7612.4	24	1.12	1.12	1.12	58.1	Rainy	152.6	260
24-Aug-24	10:00AM	25-Aug-24	10:00AM	2.8040	2.8709	7612.4	7636.4	24	1.12	1.12	1.12	41.6	Sunny	152.6	260
30-Aug-24	10:00AM	31-Aug-24	10:00AM	2.8079	2.9019	7636.4	7660.4	24	1.12	1.12	1.12	58.4	Rainy	152.6	260

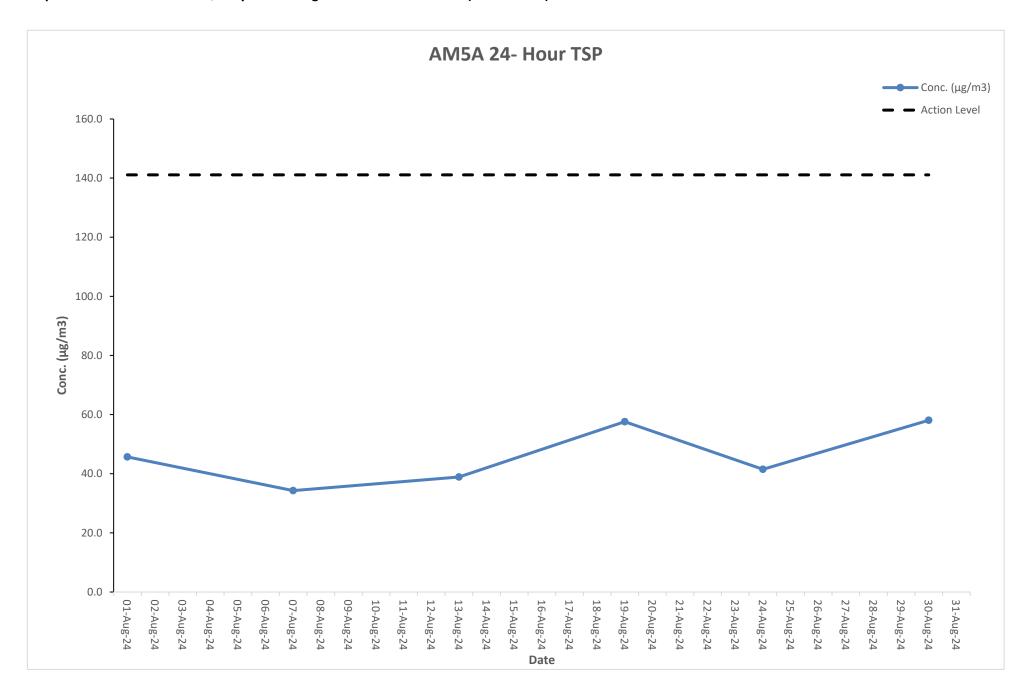
Air Quality Monitoring Result at Station AM5A (24-hour TSP)

Star	rt	Finis	sh	Filter W	eight (g)		d Time ding	Sampling	Flov	v Rate (n	n³/min)	Conc.	Weather	Action	Limit
Date	Time	Date	Time	Initial	Final	Initial	Final	Time (hrs)	Initial	Final	Average	(µg/m3)	Condition	Level	Level
01-Aug-24	10:00AM	02-Aug-24	10:00AM	2.8012	2.8748	7654.6	7678.6	24	1.12	1.12	1.12	45.7	Rainy	141.1	260
07-Aug-24	10:00AM	08-Aug-24	10:00AM	2.8086	2.8639	7678.6	7702.6	24	1.12	1.12	1.12	34.3	Cloudy	141.1	260
13-Aug-24	10:00AM	14-Aug-24	10:00AM	2.8068	2.8694	7702.6	7726.6	24	1.12	1.12	1.12	38.9	Rainy	141.1	260
19-Aug-24	10:00AM	20-Aug-24	10:00AM	2.8068	2.8996	7726.6	7750.6	24	1.12	1.12	1.12	57.6	Rainy	141.1	260
24-Aug-24	10:00AM	25-Aug-24	10:00AM	2.8018	2.8686	7750.6	7774.6	24	1.12	1.12	1.12	41.5	Sunny	141.1	260
30-Aug-24	10:00AM	31-Aug-24	10:00AM	2.8015	2.8950	7774.6	7798.6	24	1.12	1.12	1.12	58.1	Rainy	141.1	260

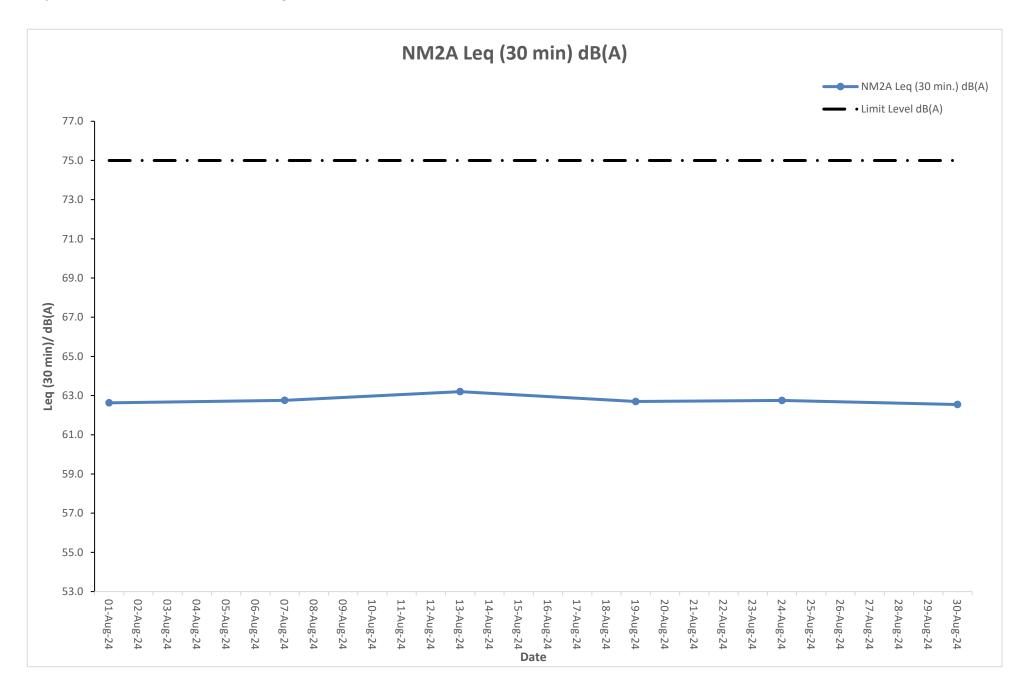
The station set-up of a façade measurement at station NM2A.

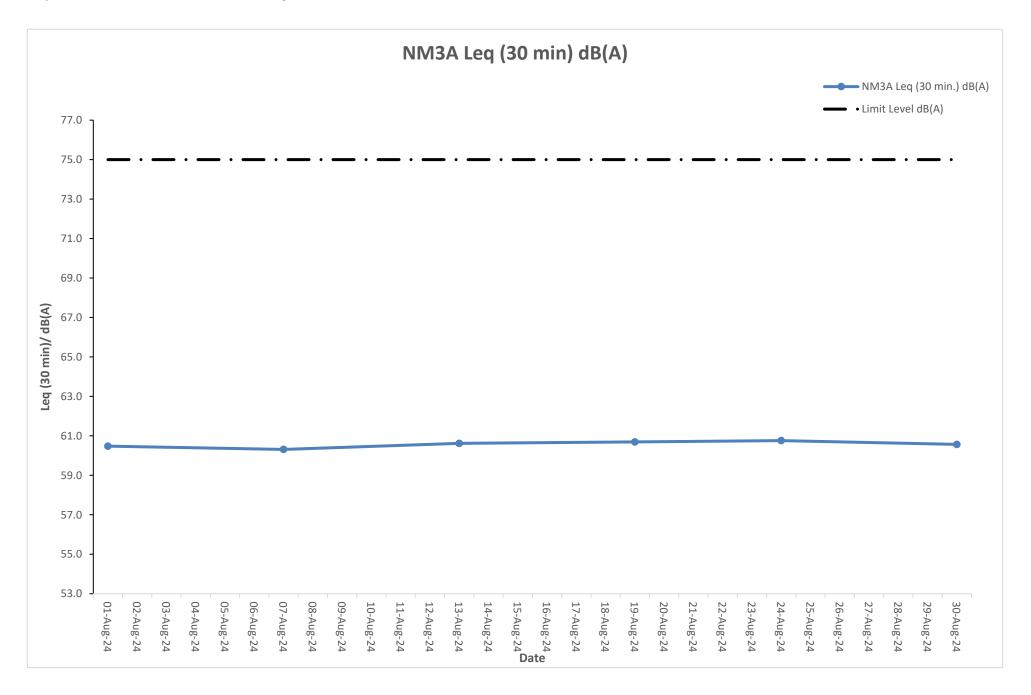
The station set-up of a façade measurement at station NM3A.

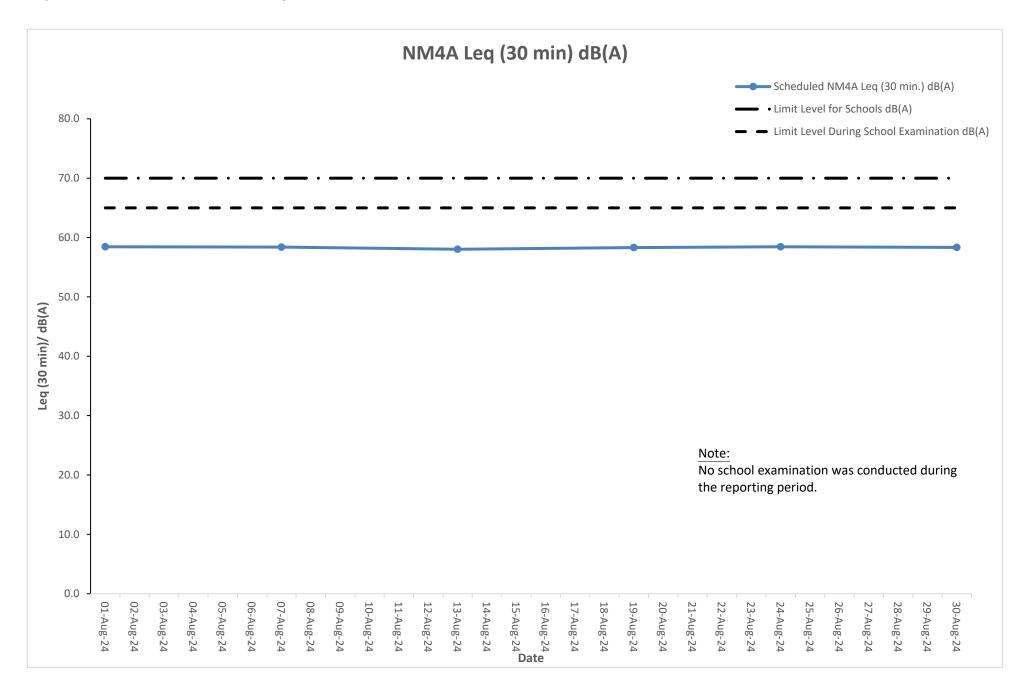
The station set-up of a façade measurement at station NM4A.

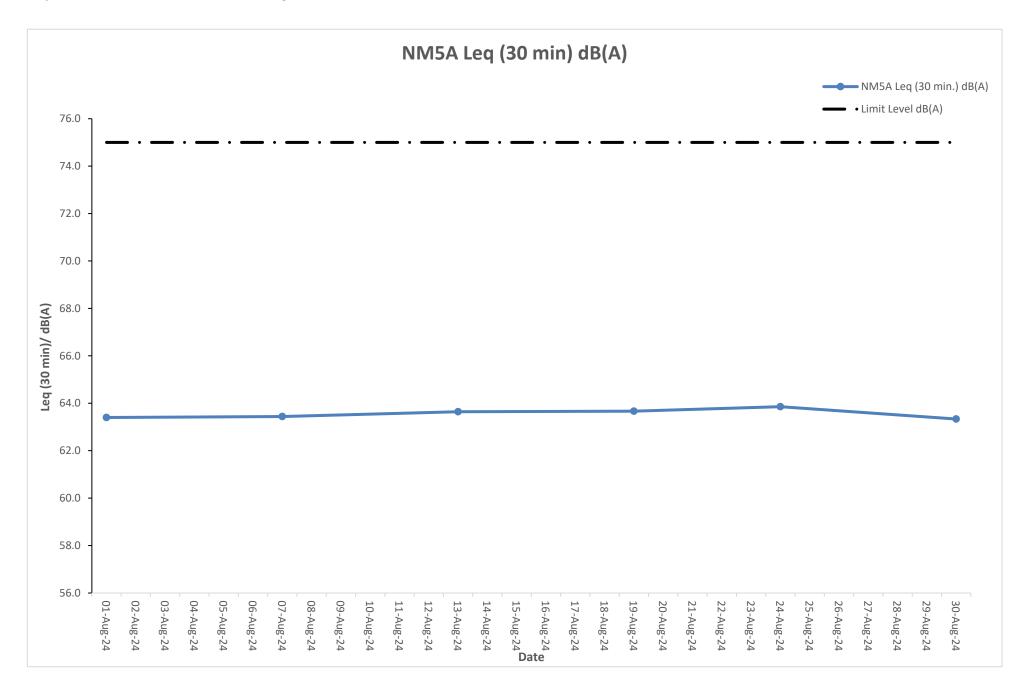
The station set-up of a free-field measurement at station NM5A.
