South Island Line (East)

Monitoring on the Implementation of
Ecological Planting & Landscape Plan
during 3-year Post-Planting Care and Maintenance Period

(January 2016 – December 2018)

Final Monitoring Report

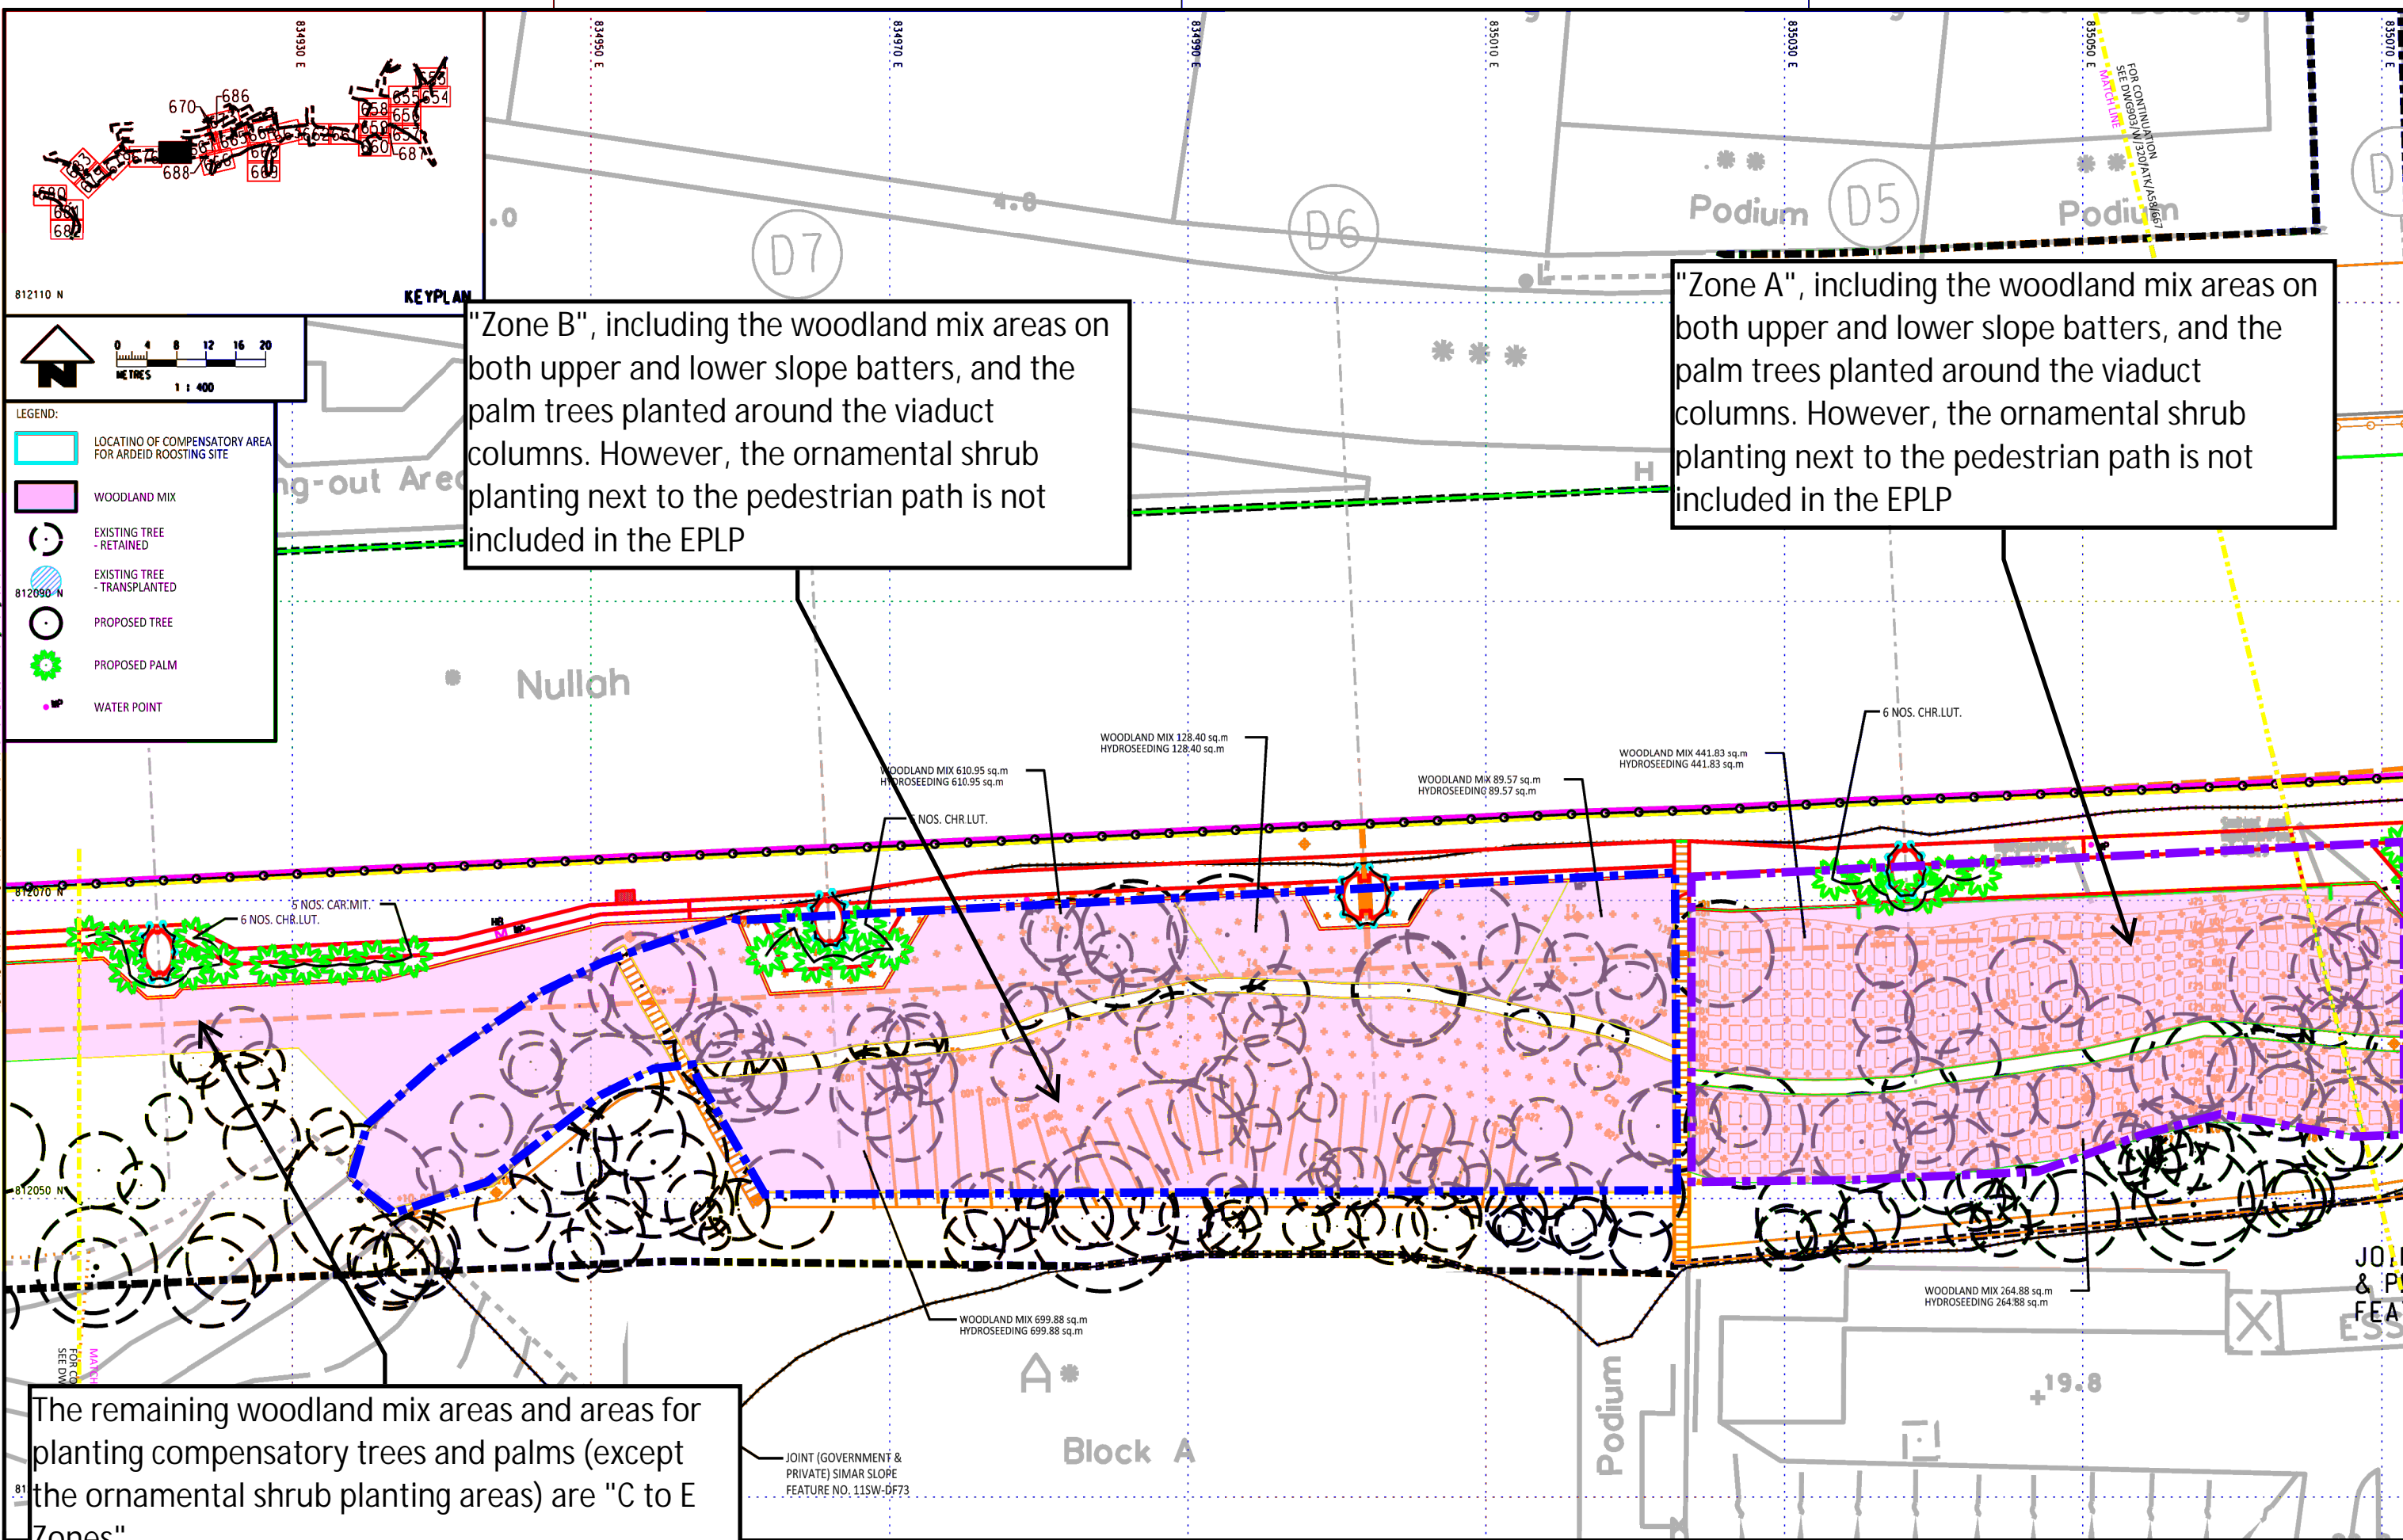
Figure 1

Planting areas and landscape treatment works along Wong Chuk Hang Nullah (Figures 1b-1e extracted from the approved EPLP)

"Zone B", including the woodland mix areas on both upper and lower slope batters, and the palm trees planted around the viaduct columns. However, the ornamental shrub planting next to the pedestrian path is not included in the EPLP

"Zone A", including the woodland mix areas on both upper and lower slope batters, and the palm trees planted around the viaduct columns. However, the ornamental shrub planting next to the pedestrian path is not included in the EPLP

- 2.1.3 The habitat enhancement area (from Zones A to E except compensatory planting area as shown in **Figure 1**) was proposed on the south side of WCH Nullah for ecological compensation and enhancing the amenity values along the pedestrian link and the woodland mix on the slopes by the nullah side. This area comprises woodland mix areas (planted with native whip trees and shrub seedlings, together with hydroseeding within this woodland mix), purely hydroseeded area on the slopes, hydromulched area with erosion control mat, undisturbed areas with preserved vegetation on the slopes, and planting areas of native trees and palms. Grasses used in the hydroseeded and hydromulched areas are common grass species (such as Bermuda Grass *Cynodon dactylon*) following the CEDD's *General Specification For Civil Engineering Works*. The native whip trees, shrub seedlings, trees and palms proposed in the approved EPLP are summarised in **Table 1** below. However, planting of ornamental shrubs (including but not limited to *Allamanda cathartica*, *Alpinia zerumbet* cv. 'Variegata', *Ixora chinensis*, *Monstera deliciosa*, *Philodendron selloum* and *Schefflera arboricola*) along the planting beds to the south of the Nullah is not under the monitoring and management regime of the approved EPLP. Such shrub planting has been carried out for amenity purposes only.

- 2.1.5 Compensatory planting area was proposed at the lower course of the WCH Nullah, approximately 200m to the west of the historical ardeid night roosting site identified in the EIA Report of SIL(E). This area is designed with reference to the plant composition of the historical ardeid roosting site to the south of the Nullah, as well as the plant species often used by ardeids for roosting. Compensatory trees of common tree species, as shown in the below **Table 2**, were planted in staggered pattern within the compensatory area for ardeid roosting site (location shown in **Figure 1**).

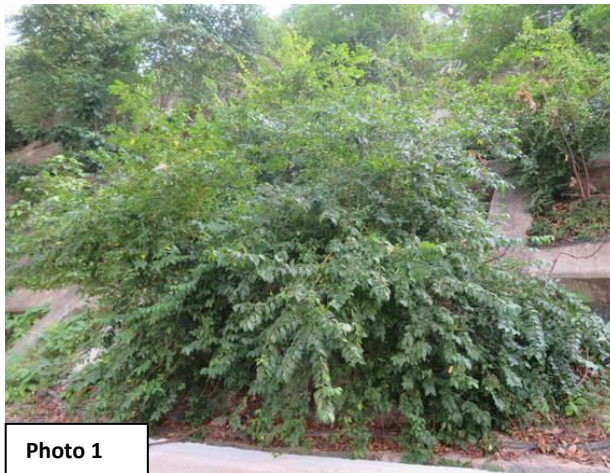
Photo 1

Photos 1-11 show the latest growth performance of the selected shrub seedlings and whip trees planted in the woodland mix areas.

Ligustrum sinense

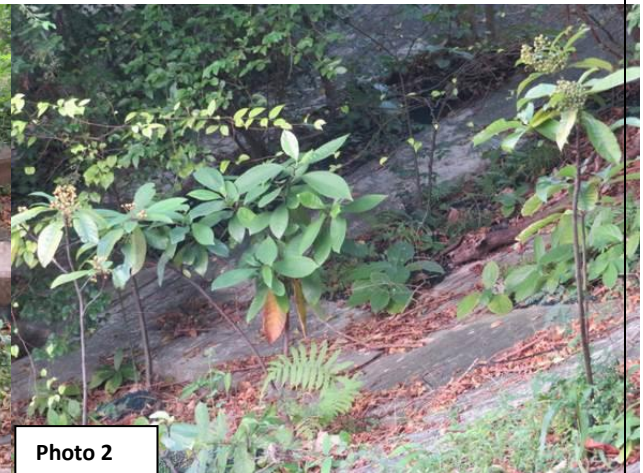
Photo 2

Psychotria asiatica

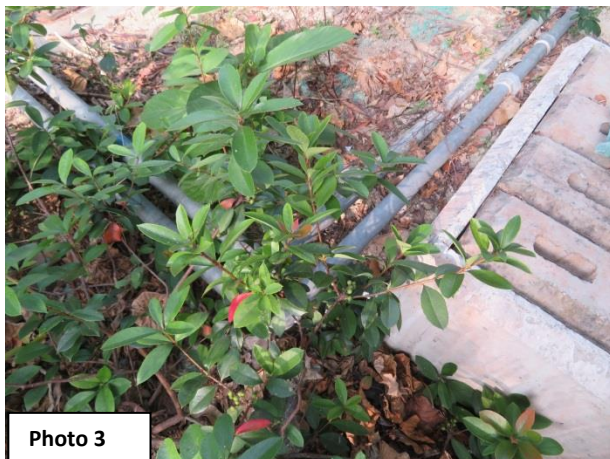
Photo 3

Rhaphiolepis indica

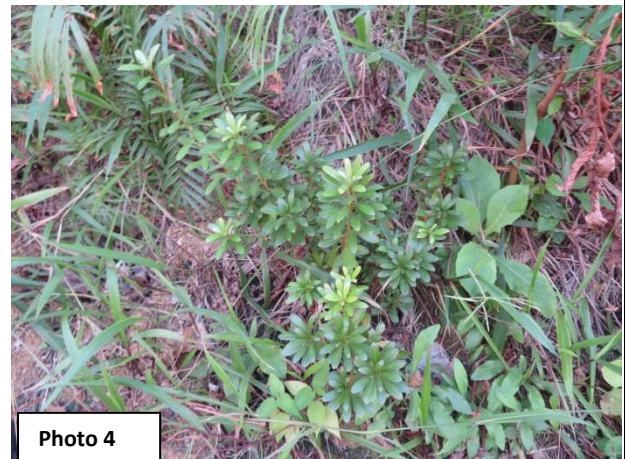
Photo 4

Rhododendron simsii

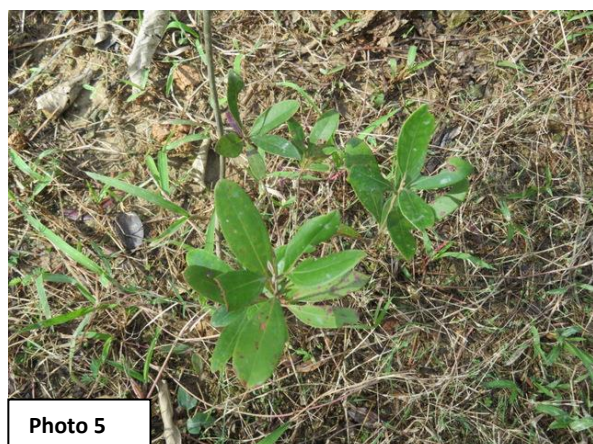
Photo 5

Rhodomyrtus tomentosa

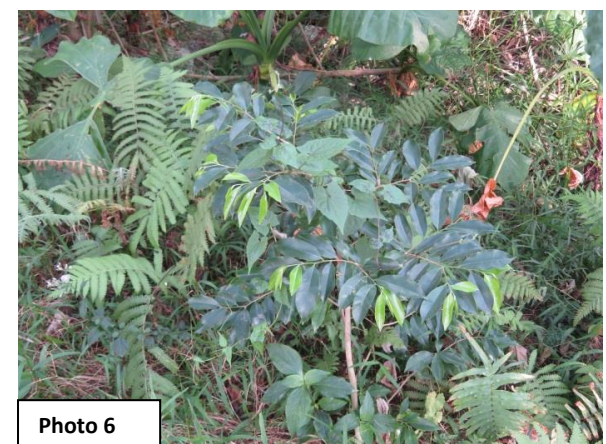
Photo 6

Aquilaria sinensis

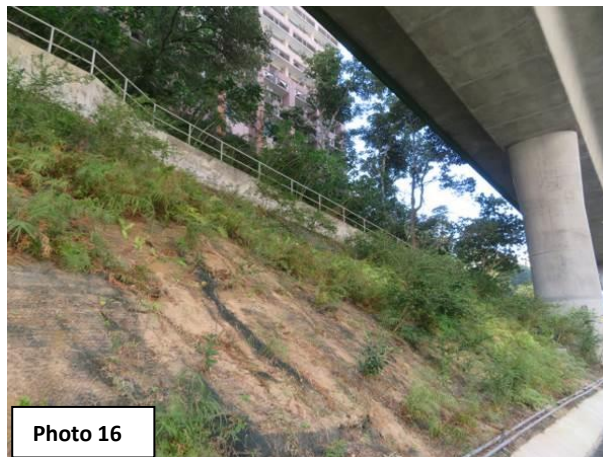
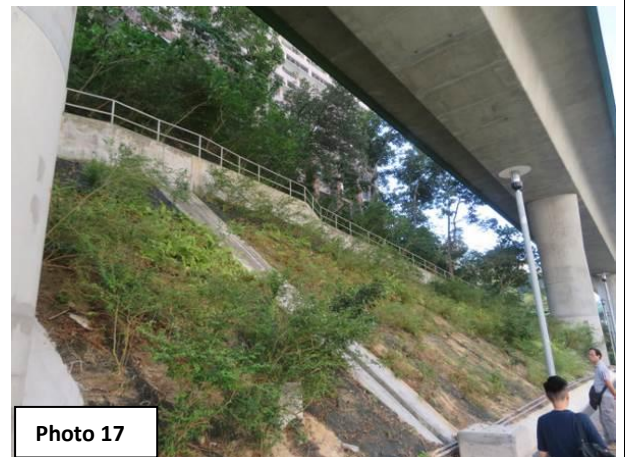
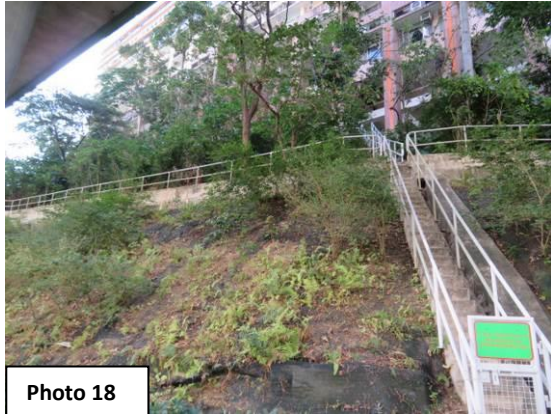
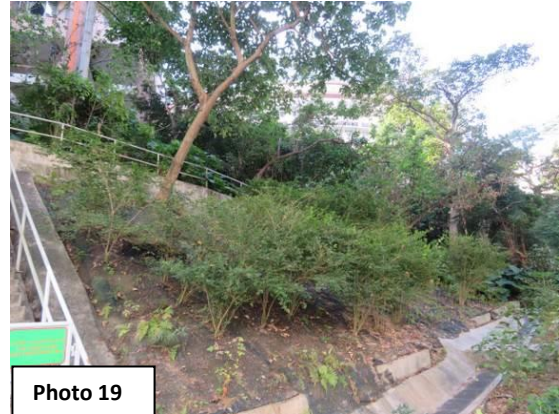
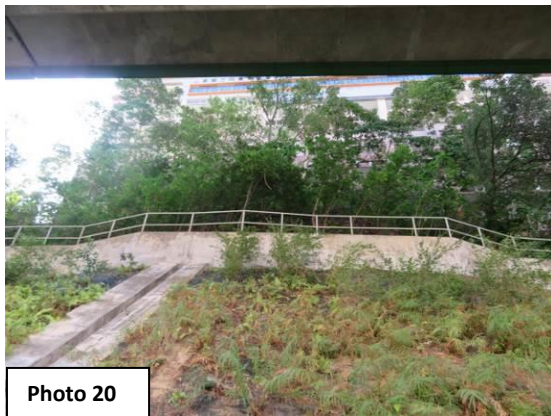
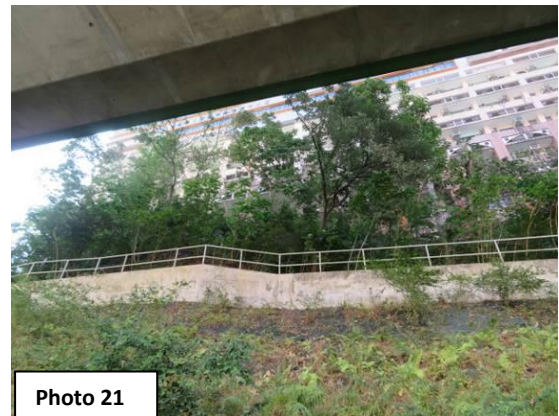
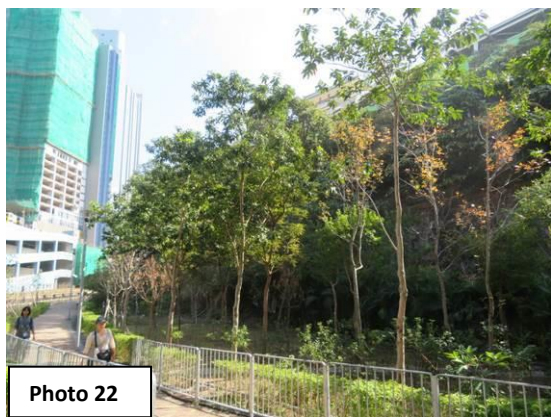
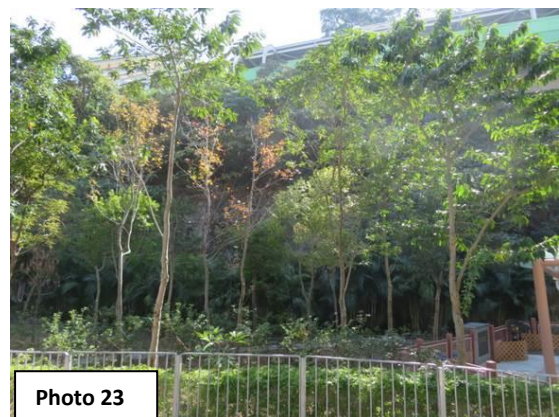
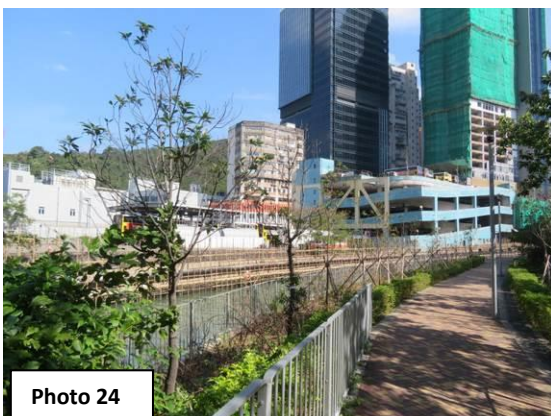
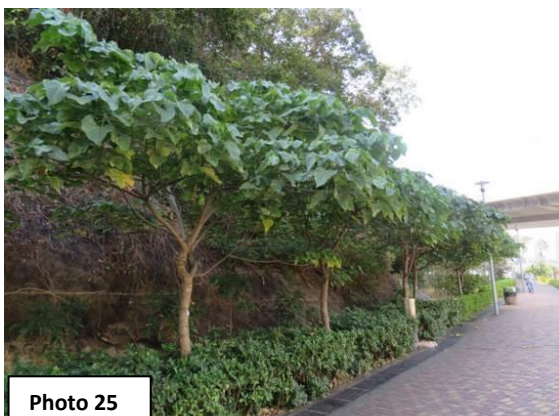
Photos 12-34 show the latest site condition and growth performance of planted vegetation as inspected on 21st December 2018. (**Photos 12-15** for slopes at Zone A; **Photos 16-21** for slopes at Zone B; **Photos 22-34** show the remaining EPLP areas along the nullah; **Photos 22-25** show planted trees at the compensatory planting area for the ardeid roosting site; **Photos 26-30** show the planted trees and palms in the remaining part of the EPLP area; **Photos 31-32** show the performance of the planted seedlings in the woodland mix areas; **Photos 33-34** show the general appearance of the hydromulched slopes).

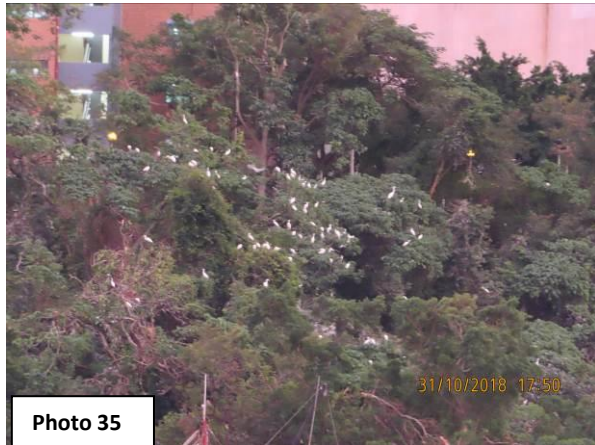
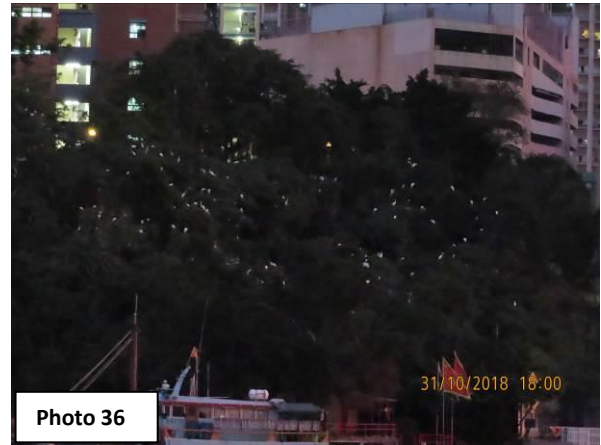
Photos 35-36 show the new ardeid night roosting site at the north of Ap Lei Chau. Waterbirds were also observed roosting on the roof of yacht repairing industry along the Aberdeen Channel during the additional ardeid survey.
