**Central Kowloon Route**

**Yau Ma Tei East**

**Contract No. HY/2014/08**

Document/ <del>Plan</del> to be <del>Certified</del> / Verified:	Monthly EM&A Report No.74 (May 2024)
Date of Report:	12 June 2024
Date received by IEC:	12 June 2024

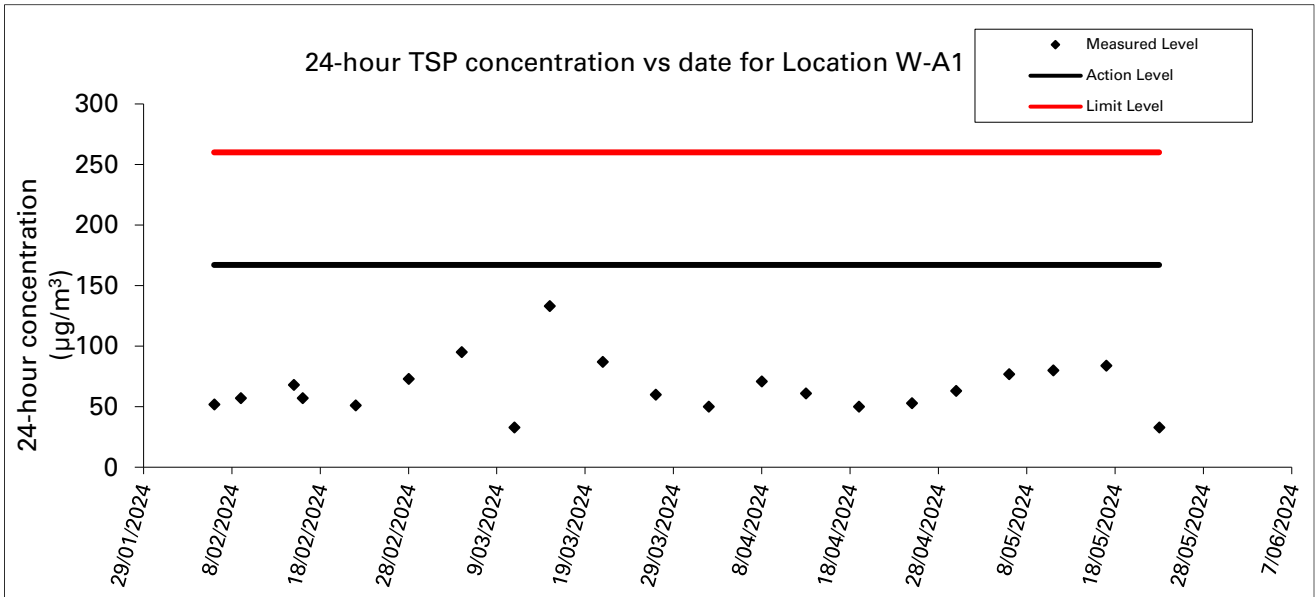
Figure 3: Graphical Illustration of Measured 24-hour TSP ( $\mu\text{g}/\text{m}^3$ ) Levels at W-A1

Location: Yau Ma Tei Catholic Primary School (Hoi Wang Road) (W-A1)  
 Monitoring date: 6, 11, 17 and 23 May 2024  
 Parameter : TSP 24-hour  
 Other Factors Nearby traffic

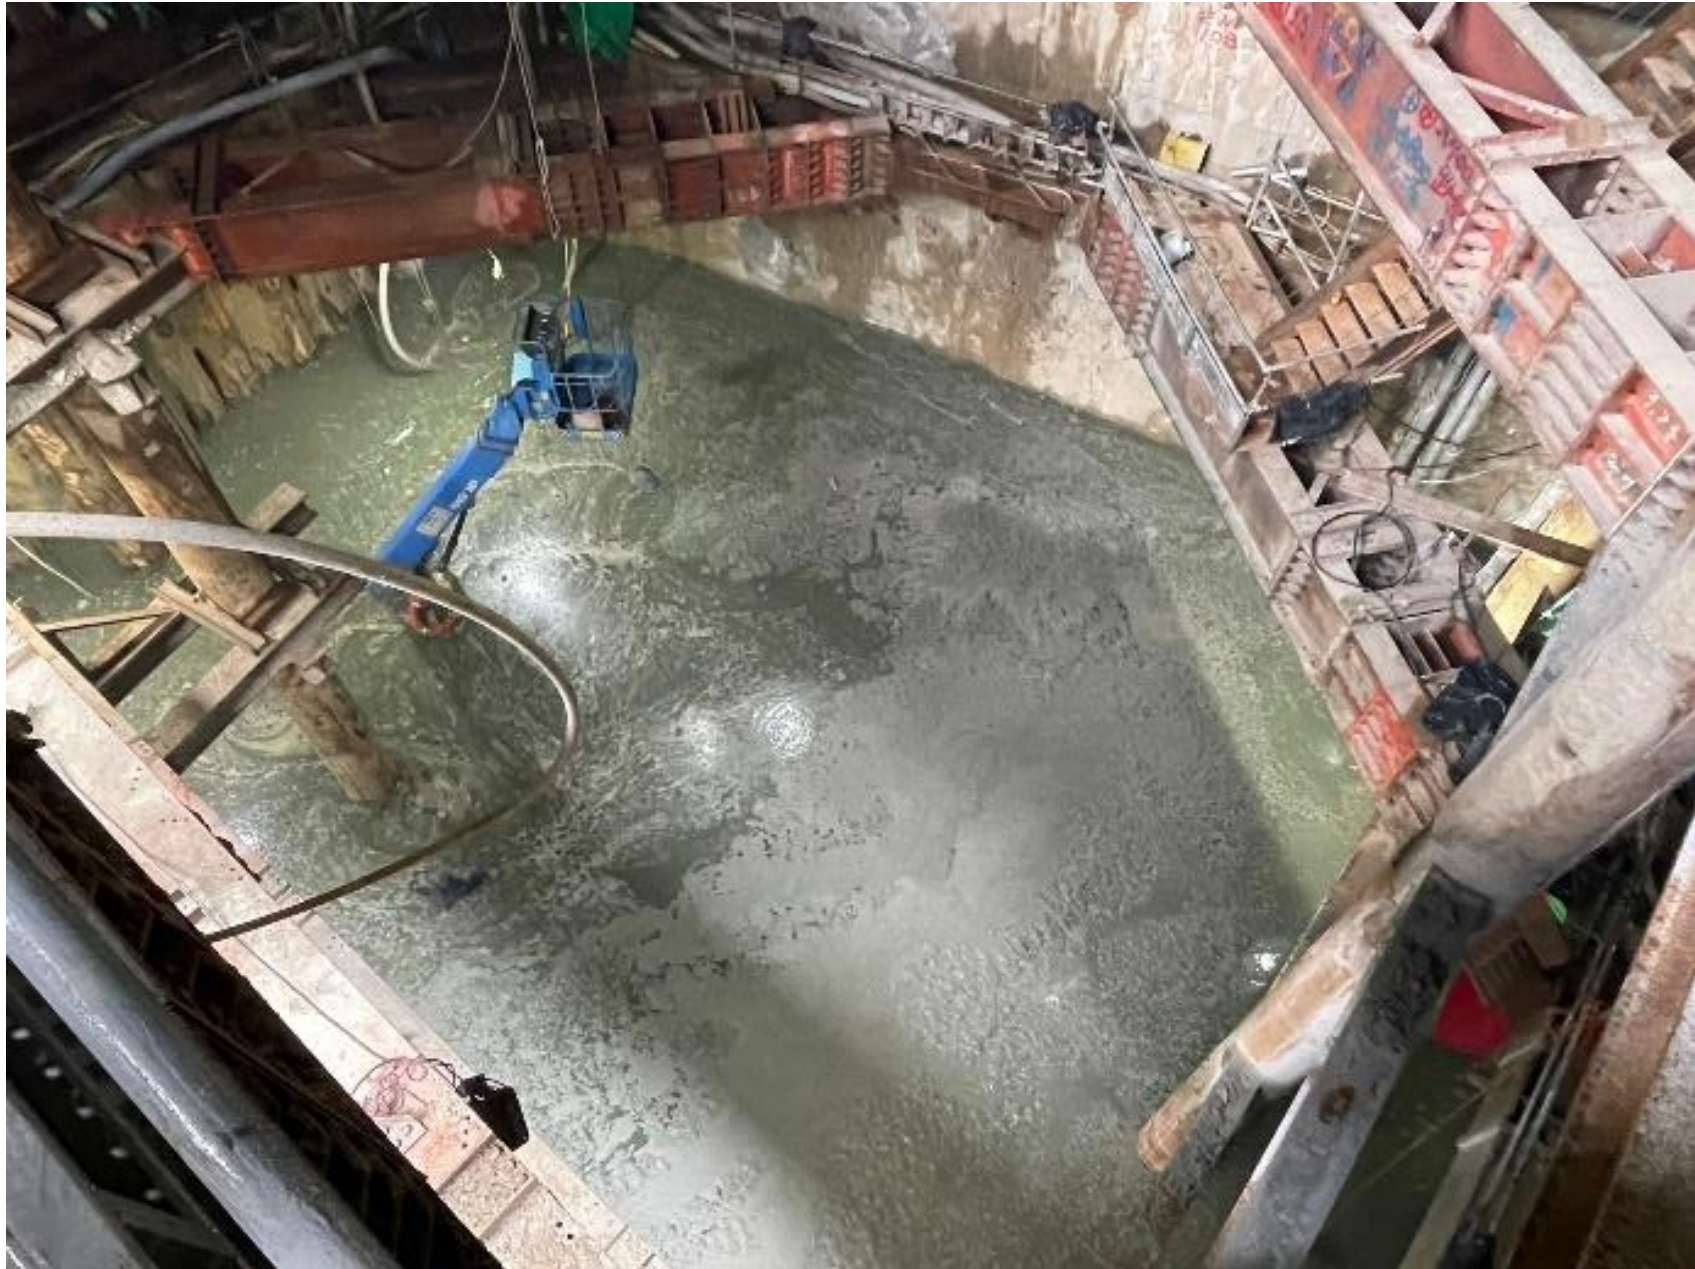
Remark 3: On-site photo

Noise barrier details :	
If no, why? :	Not applicable
Is hand-held breaker used? ?	NO
If yes, what type? :	
Is Noise barrier provided for hand-held breaker? :	NO
If no, why? :

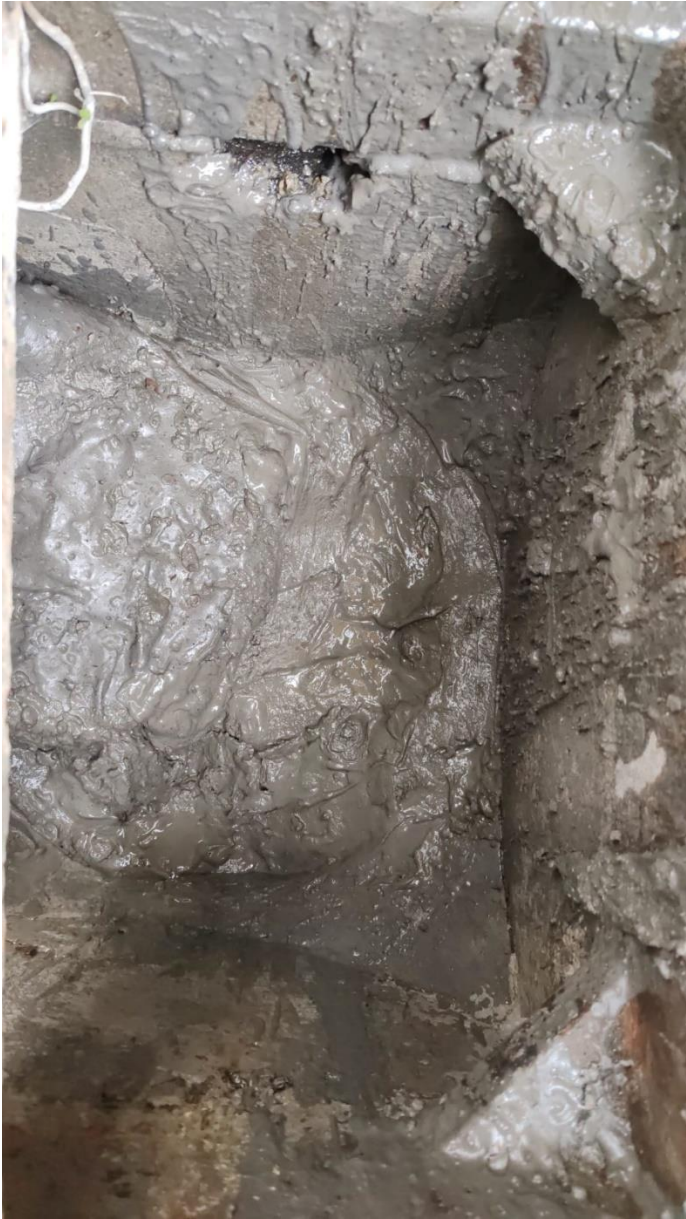
**Remark 2: Site photo of the roadside gullies**

Project	Central Kowloon Route, Yau Ma Tei East Section	
Complaint Code	EC132-CKRYMTE20240509_001	
Complaint description	The complainant made the complaint on 2 May 2024, about suspected illegal wastewater discharge from site area near Yau Ma Tei Electric Substation.	
Parameter	Water Quality	
Investigation finding	<p>The complainant made the complaint on 2 May 2024, about suspected illegal wastewater discharge from site area near Yau Ma Tei Electric Substation<sup>1</sup>.</p> <p>As confirmed by the Contractor, the roadside gullies connected with pipes within the construction site were entirely blocked out from the storm water system<sup>2</sup>. The roadside gullies are served as water collection pits to collect water generated from the site. Pumps are placed inside the roadside gullies to pump water to sedimentation tank for reuse within the site. The water is reused for implementation of environmental mitigation measures such as wheels washing and dust control. The remaining water inside the sedimentation tank is properly treated by wastewater treatment facility before being discharged at the designated discharge point under the Discharge License. No wastewater is discharged from the forementioned roadside gullies.</p> <p>Considering the fulfillment of stipulated requirements by the Contractor for EM&amp;A manual and the discharge license, it is concluded that there was no non-compliance of the Project regarding water impact from construction site.</p>
