Central Kowloon Route

Yau Ma Tei East

Contract No. HY/2014/08

Document/ Plan to be Certified / Verified:	Monthly EM&A Report No.76 (July 2024)
Date of Report:	9 August 2024
Date received by IEC:	9 August 2024

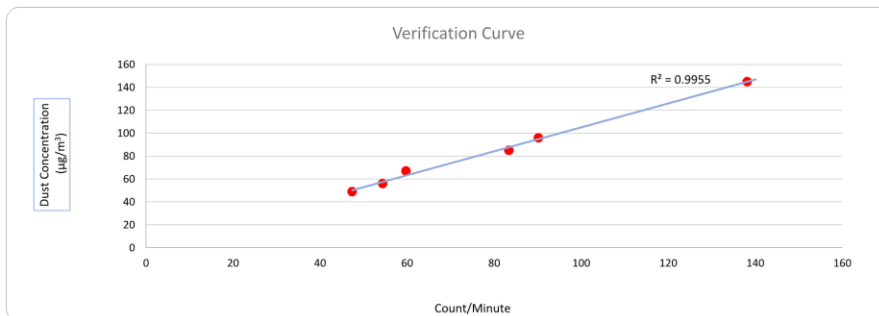
Linear Regression of y on x

Slope, K factor:	1.0443	Intercept:	0.6370	*Correlation Coefficient, R:	0.9978
Verification Test Result:	Strong Correlation. Results were accepted.			* If the Correlation Coefficient, R is <0.5. Checking and Re-verification are required.

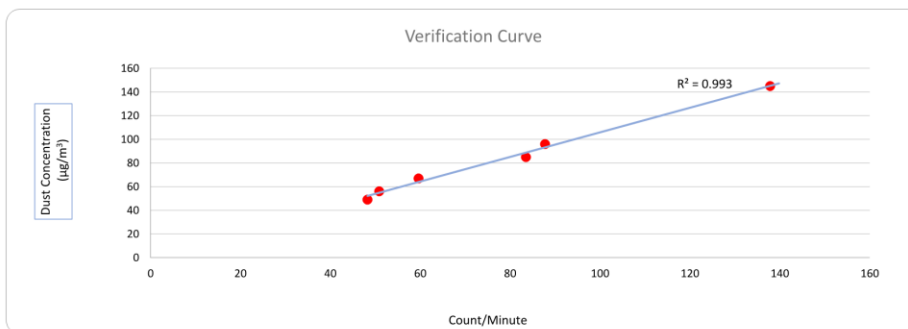
Linear Regression of y on x

Slope, K factor:	1.0388	Intercept:	1.9869	*Correlation Coefficient, R:	0.9965
Verification Test Result:	Strong Correlation, Results were accepted.			* If the Correlation Coefficient, R is <0.5. Checking and Re-verification are required.

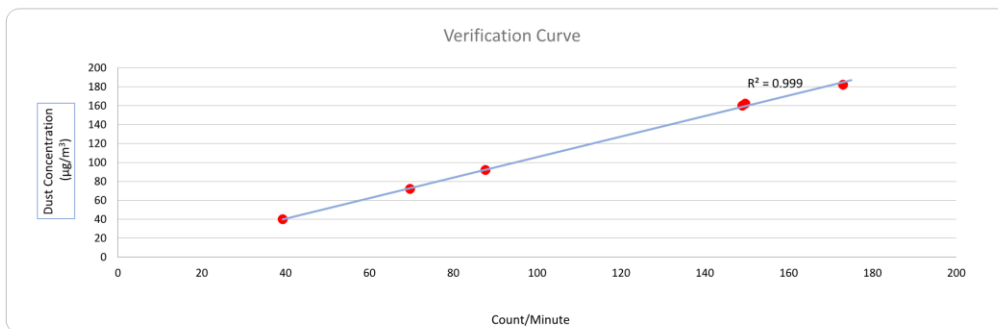
Linear Regression of y on x

Slope, K factor:	1.0840	Intercept:	-2.7589	*Correlation Coefficient,R:	0.9995
Verification Test Result:	Strong Correlation, Results were accepted.			* If the Correlation Coefficient, R is <0.5. Checking and Re-verification are required.

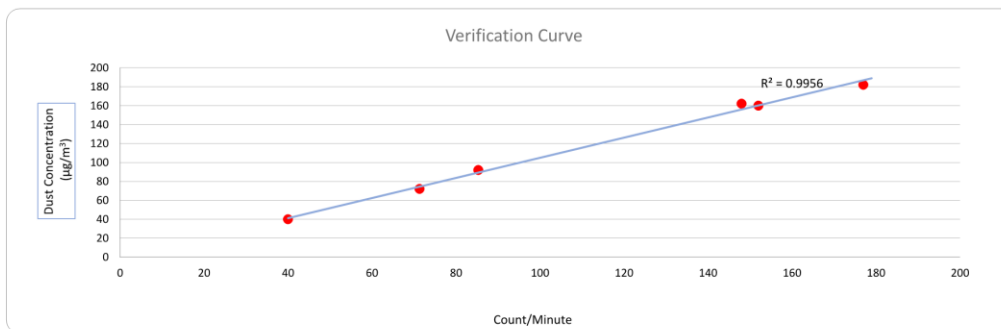
Linear Regression of y on x

Slope, K factor:	<u>1.0635</u>	Intercept:	<u>-1.4006</u>	*Correlation Coefficient,R:	<u>0.9978</u>
Verification Test Result:	<u>Strong Correlation, Results were accepted.</u>			* If the Correlation Coefficient, R is <0.5. Checking and Re-verification are required.

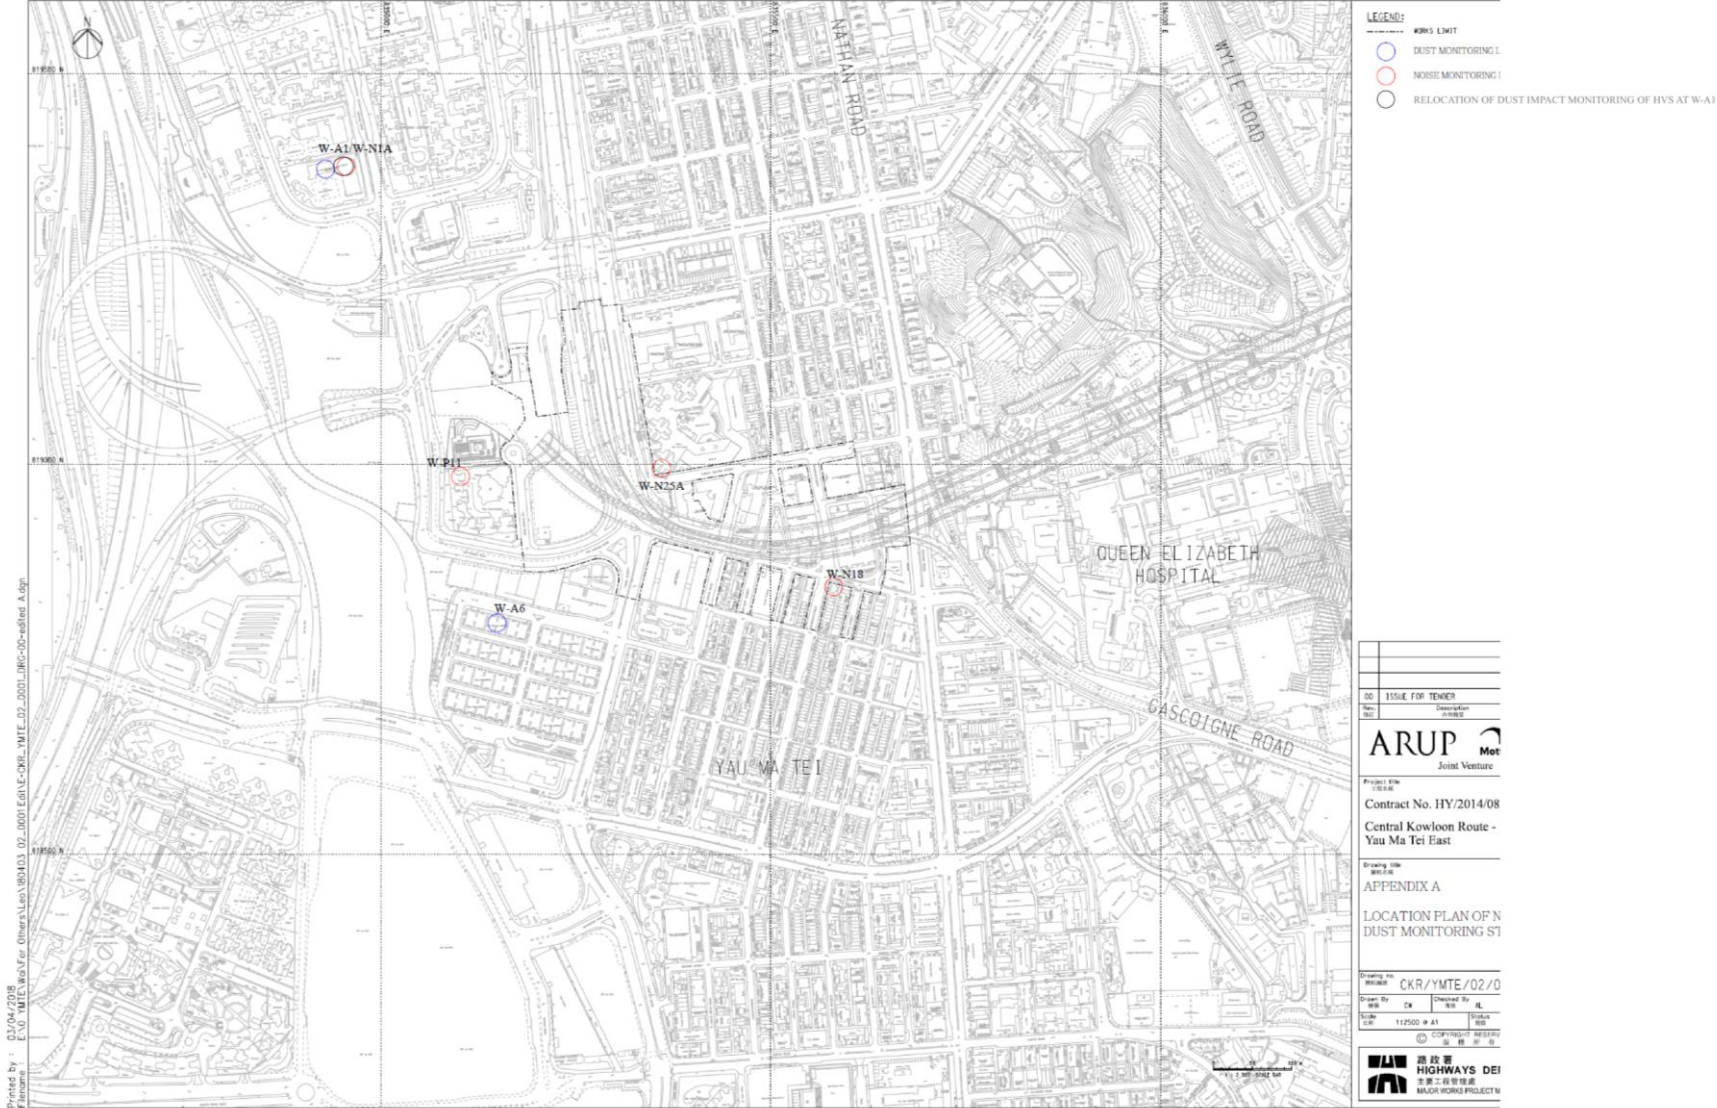
Appendix K

Location Plan of Noise and Air Quality Monitoring Station

- 3.4.1. During the site visit, both of the original proposed dust monitoring locations were rejected due to the condition at The Coronation was not favourable for monitoring and the access was declined by the management office of Hong Kong Community College (HKCC) of PolyU. Two alternative air monitoring stations Yau Ma Tei Catholic Primary School (Hoi Wang Road) and Man Cheong Building had been proposed by ET and approved by IEC. 2 designated air monitoring locations were identified and agreed with IEC and EPD. Details of air monitoring stations are described in Table 3.3. The location plan of air quality monitoring stations is shown in Appendix K.

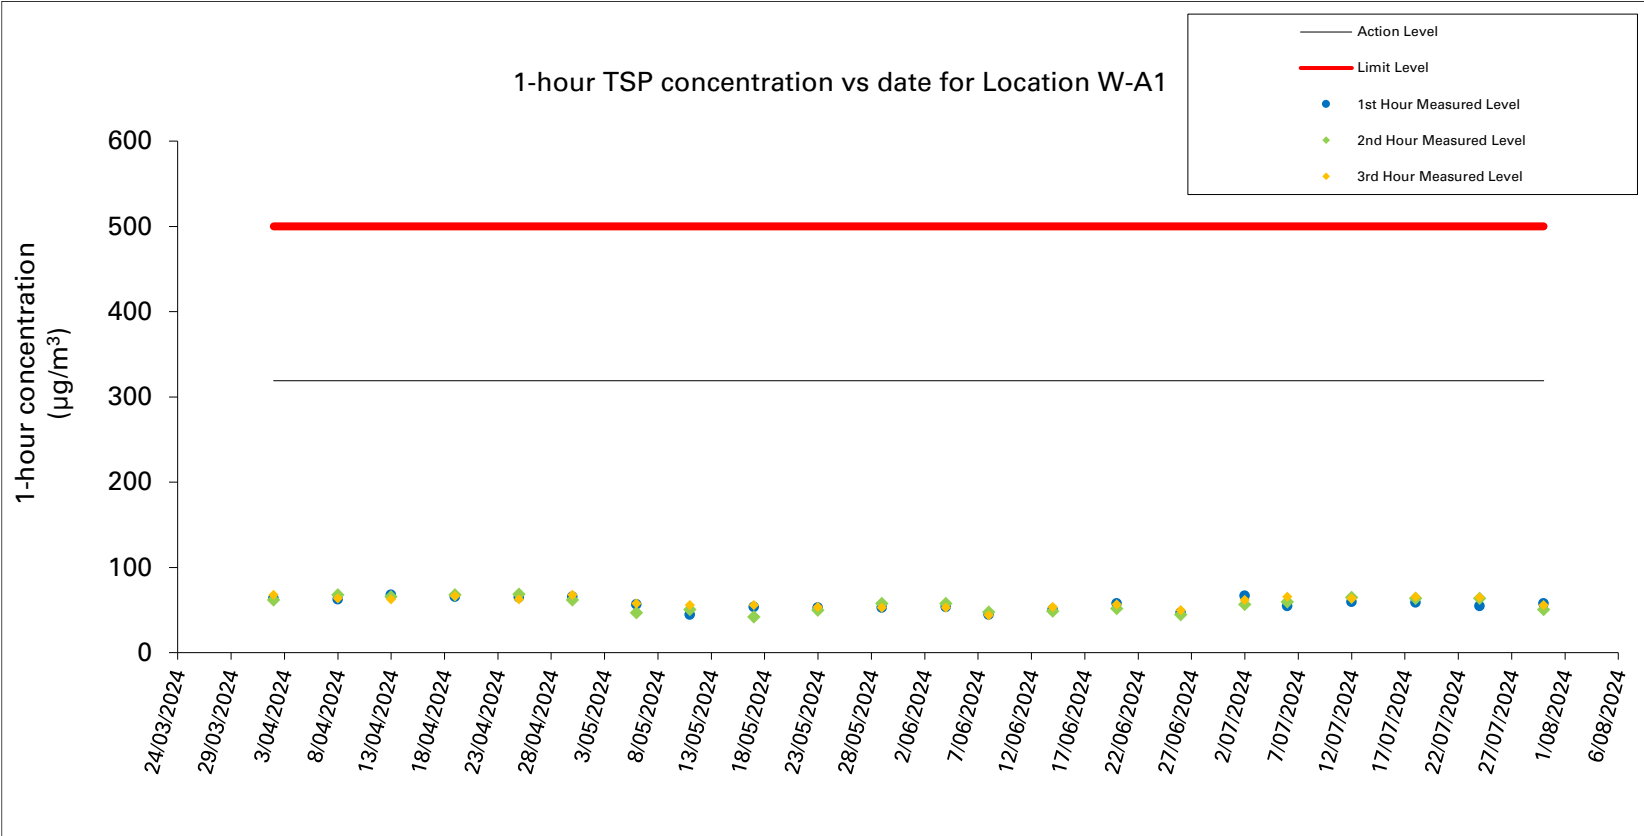
Figure 1: Graphical Illustration of Measured 1-hour TSP (µg/m³) Levels at W-A1

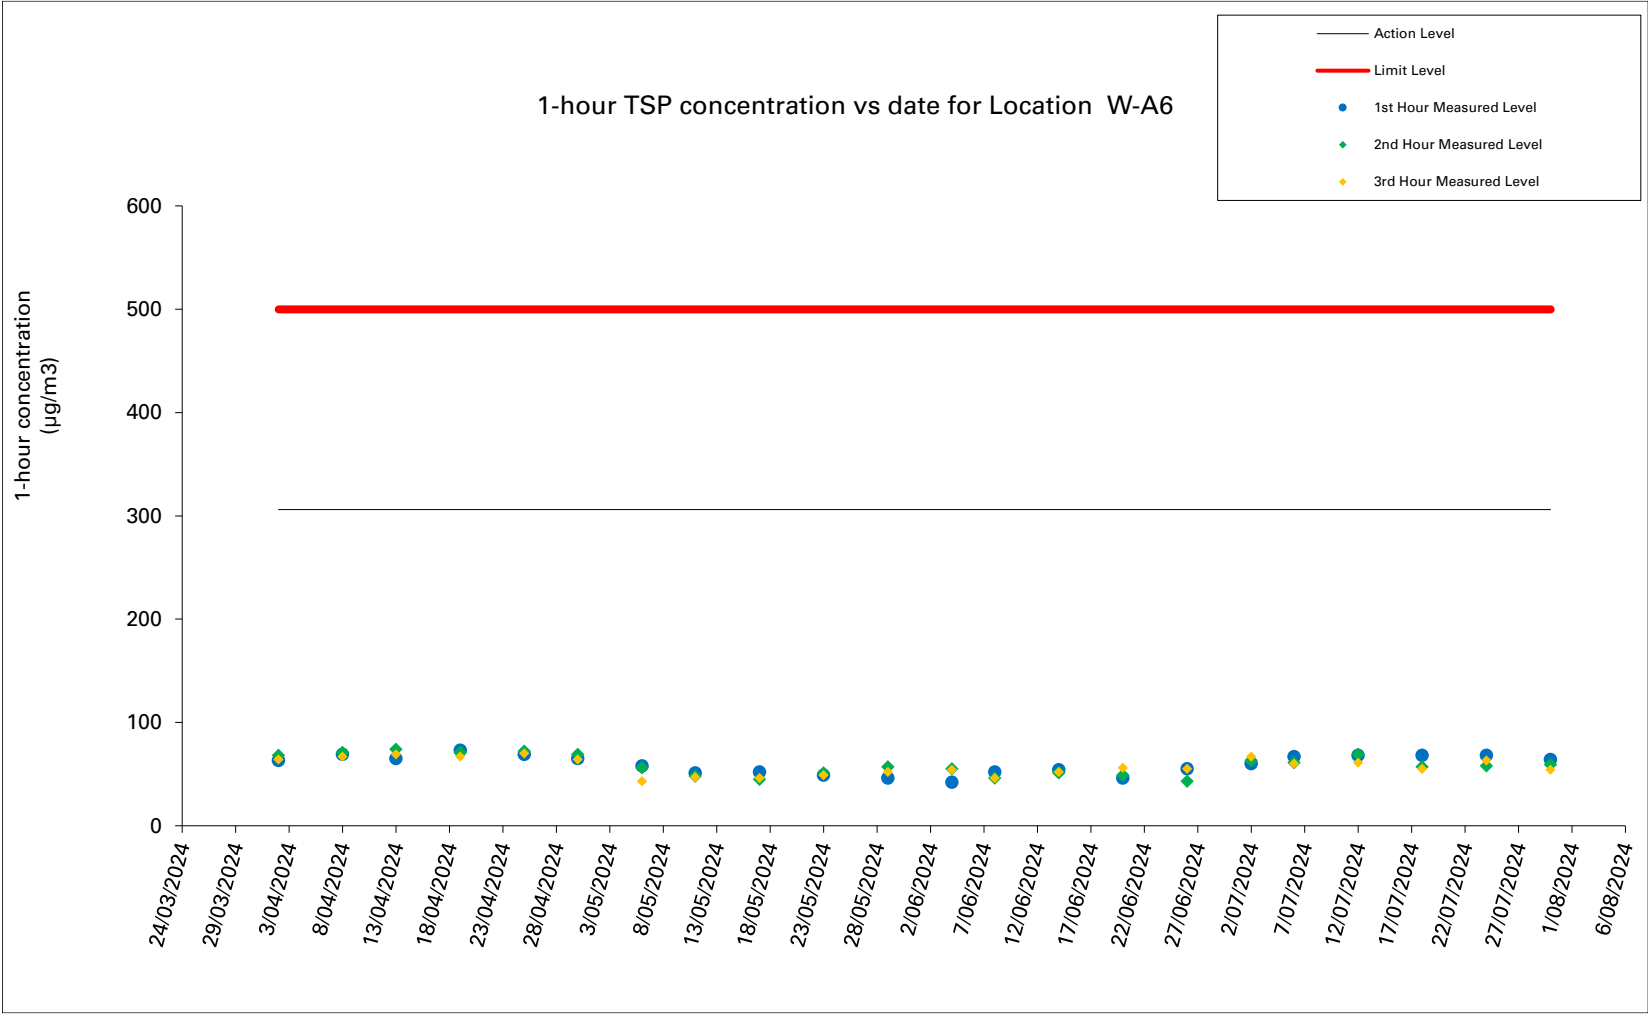
Figure 2: Graphical Illustration of Measured 1-hour TSP ($\mu\text{g}/\text{m}^3$) Levels at W-A6

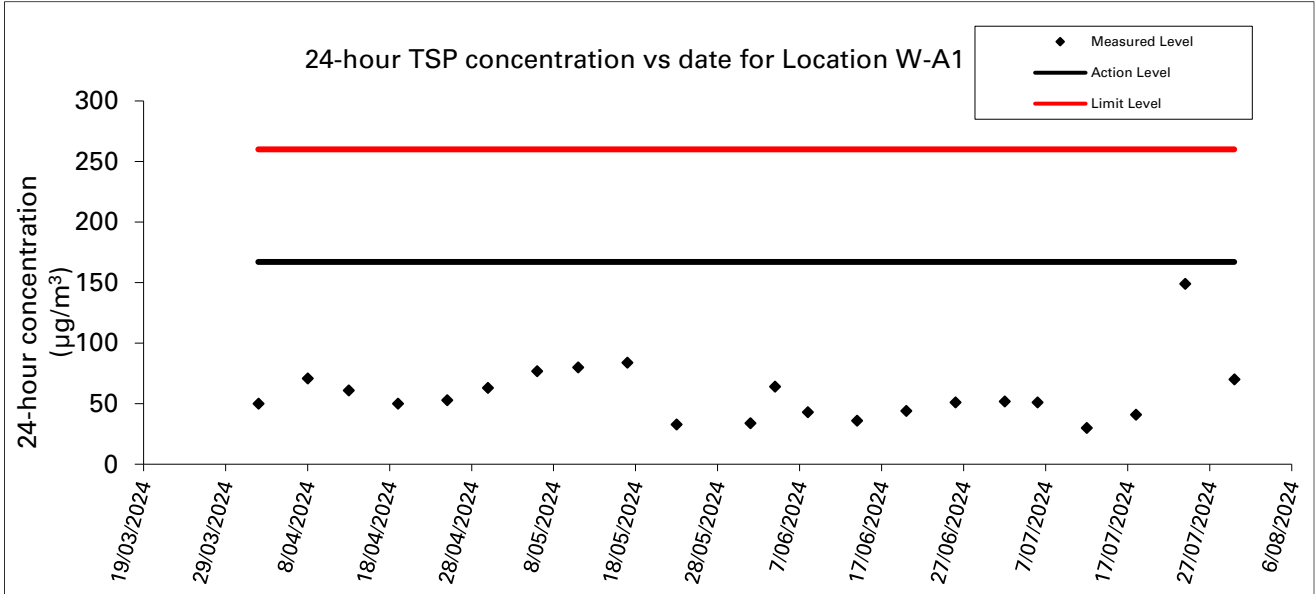
Figure 3: Graphical Illustration of Measured 24-hour TSP ($\mu\text{g}/\text{m}^3$) Levels at W-A1

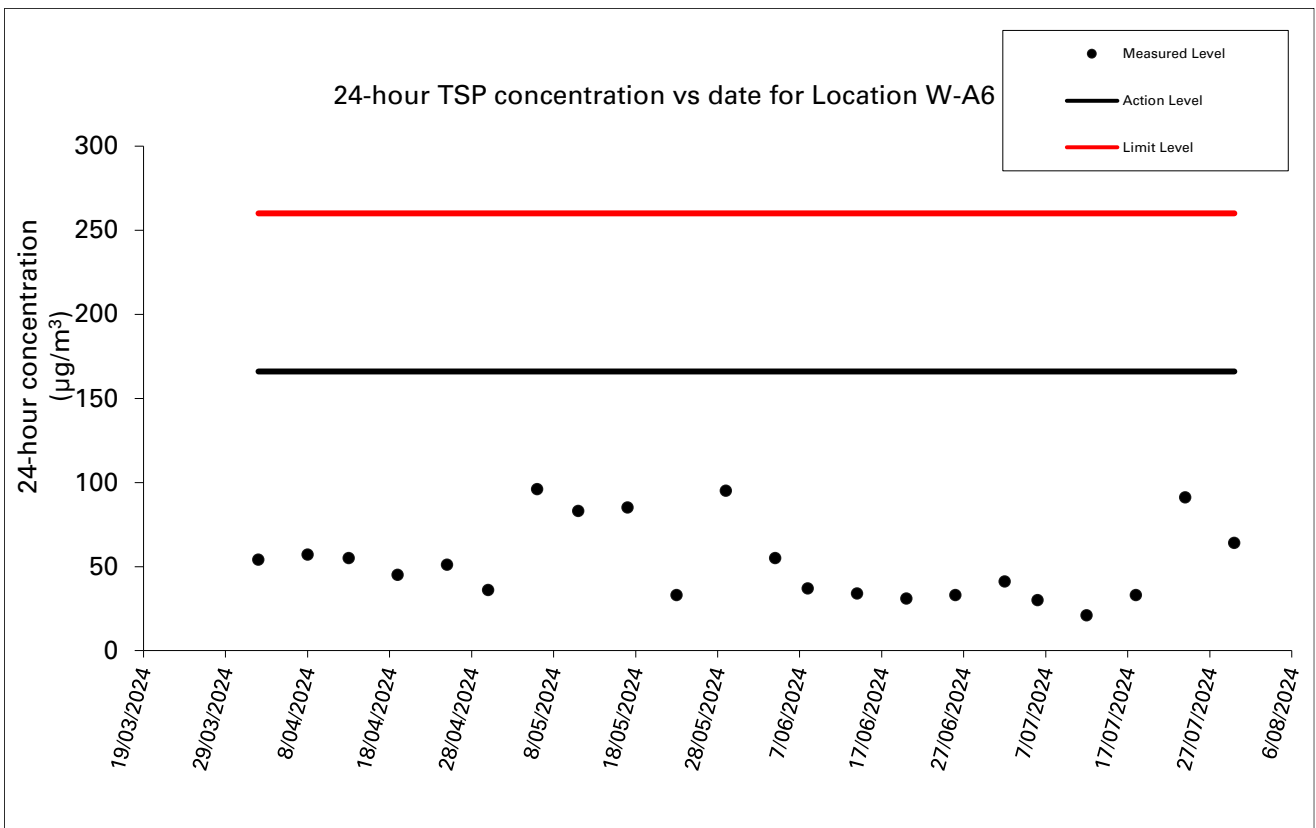
Figure 4: Graphical Illustration of Measured 24-hour TSP ($\mu\text{g}/\text{m}^3$) Levels at W-A6

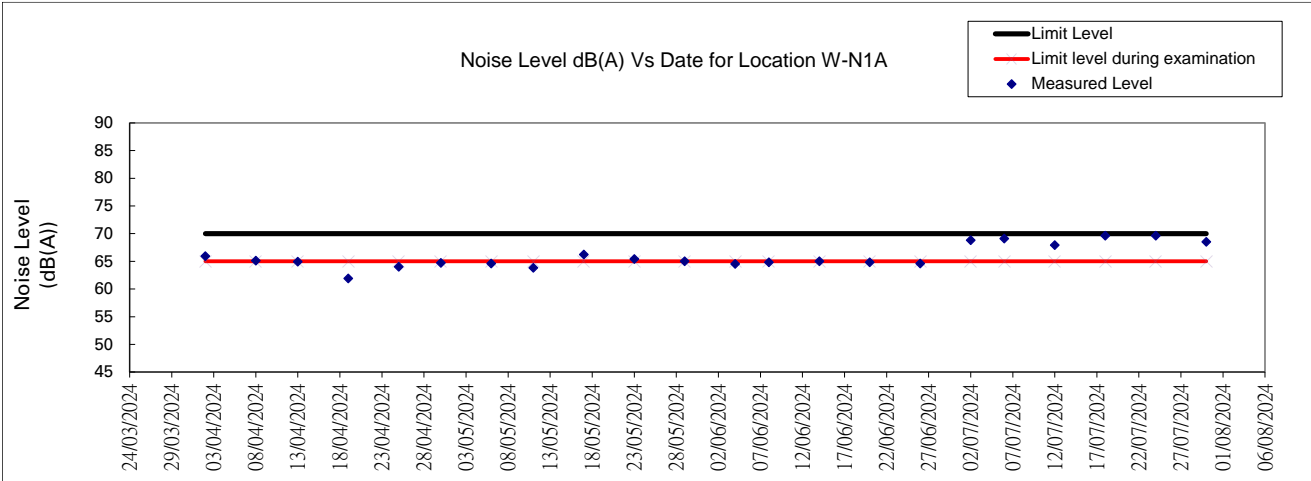
Figure 1: Graphical Illustration of Measured Noise Levels at W-N1A

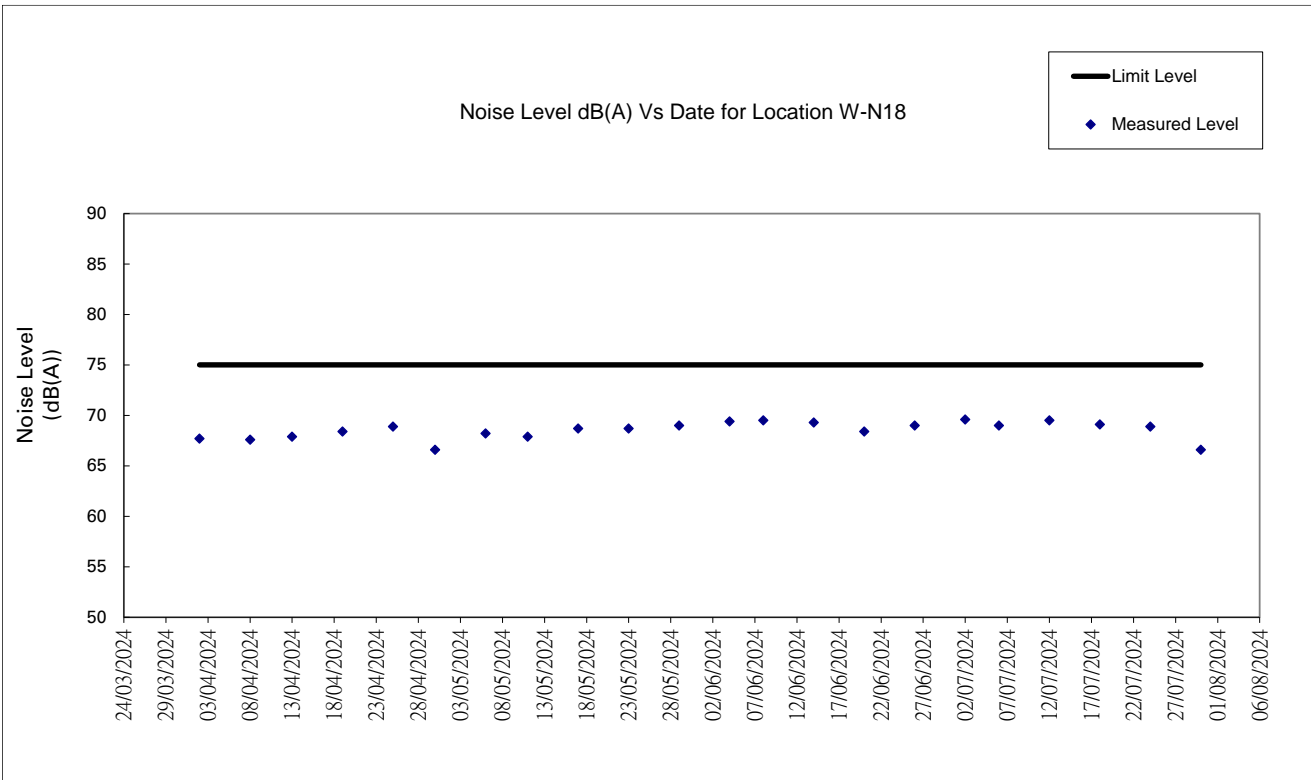
Figure 2: Graphical Illustration of Measured Noise Levels at W-N18

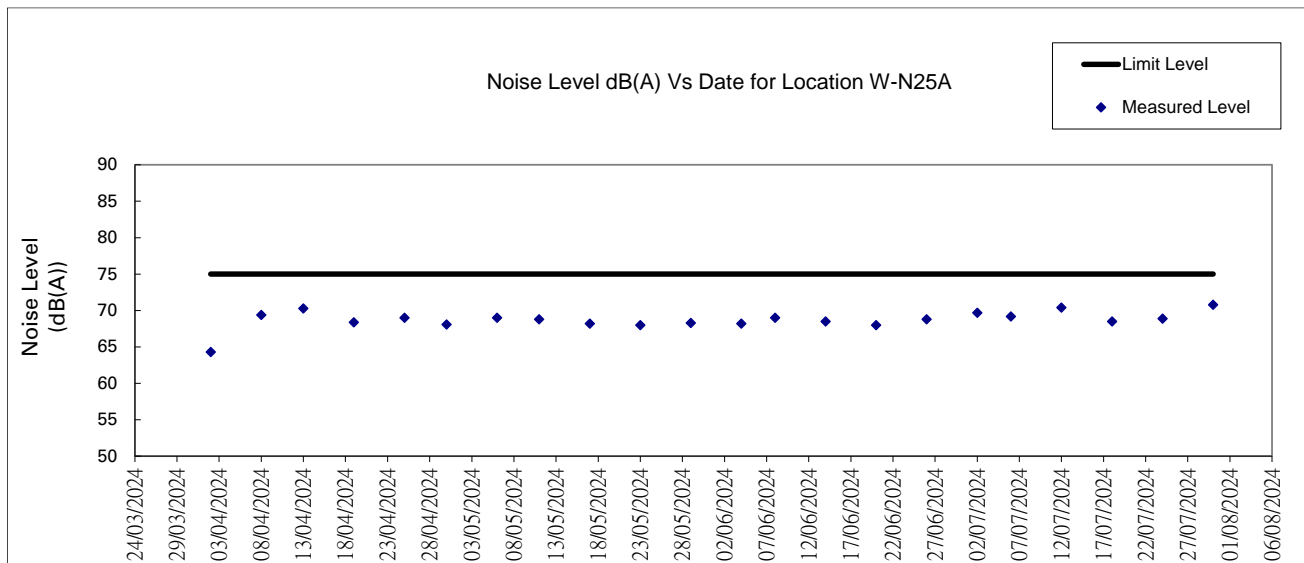
Figure 3: Graphical Illustration of Measured Noise Levels at W-N25A

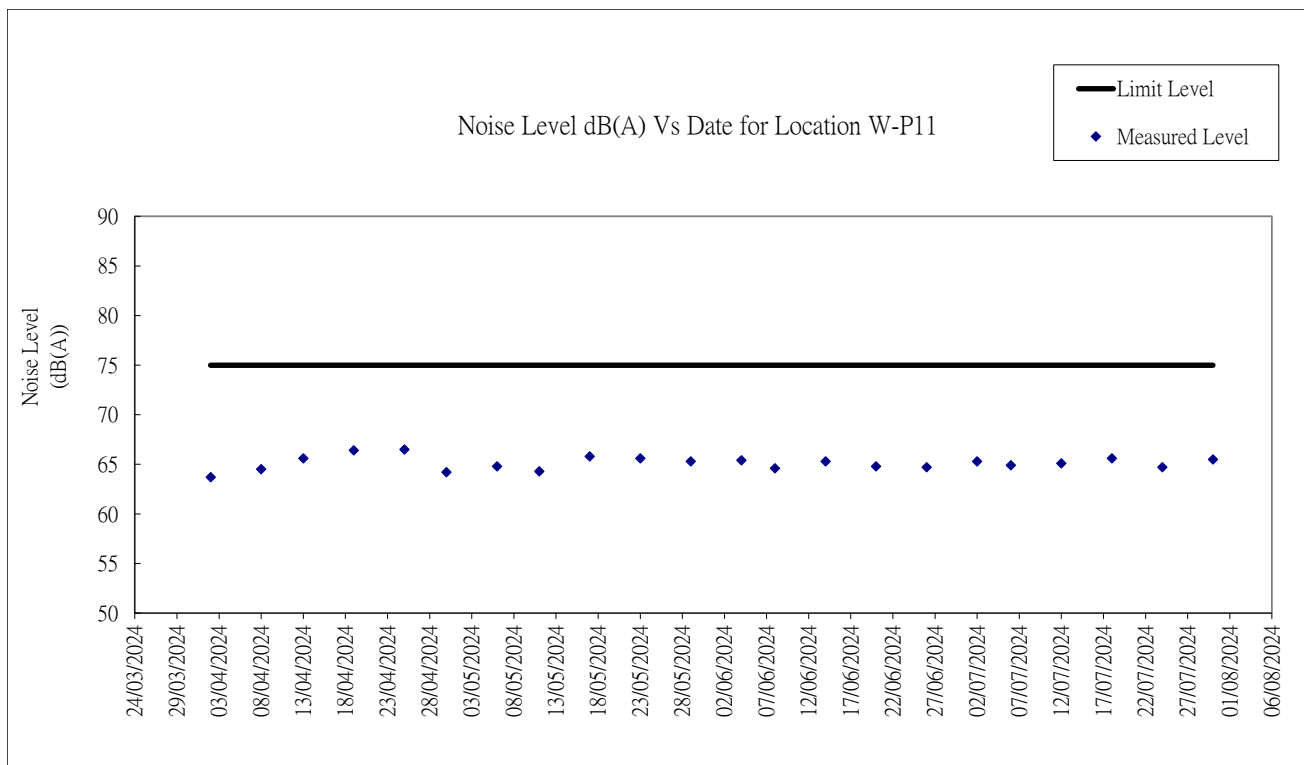
Figure 4: Graphical Illustration of Measured Noise Levels at W-P11

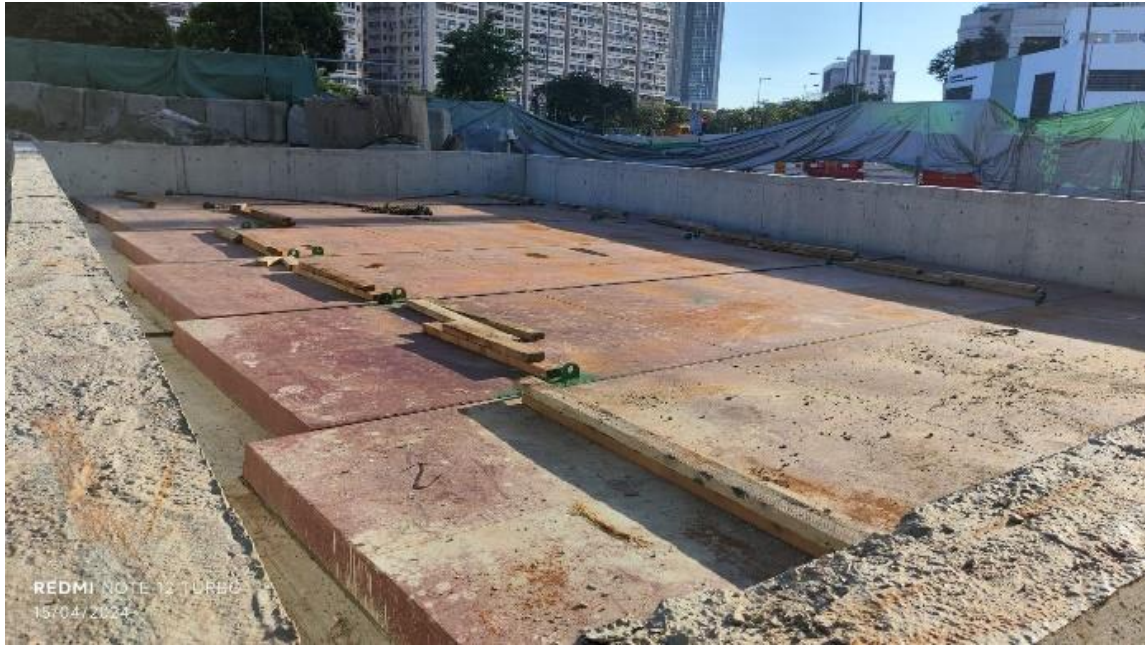
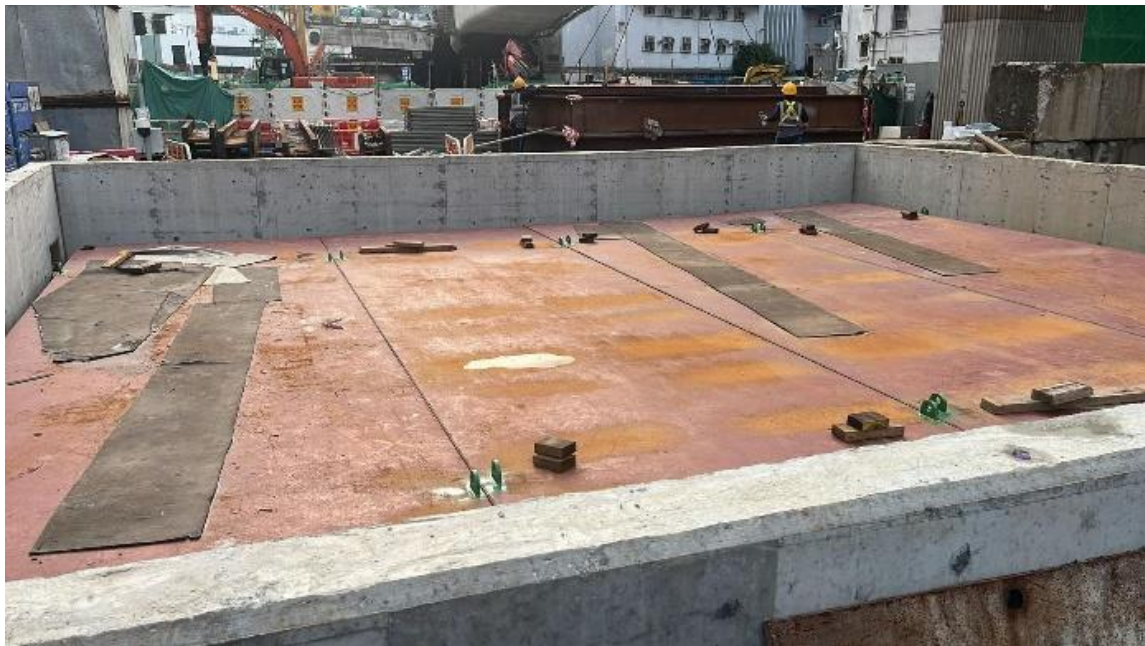
Remark 2: Noise mitigation measure

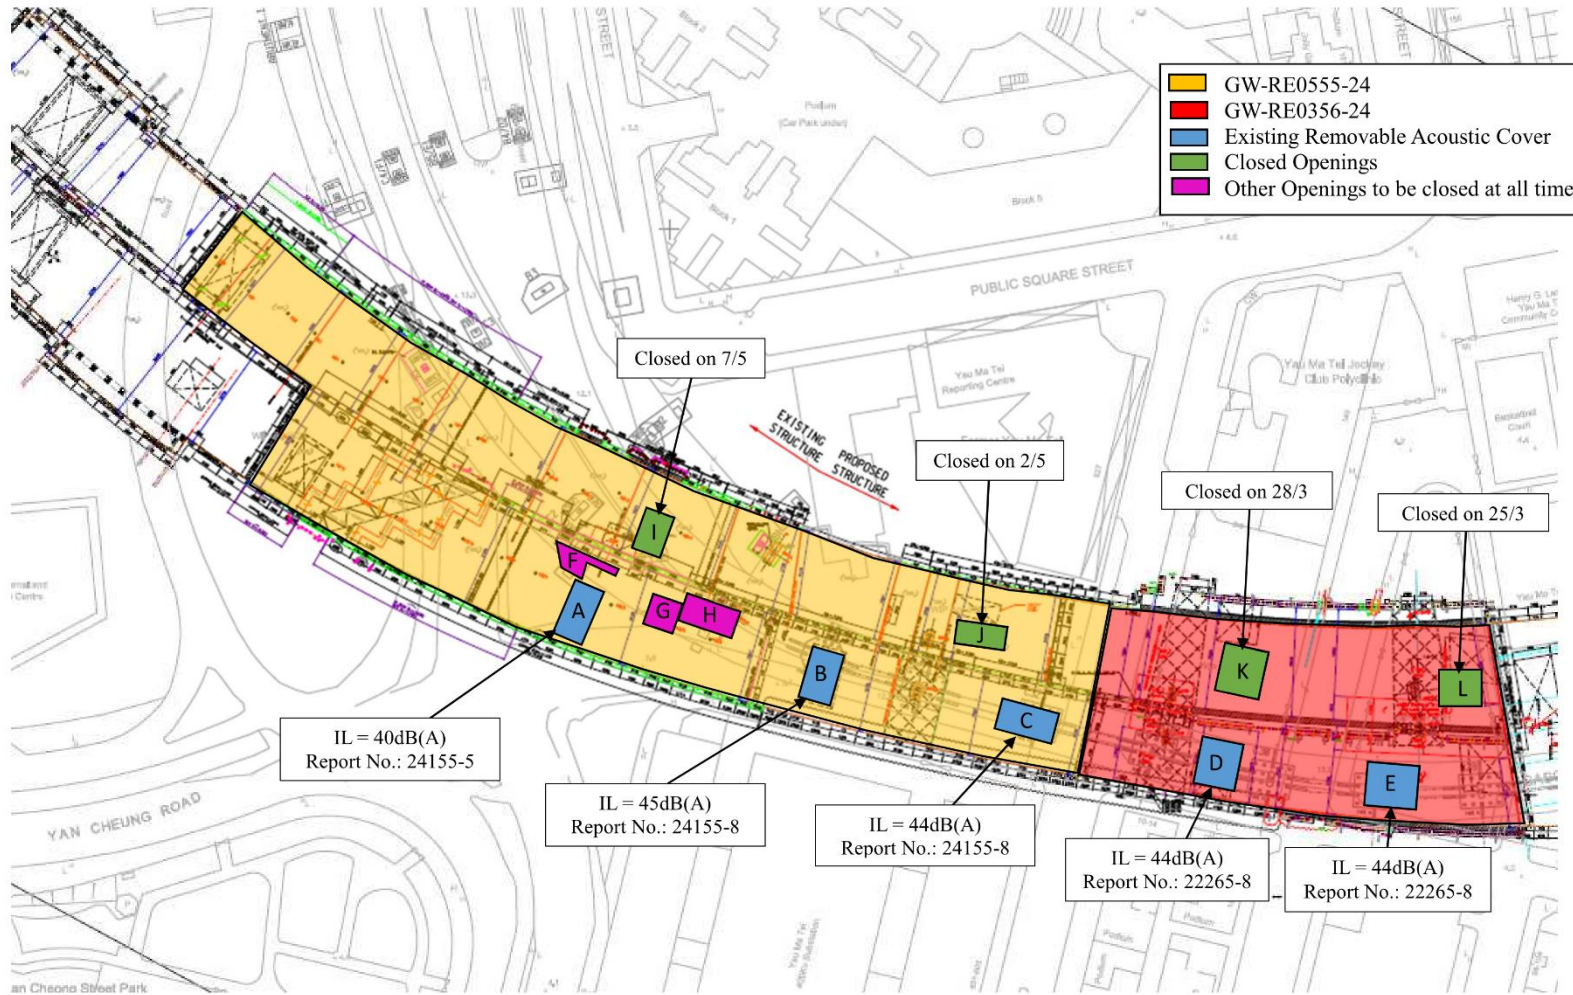
Remark 4: Layout plan of Removable Acoustic Cover for Underground CNP

Layout Plan of Removable Acoustic Cover for Underground CNP

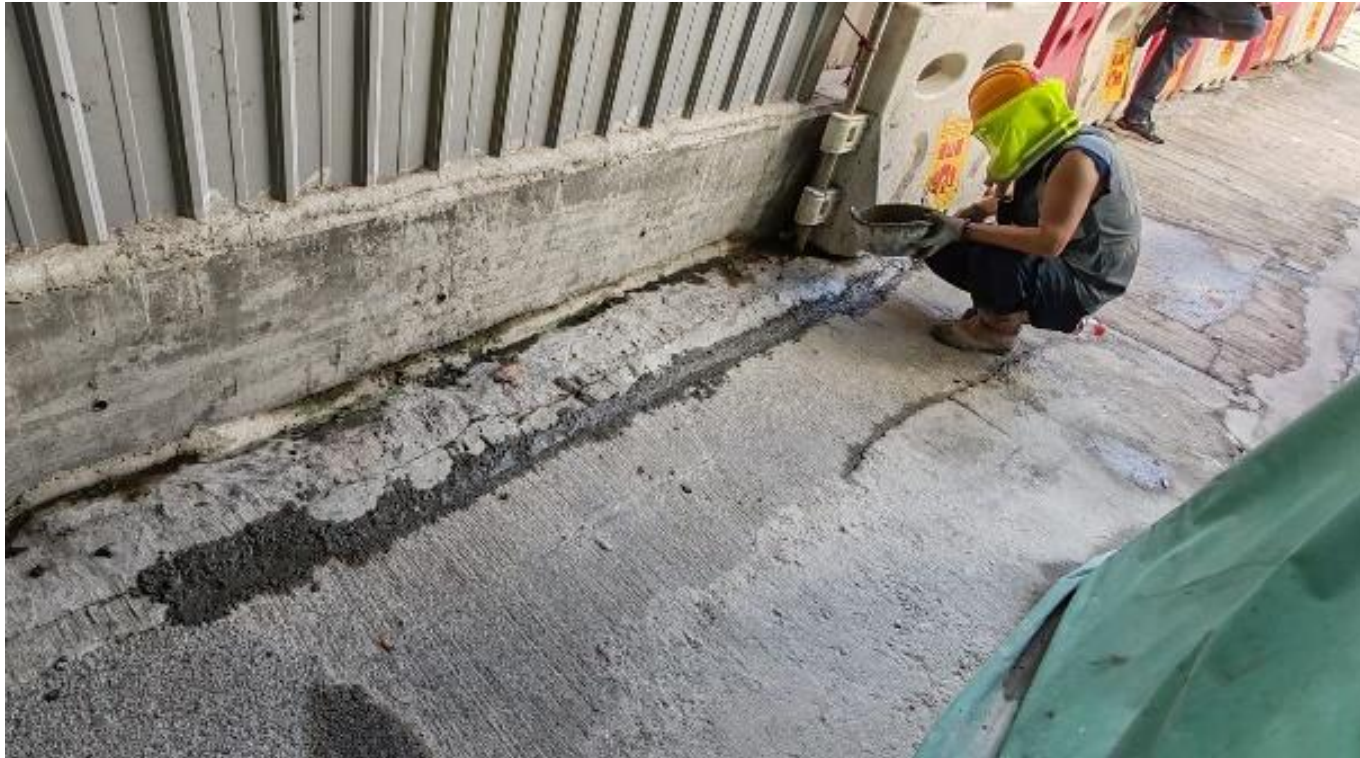
Remark 2: Further sealing up to the hoarding
