**Service Contract No. WD/04/2020  
Development of Lok Ma Chau Loop:  
Main Works Package 1 –  
Environmental Team**

**Environmental Permit No.:  
EP-477/2013/B  
- Development of Lok Ma Chau Loop**

**Monthly Environmental Monitoring and  
Audit Report for March 2024**

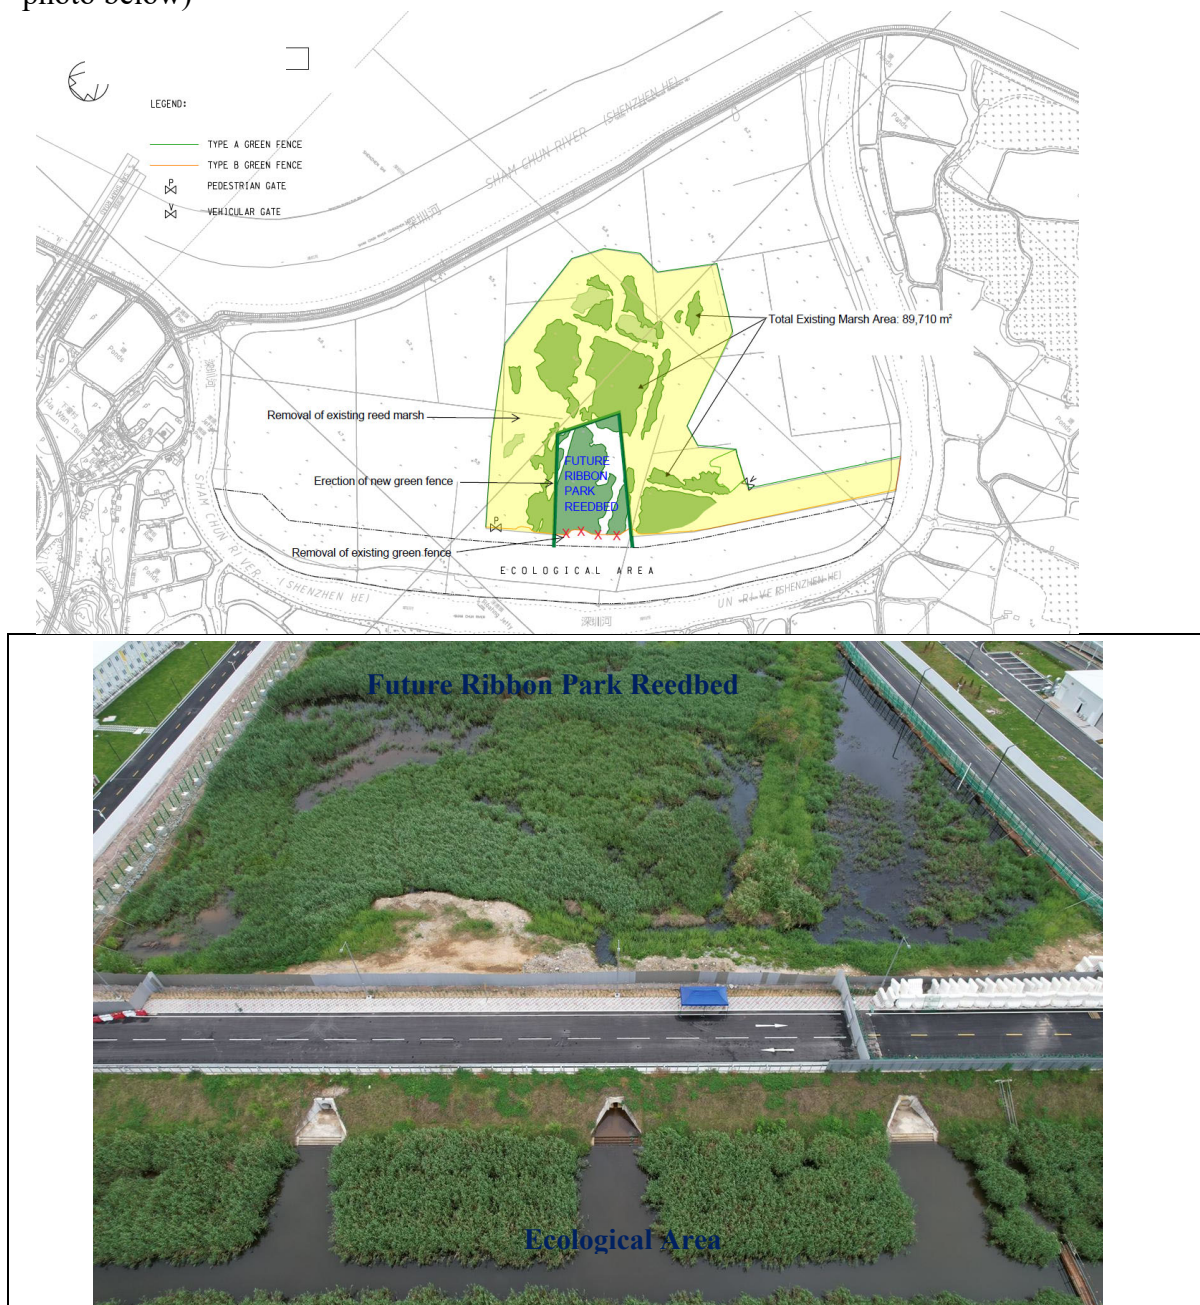
- 10.8 The green fence around the future Ribbon Park Reedbed has been removed and replaced by the hoarding due to the other project's land occupier since March 2022. (See Figure & photo below)

10.10 The Contractor was reminded to maintain the green fence around construction areas and ensure no disturbance to the exiting trees and reed marsh habitat subject to the latest situation of LMC Loop.

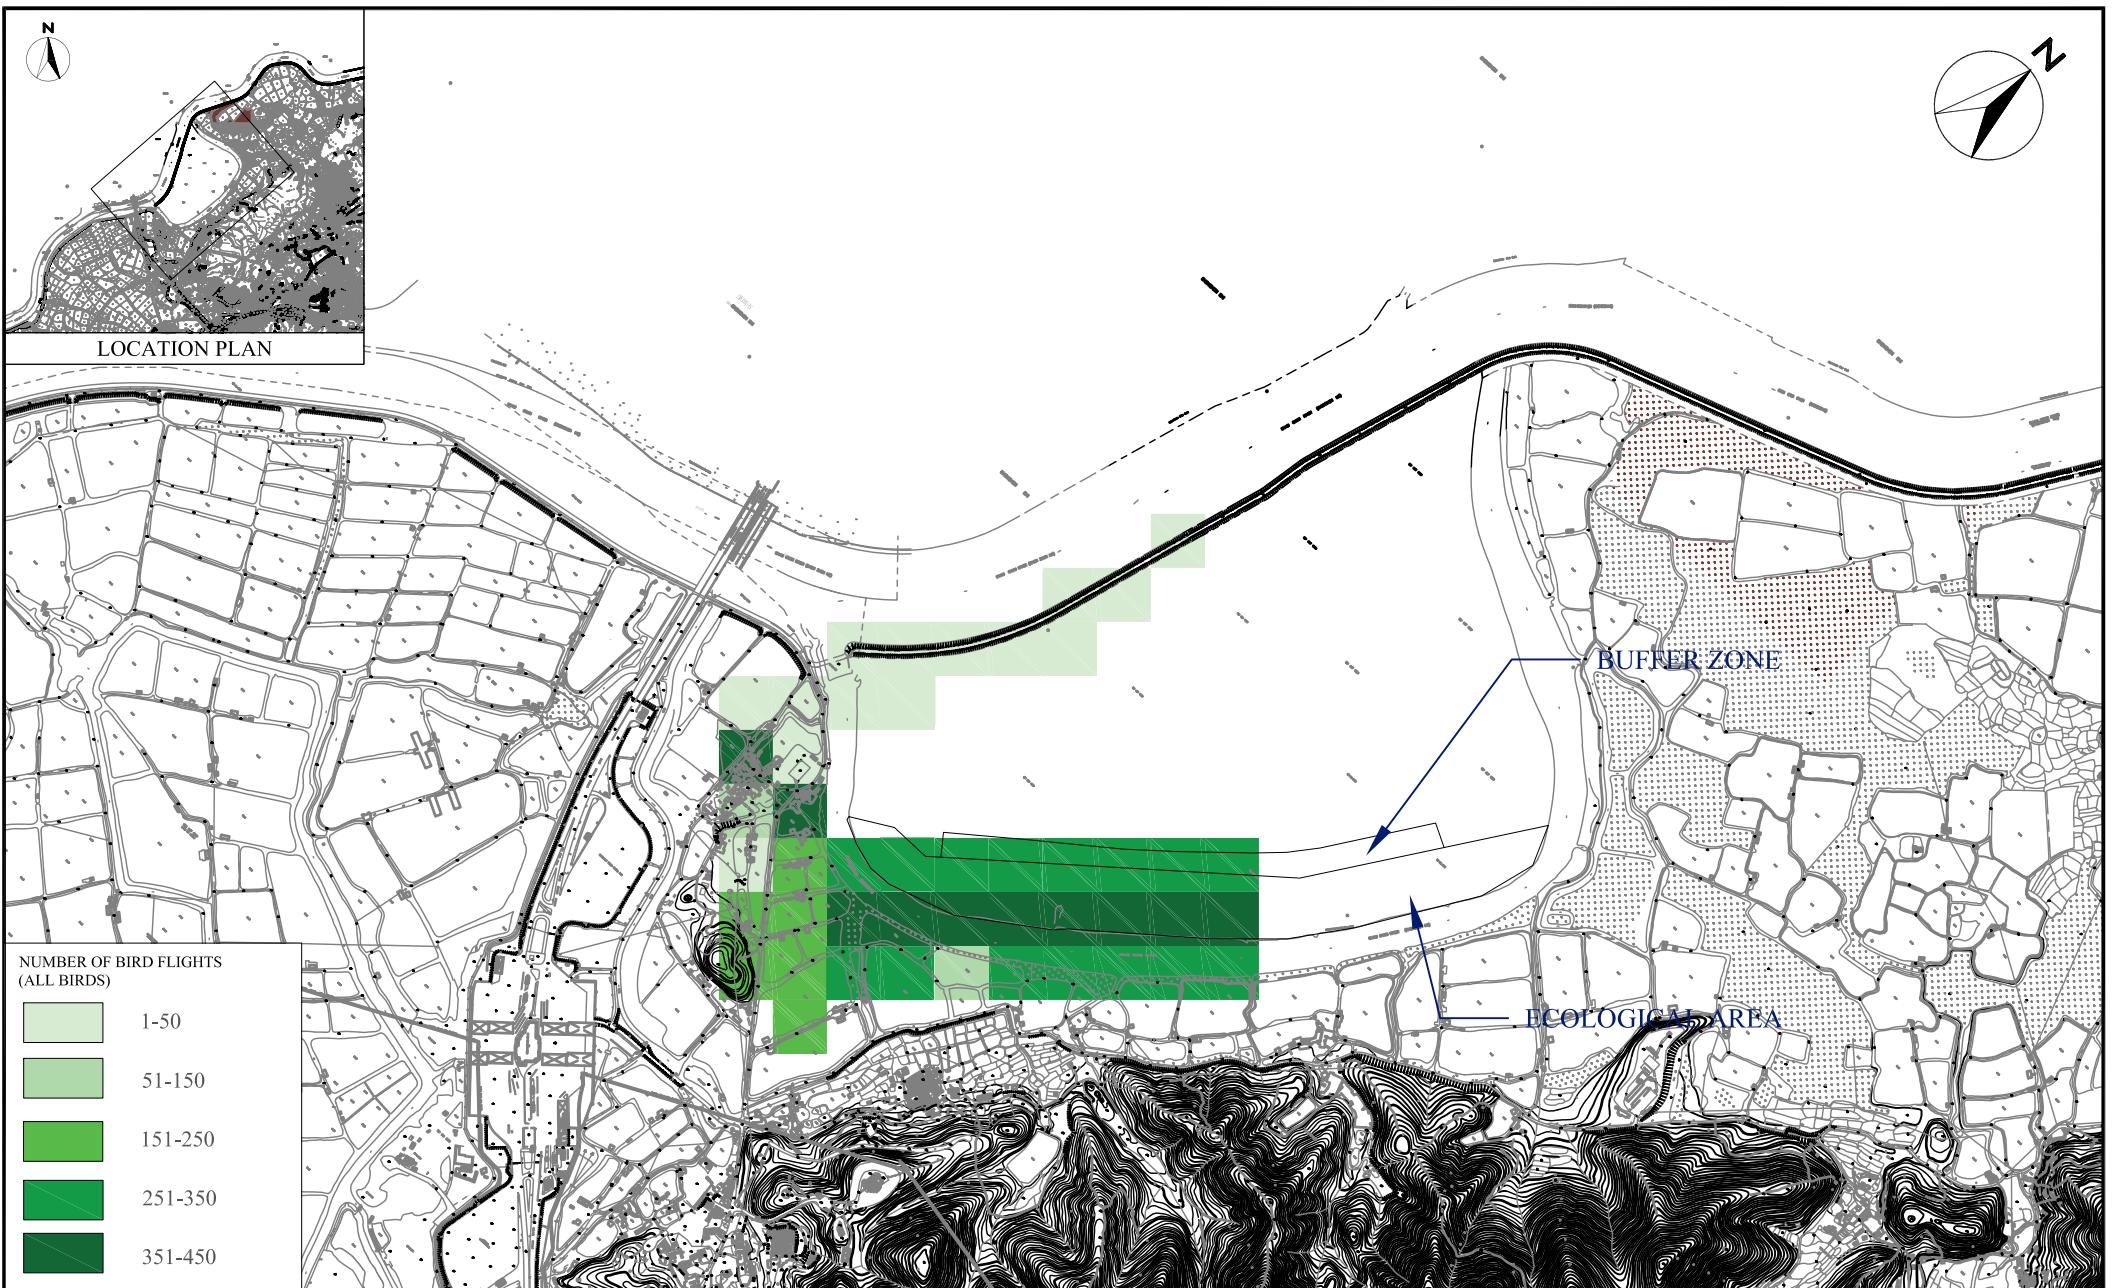
NUMBER OF BIRD FLIGHTS  
(ALL BIRDS)

- 6.15 The total number of bird-flights (number of birds of each species passing through each 100m square) observed across all 100m grid squares was 9,674. **Table 6.2** shows the number of bird-flights for the five species respectively.

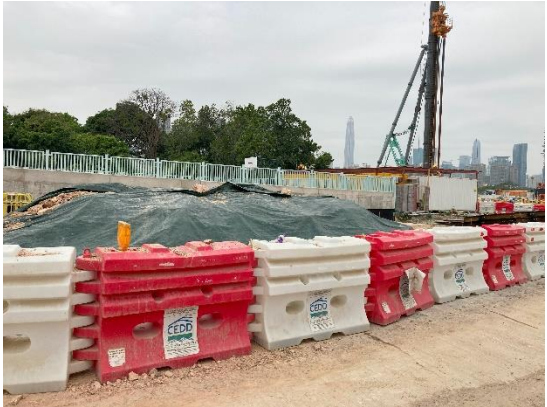
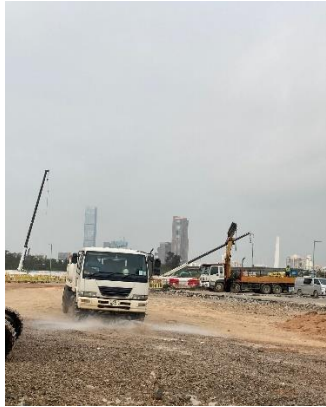
Ref	Location/ Working Period	Anticipated Major Impacts	Recommended Mitigation Measures	Photo Records (Partial)
EIA S3.8	All site area	Dust impact	<ul style="list-style-type: none"> <li>Any excavated or stockpile of dusty material should be covered entirely by impervious sheeting or sprayed with water to maintain the entire surface wet and then removed or backfilled or reinstated where practicable within 24 hours of the excavation or unloading;</li> <li>Any dusty materials remaining after a stockpile is removed should be wetted with water and cleared from the surface of roads;</li> </ul>

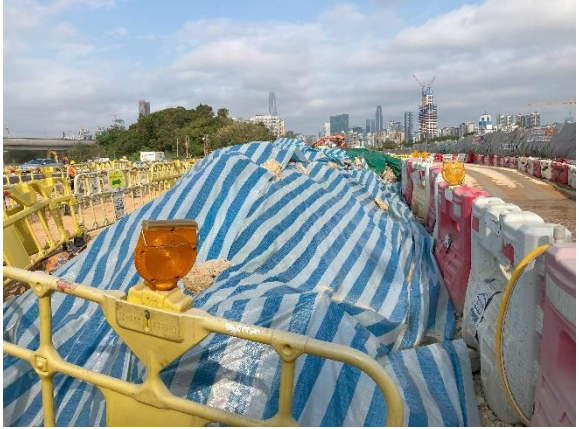
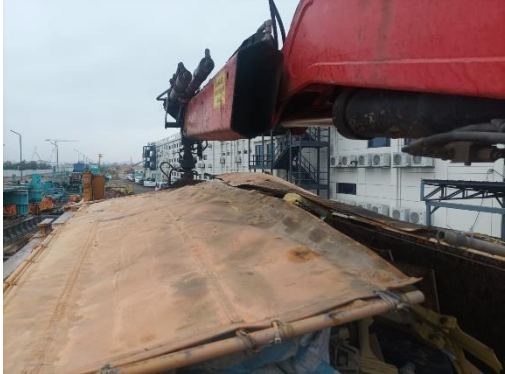
Ref	Location/ Working Period	Anticipated Major Impacts	Recommended Mitigation Measures	Photo Records (Partial)
EIA S3.8	All site area	Dust impact	<ul style="list-style-type: none"> <li>• A stockpile of dusty material should not be extended beyond the pedestrian barriers, fencing or traffic cones;</li> <li>• The load of dusty materials on a vehicle leaving a construction site should be covered entirely by impervious sheeting to ensure that the dusty materials do not leak from the vehicle;</li> </ul>

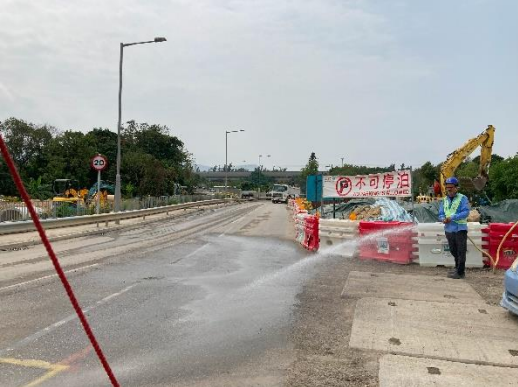
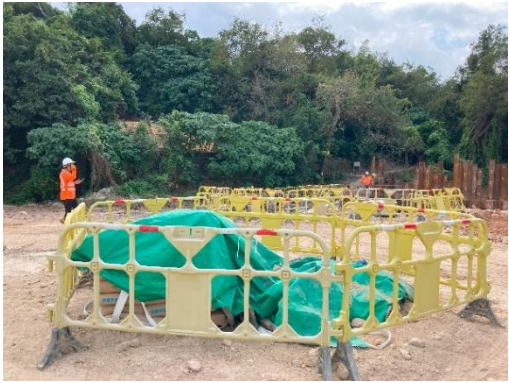
Ref	Location/ Working Period	Anticipated Major Impacts	Recommended Mitigation Measures	Photo Records (Partial)
EIA S3.8	All site area	Dust impact	<ul style="list-style-type: none"> <li>• The portion of any road leading only to construction site that is within 30m of a vehicle entrance or exit should be kept clear of dusty materials;</li> <li>• Every stock of more than 20 bags of cement or dry pulverised fuel ash (PFA) should be covered entirely by impervious sheeting or placed in an area sheltered on the top and the 3 sides;</li> </ul>

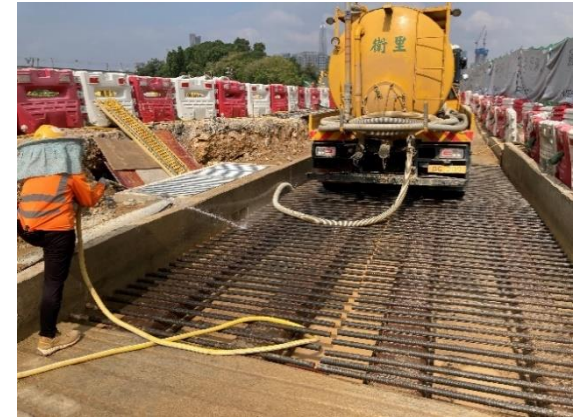
- Where practicable, vehicle washing facilities with high pressure water jet should be provided at every discernible or designated vehicle exit point. The area where vehicle washing takes place and the road section between the washing facilities and the exit point should be paved with concrete, bituminous materials or hardcores.

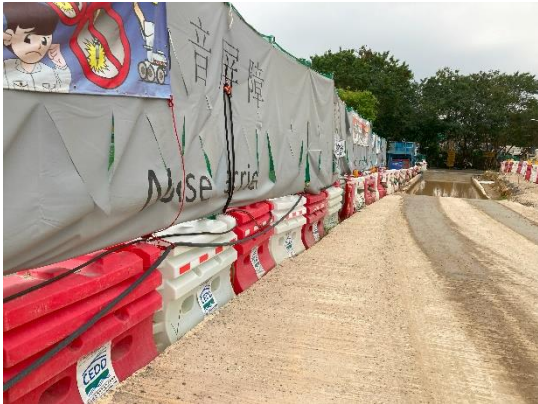
Ref	Location/ Working Period	Anticipated Major Impacts	Recommended Mitigation Measures	Photo Records (Partial)
EIA S4.8	All site area	Noise impact	<ul style="list-style-type: none"> <li>Mobile plant should be sited as far away from NSRs as possible and practicable;</li> <li>All generator used onsite are Quality Powered Mechanical Equipment (QPME) registered with EPD.</li> <li>Install movable noise barriers and full enclosure, screen the noisy plants including air compressor and generator.</li> </ul>

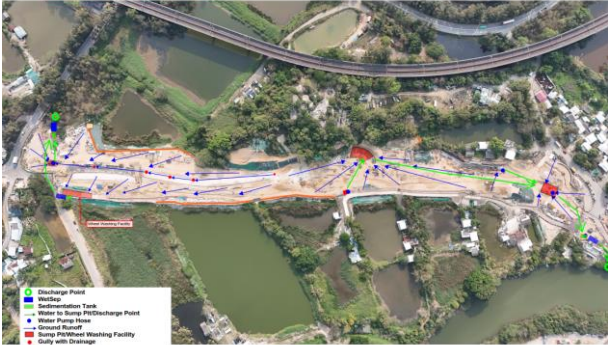
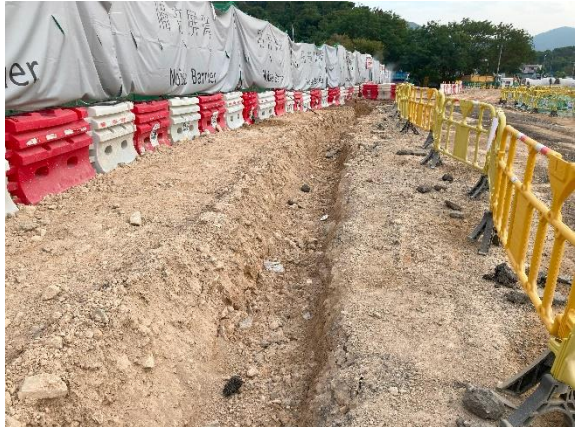
Ref	Location/ Working Period	Anticipated Major Impacts	Recommended Mitigation Measures	Photo Records (Partial)
EIA S5.7	All site area	Water Pollution Control	<ul style="list-style-type: none"> <li>Update and implementation of Stormwater Pollution Control Plan.</li> <li>At the start of site establishment, perimeter cut-off drains to direct off-site water around the site should be constructed with internal drainage works and erosion and sedimentation control facilities implemented. Channels (both temporary and permanent drainage pipes and culverts), earth bunds or sand bag barriers should be provided on site to direct stormwater to silt removal facilities. The design of the temporary on-site drainage system will be undertaken by the contractor prior to the commencement of construction.</li> </ul>	<p>WCR drainage arrangement</p>

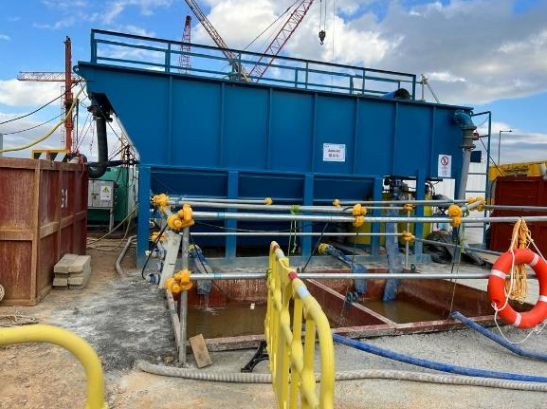
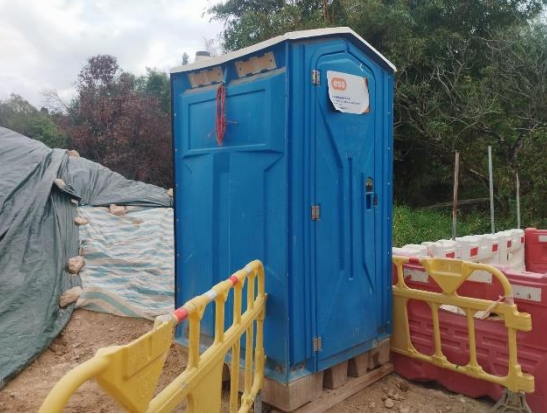
Ref	Location/ Working Period	Anticipated Major Impacts	Recommended Mitigation Measures	Photo Records (Partial)
			<ul style="list-style-type: none"> <li>The design of efficient silt removal facilities should be based on the guidelines in Appendix A1 of ProPECC PN 1/94. The detailed design of the sand/silt traps should be undertaken by the contractor prior to the commencement of construction.</li> </ul> <p>All drainage facilities and erosion and sediment control structures should be regularly inspected and maintained to ensure proper and efficient operation at all times and particularly following rainstorms.</p> <ul style="list-style-type: none"> <li>Portable chemical toilets and sewage holding tanks should be provided for handling the construction sewage generated by the workforce. A licensed contractor should be employed to provide appropriate and adequate portable toilets to cater 0.15m<sup>3</sup>/day/employed populations and be responsible for appropriate disposal and maintenance.</li> </ul>

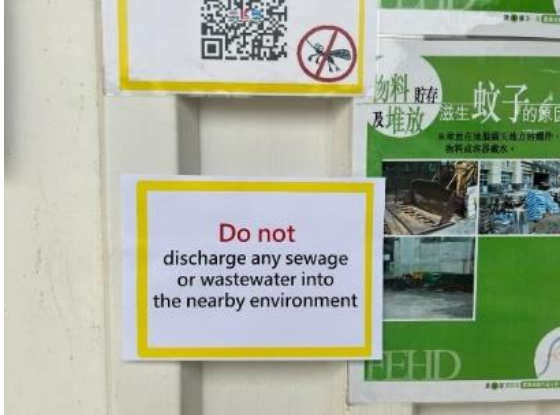
Ref	Location/ Working Period	Anticipated Major Impacts	Recommended Mitigation Measures	Photo Records (Partial)
			<ul style="list-style-type: none"> <li>• Notices should be posted at conspicuous locations to remind the workers not to discharge any sewage or wastewater into the nearby environment during the construction phase of the Project. Regular environmental audit on the construction site should be conducted in order to provide an effective control of any malpractices and achieve continual improvement of environmental performance on site.</li> </ul>

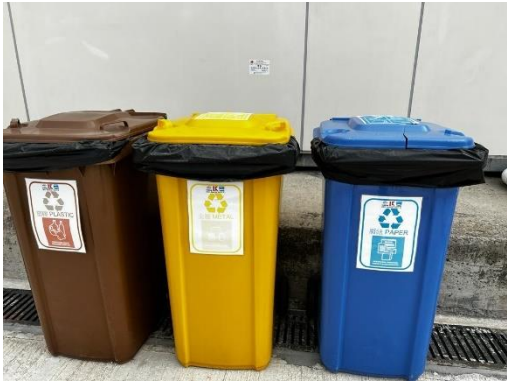
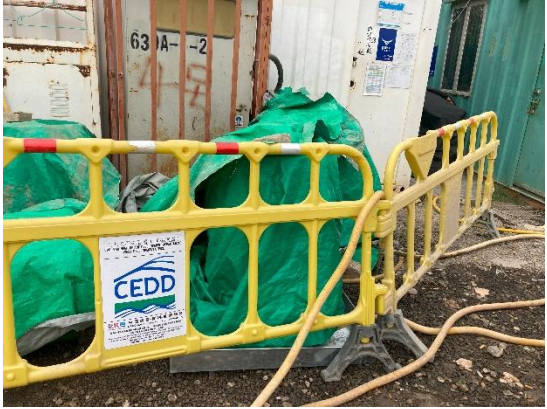
Ref	Location/ Working Period	Anticipated Major Impacts	Recommended Mitigation Measures	Photo Records (Partial)
EIA S7.6	All site area	Waste Generation	<ul style="list-style-type: none"> <li>• Segregate and store different types of waste in different containers, skip or stockpiles to enhance reuse or recycling of materials and their proper disposal;</li> <li>• Proper storage and site practices to minimize the potential for damage and contamination of construction materials;</li> </ul>

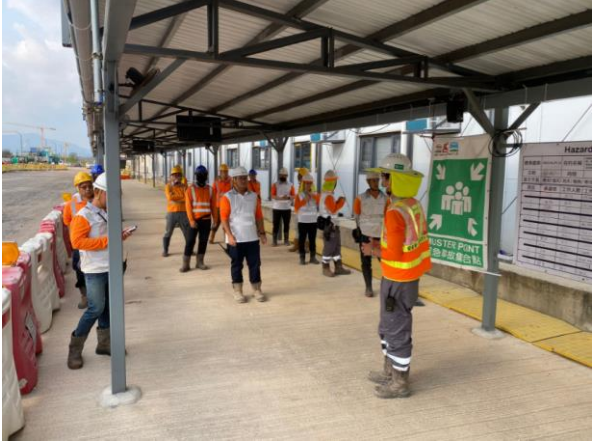
Ref	Location/ Working Period	Anticipated Major Impacts	Recommended Mitigation Measures	Photo Records (Partial)
			<ul style="list-style-type: none"><li>• Provide training to workers on the importance of appropriate waste management procedures, including waste reduction, reuse and recycling.</li></ul>

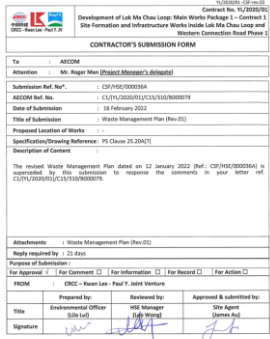
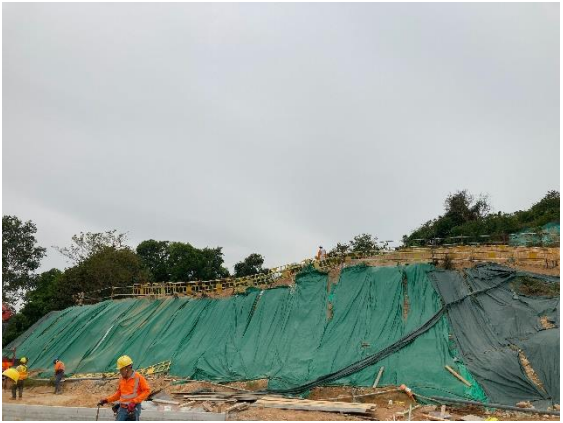
Ref	Location/ Working Period	Anticipated Major Impacts	Recommended Mitigation Measures	Photo Records (Partial)
			<ul style="list-style-type: none"> <li>• Prepare Waste Management Plan and submit to the Engineer for approval</li> <li>• Proper storage and sorting of excavated inert materials to maximize on site reuse for backfilling</li> </ul>

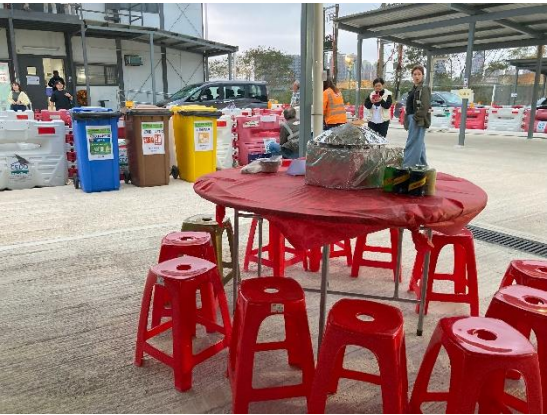
Ref	Location/ Working Period	Anticipated Major Impacts	Recommended Mitigation Measures	Photo Records (Partial)
			<ul style="list-style-type: none"> <li>• General refuse should be stored in enclosed bins separately from construction and chemical wastes. Recycling bins should also be placed to encourage recycling.</li> </ul>

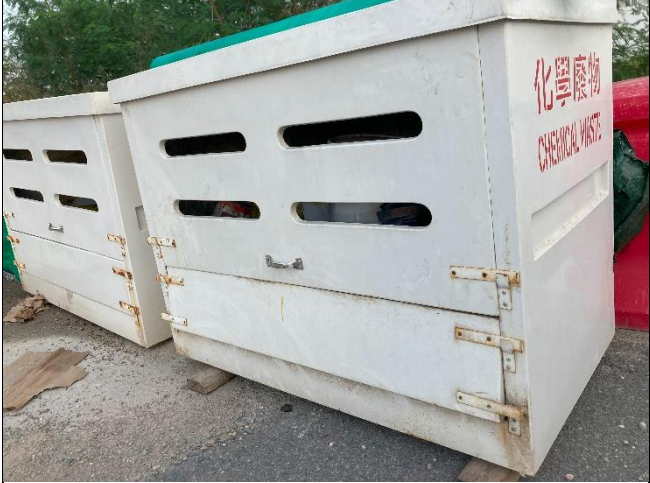
Ref	Location/ Working Period	Anticipated Major Impacts	Recommended Mitigation Measures	Photo Records (Partial)
			<ul style="list-style-type: none"> <li>If chemical wastes are produced at the construction site, the Contractors should register with EPD as chemical waste producers. Chemical wastes should be stored in appropriate containers and collected by a licensed chemical waste contractor. Chemical wastes (e.g. spent lubricant oil) should be recycled at an appropriate facility as far as possible, while the chemical waste that cannot be recycled should be disposed of at either the Chemical Waste Treatment Centre, or another licensed facility, in accordance with the Waste Disposal (Chemical Waste) (General) Regulation.</li> </ul>

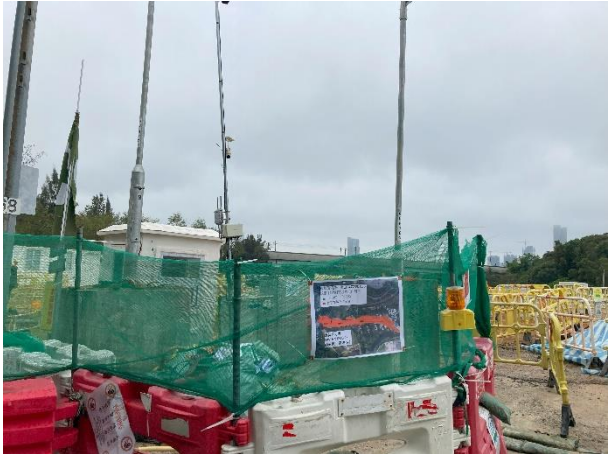
Ref	Location/ Working Period	Anticipated Major Impacts	Recommended Mitigation Measures	Photo Records (Partial)
	Old Shenzhen River meander and other identified important ecologically sensitive areas,		Using powered mechanical equipment for construction works only during the period 9am to 5pm at and near the old Shenzhen River meander and other identified important ecologically sensitive areas, if any;

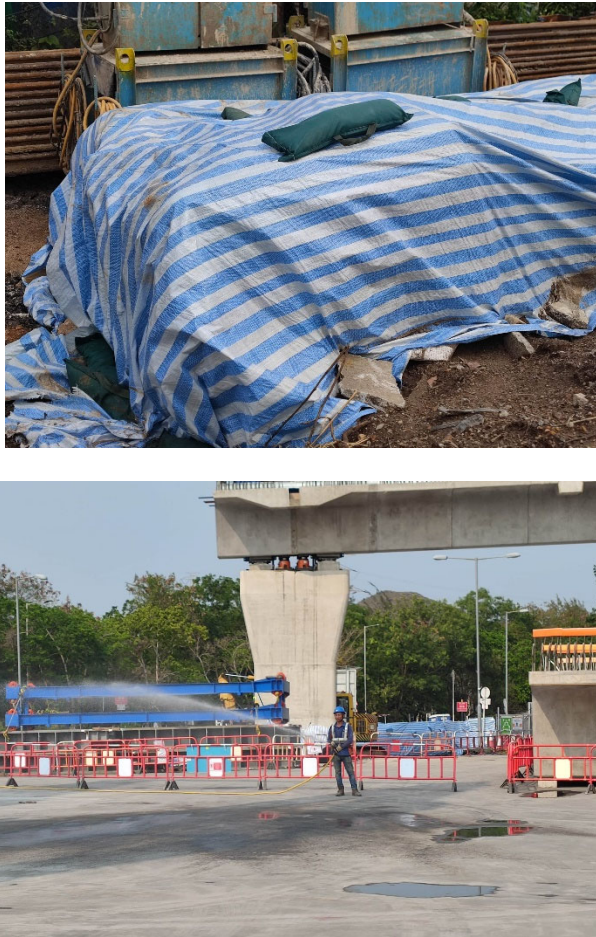
Ref*	Location/Working Period	Anticipated Major Impacts	Recommended Mitigation Measures	Photo Records (Partial)
EIA S3.8	All site area	Dust impact	<ul style="list-style-type: none"> <li>Any excavated or stockpile of dusty material should be covered entirely by impervious sheeting or sprayed with water to maintain the entire surface wet and then removed or backfilled or reinstated where practicable within 24 hours of the excavation or unloading;</li> <li>Any dusty materials remaining after a stockpile is removed should be wetted with water and cleared from the surface of roads;</li> </ul>

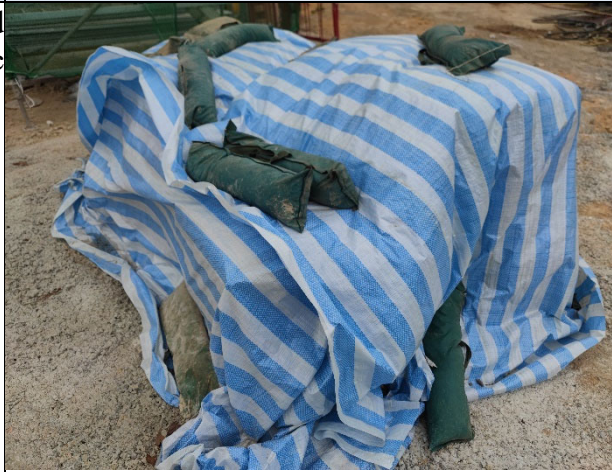
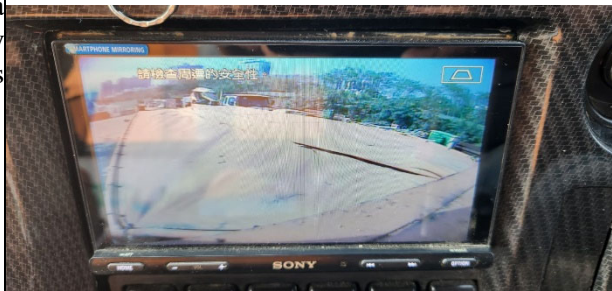
Ref*	Location/ Working Period	Anticipated Major Impacts	Recommended Mitigation Measures	Photo Records (Partial)
EIA S3.8	All site area	Dust impact	<ul style="list-style-type: none"> <li>• A stockpile of dusty material should not be extend beyond the pedestrian barriers, fencing or traffic cones;</li> <li>• The load of dusty materials on a vehicle leaving a construction site should be covered entirely by impervious sheeting to ensure that the dusty materials do not leak from the vehicle;</li> </ul>

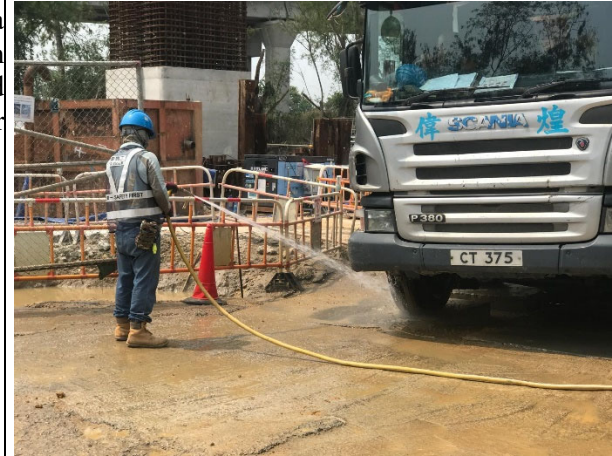
• Where practicable, vehicle washing facilities with high pressure water jet should be provided at every discernible or designated vehicle exit point. The area where vehicle washing takes place and the road section between the washing facilities and the exit point should be paved with concrete, bituminous materials or hardcores.

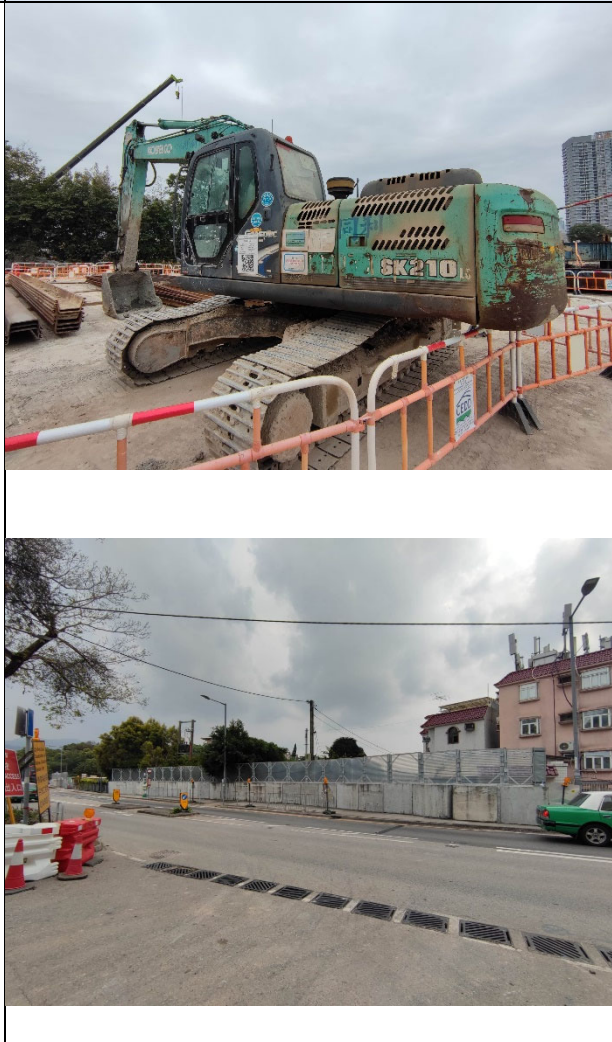
Ref*	Location/ Working Period	Anticipated Major Impacts	Recommended Mitigation Measures	Photo Records (Partial)
EIA S4.8	All site area	Noise impact	<ul style="list-style-type: none"> <li>• Mobile plant should be sited as far away from NSRs as possible and practicable;</li> <li>• Install movable noise barriers and full enclosure, screen the noisy plants including air compressor and generator.</li> </ul>

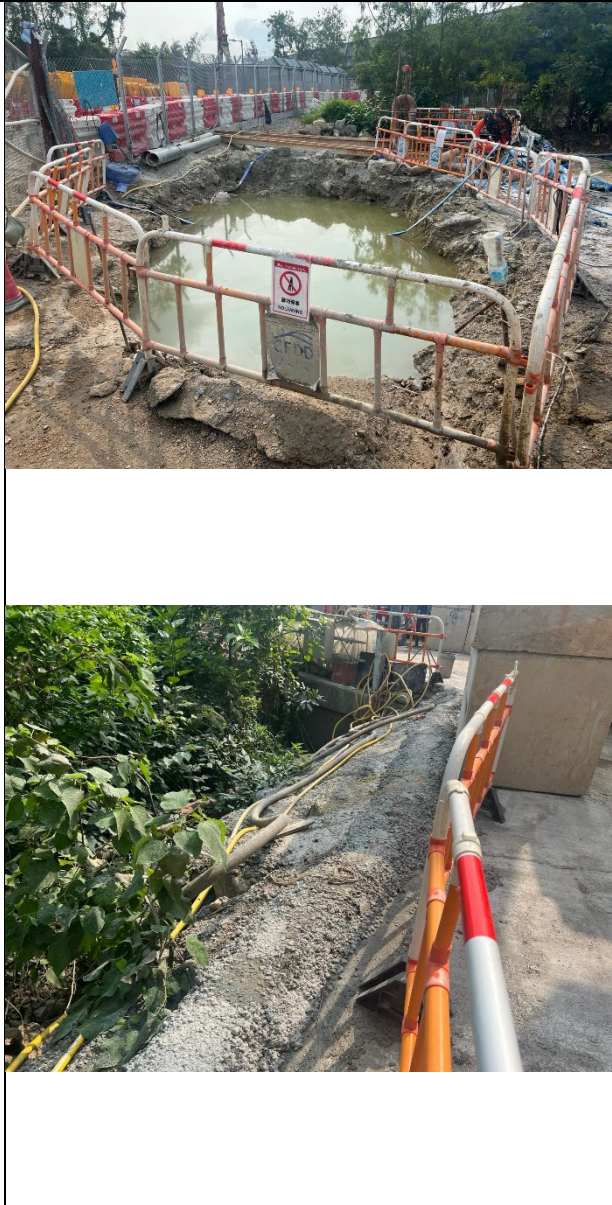
EIA S5.7	All site area	Water Pollution Control	<ul style="list-style-type: none"><li>• At the start of site establishment, perimeter cut-off drains to direct off-site water around the site should be constructed with internal drainage works and erosion and sedimentation control facilities implemented. Channels (both temporary and permanent drainage pipes and culverts), earth bunds or sand bag barriers should be provided on site to direct stormwater to silt removal facilities. The design of the temporary on-site drainage system will be undertaken by the contractor prior to the commencement of construction.</li> <li>• Diversion of natural stormwater should be provided as far as possible. The design of temporary on-site drainage should prevent runoff going through site surface, construction machinery and equipment in order to avoid or minimize polluted runoff.</li></ul>

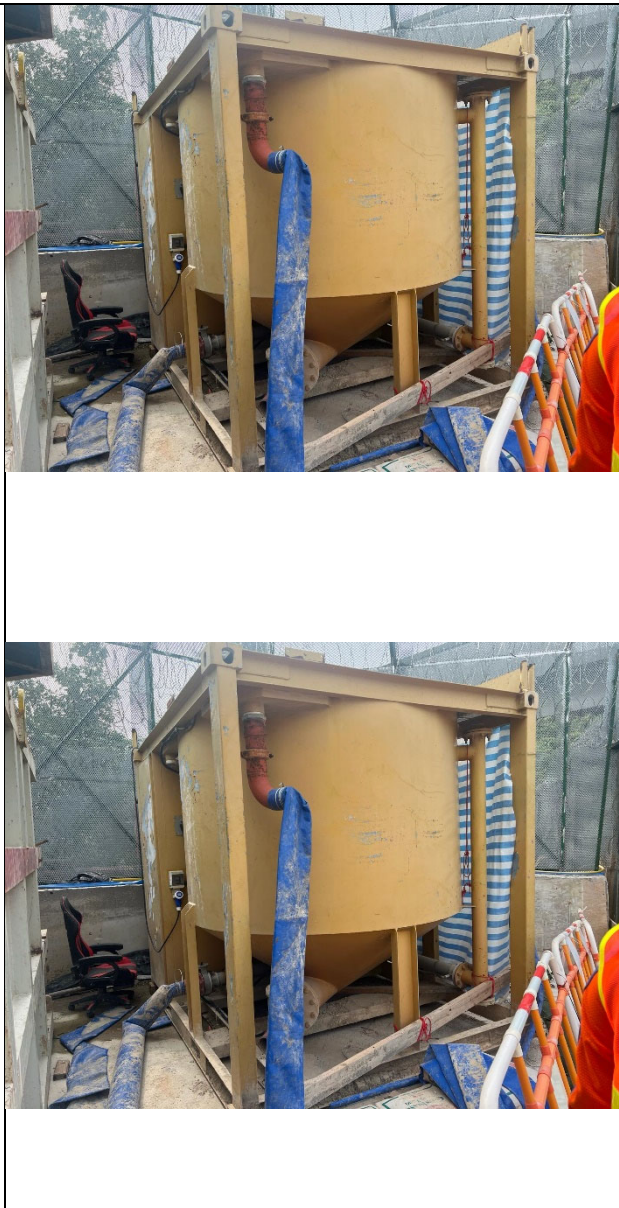
<ul style="list-style-type: none"><li>• Sedimentation tanks with sufficient capacity, constructed from pre-formed individual cells of approximately 6 to 8 m<sup>3</sup> capacities, are recommended as a general mitigation measure which can be used for settling surface runoff prior to disposal. The system capacity shall be flexible and able to handle multiple inputs from a variety of sources and suited to applications where the influent is pumped.</li> <li>• The design of efficient silt removal facilities should be based on the guidelines in Appendix A1 of ProPECC PN 1/94. The detailed design of the sand/silt traps should be undertaken by the contractor prior to the commencement of construction.</li></ul>

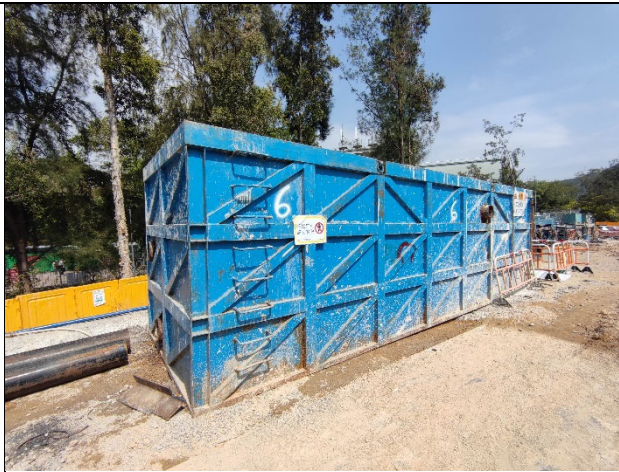
<ul style="list-style-type: none"><li>• Notices should be posted at conspicuous locations to remind the workers not to discharge any sewage or wastewater into the nearby environment during the construction phase of the Project. Regular environmental audit on the construction site should be conducted in order to provide an effective control of any malpractices and achieve continual improvement of environmental performance on site.</li></ul>

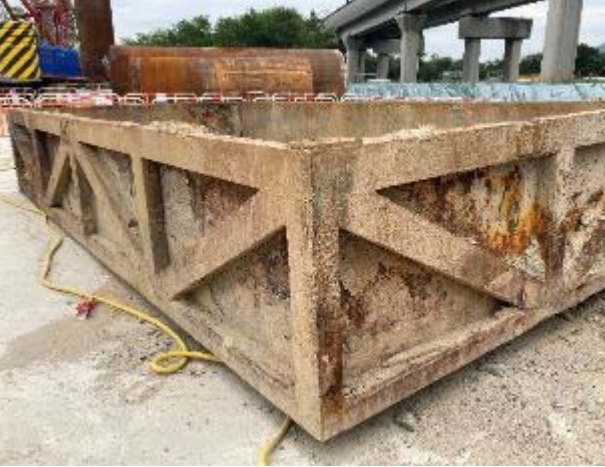
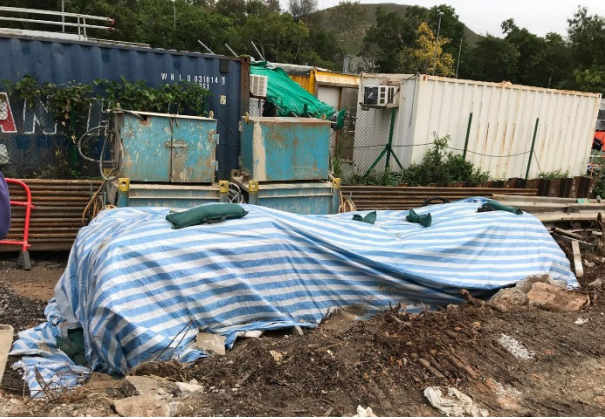
Ref*	Location/ Working Period	Anticipated Major Impacts	Recommended Mitigation Measures	Photo Records (Partial)
EIA S7.6	All site area	Waste Generation	<ul style="list-style-type: none"> <li>• Segregate and store different types of waste in different containers, skip or stockpiles to enhance reuse or recycling of materials and their proper disposal;</li> <li>• Proper storage and site practices to minimize the potential for damage and contamination of construction materials;</li> </ul>

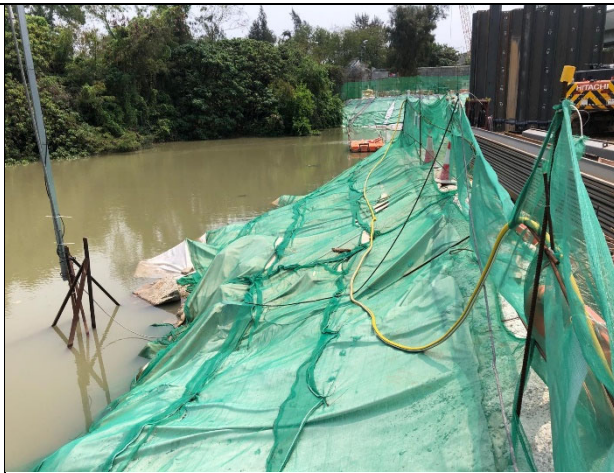
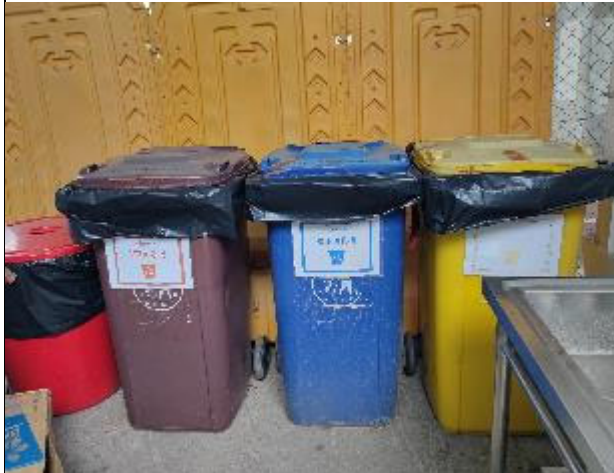
<ul style="list-style-type: none"><li>• Proper storage and sorting of excavated inert materials to maximize on site reuse for backfilling</li>          <li>• General refuse should be stored in enclosed bins separately from construction and chemical wastes. Recycling bins should also be placed to encourage recycling.</li></ul>

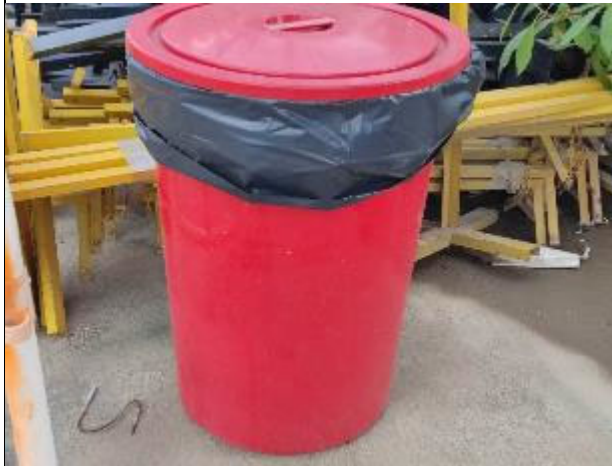
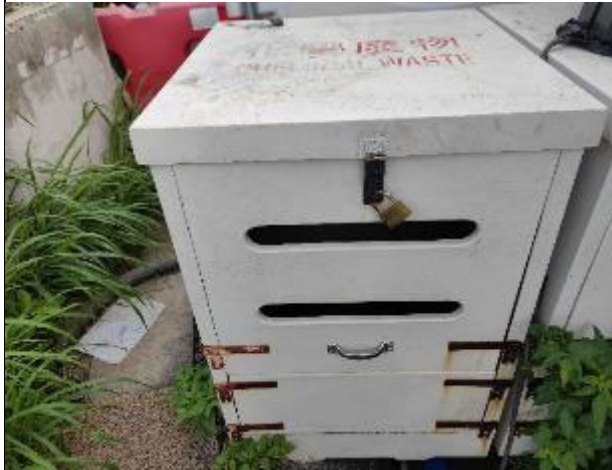
<ul style="list-style-type: none"><li>• Preferably enclosed and covered areas should be provided for general refuse collection and routine cleaning for these areas should also be implemented to keep areas clean.</li> <li>• If chemical wastes are produced at the construction site, the Contractors should register with EPD as chemical waste producers. Chemical wastes should be stored in appropriate containers and collected by a licensed chemical waste contractor. Chemical wastes (e.g. spent lubricant oil) should be recycled at an appropriate facility as far as possible, while the chemical waste that cannot be recycled should be disposed of at either the Chemical Waste Treatment Centre, or another licensed facility, in accordance with the Waste Disposal (Chemical Waste) (General) Regulation.</li></ul>

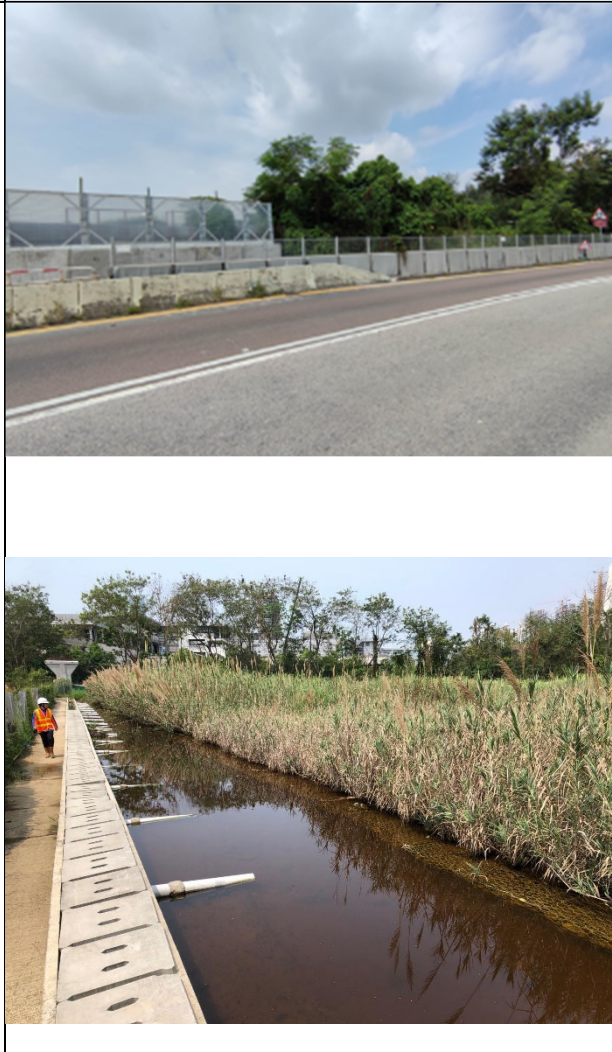
<p>The top photograph shows a road with a newly installed noise barrier. The barrier is a grey, non-reflective material supported by concrete pillars. The bottom photograph shows a reedbed, which is a wetland area with tall reeds and a concrete walkway. A person in an orange safety vest is visible on the walkway.</p>

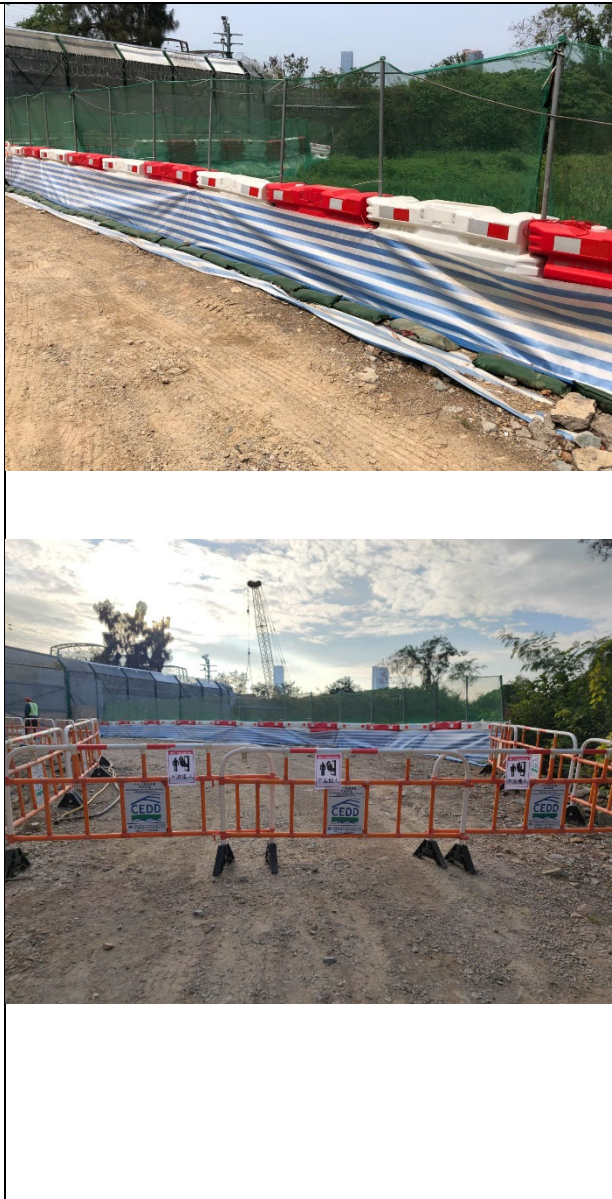
ERR S4.2.2	STEMDC	Ecology	<ul style="list-style-type: none"><li>• Installation of 3m-high olive green fence site hoarding around construction areas to reduce disturbance and such installation should allow passage of animal</li> <li>• Well-defined and fenced work area to prevent intentional or accidental encroachment or trespassing to other part of the mitigation wetland for access, parking, operation of plants/machineries, or stockpiling of construction material/waste nearby</li></ul>

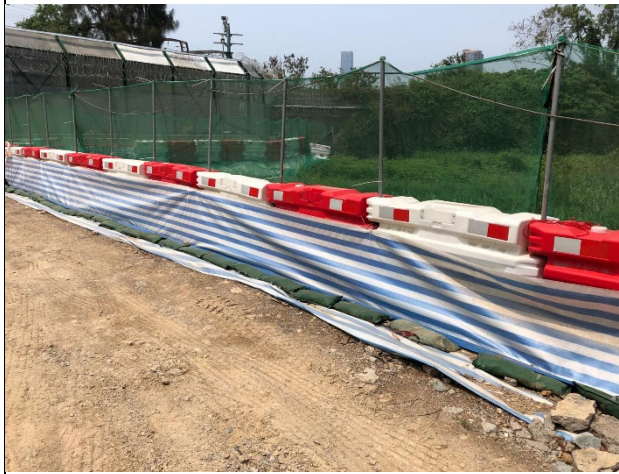
<ul style="list-style-type: none"> <li>Measures to avoid any spillage or discharge of untreated runoff from the site to other part of the mitigation wetland should be implemented, including but not limited to provision of sandbags barrier and perimeter channels at site boundaries,</li> </ul>

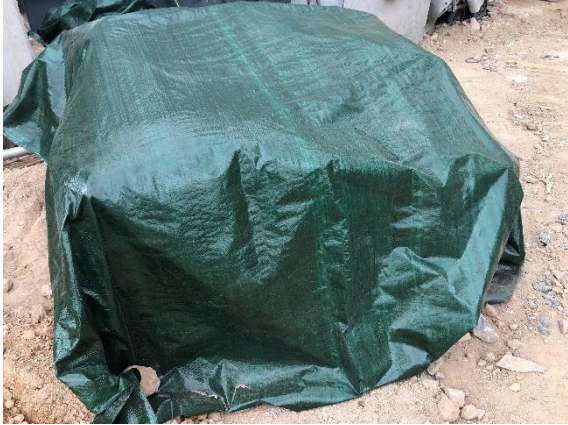
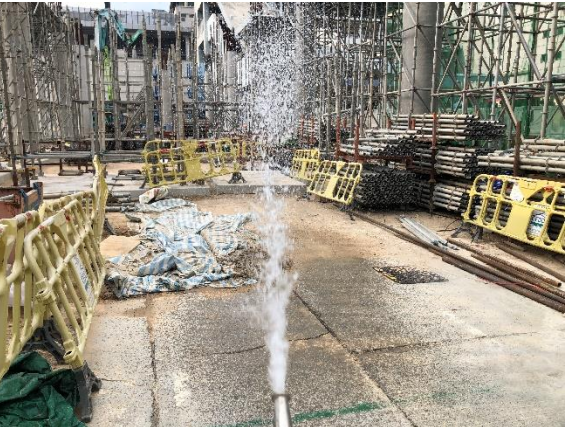
Ref*	Location/ Working Period	Anticipated Major Impacts	Recommended Mitigation Measures	Photo Records (Partial)
EIA S3.8	All site area	Dust impact	<ul style="list-style-type: none"> <li>Any excavated or stockpile of dusty material should be covered entirely by impervious sheeting or sprayed with water to maintain the entire surface wet and then removed or backfilled or reinstated where practicable within 24 hours of the excavation or unloading;</li> <li>Any dusty materials remaining after a stockpile is removed should be wetted with water and cleared from the surface of roads;</li> </ul>

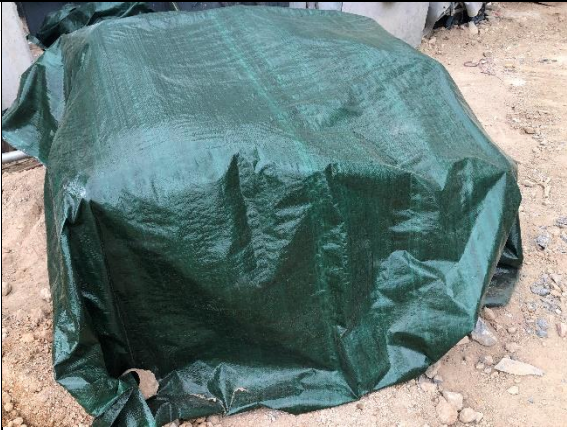
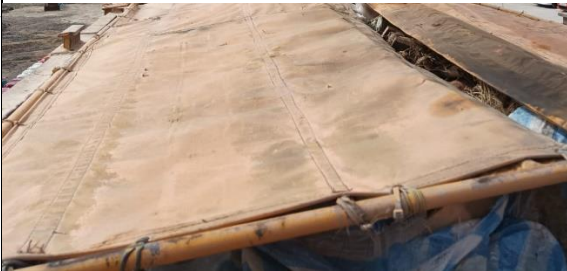
Ref*	Location/ Working Period	Anticipated Major Impacts	Recommended Mitigation Measures	Photo Records (Partial)
EIA S3.8	All site area	Dust impact	<ul style="list-style-type: none"> <li>• A stockpile of dusty material should not be extend beyond the pedestrian barriers, fencing or traffic cones;</li> <li>• The load of dusty materials on a vehicle leaving a construction site should be covered entirely by impervious sheeting to ensure that the dusty materials do not leak from the vehicle;</li> </ul>

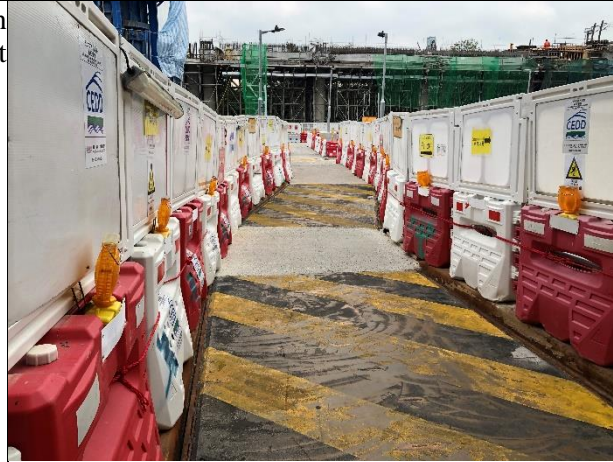
• The portion of any road leading only to construction site that is within 30m of a vehicle entrance or exit should be kept clear of dusty materials;

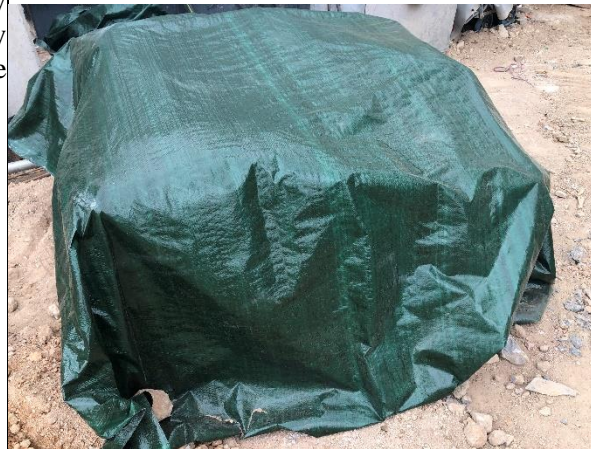
• Every stock of more than 20 bags of cement or dry pulverised fuel ash (PFA) should be covered entirely by impervious sheeting or placed in an area sheltered on the top and the 3 sides;

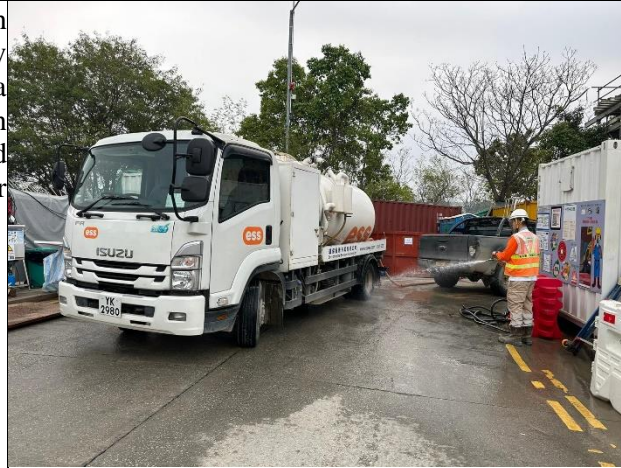
- Where practicable, vehicle washing facilities with high pressure water jet should be provided at every discernible or designated vehicle exit point. The area where vehicle washing takes place and the road section between the washing facilities and the exit point should be paved with concrete, bituminous materials or hardcores.
