**Service Contract No. WD/04/2020  
Development of Lok Ma Chau Loop:  
Main Works Package 1 –  
Environmental Team**

**Environmental Permit No.:  
EP-477/2013/B  
- Development of Lok Ma Chau Loop**

**Monthly Environmental Monitoring and  
Audit Report for March 2024**

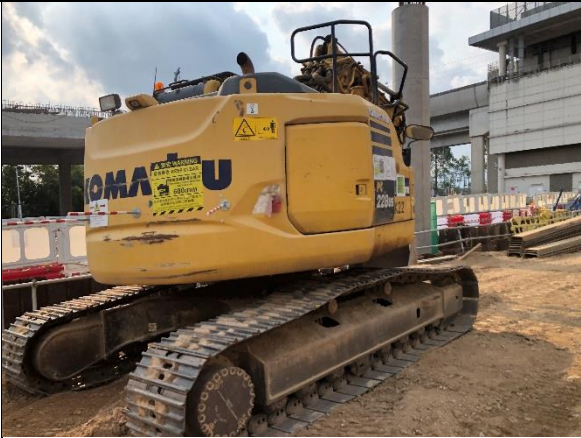
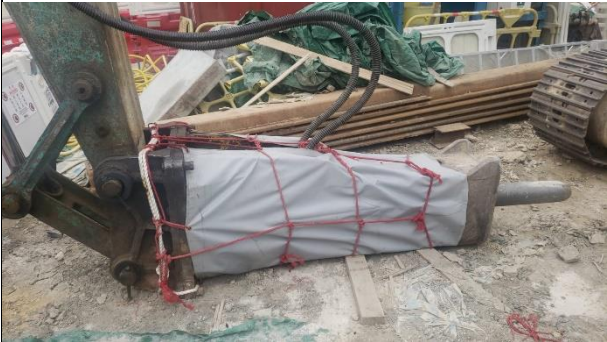
Ref*	Location/ Working Period	Anticipated Major Impacts	Recommended Mitigation Measures	Photo Records (Partial)
EIA S4.8	All site area	Noise impact	<ul style="list-style-type: none"> <li>• Mobile plant should be sited as far away from NSRs as possible and practicable;</li> <li>• Install movable noise barriers and full enclosure, screen the noisy plants including air compressor and generator.</li> </ul>

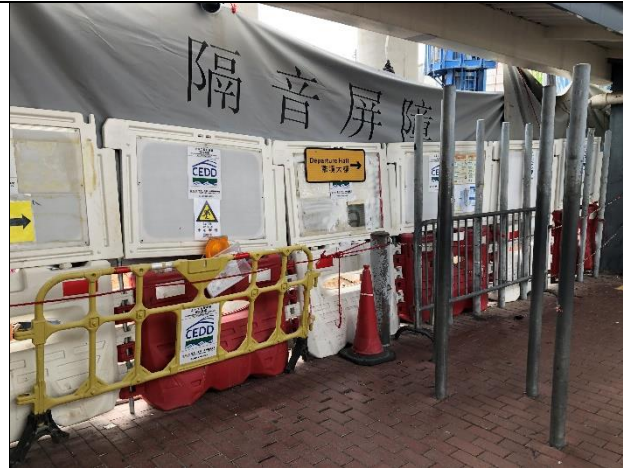
• An acoustic canvas had been deployed along the site boundary facing the public.

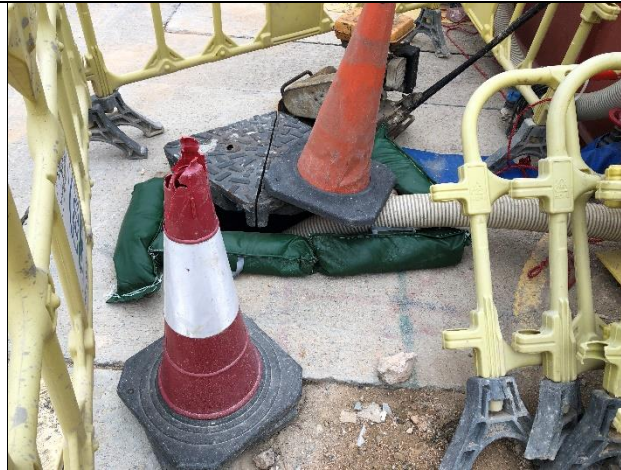
• Diversion of natural stormwater should be provided as far as possible. The design of temporary on-site drainage should prevent runoff going through site surface, construction machinery and equipment in order to avoid or minimize polluted runoff.

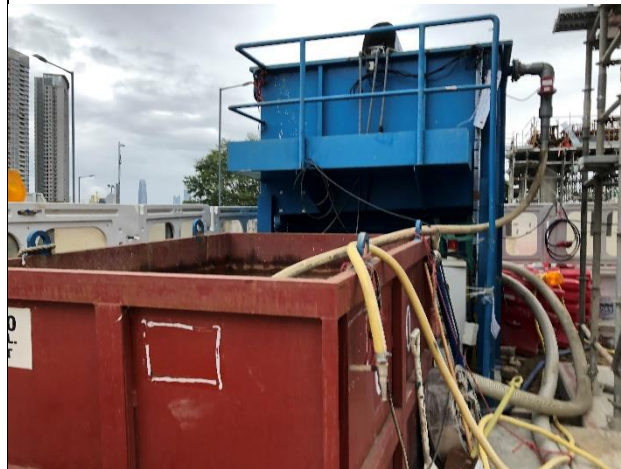
• Sedimentation tanks with sufficient capacity, constructed from pre-formed individual cells of approximately 6 to 8 m<sup>3</sup> capacities, are recommended as a general mitigation measure which can be used for settling surface runoff prior to disposal. The system capacity shall be flexible and able to handle multiple inputs from a variety of sources and suited to applications where the influent is pumped.

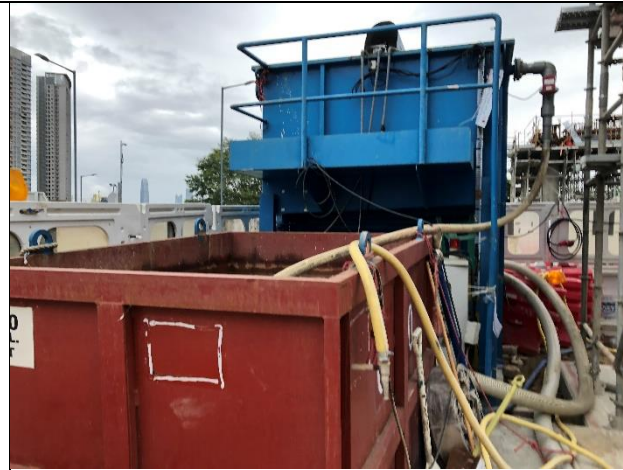
• The design of efficient silt removal facilities should be based on the guidelines in Appendix A1 of ProPECC PN 1/94. The detailed design of the sand/silt traps should be undertaken by the contractor prior to the commencement of construction.

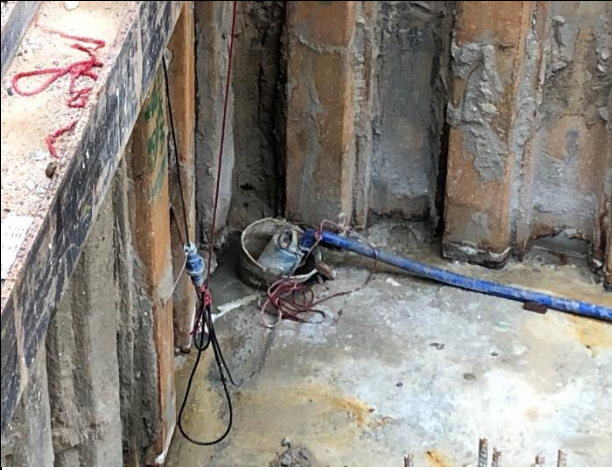
<ul style="list-style-type: none"><li>•An additional water pump had been set up and the concerned outlet have been sealed up with concrete</li></ul>

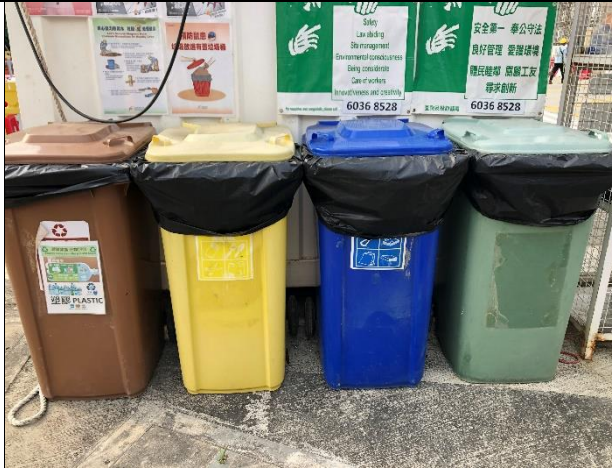
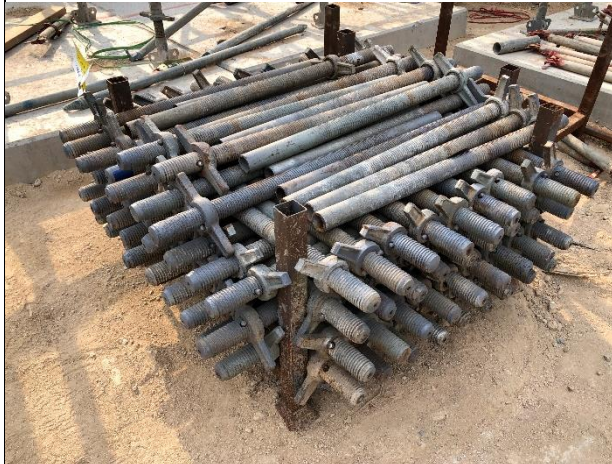
Ref*	Location/ Working Period	Anticipated Major Impacts	Recommended Mitigation Measures	Photo Records (Partial)
EIA S7.6	All site area	Waste Generation	<ul style="list-style-type: none"> <li>• Segregate and store different types of waste in different containers, skip or stockpiles to enhance reuse or recycling of materials and their proper disposal;</li> <li>• Proper storage and site practices to minimize the potential for damage and contamination of construction materials;</li> </ul>

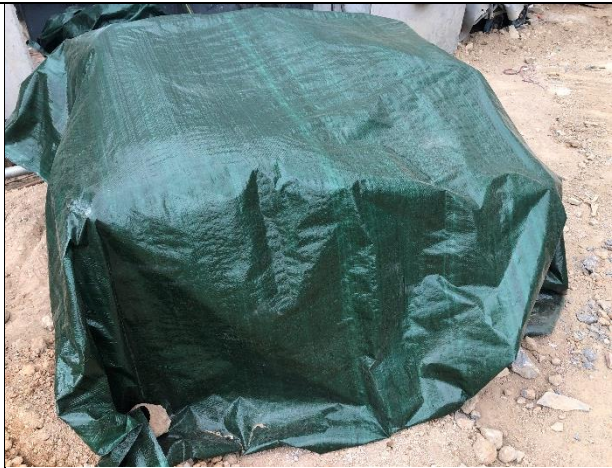
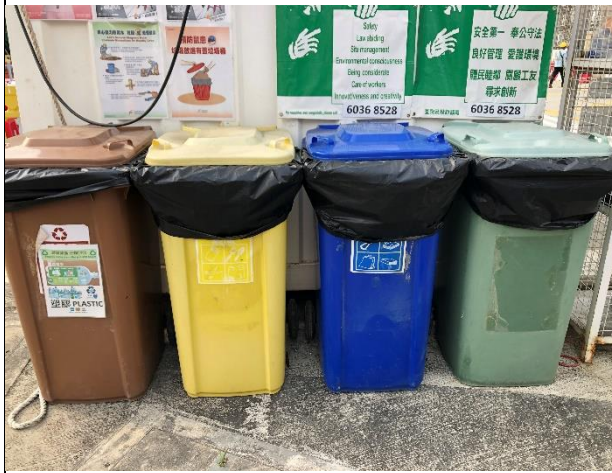
<ul style="list-style-type: none"><li>• Proper storage and sorting of excavated inert materials to maximize on site reuse for backfilling</li>          <li>• General refuse should be stored in enclosed bins separately from construction and chemical wastes. Recycling bins should also be placed to encourage recycling.</li></ul>

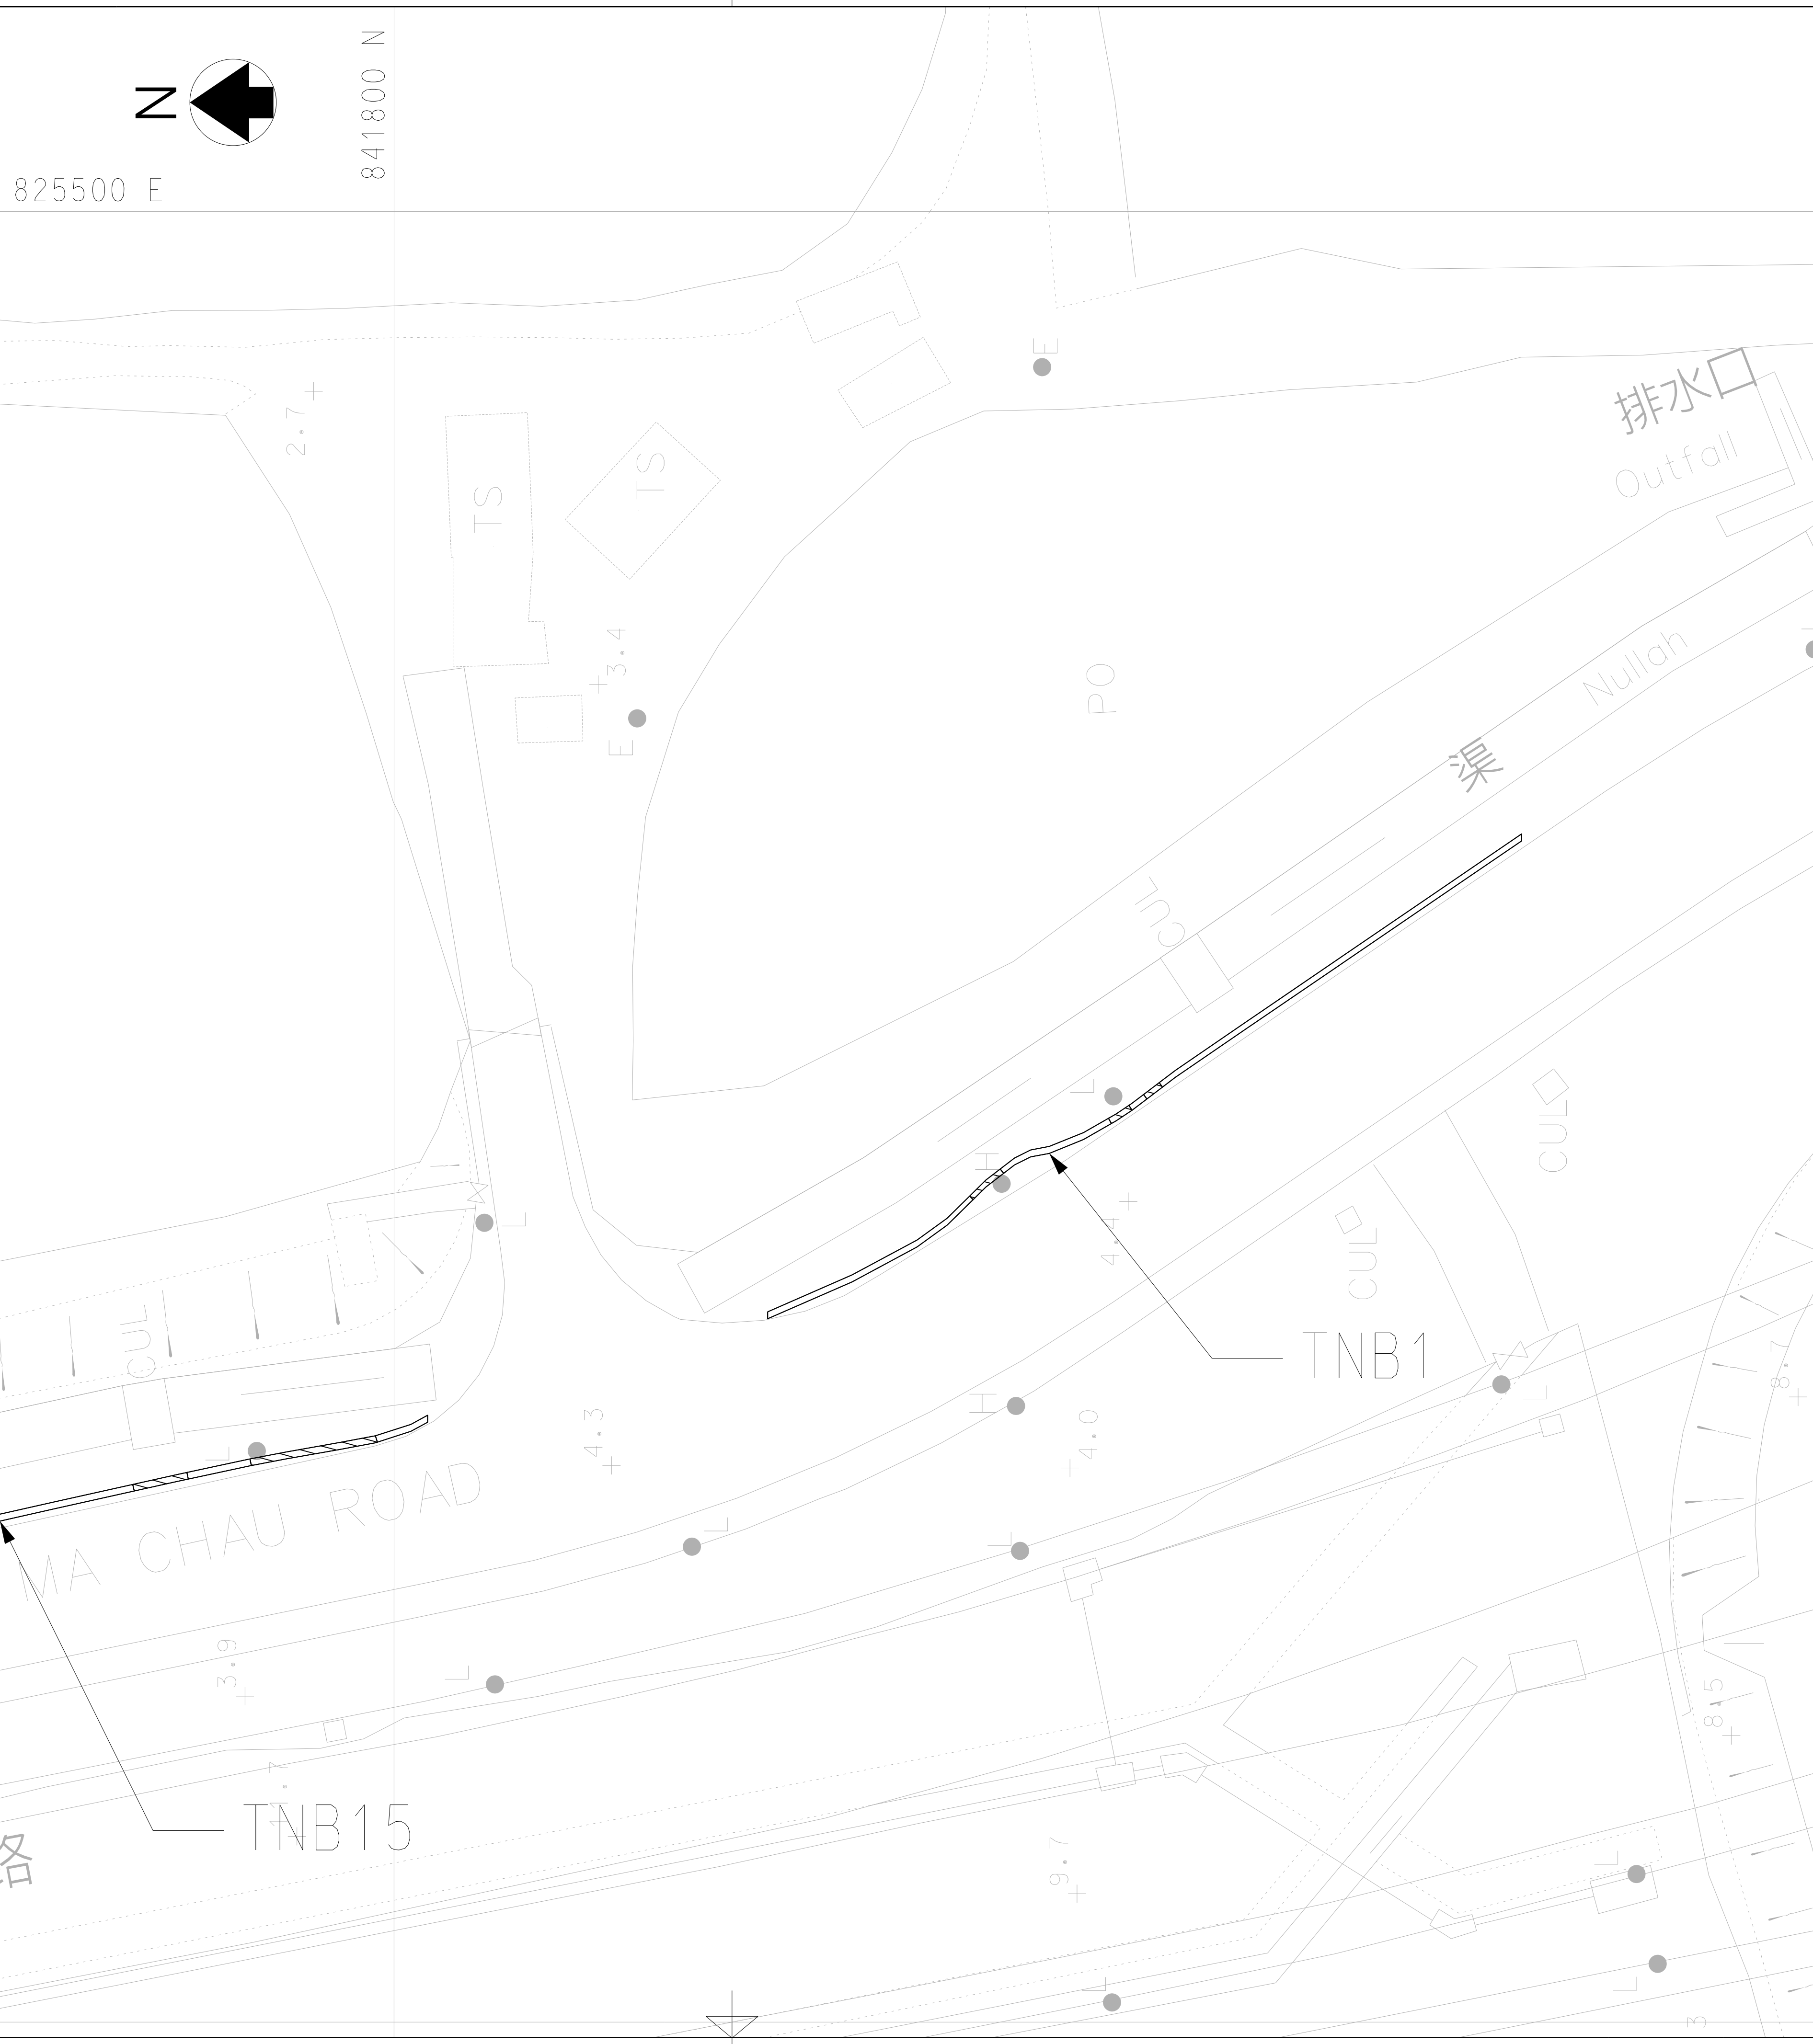
0.8m - HIGH TEMPORARY NOISE BARRIER (TYPE A)  
 0.8m - HIGH TEMPORARY NOISE BARRIER (TYPE B)
