**Service Contract No. WD/04/2020
Development of Lok Ma Chau Loop:
Main Works Package 1 –
Environmental Team**

**Environmental Permit No.:
EP-477/2013/B
- Development of Lok Ma Chau Loop**

**Monthly Environmental Monitoring and
Audit Report for April 2024**

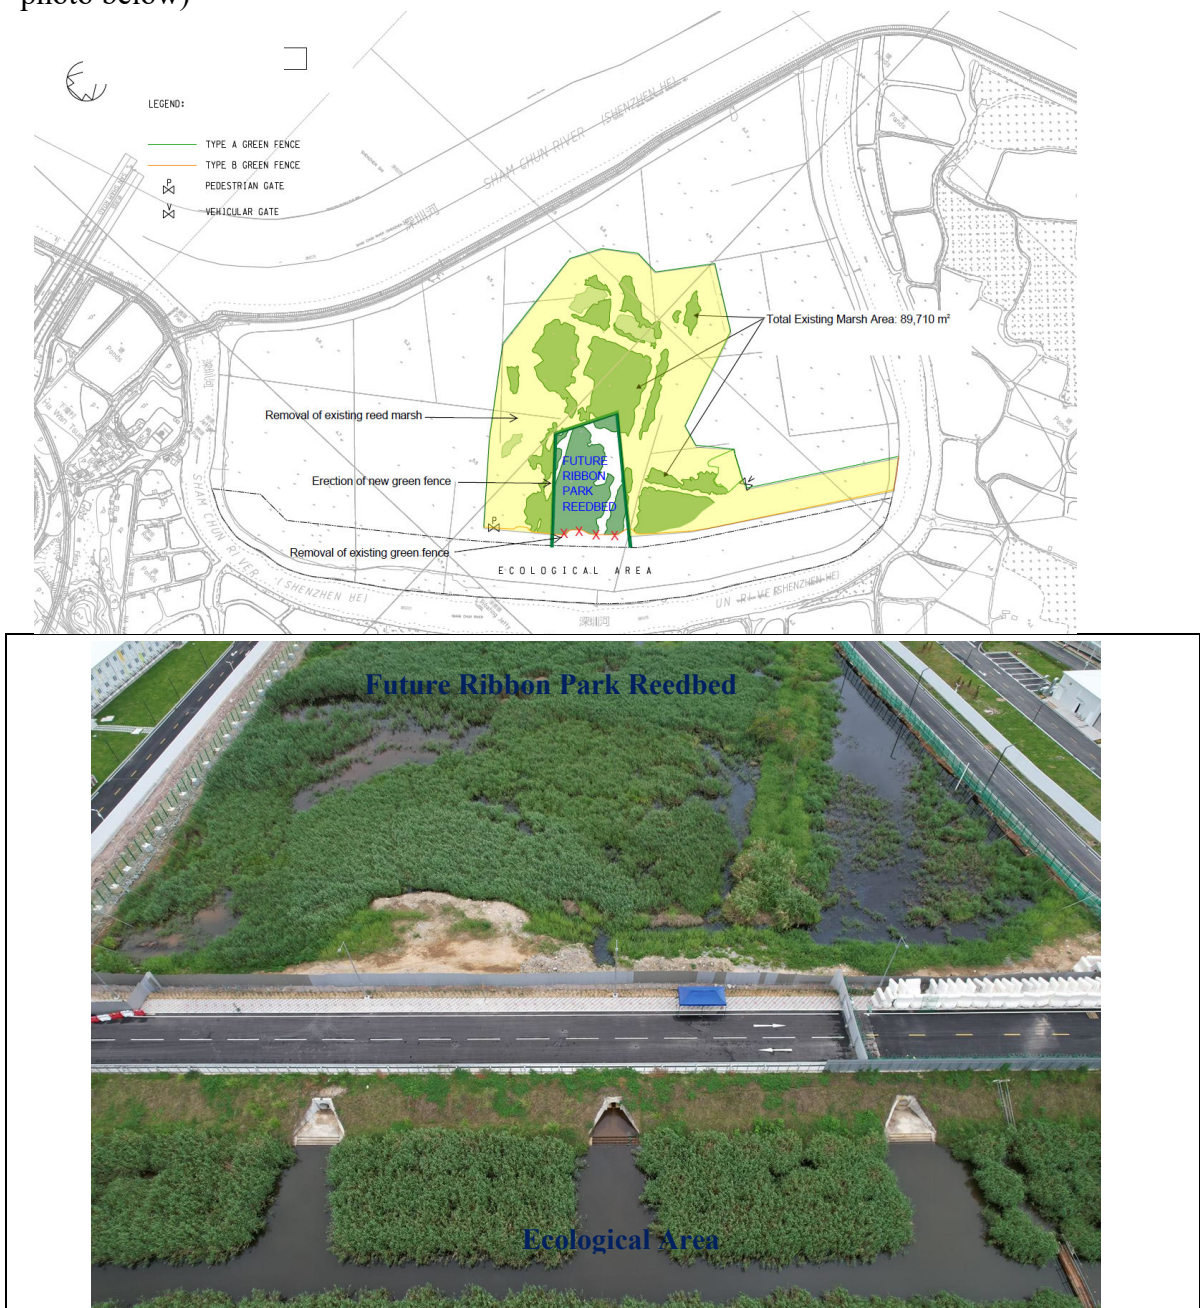
- 10.8 The green fence around the future Ribbon Park Reedbed has been removed and replaced by the hoarding due to the other project’s land occupier since March 2022. (See Figure & photo below)

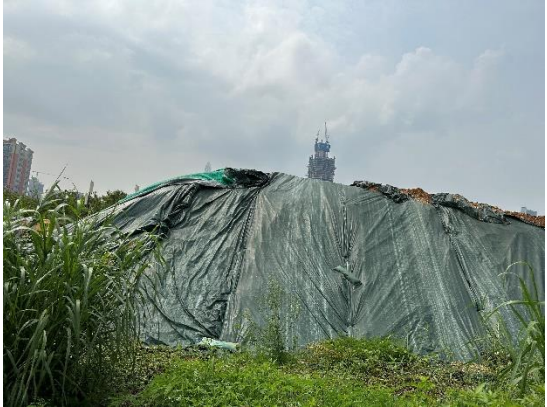
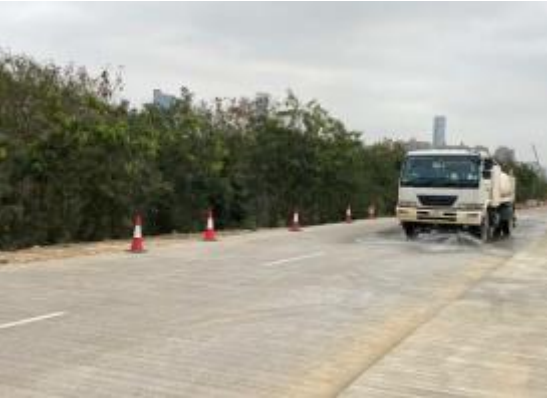
Ref	Location/ Working Period	Anticipated Major Impacts	Recommended Mitigation Measures	Photo Records (Partial)
EIA S3.8	All site area	Dust impact	<ul style="list-style-type: none"> Any excavated or stockpile of dusty material should be covered entirely by impervious sheeting or sprayed with water to maintain the entire surface wet and then removed or backfilled or reinstated where practicable within 24 hours of the excavation or unloading; Any dusty materials remaining after a stockpile is removed should be wetted with water and cleared from the surface of roads;

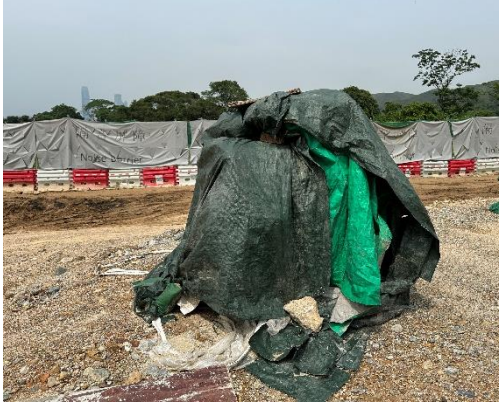
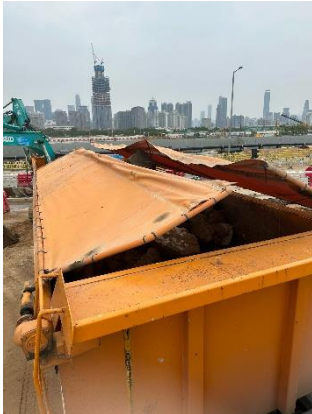
Ref	Location/ Working Period	Anticipated Major Impacts	Recommended Mitigation Measures	Photo Records (Partial)
EIA S3.8	All site area	Dust impact	<ul style="list-style-type: none"> • A stockpile of dusty material should not be extended beyond the pedestrian barriers, fencing or traffic cones; • The load of dusty materials on a vehicle leaving a construction site should be covered entirely by impervious sheeting to ensure that the dusty materials do not leak from the vehicle;

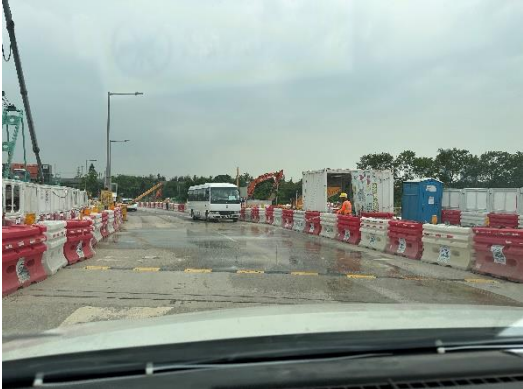
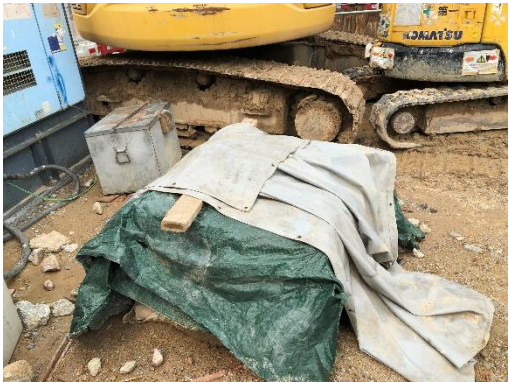
Ref	Location/ Working Period	Anticipated Major Impacts	Recommended Mitigation Measures	Photo Records (Partial)
EIA S3.8	All site area	Dust impact	<ul style="list-style-type: none"> • The portion of any road leading only to construction site that is within 30m of a vehicle entrance or exit should be kept clear of dusty materials; • Every stock of more than 20 bags of cement or dry pulverised fuel ash (PFA) should be covered entirely by impervious sheeting or placed in an area sheltered on the top and the 3 sides;

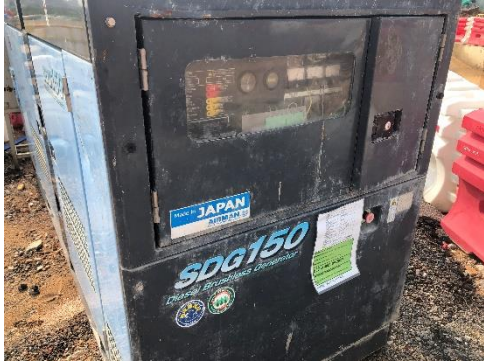
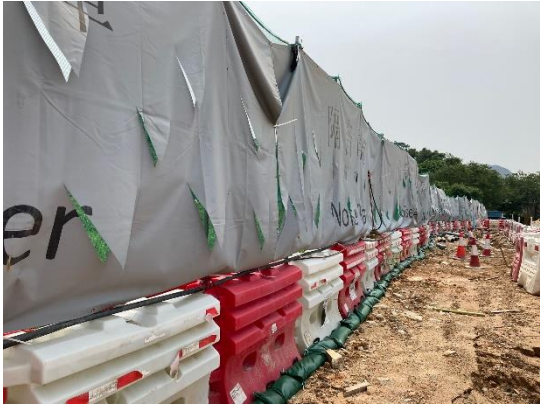
Ref	Location/ Working Period	Anticipated Major Impacts	Recommended Mitigation Measures	Photo Records (Partial)
EIA S4.8	All site area	Noise impact	<ul style="list-style-type: none"> Mobile plant should be sited as far away from NSRs as possible and practicable; All generator used onsite are Quality Powered Mechanical Equipment (QPME) registered with EPD. Install movable noise barriers and full enclosure, screen the noisy plants including air compressor and generator.

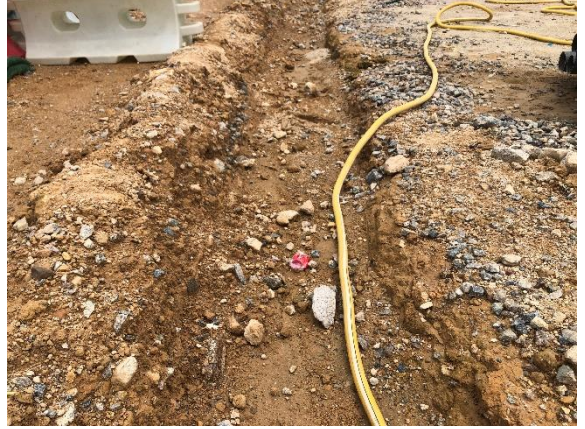
Ref	Location/ Working Period	Anticipated Major Impacts	Recommended Mitigation Measures	Photo Records (Partial)
EIA S5.7	All site area	Water Pollution Control	<ul style="list-style-type: none"> Update and implementation of Stormwater Pollution Control Plan. At the start of site establishment, perimeter cut-off drains to direct off-site water around the site should be constructed with internal drainage works and erosion and sedimentation control facilities implemented. Channels (both temporary and permanent drainage pipes and culverts), earth bunds or sand bag barriers should be provided on site to direct stormwater to silt removal facilities. The design of the temporary on-site drainage system will be undertaken by the contractor prior to the commencement of construction. 	<p>WCR drainage arrangement</p>

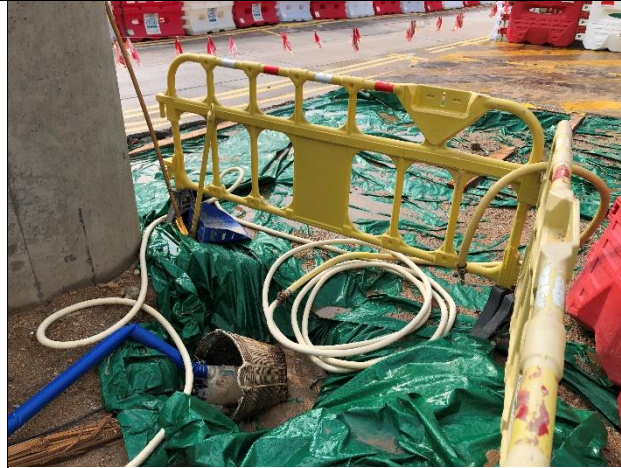
•An additional water pump had been set up and the concerned outlet have been sealed up with concrete
