**Service Contract No. WD/04/2020  
Development of Lok Ma Chau Loop:  
Main Works Package 1 –  
Environmental Team**

**Environmental Permit No.:  
EP-477/2013/B  
- Development of Lok Ma Chau Loop**

**Monthly Environmental Monitoring and  
Audit Report for May 2024**

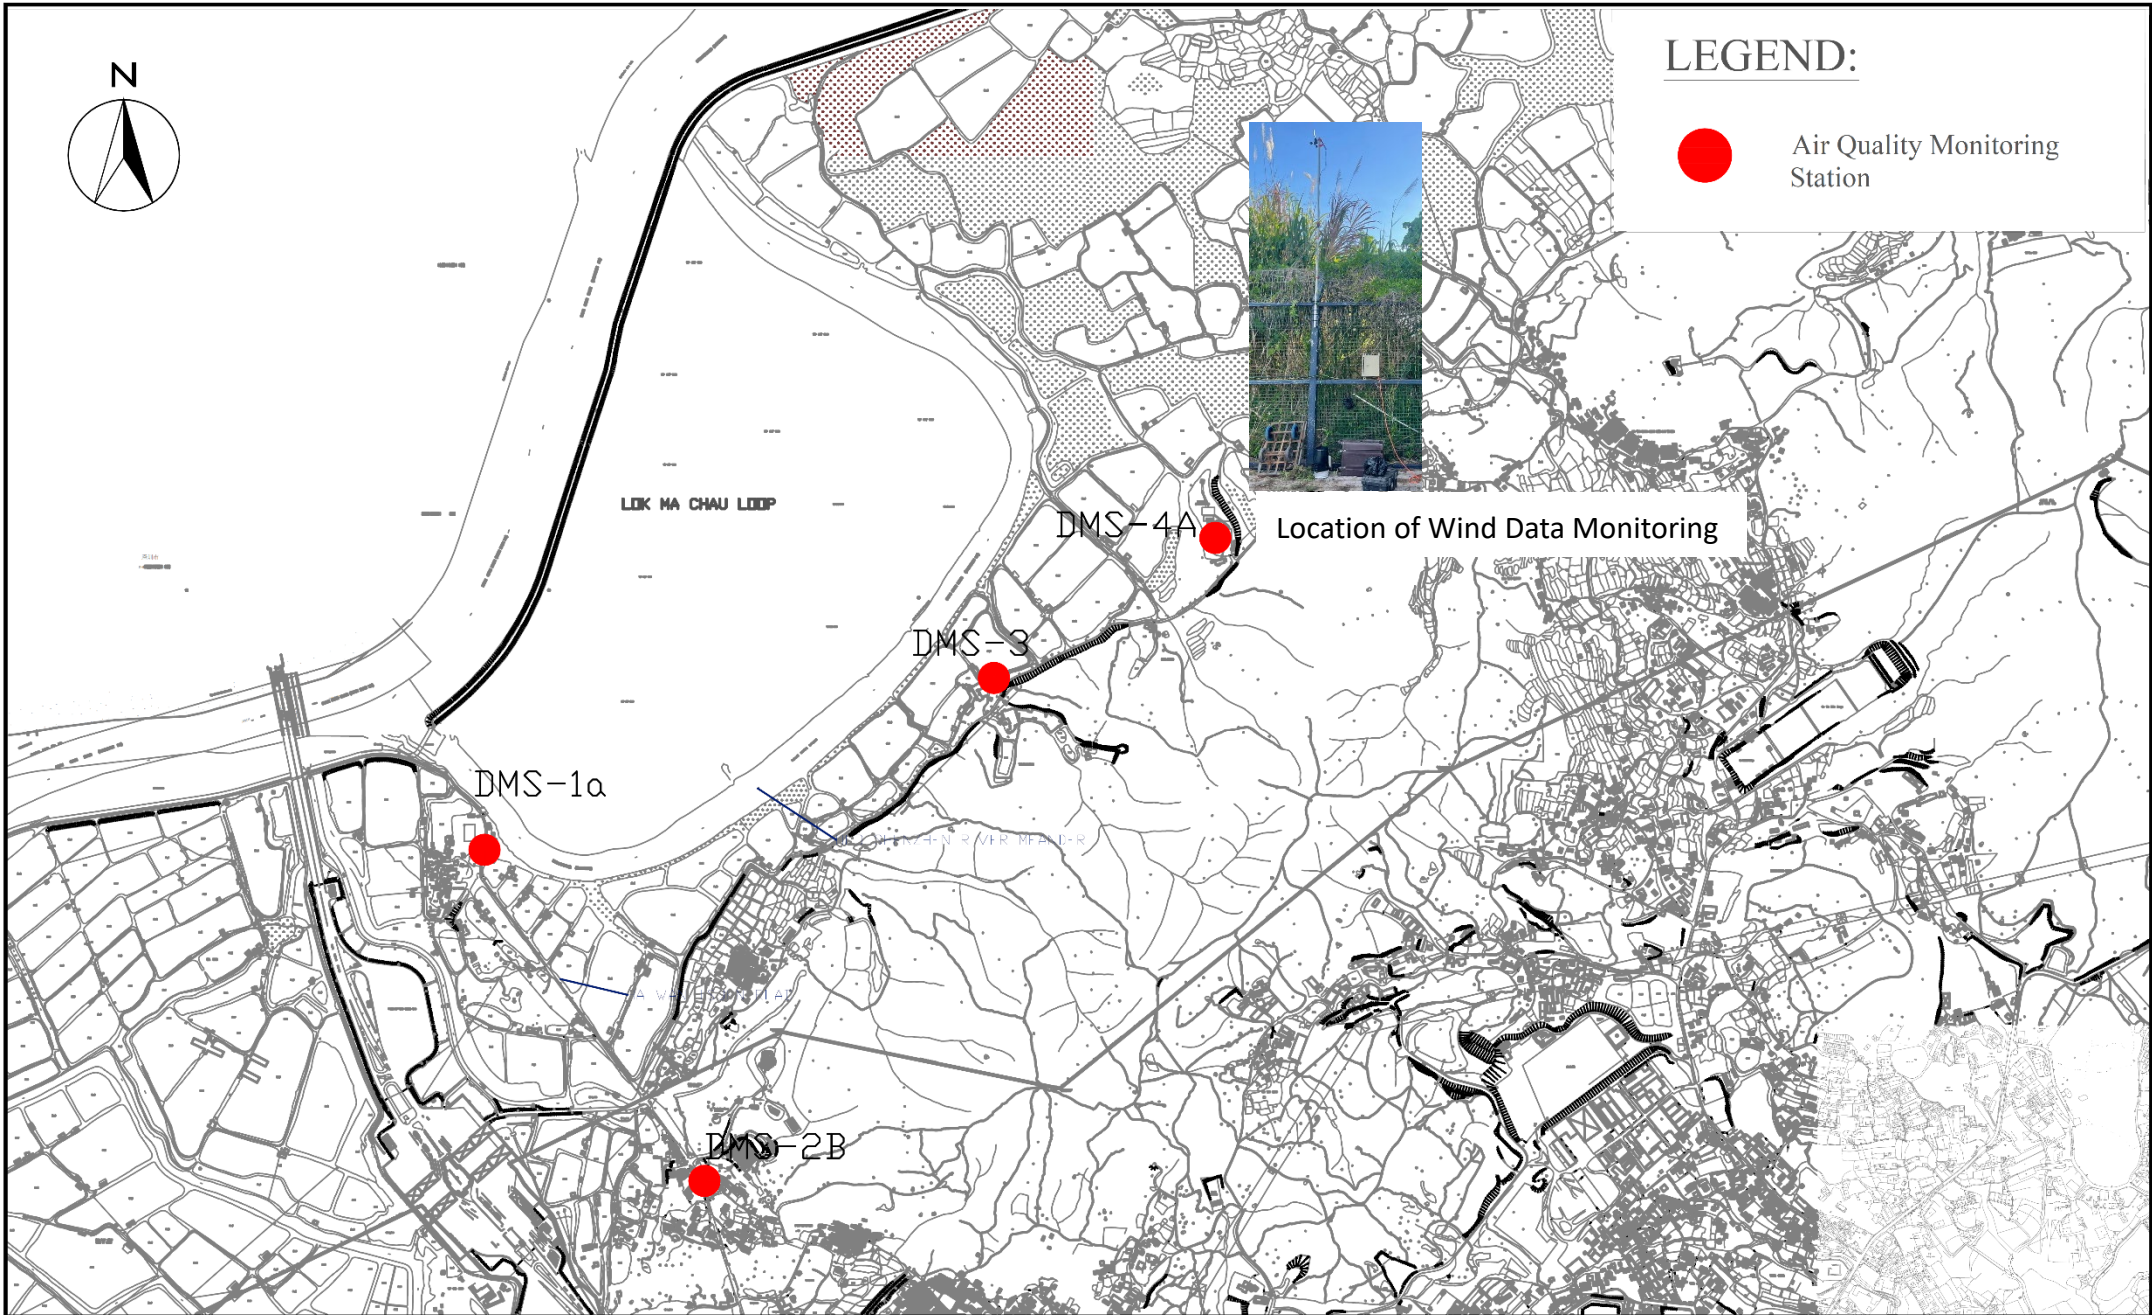
SCALE	1:400 A4	DATE	FEB 2023
CHECK	PC	DRAWN	IT
JOB No.	WMA21009	FIGURE NO.	Fig 2
		REV	-

- 3.19 The wind speed and wind direction were recorded by the installed Wind Anemometer set at DMS-4A. The location is shown in **Figure 2**.
- 3.20 The general weather condition and the wind data for the reporting month are summarised in **Appendix I**.

Location of Wind Data Monitoring

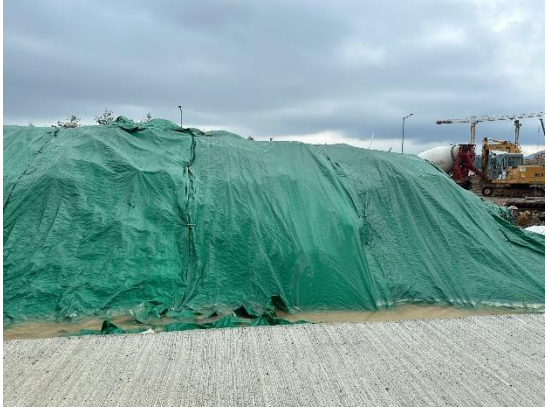
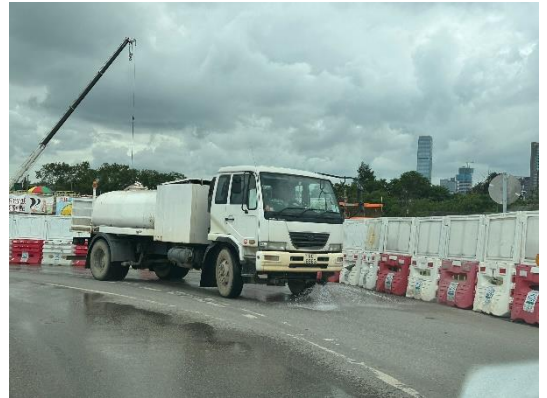
Ref	Location/ Working Period	Anticipated Major Impacts	Recommended Mitigation Measures	Photo Records (Partial)
EIA S3.8	All site area	Dust impact	<ul style="list-style-type: none"> <li>Any excavated or stockpile of dusty material should be covered entirely by impervious sheeting or sprayed with water to maintain the entire surface wet and then removed or backfilled or reinstated where practicable within 24 hours of the excavation or unloading;</li> <li>Any dusty materials remaining after a stockpile is removed should be wetted with water and cleared from the surface of roads;</li> </ul>

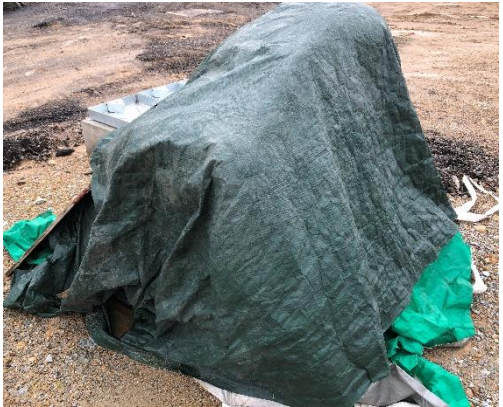
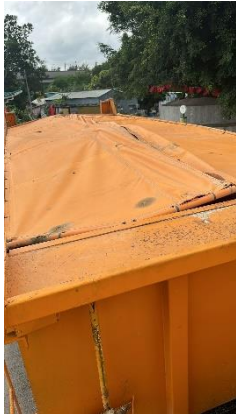
Ref	Location/ Working Period	Anticipated Major Impacts	Recommended Mitigation Measures	Photo Records (Partial)
EIA S3.8	All site area	Dust impact	<ul style="list-style-type: none"> <li>• A stockpile of dusty material should not be extended beyond the pedestrian barriers, fencing or traffic cones;</li> <li>• The load of dusty materials on a vehicle leaving a construction site should be covered entirely by impervious sheeting to ensure that the dusty materials do not leak from the vehicle;</li> </ul>

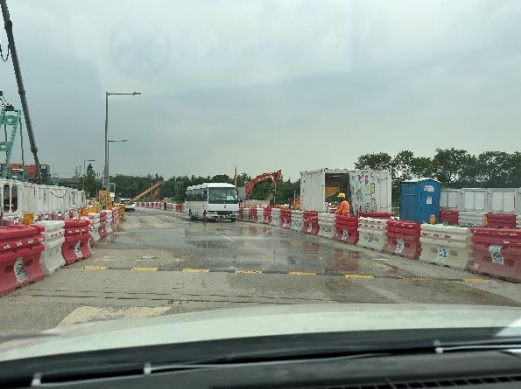
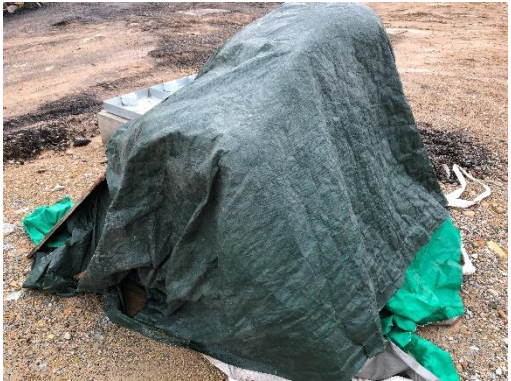
Ref	Location/ Working Period	Anticipated Major Impacts	Recommended Mitigation Measures	Photo Records (Partial)
EIA S3.8	All site area	Dust impact	<ul style="list-style-type: none"> <li>• The portion of any road leading only to construction site that is within 30m of a vehicle entrance or exit should be kept clear of dusty materials;</li> <li>• Every stock of more than 20 bags of cement or dry pulverised fuel ash (PFA) should be covered entirely by impervious sheeting or placed in an area sheltered on the top and the 3 sides;</li> </ul>

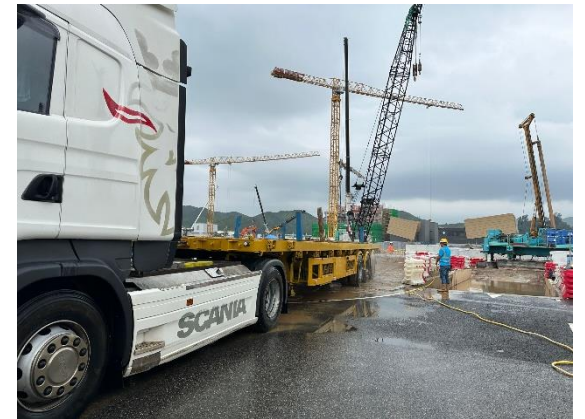
- Where practicable, vehicle washing facilities with high pressure water jet should be provided at every discernible or designated vehicle exit point. The area where vehicle washing takes place and the road section between the washing facilities and the exit point should be paved with concrete, bituminous materials or hardcores.

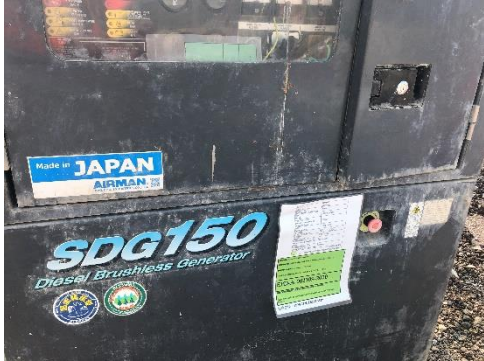
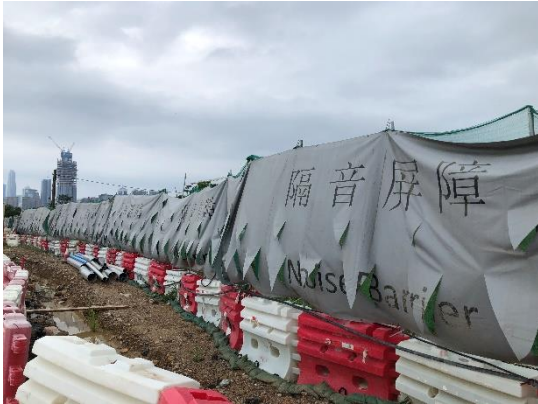
Ref	Location/ Working Period	Anticipated Major Impacts	Recommended Mitigation Measures	Photo Records (Partial)
EIA S4.8	All site area	Noise impact	<ul style="list-style-type: none"> <li>Mobile plant should be sited as far away from NSRs as possible and practicable;</li> <li>All generator used onsite are Quality Powered Mechanical Equipment (QPME) registered with EPD.</li> <li>Install movable noise barriers and full enclosure, screen the noisy plants including air compressor and generator.</li> </ul>

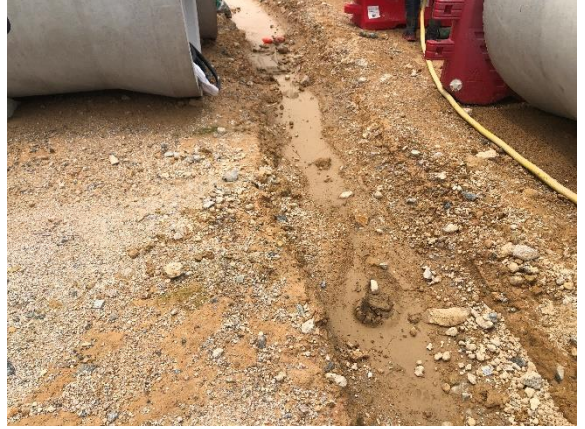
Ref	Location/ Working Period	Anticipated Major Impacts	Recommended Mitigation Measures	Photo Records (Partial)
EIA S5.7	All site area	Water Pollution Control	<ul style="list-style-type: none"> <li>Update and implementation of Stormwater Pollution Control Plan.</li> <li>At the start of site establishment, perimeter cut-off drains to direct off-site water around the site should be constructed with internal drainage works and erosion and sedimentation control facilities implemented. Channels (both temporary and permanent drainage pipes and culverts), earth bunds or sand bag barriers should be provided on site to direct stormwater to silt removal facilities. The design of the temporary on-site drainage system will be undertaken by the contractor prior to the commencement of construction.</li> </ul>	<p>WCR drainage arrangement</p>

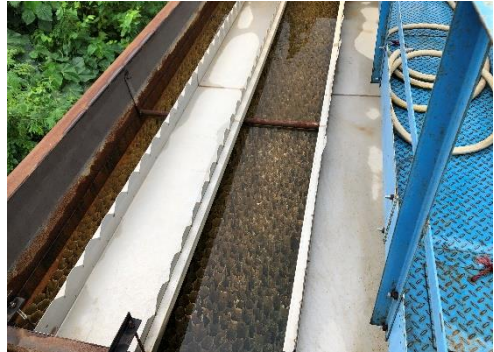
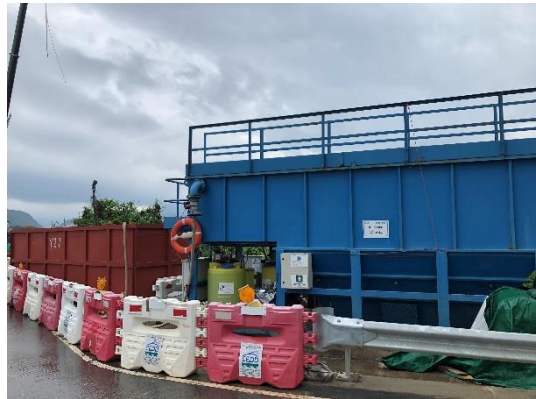
Ref	Location/ Working Period	Anticipated Major Impacts	Recommended Mitigation Measures	Photo Records (Partial)
			<ul style="list-style-type: none"> <li>• Diversion of natural stormwater should be provided as far as possible. The design of temporary on-site drainage should prevent runoff going through site surface, construction machinery and equipments in order to avoid or minimize polluted runoff.</li> </ul> <p>Sedimentation tanks with sufficient capacity, constructed from pre-formed individual cells of approximately 6 to 8 m<sup>3</sup> capacities, are recommended as a general mitigation measure which can be used for settling surface runoff prior to disposal. The system capacity shall be flexible and able to handle multiple inputs from a variety of sources and suited to applications where the influent is pumped.</p>

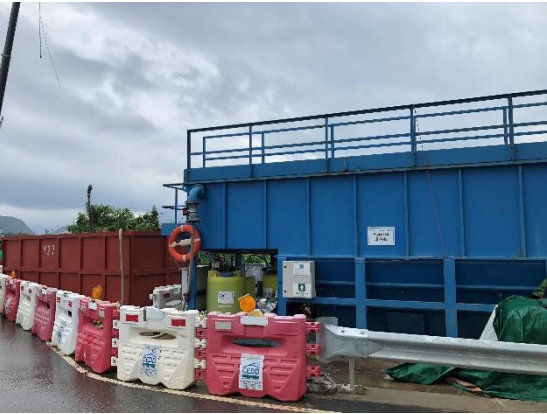
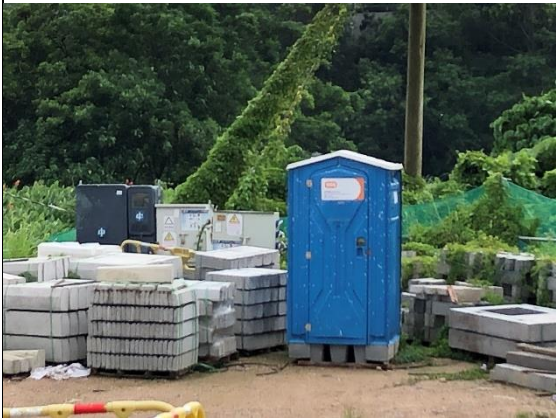
Ref	Location/ Working Period	Anticipated Major Impacts	Recommended Mitigation Measures	Photo Records (Partial)
			<ul style="list-style-type: none"> <li>The design of efficient silt removal facilities should be based on the guidelines in Appendix A1 of ProPECC PN 1/94. The detailed design of the sand/silt traps should be undertaken by the contractor prior to the commencement of construction.</li> </ul> <p>All drainage facilities and erosion and sediment control structures should be regularly inspected and maintained to ensure proper and efficient operation at all times and particularly following rainstorms.</p> <ul style="list-style-type: none"> <li>Portable chemical toilets and sewage holding tanks should be provided for handling the construction sewage generated by the workforce. A licensed contractor should be employed to provide appropriate and adequate portable toilets to cater 0.15m<sup>3</sup>/day/employed populations and be responsible for appropriate disposal and maintenance.</li> </ul>

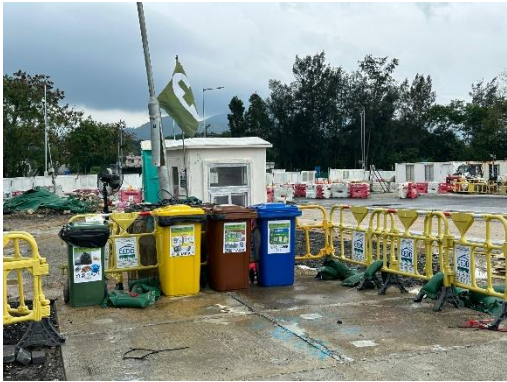
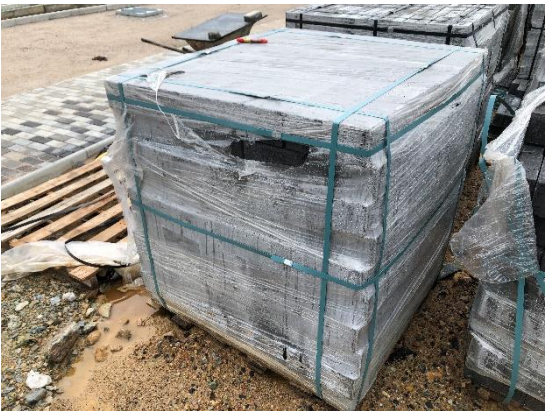
Ref	Location/ Working Period	Anticipated Major Impacts	Recommended Mitigation Measures	Photo Records (Partial)
EIA S7.6	All site area	Waste Generation	<ul style="list-style-type: none"> <li>• Segregate and store different types of waste in different containers, skip or stockpiles to enhance reuse or recycling of materials and their proper disposal;</li> <li>• Proper storage and site practices to minimize the potential for damage and contamination of construction materials;</li> </ul>

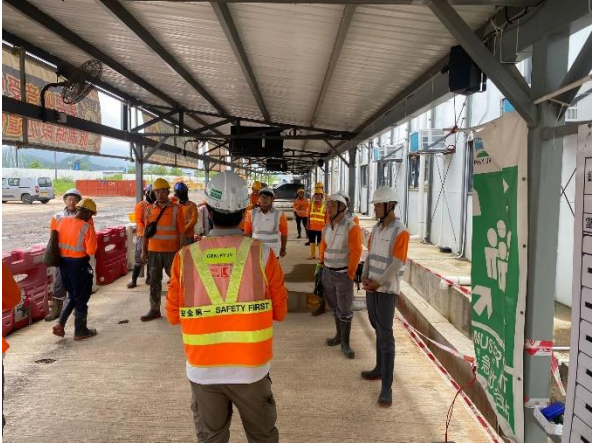
Ref	Location/ Working Period	Anticipated Major Impacts	Recommended Mitigation Measures	Photo Records (Partial)
			<ul style="list-style-type: none"> <li>• Provide training to workers on the importance of appropriate waste management procedures, including waste reduction, reuse and recycling.</li> </ul>

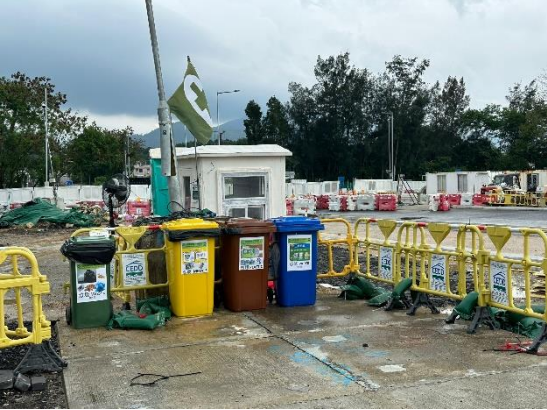
Ref	Location/ Working Period	Anticipated Major Impacts	Recommended Mitigation Measures	Photo Records (Partial)
			<ul style="list-style-type: none"> <li>• General refuse should be stored in enclosed bins separately from construction and chemical wastes. Recycling bins should also be placed to encourage recycling.</li> </ul>

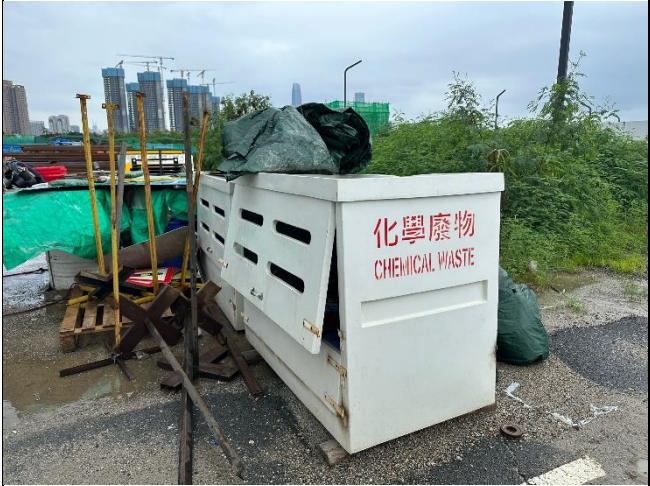
Ref	Location/ Working Period	Anticipated Major Impacts	Recommended Mitigation Measures	Photo Records (Partial)
			<ul style="list-style-type: none"> <li>If chemical wastes are produced at the construction site, the Contractors should register with EPD as chemical waste producers. Chemical wastes should be stored in appropriate containers and collected by a licensed chemical waste contractor. Chemical wastes (e.g. spent lubricant oil) should be recycled at an appropriate facility as far as possible, while the chemical waste that cannot be recycled should be disposed of at either the Chemical Waste Treatment Centre, or another licensed facility, in accordance with the Waste Disposal (Chemical Waste) (General) Regulation.</li> </ul>

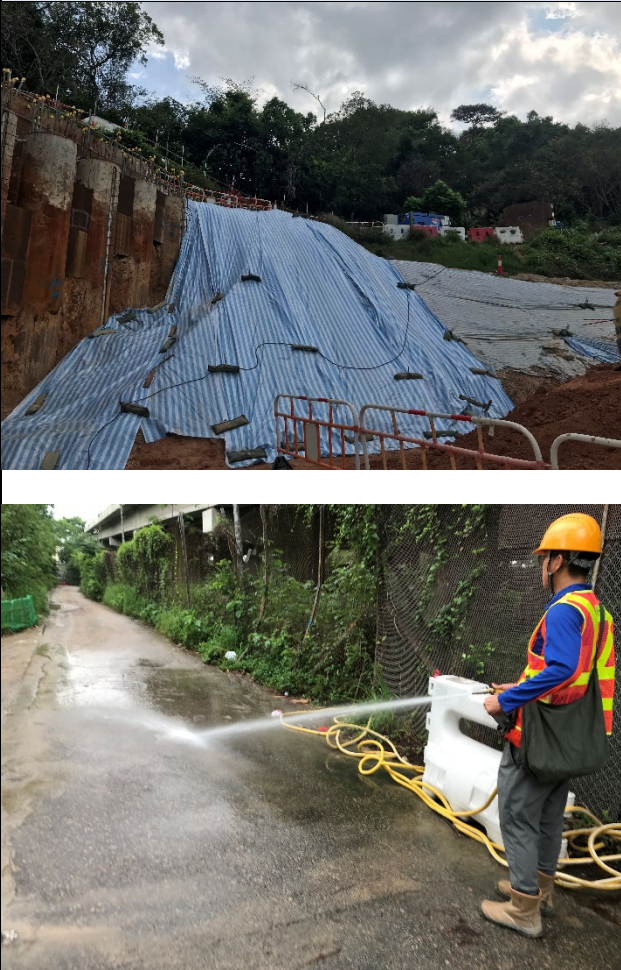
<p>The top photograph shows a large stockpile of earth or material covered with blue impervious sheeting, secured with weights, to prevent dust emission. The bottom photograph shows a worker in a high-visibility vest and hard hat using a high-pressure water sprayer to wet a road surface, clearing any remaining dust.</p>

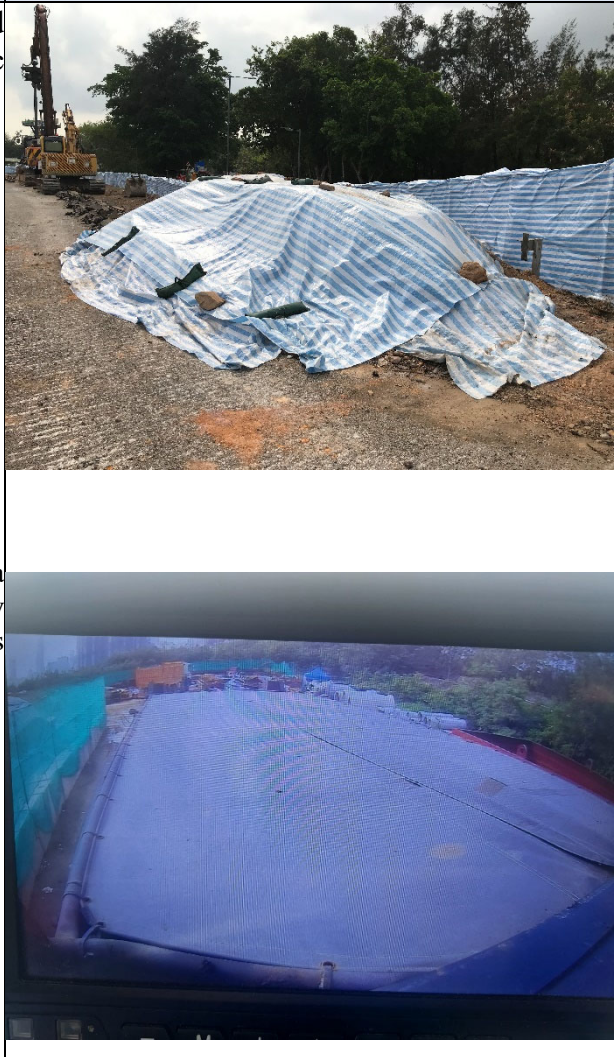
Ref*	Location/ Working Period	Anticipated Major Impacts	Recommended Mitigation Measures	Photo Records (Partial)
EIA S3.8	All site area	Dust impact	<ul style="list-style-type: none"> <li>• A stockpile of dusty material should not be extend beyond the pedestrian barriers, fencing or traffic cones;</li> <li>• The load of dusty materials on a vehicle leaving a construction site should be covered entirely by impervious sheeting to ensure that the dusty materials do not leak from the vehicle;</li> </ul>

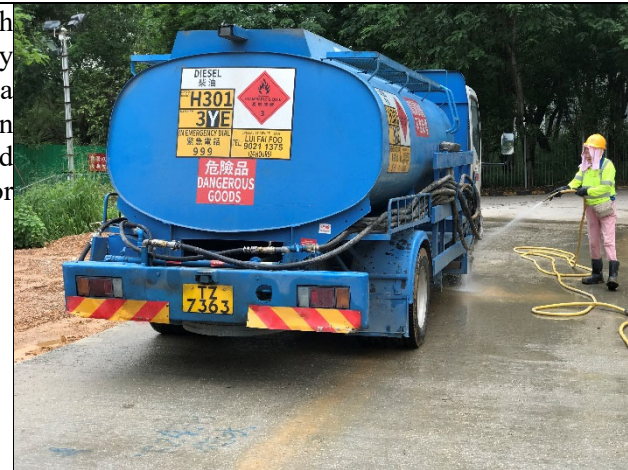
• Where practicable, vehicle washing facilities with high pressure water jet should be provided at every discernible or designated vehicle exit point. The area where vehicle washing takes place and the road section between the washing facilities and the exit point should be paved with concrete, bituminous materials or hardcores.

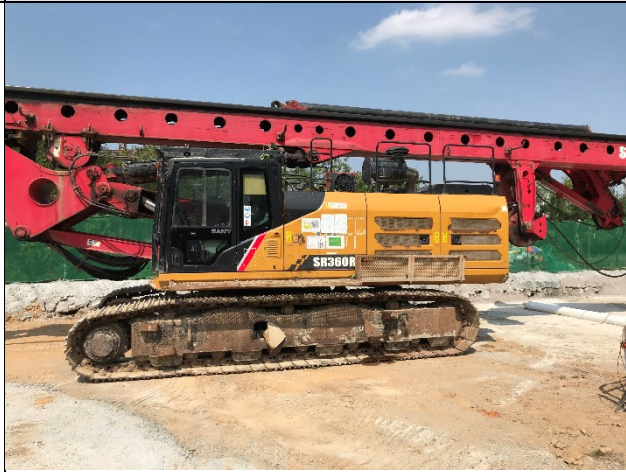
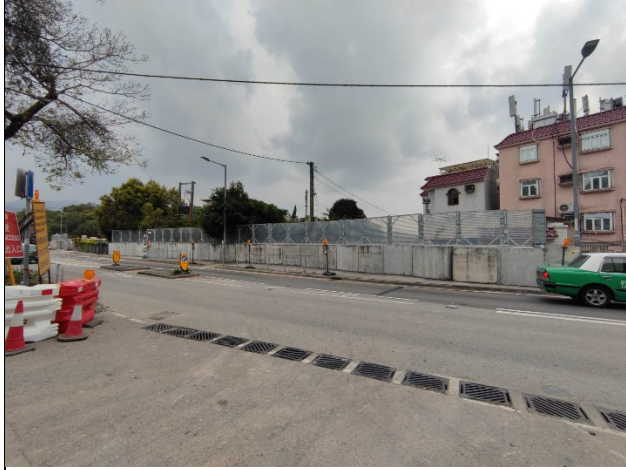
Ref*	Location/ Working Period	Anticipated Major Impacts	Recommended Mitigation Measures	Photo Records (Partial)
EIA S4.8	All site area	Noise impact	<ul style="list-style-type: none"> <li>• Mobile plant should be sited as far away from NSRs as possible and practicable;</li> <li>• Install movable noise barriers and full enclosure, screen the noisy plants including air compressor and generator.</li> </ul>

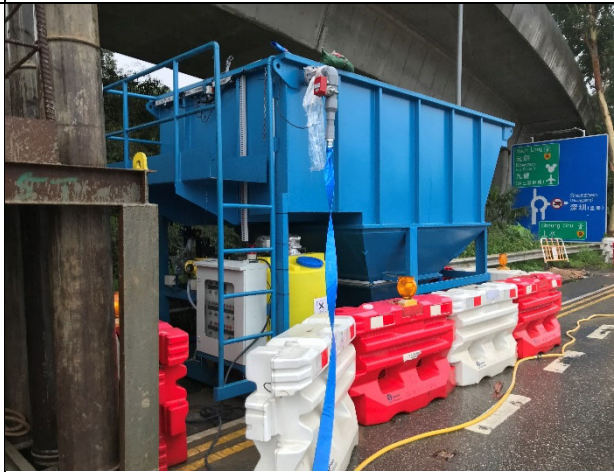
<p>EIA S5.7</p>	<p>All site area</p>	<p>Water Pollution Control</p>	<p>• At the start of site establishment, perimeter cut-off drains to direct off-site water around the site should be constructed with internal drainage works and erosion and sedimentation control facilities implemented. Channels (both temporary and permanent drainage pipes and culverts), earth bunds or sand bag barriers should be provided on site to direct stormwater to silt removal facilities. The design of the temporary on-site drainage system will be undertaken by the contractor prior to the commencement of construction.</p>

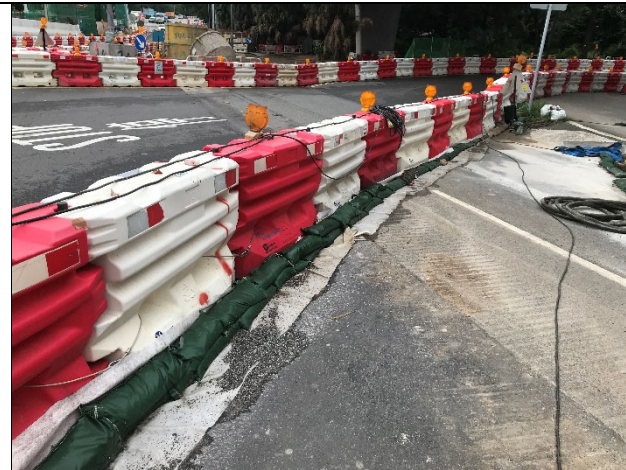
• Diversion of natural stormwater should be provided as far as possible. The design of temporary on-site drainage should prevent runoff going through site surface, construction machinery and equipment in order to avoid or minimize polluted runoff.

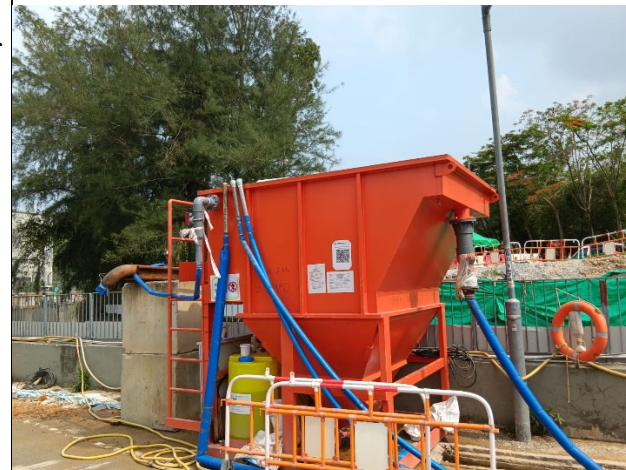
• Sedimentation tanks with sufficient capacity, constructed from pre-formed individual cells of approximately 6 to 8 m<sup>3</sup> capacities, are recommended as a general mitigation measure which can be used for settling surface runoff prior to disposal. The system capacity shall be flexible and able to handle multiple inputs from a variety of sources and suited to applications where the influent is pumped.

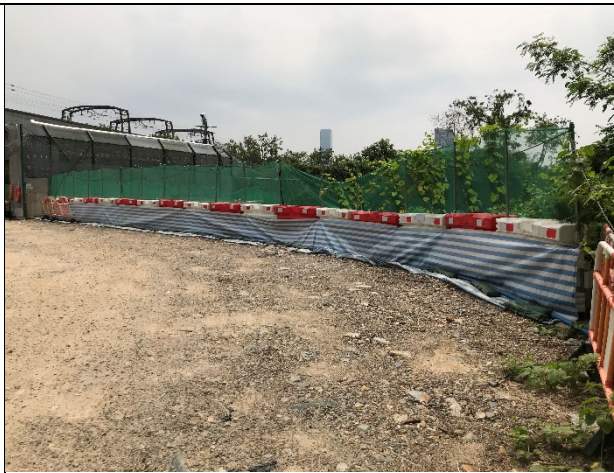
<p>The noise curtain for noisy plants will be installed before bored piling work.</p>
--	--	--	---	---

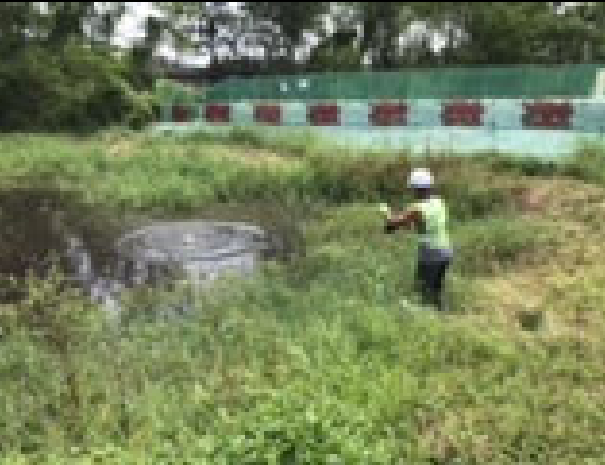
<p>Water quality monitoring in May had been conducted on 9 May 2024.</p>
---------------	--------	---------	--	--

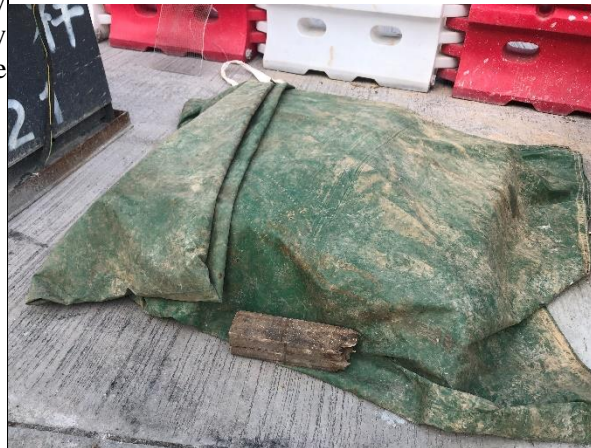
• Every stock of more than 20 bags of cement or dry pulverised fuel ash (PFA) should be covered entirely by impervious sheeting or placed in an area sheltered on the top and the 3 sides;

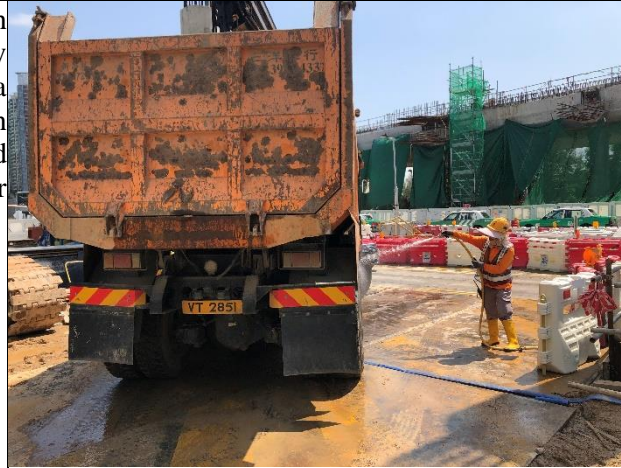
• Where practicable, vehicle washing facilities with high pressure water jet should be provided at every discernible or designated vehicle exit point. The area where vehicle washing takes place and the road section between the washing facilities and the exit point should be paved with concrete, bituminous materials or hardcores.

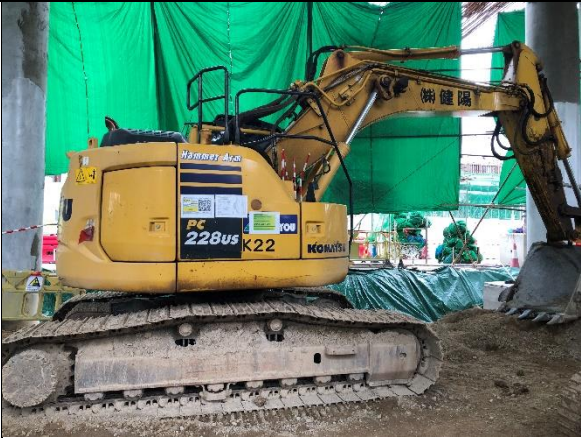
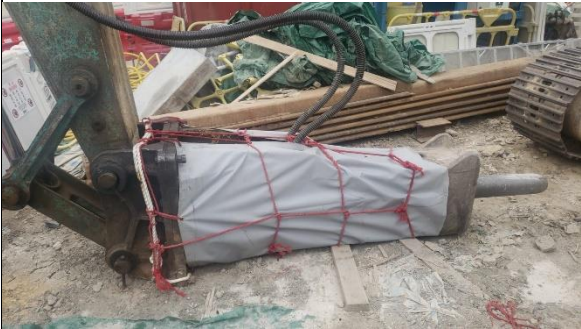
Ref*	Location/ Working Period	Anticipated Major Impacts	Recommended Mitigation Measures	Photo Records (Partial)
EIA S4.8	All site area	Noise impact	<ul style="list-style-type: none"> <li>• Mobile plant should be sited as far away from NSRs as possible and practicable;</li> <li>• Install movable noise barriers and full enclosure, screen the noisy plants including air compressor and generator.</li> </ul>

• An acoustic canvas had been deployed along the site boundary facing the public.

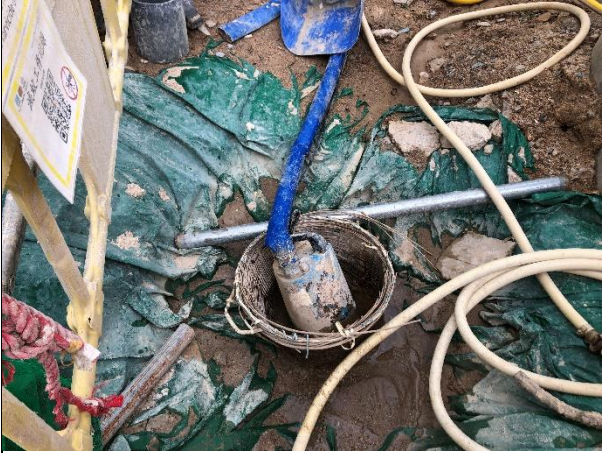
<ul style="list-style-type: none"><li>•An additional water pump had been set up and the concerned outlet have been sealed up with concrete</li></ul>
