**Service Contract No. WD/04/2020
Development of Lok Ma Chau Loop:
Main Works Package 1 –
Environmental Team**

**Environmental Permit No.:
EP-477/2013/B
- Development of Lok Ma Chau Loop**

**Monthly Environmental Monitoring and
Audit Report for July 2024**

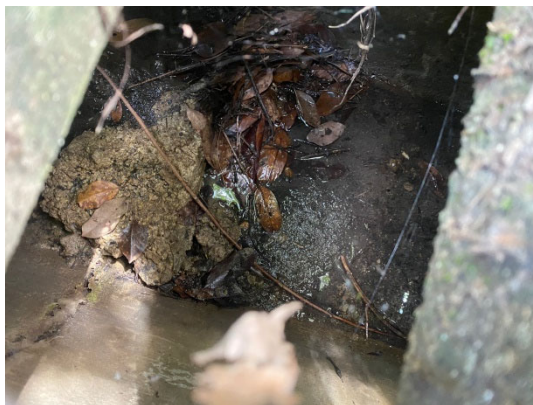
**IS6**

5.36 No water quality monitoring was conducted at IS6 in the reporting month since the channel was dry. Water quality monitoring station, IS6 will be further reviewed and a proposal for any alternative monitoring location including justification will be submitted for approval from IEC and EPD (if necessary).

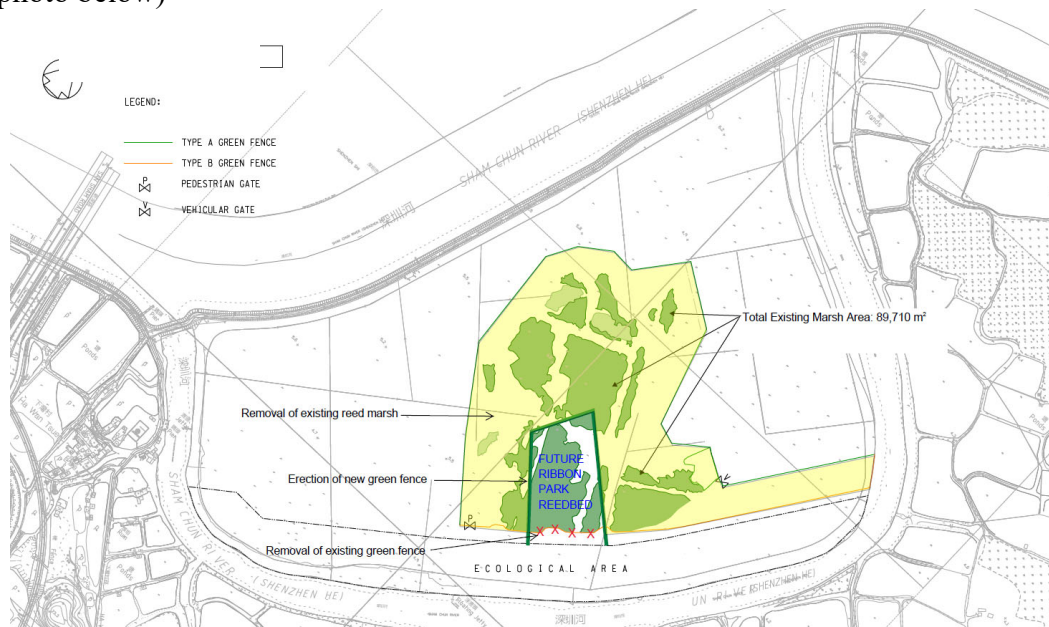
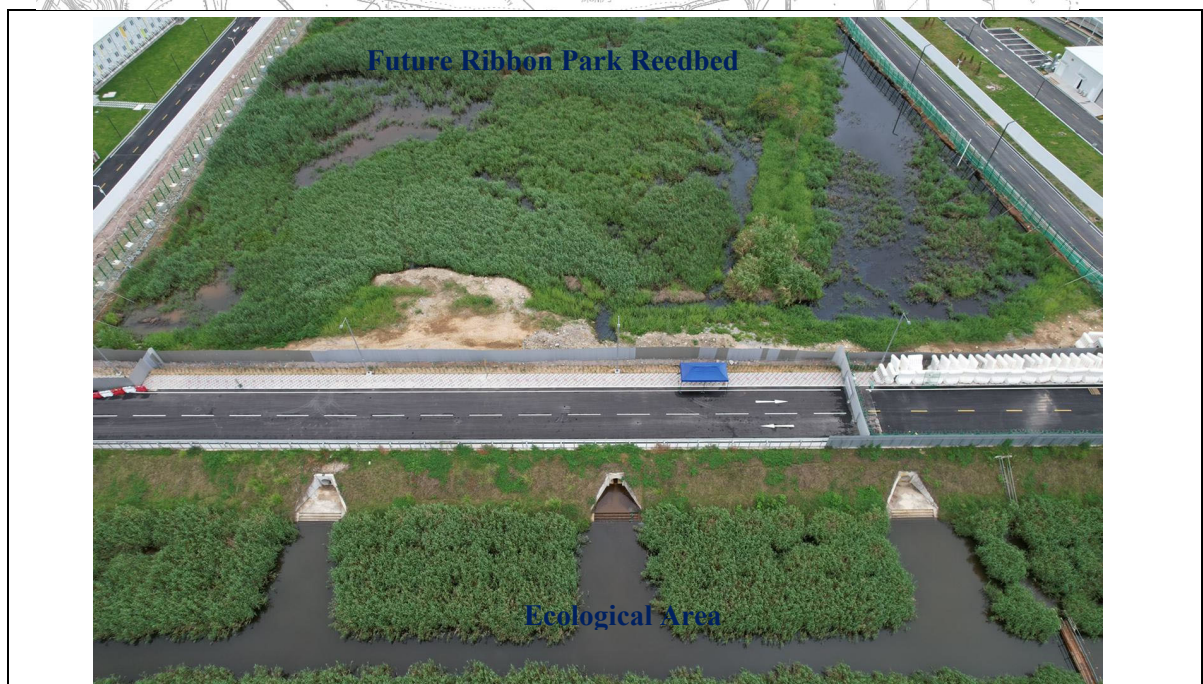
- 10.8 The green fence around the future Ribbon Park Reedbed has been removed and replaced by the hoarding due to the other project’s land occupier since March 2022. (See Figure & photo below)

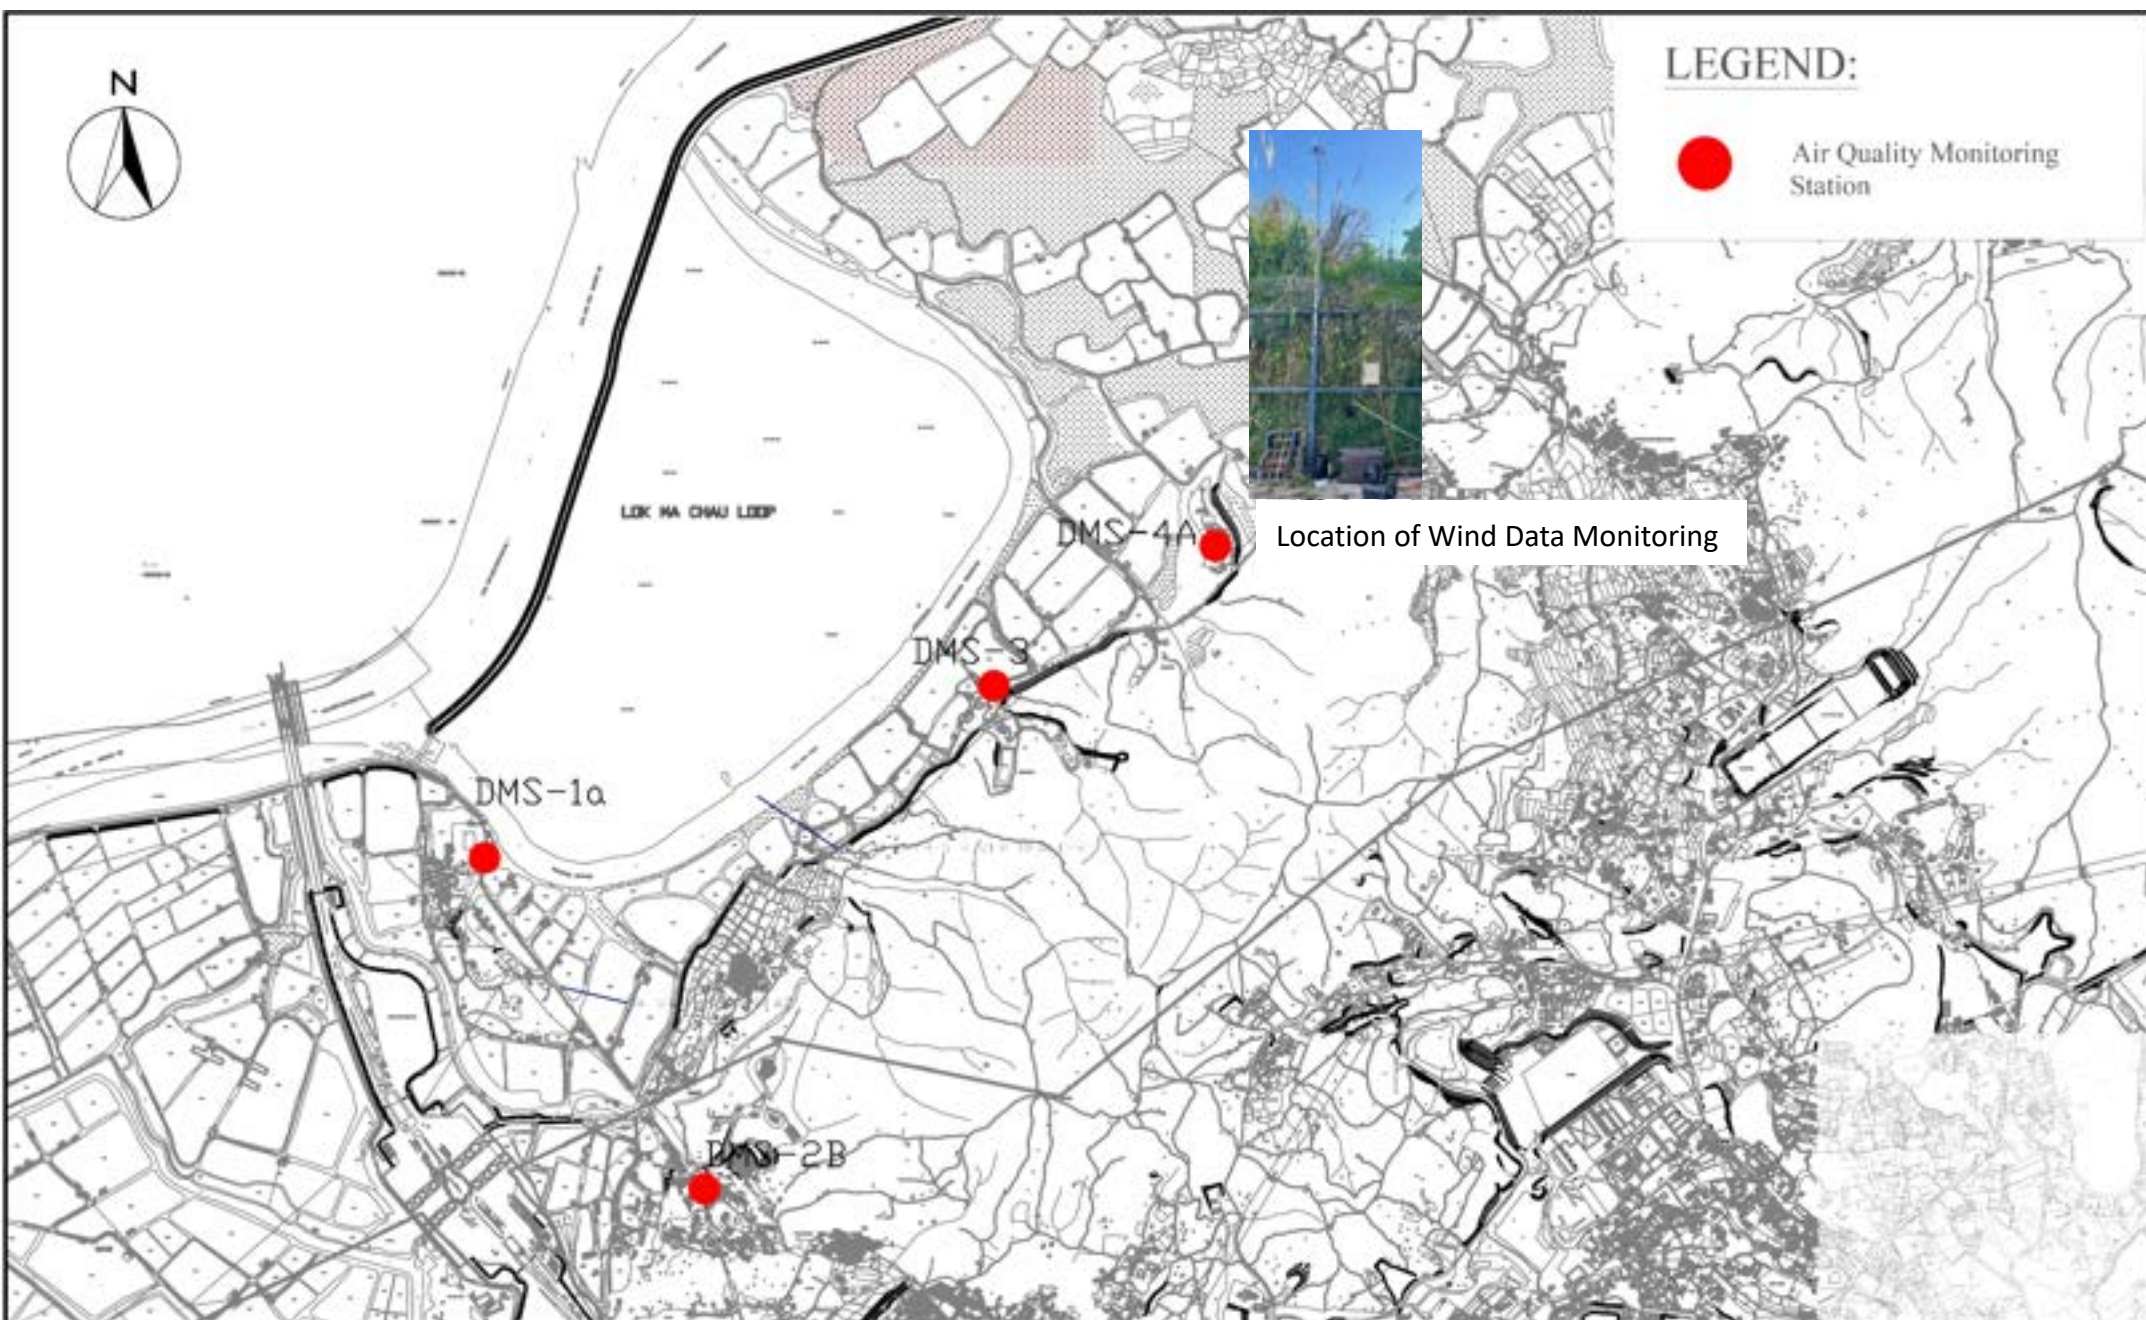
Location of Wind Data Monitoring

- 3.19 The wind speed and wind direction were recorded by the installed Wind Anemometer set at DMS-4A. The location is shown in **Figure 2**.
- 3.20 The general weather condition and the wind data for the reporting month are summarised in **Appendix I**.

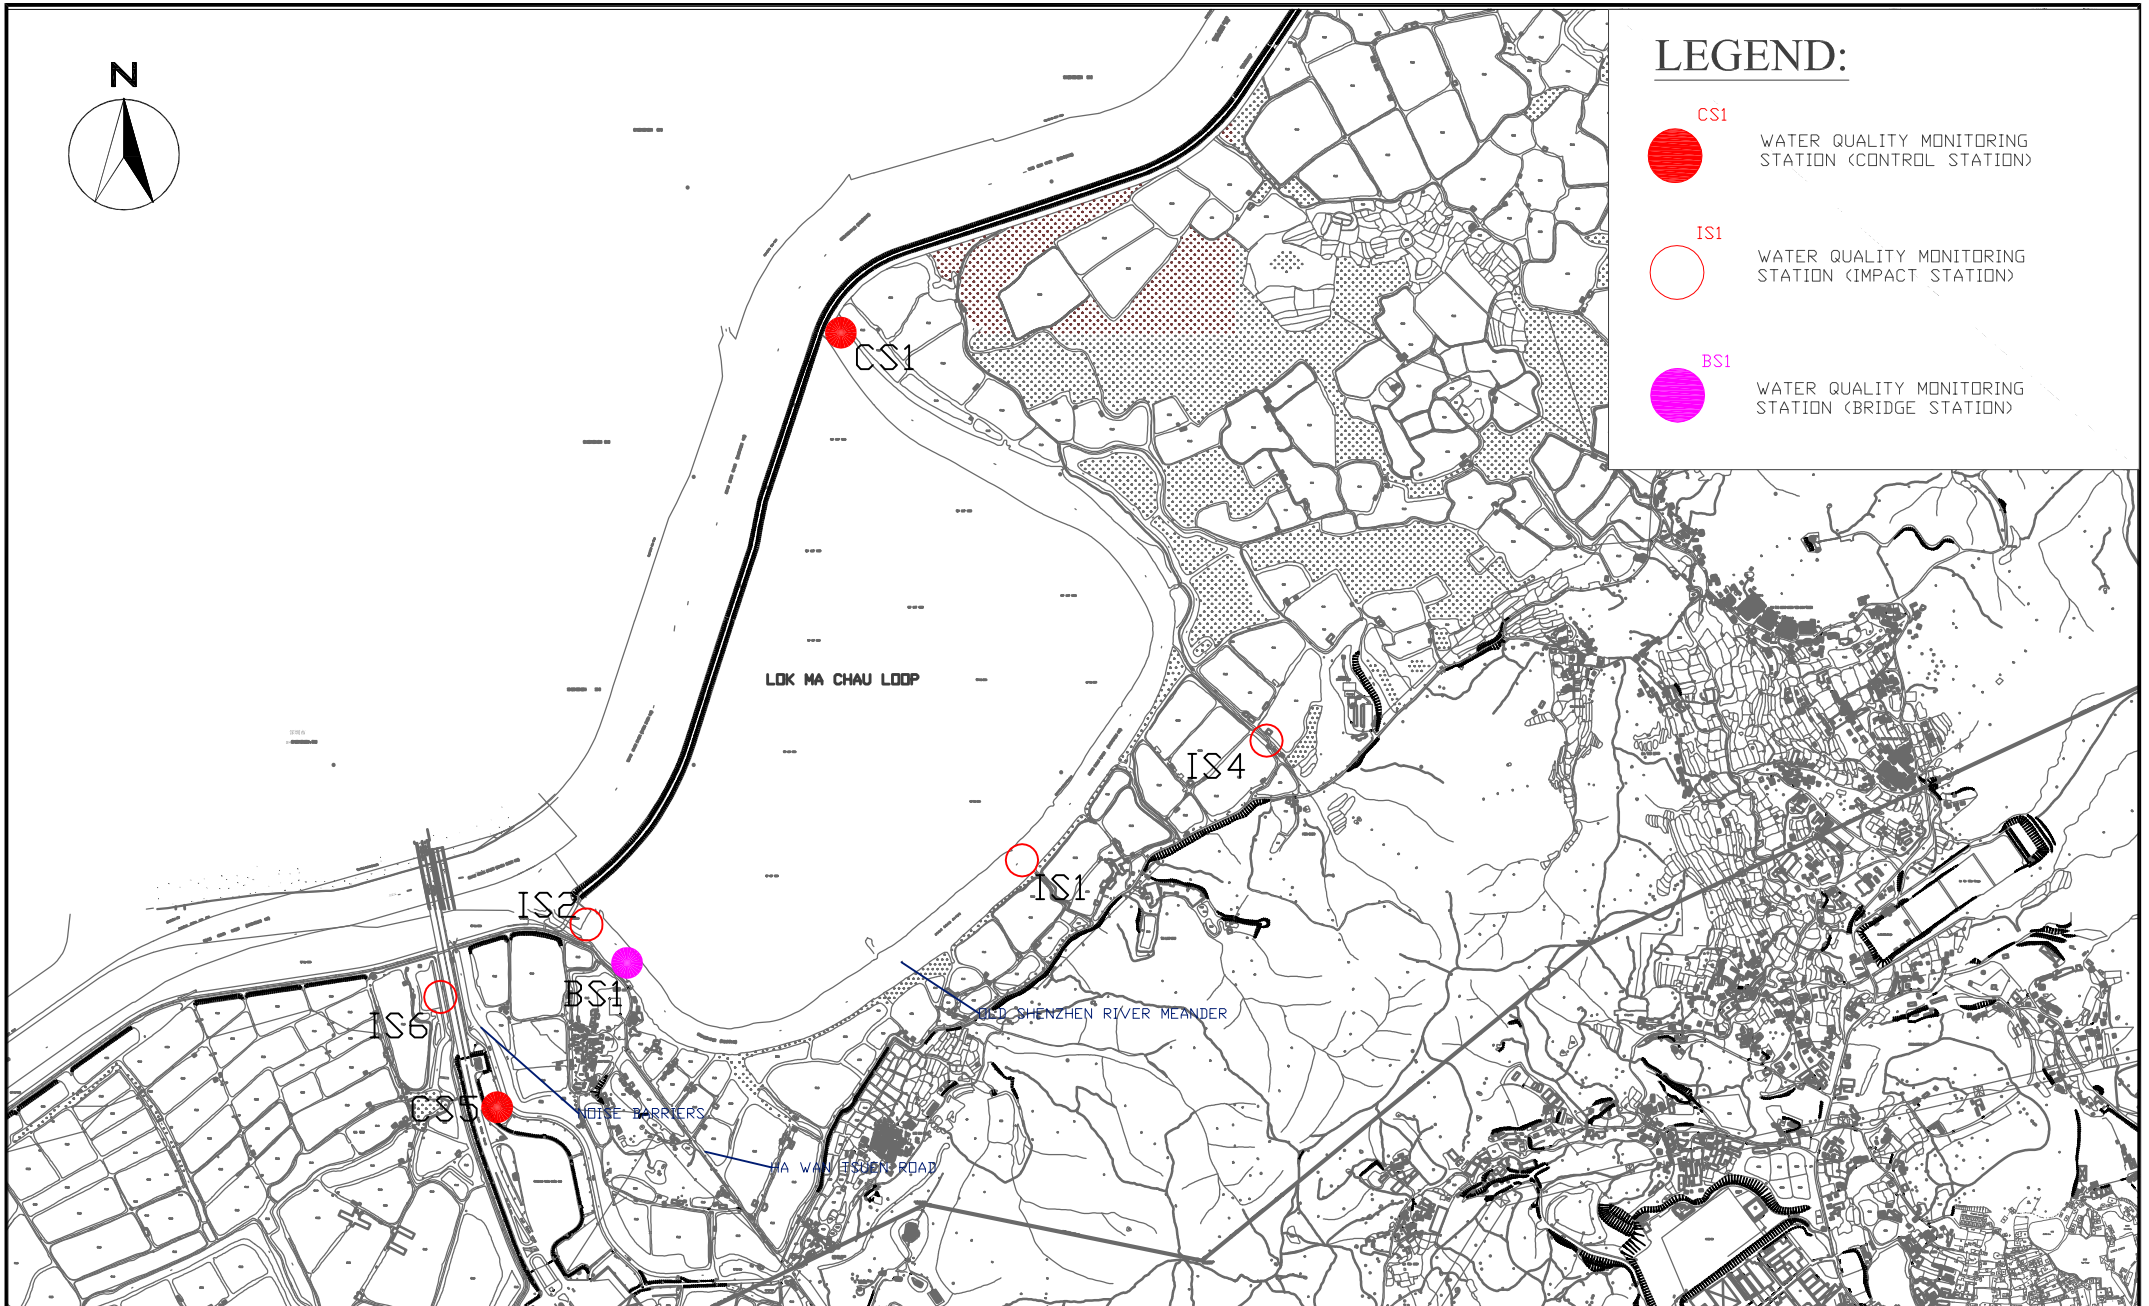
- CS1 WATER QUALITY MONITORING STATION (CONTROL STATION)
- IS1 WATER QUALITY MONITORING STATION (IMPACT STATION)
- BS1 WATER QUALITY MONITORING STATION (BRIDGE STATION)

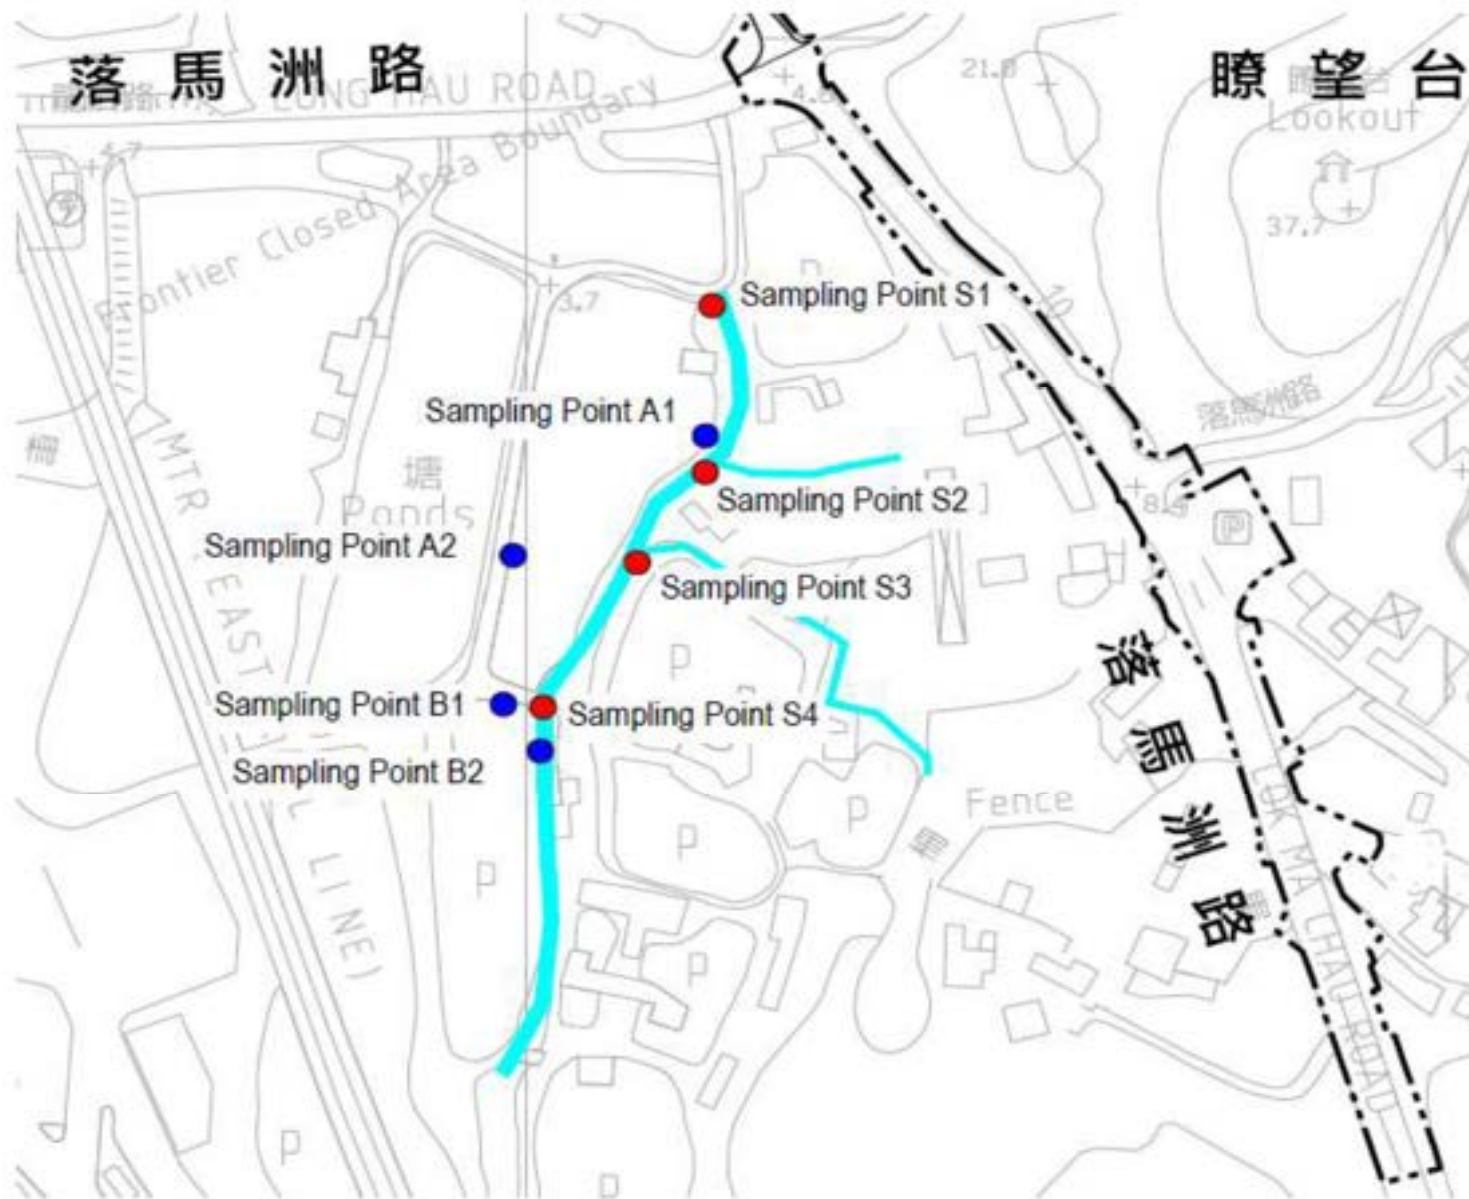
Locations of Rose Bitterling Sampling Points

- 6.47 Monitoring of Rose Bitterling and *in situ* monitoring of water quality were conducted at the stream and associated ponds south of Lok Ma Chau Road where Rose Bitterling is present. There are 4 sampling points along the stream, and 4 sampling points at the ponds. The sampling locations are shown in **Figure 5c**.
- 6.48 *In situ* monitoring of water quality in LMC Meander was conducted at 3 monitoring stations, including CS1, IS1 and IS2, as stated in Section 6.3 of the EM&A Manual. The monitoring stations are shown in **Figure 4**.

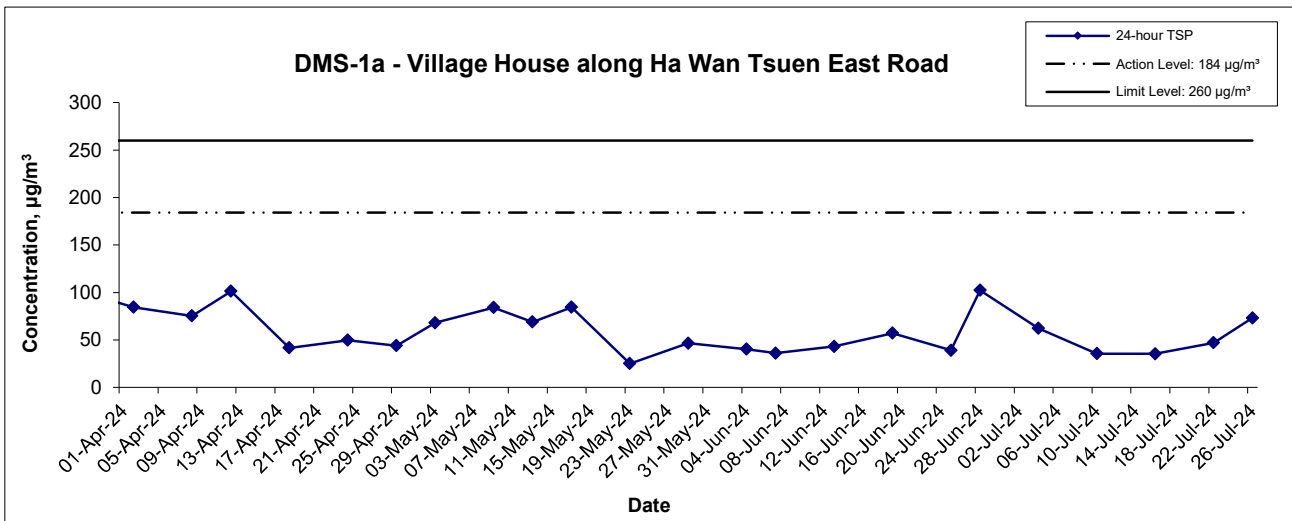
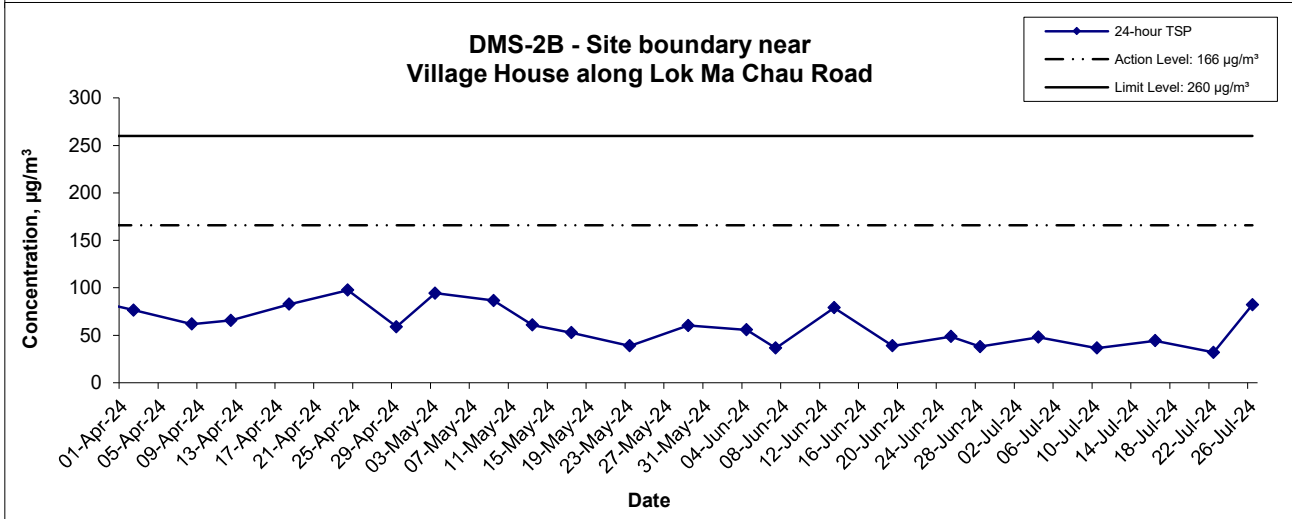
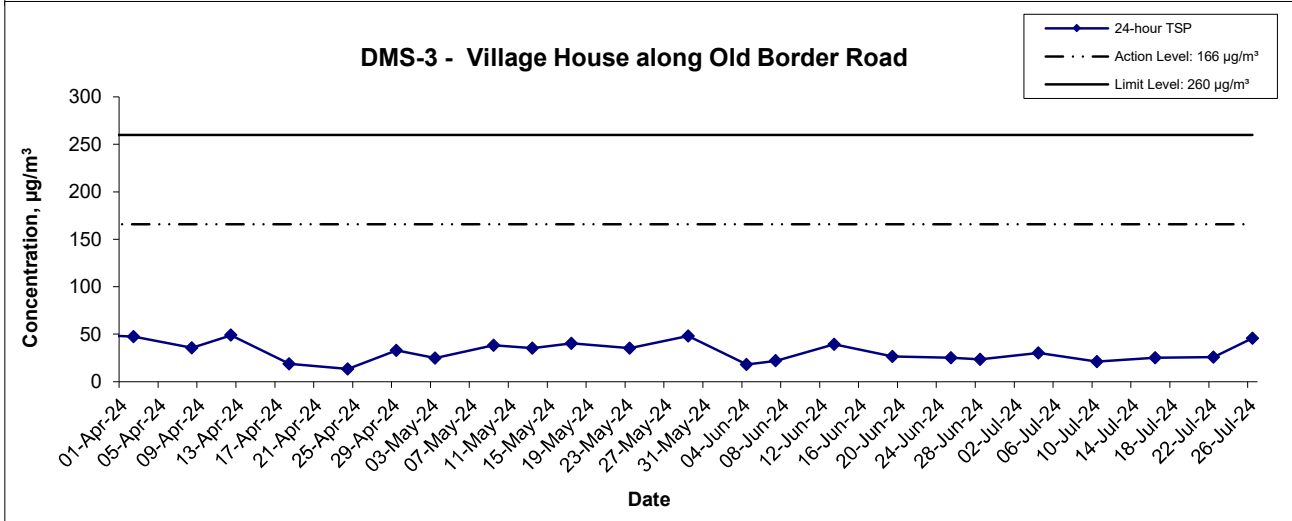
24-hour TSP Concentration Levels

Title Service Contract No. WD/04/2020 Development of Lok Ma Chau Loop: Main Works Package 1 - Environmental Team Graphical Presentation of 24-hour TSP Monitoring Results	Scale	N.T.S	Project No.	WMA21009	consulting . testing . research
	Date	Jul 24	Appendix	F

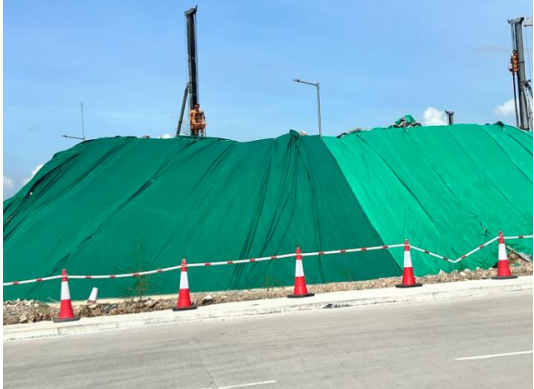
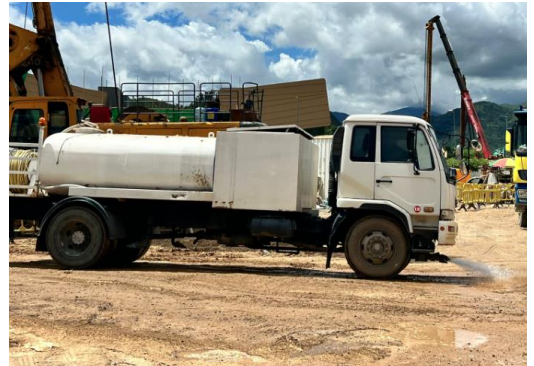
Ref	Location/ Working Period	Anticipated Major Impacts	Recommended Mitigation Measures	Photo Records (Partial)
EIA S3.8	All site area	Dust impact	<ul style="list-style-type: none"> Any excavated or stockpile of dusty material should be covered entirely by impervious sheeting or sprayed with water to maintain the entire surface wet and then removed or backfilled or reinstated where practicable within 24 hours of the excavation or unloading; Any dusty materials remaining after a stockpile is removed should be wetted with water and cleared from the surface of roads;

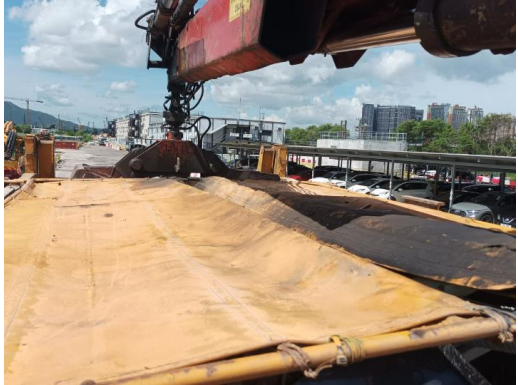
Ref	Location/ Working Period	Anticipated Major Impacts	Recommended Mitigation Measures	Photo Records (Partial)
EIA S3.8	All site area	Dust impact	<ul style="list-style-type: none"> • A stockpile of dusty material should not be extended beyond the pedestrian barriers, fencing or traffic cones; • The load of dusty materials on a vehicle leaving a construction site should be covered entirely by impervious sheeting to ensure that the dusty materials do not leak from the vehicle;

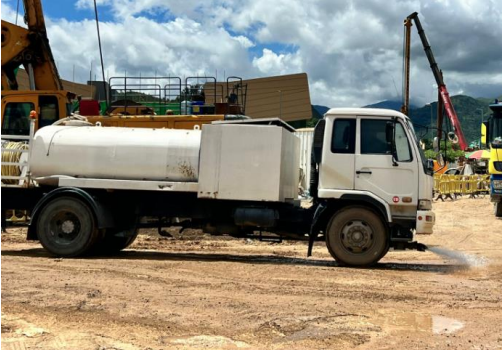
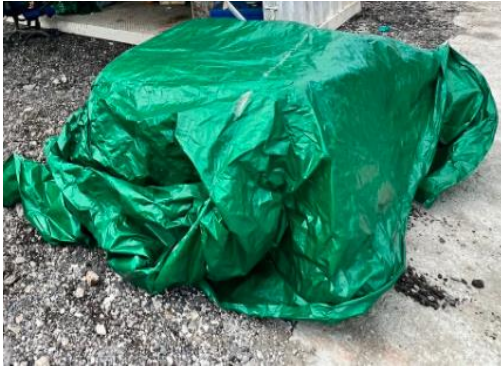
Ref	Location/ Working Period	Anticipated Major Impacts	Recommended Mitigation Measures	Photo Records (Partial)
EIA S3.8	All site area	Dust impact	<ul style="list-style-type: none"> • The portion of any road leading only to construction site that is within 30m of a vehicle entrance or exit should be kept clear of dusty materials; • Every stock of more than 20 bags of cement or dry pulverised fuel ash (PFA) should be covered entirely by impervious sheeting or placed in an area sheltered on the top and the 3 sides;

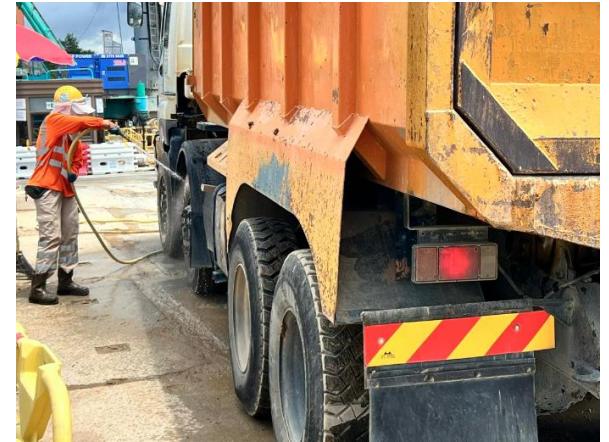
- Where practicable, vehicle washing facilities with high pressure water jet should be provided at every discernible or designated vehicle exit point. The area where vehicle washing takes place and the road section between the washing facilities and the exit point should be paved with concrete, bituminous materials or hardcores.

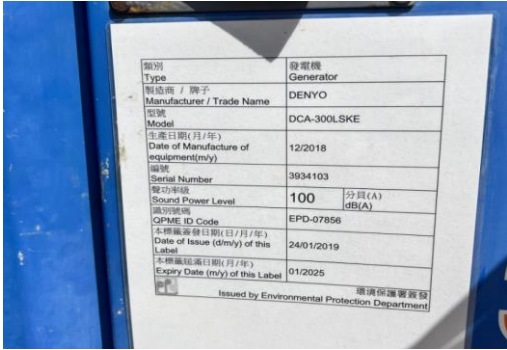
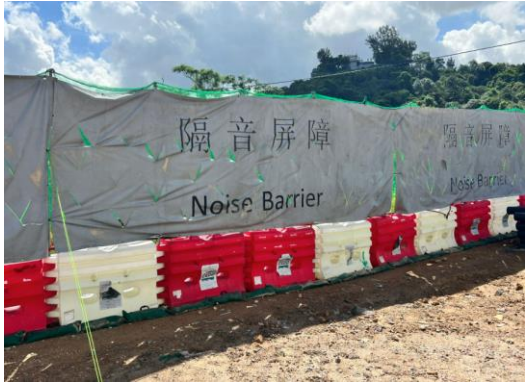
Ref	Location/ Working Period	Anticipated Major Impacts	Recommended Mitigation Measures	Photo Records (Partial)
EIA S4.8	All site area	Noise impact	<ul style="list-style-type: none"> Mobile plant should be sited as far away from NSRs as possible and practicable; All generator used onsite are Quality Powered Mechanical Equipment (QPME) registered with EPD. Install movable noise barriers and full enclosure, screen the noisy plants including air compressor and generator.

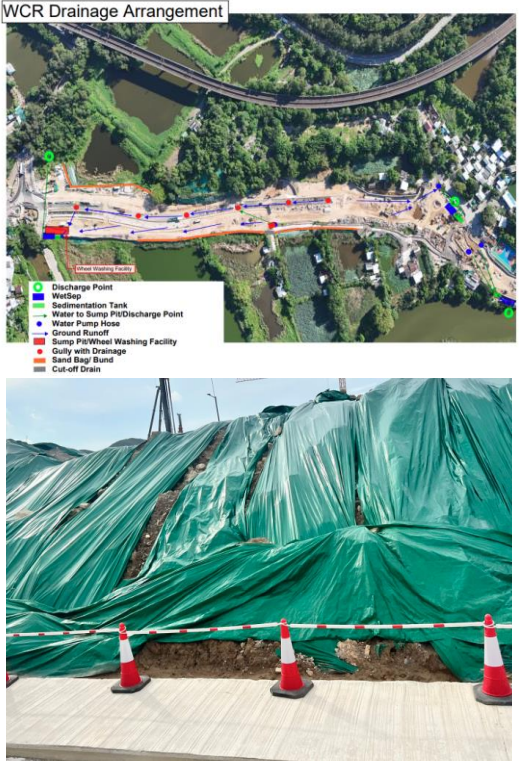
<p>The photo records include a site plan titled 'WCR Drainage Arrangement' and a photograph of a construction site. The site plan shows various drainage features: Discharge Point (green circle), Wet/Dep (blue square), Sedimentation Tank (blue rectangle), Water to Sump Pit/Discharge Point (blue line), Water Pump Hose (blue line with dots), Ground Runoff (red line), Sump Pit/Wheel Washing Facility (red rectangle), Gully with Drainage (red line), Sand Bag Bund (orange rectangle), and Cut-off Drain (black line). The photograph shows a construction site with large areas covered in green tarpaulin, with orange and white traffic cones and a red and white striped barrier in the foreground.</p>

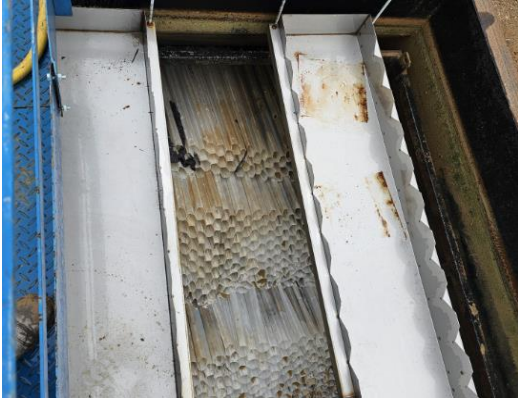
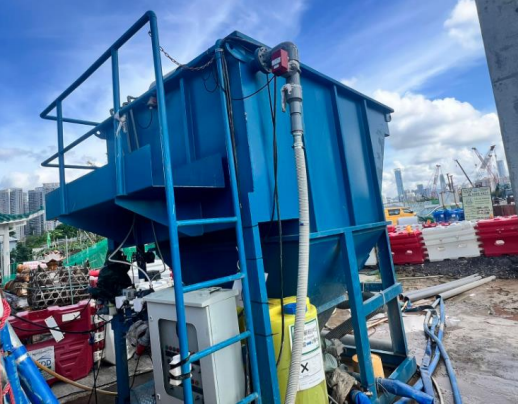
Ref	Location/ Working Period	Anticipated Major Impacts	Recommended Mitigation Measures	Photo Records (Partial)
			<ul style="list-style-type: none"> • Diversion of natural stormwater should be provided as far as possible. The design of temporary on-site drainage should prevent runoff going through site surface, construction machinery and equipments in order to avoid or minimize polluted runoff. <p>Sedimentation tanks with sufficient capacity, constructed from pre-formed individual cells of approximately 6 to 8 m³ capacities, are recommended as a general mitigation measure which can be used for settling surface runoff prior to disposal. The system capacity shall be flexible and able to handle multiple inputs from a variety of sources and suited to applications where the influent is pumped.</p>

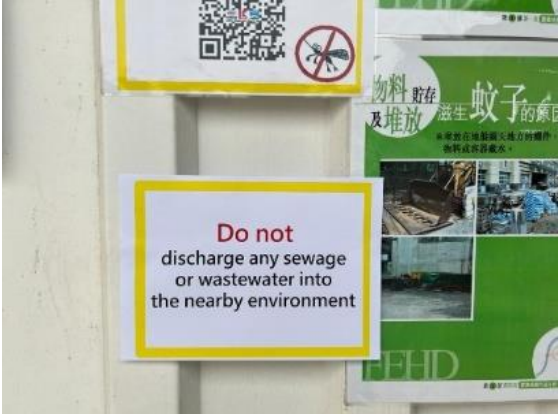
Ref	Location/ Working Period	Anticipated Major Impacts	Recommended Mitigation Measures	Photo Records (Partial)
			<ul style="list-style-type: none"> • Notices should be posted at conspicuous locations to remind the workers not to discharge any sewage or wastewater into the nearby environment during the construction phase of the Project. Regular environmental audit on the construction site should be conducted in order to provide an effective control of any malpractices and achieve continual improvement of environmental performance on site.

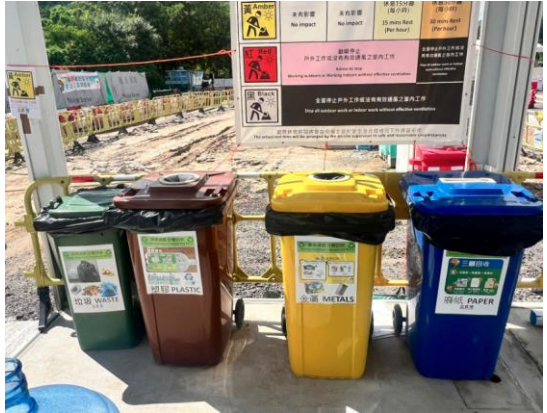
Ref	Location/ Working Period	Anticipated Major Impacts	Recommended Mitigation Measures	Photo Records (Partial)
EIA S7.6	All site area	Waste Generation	<ul style="list-style-type: none"> • Segregate and store different types of waste in different containers, skip or stockpiles to enhance reuse or recycling of materials and their proper disposal; • Proper storage and site practices to minimize the potential for damage and contamination of construction materials;

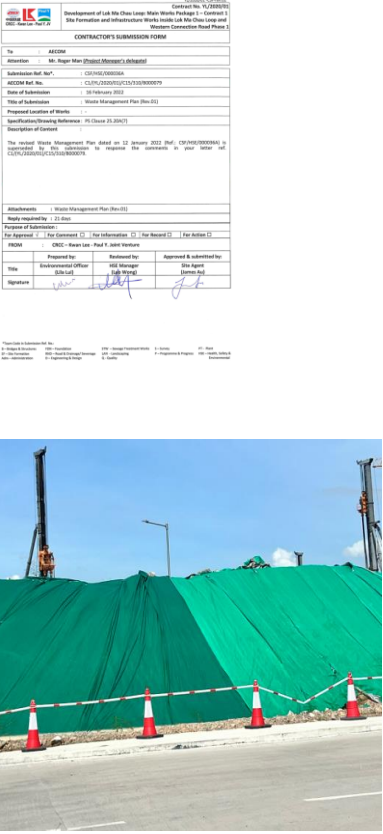
Ref	Location/ Working Period	Anticipated Major Impacts	Recommended Mitigation Measures	Photo Records (Partial)
			<ul style="list-style-type: none"> • Prepare Waste Management Plan and submit to the Engineer for approval • Proper storage and sorting of excavated inert materials to maximize on site reuse for backfilling

<p>The image shows a 'CONTRACTOR'S SUBMISSION FORM' for a Waste Management Plan (WMP-01) submitted to the Engineer. The form includes details such as the contractor's name (ACEC), project name, and submission date (18 October 2023). Below the form is a photograph of a large pile of excavated inert materials covered with a green tarp at a construction site, with safety cones and a road in the foreground.</p>

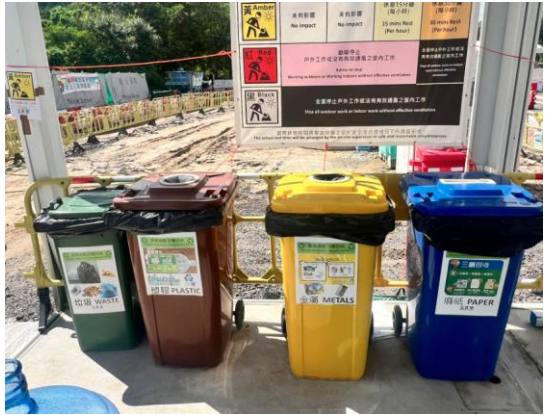
Ref	Location/ Working Period	Anticipated Major Impacts	Recommended Mitigation Measures	Photo Records (Partial)
			<ul style="list-style-type: none"> General refuse should be stored in enclosed bins separately from construction and chemical wastes. Recycling bins should also be placed to encourage recycling.

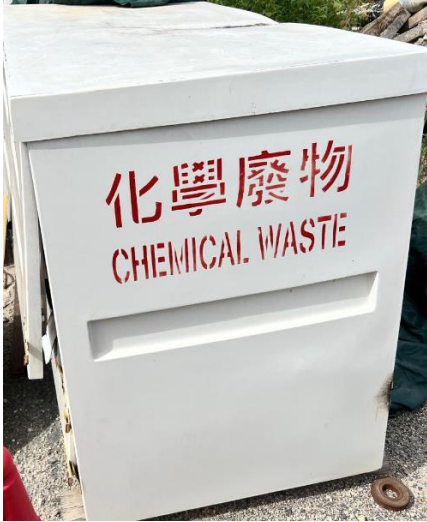
Ref	Location/ Working Period	Anticipated Major Impacts	Recommended Mitigation Measures	Photo Records (Partial)
			<ul style="list-style-type: none"> If chemical wastes are produced at the construction site, the Contractors should register with EPD as chemical waste producers. Chemical wastes should be stored in appropriate containers and collected by a licensed chemical waste contractor. Chemical wastes (e.g. spent lubricant oil) should be recycled at an appropriate facility as far as possible, while the chemical waste that cannot be recycled should be disposed of at either the Chemical Waste Treatment Centre, or another licensed facility, in accordance with the Waste Disposal (Chemical Waste) (General) Regulation.

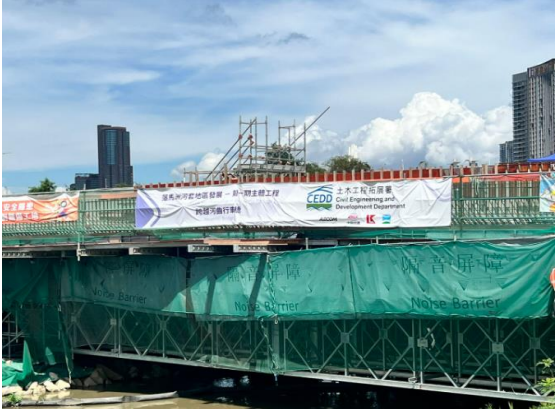
Ref	Location/ Working Period	Anticipated Major Impacts	Recommended Mitigation Measures	Photo Records (Partial)
EIA 12.7 EP 2.7	Constructi on site within the project Pond habitat along alignment (mainly Ha Wan Tsuen Road)	Ecology	Installing 3m high olive-green fence around construction areas to allow or deter different animal passages where appropriate; Carrying out outside dry-season (from November to February next year), the construction works associated with the site formation in the Ecological Area, stabilization of the bank of the old Shenzhen River meander, to minimise disturbances to migratory birds/water birds;

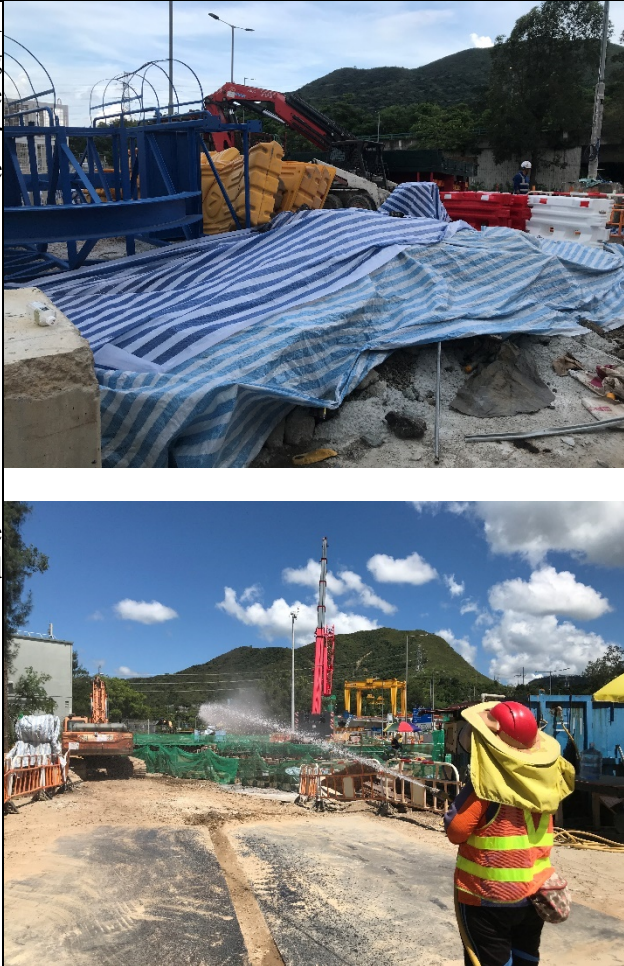
Ref*	Location/Working Period	Anticipated Major Impacts	Recommended Mitigation Measures	Photo Records (Partial)
EIA S3.8	All site area	Dust impact	<ul style="list-style-type: none"> Any excavated or stockpile of dusty material should be covered entirely by impervious sheeting or sprayed with water to maintain the entire surface wet and then removed or backfilled or reinstated where practicable within 24 hours of the excavation or unloading; Any dusty materials remaining after a stockpile is removed should be wetted with water and cleared from the surface of roads;

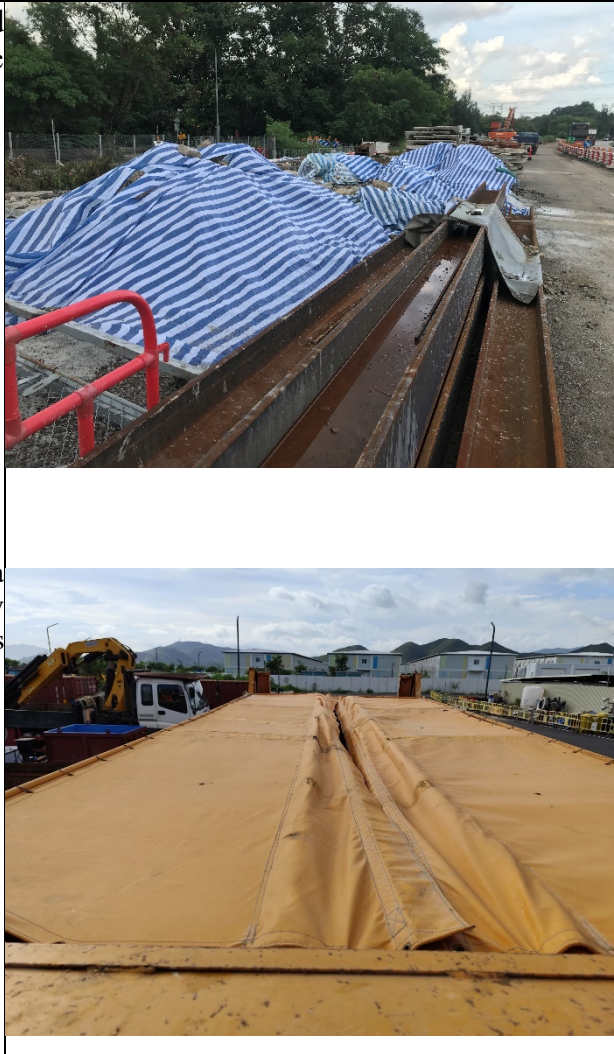
Ref*	Location/ Working Period	Anticipated Major Impacts	Recommended Mitigation Measures	Photo Records (Partial)
EIA S3.8	All site area	Dust impact	<ul style="list-style-type: none"> • A stockpile of dusty material should not be extend beyond the pedestrian barriers, fencing or traffic cones; • The load of dusty materials on a vehicle leaving a construction site should be covered entirely by impervious sheeting to ensure that the dusty materials do not leak from the vehicle;

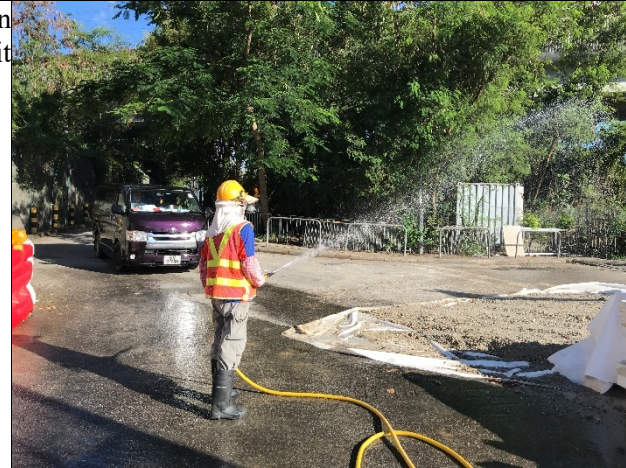
- The portion of any road leading only to construction site that is within 30m of a vehicle entrance or exit should be kept clear of dusty materials;

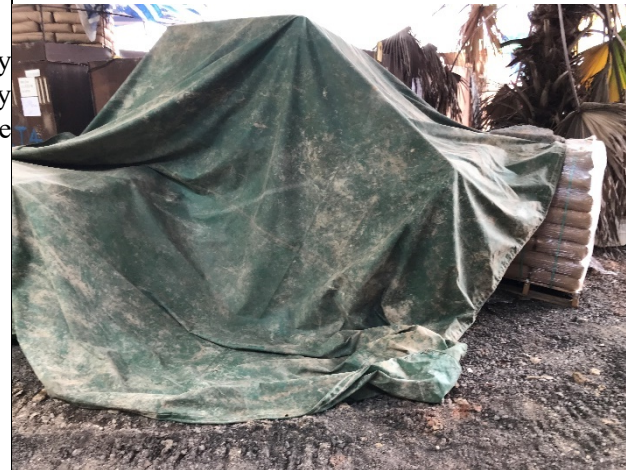
- Every stock of more than 20 bags of cement or dry pulverised fuel ash (PFA) should be covered entirely by impervious sheeting or placed in an area sheltered on the top and the 3 sides;

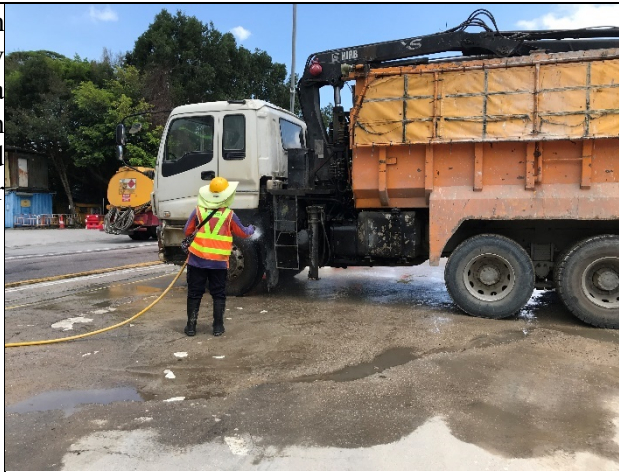
<ul style="list-style-type: none">• Where practicable, vehicle washing facilities with high pressure water jet should be provided at every discernible or designated vehicle exit point. The area where vehicle washing takes place and the road section between the washing facilities and the exit point should be paved with concrete, bituminous materials or hardcores.

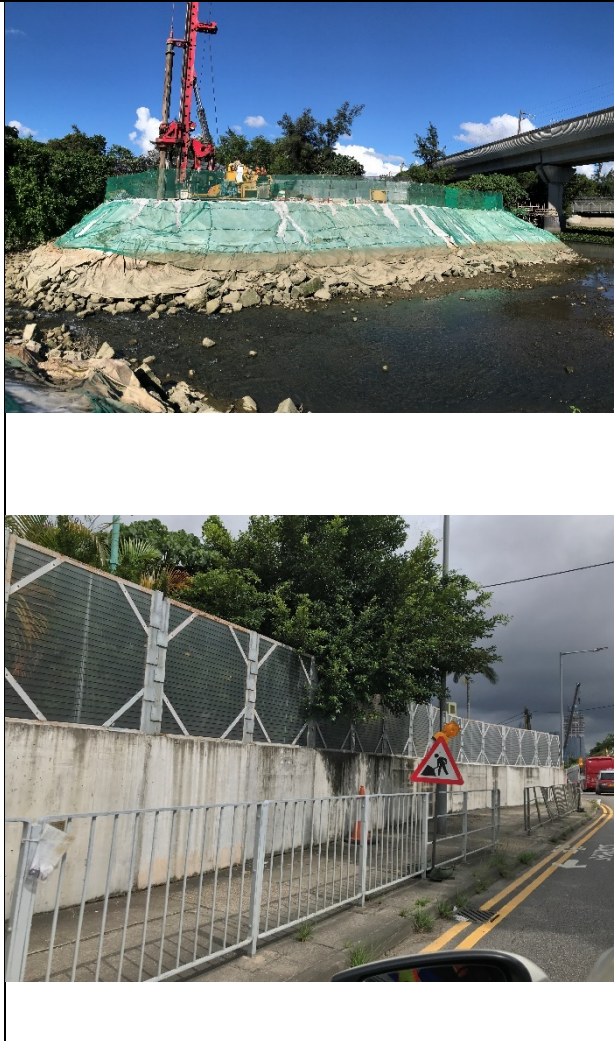
Ref*	Location/ Working Period	Anticipated Major Impacts	Recommended Mitigation Measures	Photo Records (Partial)
EIA S4.8	All site area	Noise impact	<ul style="list-style-type: none"> • Mobile plant should be sited as far away from NSRs as possible and practicable; • Install movable noise barriers and full enclosure, screen the noisy plants including air compressor and generator.

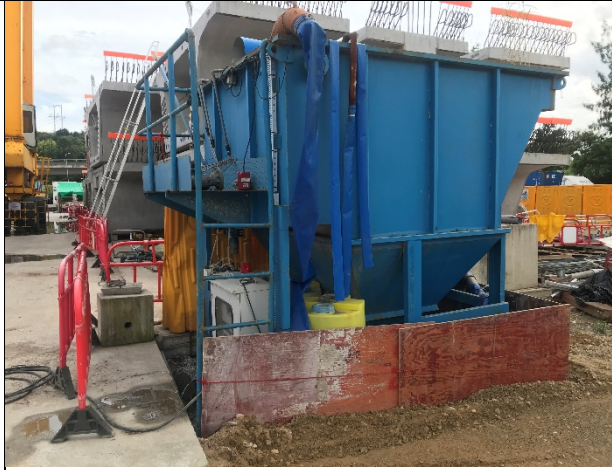
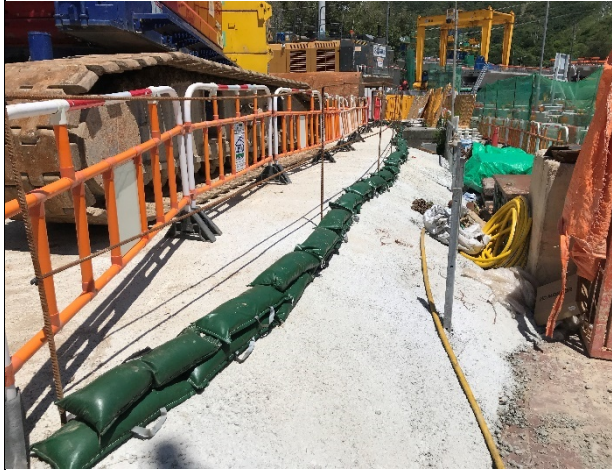
EIA S5.7	All site area	Water Pollution Control	<ul style="list-style-type: none">• At the start of site establishment, perimeter cut-off drains to direct off-site water around the site should be constructed with internal drainage works and erosion and sedimentation control facilities implemented. Channels (both temporary and permanent drainage pipes and culverts), earth bunds or sand bag barriers should be provided on site to direct stormwater to silt removal facilities. The design of the temporary on-site drainage system will be undertaken by the contractor prior to the commencement of construction. • Diversion of natural stormwater should be provided as far as possible. The design of temporary on-site drainage should prevent runoff going through site surface, construction machinery and equipment in order to avoid or minimize polluted runoff.

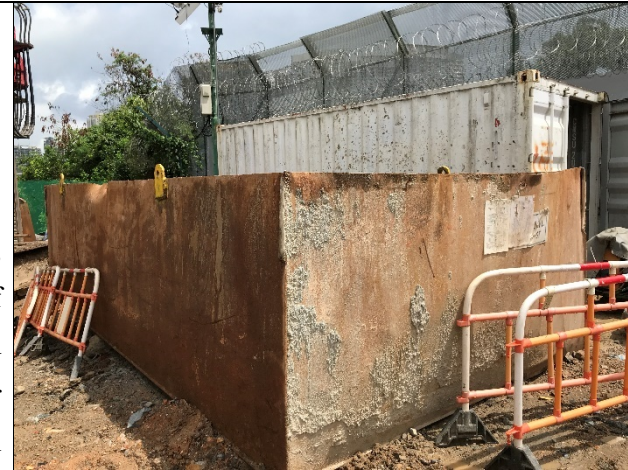
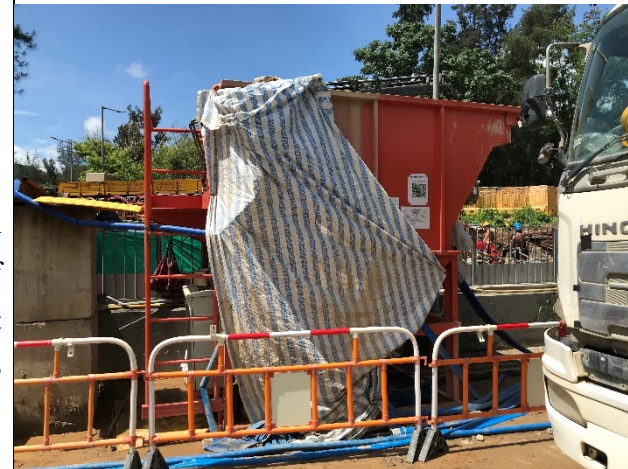
- Sedimentation tanks with sufficient capacity, constructed from pre-formed individual cells of approximately 6 to 8 m³ capacities, are recommended as a general mitigation measure which can be used for settling surface runoff prior to disposal. The system capacity shall be flexible and able to handle multiple inputs from a variety of sources and suited to applications where the influent is pumped.

- The design of efficient silt removal facilities should be based on the guidelines in Appendix A1 of ProPECC PN 1/94. The detailed design of the sand/silt traps should be undertaken by the contractor prior to the commencement of construction.

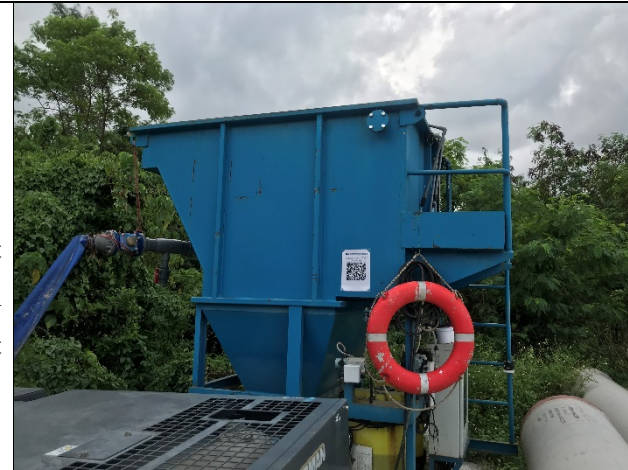
• All drainage facilities and erosion and sediment control structures should be regularly inspected and maintained to ensure proper and efficient operation at all times and particularly following rainstorms.
