**Service Contract No. WD/04/2020
Development of Lok Ma Chau Loop:
Main Works Package 1 –
Environmental Team**

**Environmental Permit No.:
EP-477/2013/B
- Development of Lok Ma Chau Loop**

**Monthly Environmental Monitoring and
Audit Report for July 2024**

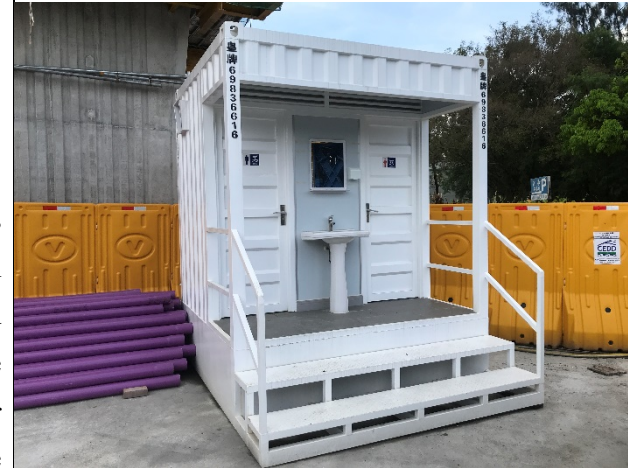
• Portable chemical toilets and sewage holding tanks should be provided for handling the construction sewage generated by the workforce. A licensed contractor should be employed to provide appropriate and adequate portable toilets to cater 0.15m³/day/employed populations and be responsible for appropriate disposal and maintenance.

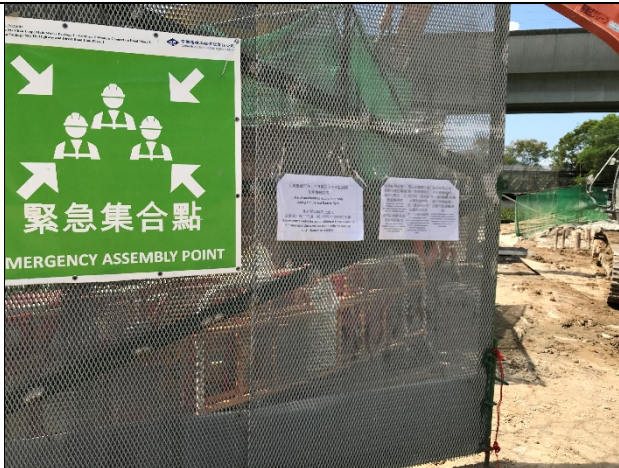
<ul style="list-style-type: none">• Notices should be posted at conspicuous locations to remind the workers not to discharge any sewage or wastewater into the nearby environment during the construction phase of the Project. Regular environmental audit on the construction site should be conducted in order to provide an effective control of any malpractices and achieve continual improvement of environmental performance on site.

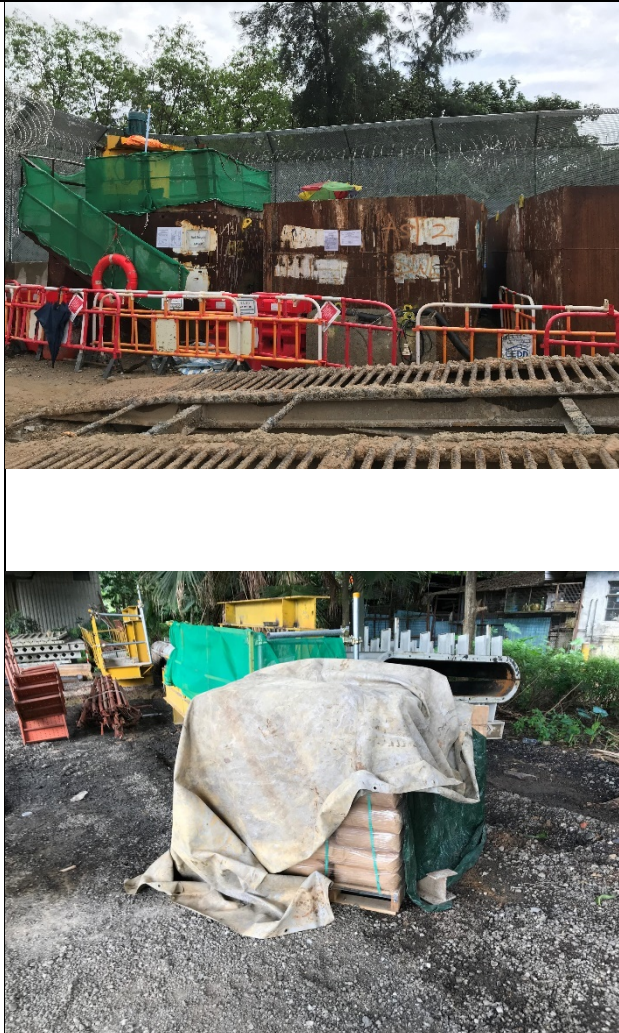
Ref*	Location/ Working Period	Anticipated Major Impacts	Recommended Mitigation Measures	Photo Records (Partial)
EIA S7.6	All site area	Waste Generation	<ul style="list-style-type: none"> • Segregate and store different types of waste in different containers, skip or stockpiles to enhance reuse or recycling of materials and their proper disposal; • Proper storage and site practices to minimize the potential for damage and contamination of construction materials;

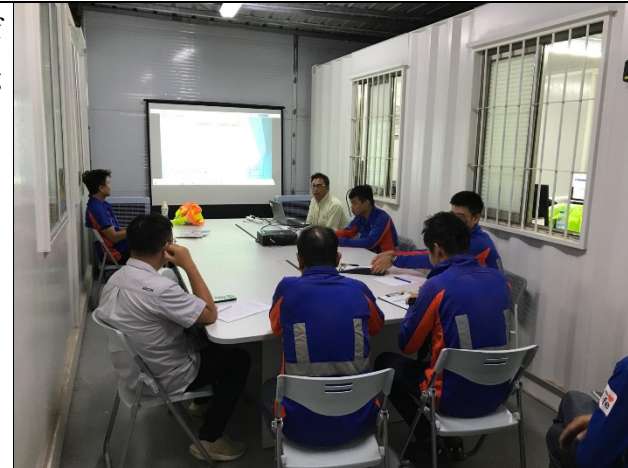
- Provide training to workers on the importance of appropriate waste management procedures, including waste reduction, reuse and recycling.

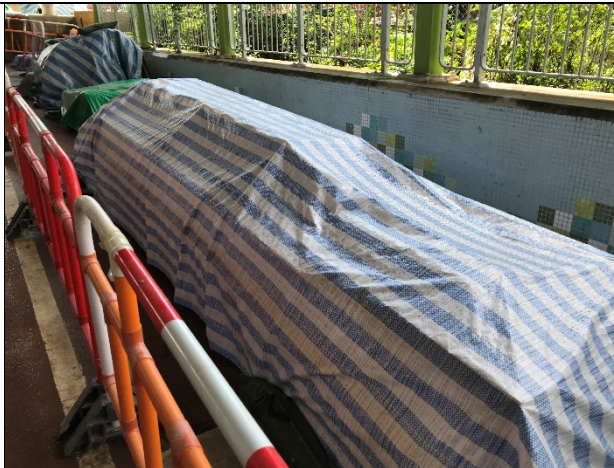
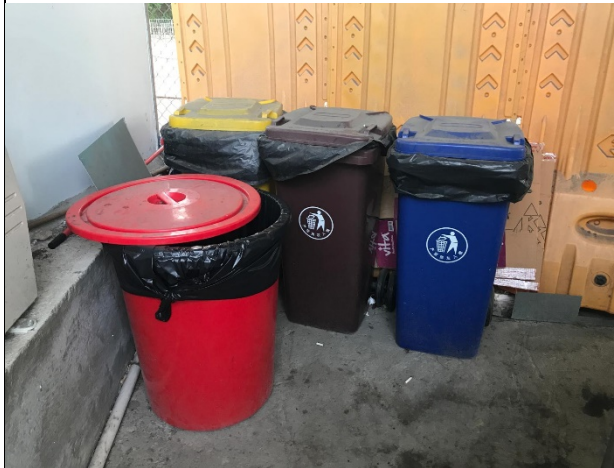
<ul style="list-style-type: none">• Proper storage and sorting of excavated inert materials to maximize on site reuse for backfilling • General refuse should be stored in enclosed bins separately from construction and chemical wastes. Recycling bins should also be placed to encourage recycling.

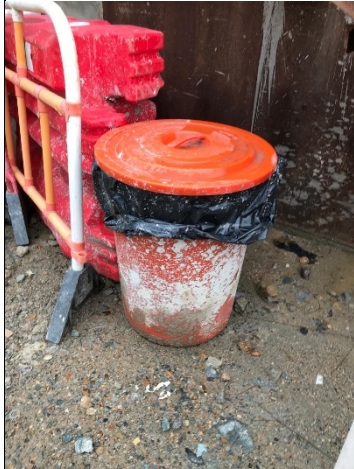
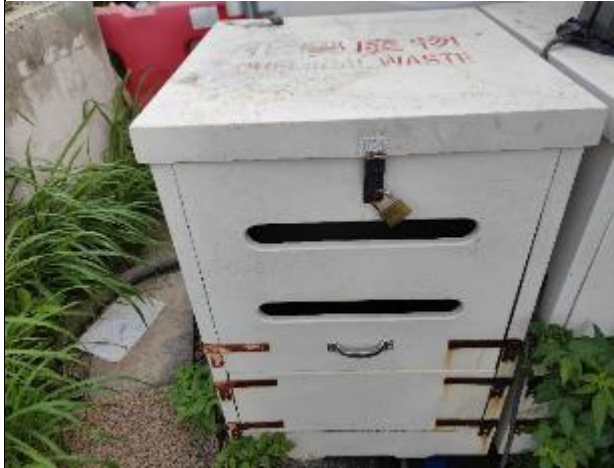
<ul style="list-style-type: none">• Preferably enclosed and covered areas should be provided for general refuse collection and routine cleaning for these areas should also be implemented to keep areas clean. • If chemical wastes are produced at the construction site, the Contractors should register with EPD as chemical waste producers. Chemical wastes should be stored in appropriate containers and collected by a licensed chemical waste contractor. Chemical wastes (e.g. spent lubricant oil) should be recycled at an appropriate facility as far as possible, while the chemical waste that cannot be recycled should be disposed of at either the Chemical Waste Treatment Centre, or another licensed facility, in accordance with the Waste Disposal (Chemical Waste) (General) Regulation.

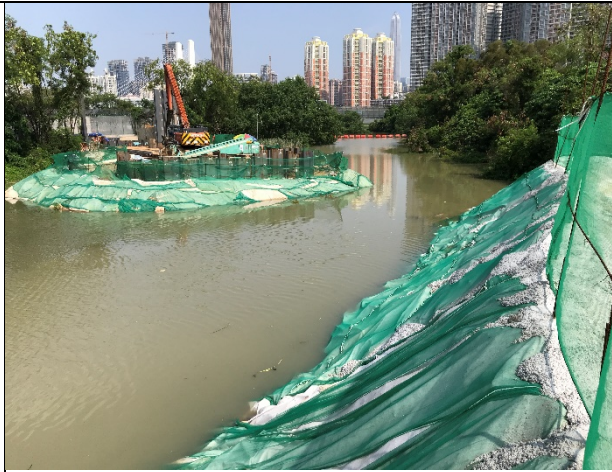
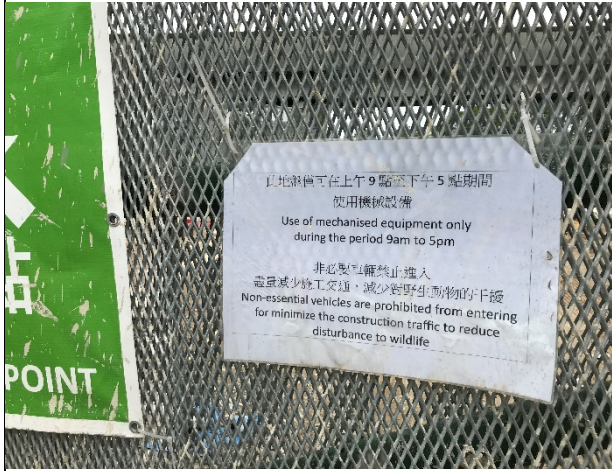
<p>ERR S4.2.2</p>	<p>STEMDC</p>	<p>Ecology</p>	<ul style="list-style-type: none">• Installation of 3m-high olive green fence site hoarding around construction areas to reduce disturbance and such installation should allow passage of animal • Use of mechanized equipment only during the period 9am to 5pm

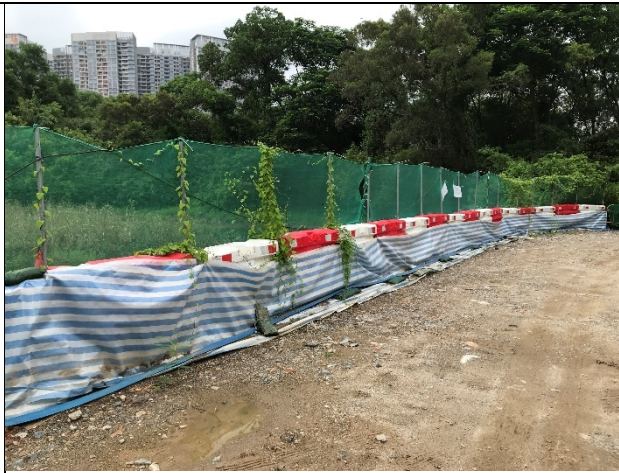
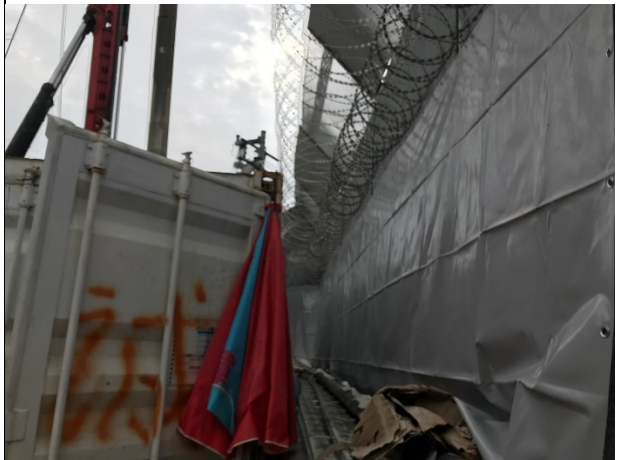
<ul style="list-style-type: none">Well-defined and fenced work area to prevent intentional or accidental encroachment or trespassing to other part of the mitigation wetland for access, parking, operation of plants/machineries, or stockpiling of construction material/waste nearby <p>Wherever feasible, noise curtain should be installed around noisy plants machineries to minimize the potential audibled disturbance to wildlife in the adjacent habitats</p>

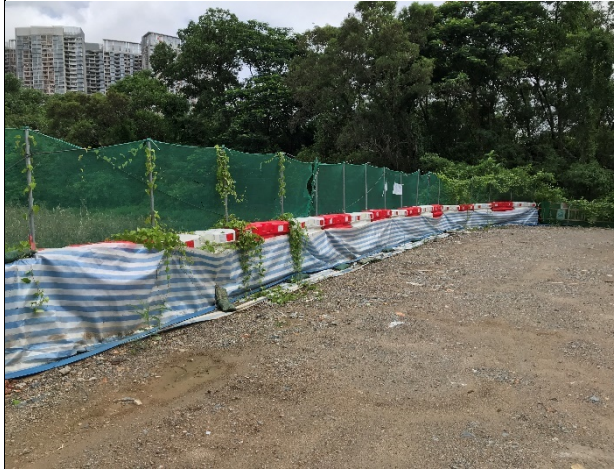
<p>Minimize the construction traffic within the mitigation wetland as far as practicable</p> <p>Measures to avoid any spillage or discharge of untreated runoff from the site to other part of the mitigation wetland should be implemented, including but not limited to provision of sandbags barrier and perimeter channels at site boundaries</p>

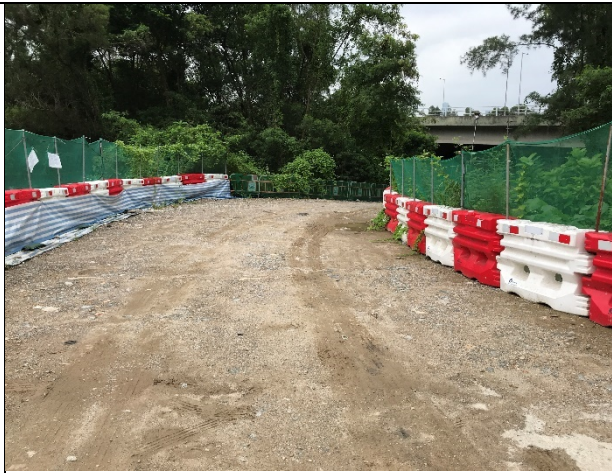
<p>Wheel washing bay and mobile toilet should be positioned outside and as far as practicable from the boundary of the mitigation wetland</p>

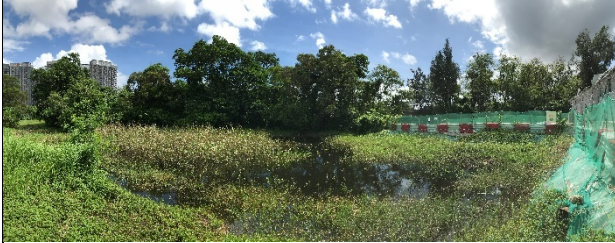
<p>Any stockpiling should be away from the mitigation pond</p>

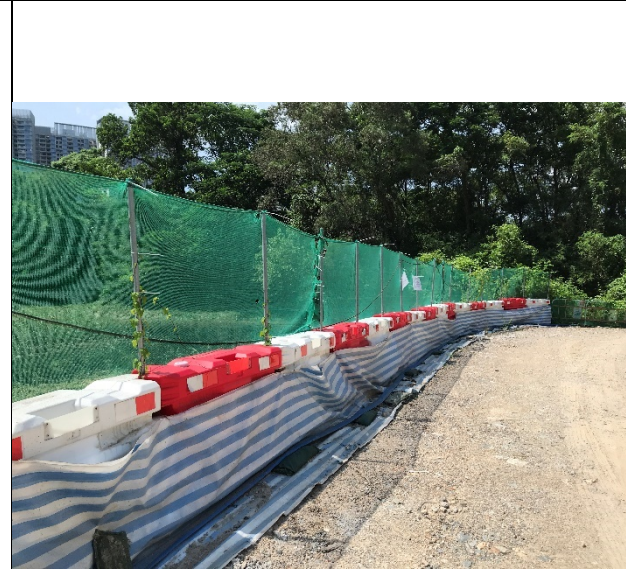
Do not provide excessive lighting along the boundary of the work site and keep the intensity and duration of lighting to a strictly necessary minimum as far as practicable

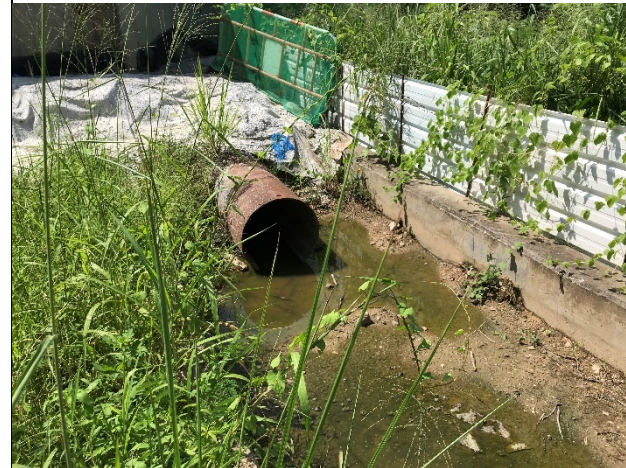
Proper upkeep of the drainage pipe installed underneath the work area to avoid any clogging

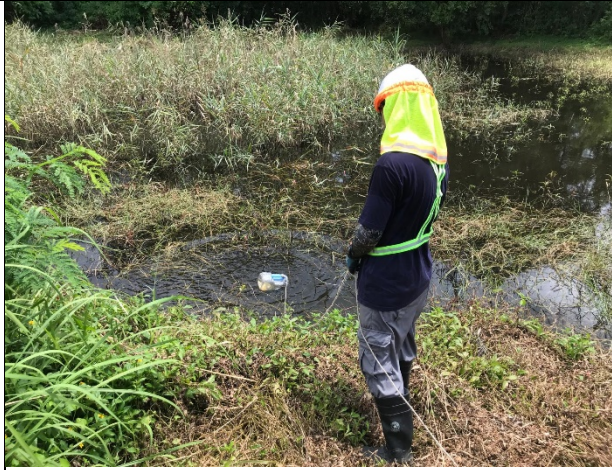
ERR S6.1.2	STEMDC	Ecology	<ul style="list-style-type: none">water quality monitoring should be carried out by the Contractor during the construction of the pier DRL-P08, and covers the northern and southern parts of the mitigation pond - where the former could act as reference during the evaluation. By making reference to the water monitoring program of the Hong Kong Wetland Park for constructed wetlands, the monitoring parameters should include water temperature, turbidity, biological oxygen demand, nitrogenous and phosphorus compounds, salinity, pH and dissolved oxygen.

<p>Water quality monitoring in July had been conducted on 11 July 2024.</p>
---------------	--------	---------	--	---

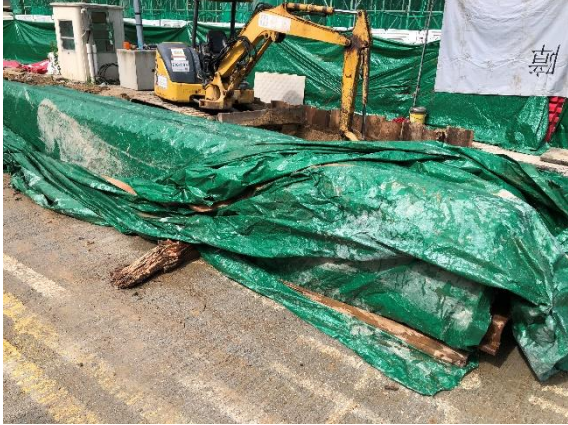
Ref*	Location/ Working Period	Anticipated Major Impacts	Recommended Mitigation Measures	Photo Records (Partial)
EIA S3.8	All site area	Dust impact	<ul style="list-style-type: none"> Any excavated or stockpile of dusty material should be covered entirely by impervious sheeting or sprayed with water to maintain the entire surface wet and then removed or backfilled or reinstated where practicable within 24 hours of the excavation or unloading; Any dusty materials remaining after a stockpile is removed should be wetted with water and cleared from the surface of roads;

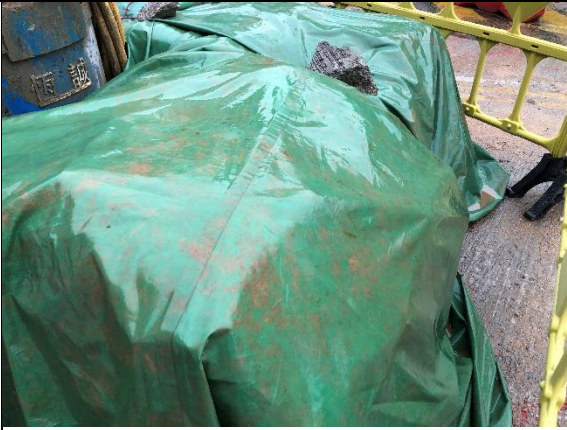
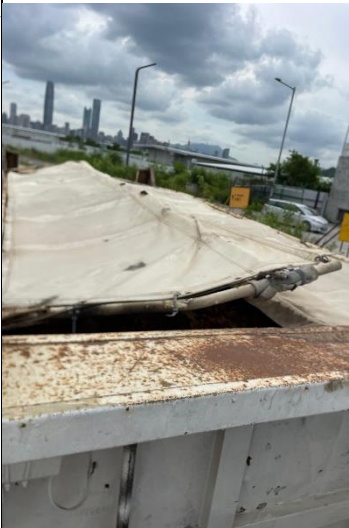
Ref*	Location/ Working Period	Anticipated Major Impacts	Recommended Mitigation Measures	Photo Records (Partial)
EIA S3.8	All site area	Dust impact	<ul style="list-style-type: none"> • A stockpile of dusty material should not be extend beyond the pedestrian barriers, fencing or traffic cones; • The load of dusty materials on a vehicle leaving a construction site should be covered entirely by impervious sheeting to ensure that the dusty materials do not leak from the vehicle;

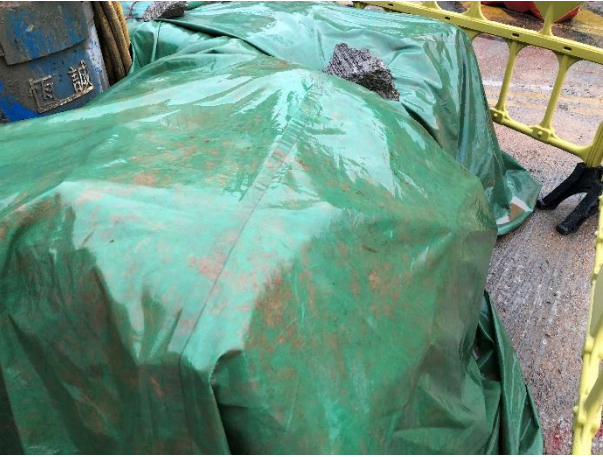
<ul style="list-style-type: none">• The portion of any road leading only to construction site that is within 30m of a vehicle entrance or exit should be kept clear of dusty materials; • Every stock of more than 20 bags of cement or dry pulverised fuel ash (PFA) should be covered entirely by impervious sheeting or placed in an area sheltered on the top and the 3 sides;

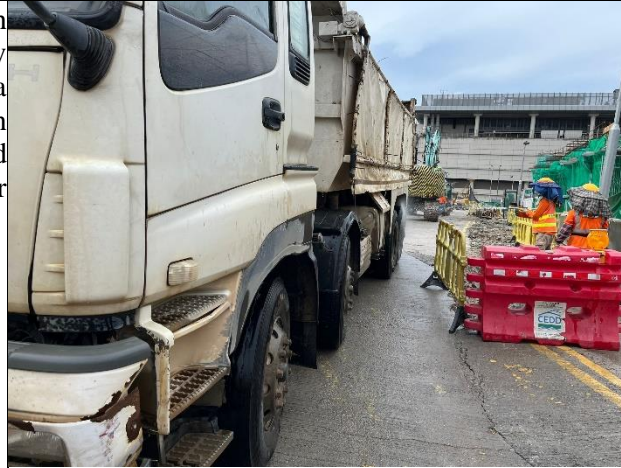
- Where practicable, vehicle washing facilities with high pressure water jet should be provided at every discernible or designated vehicle exit point. The area where vehicle washing takes place and the road section between the washing facilities and the exit point should be paved with concrete, bituminous materials or hardcores.

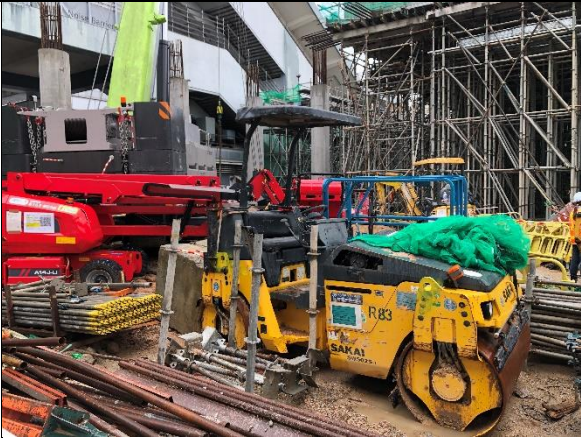
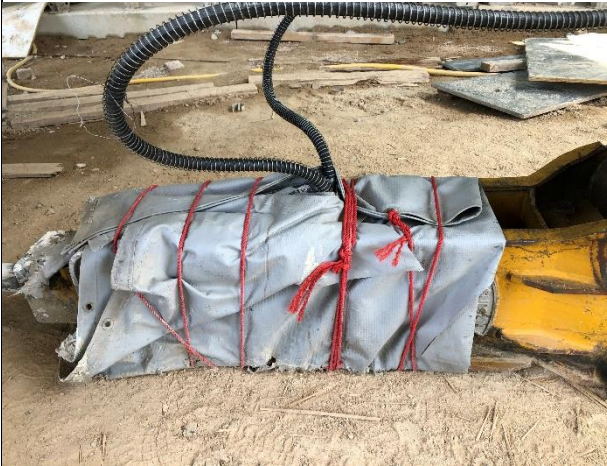
• An acoustic canvas had been deployed along the site boundary facing the public.

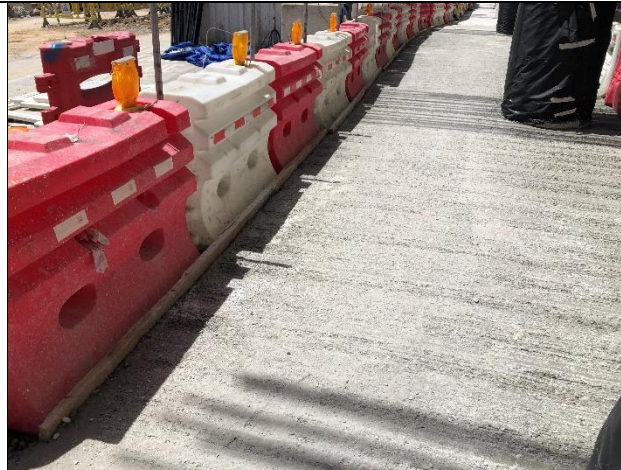
• Diversion of natural stormwater should be provided as far as possible. The design of temporary on-site drainage should prevent runoff going through site surface, construction machinery and equipment in order to avoid or minimize polluted runoff.

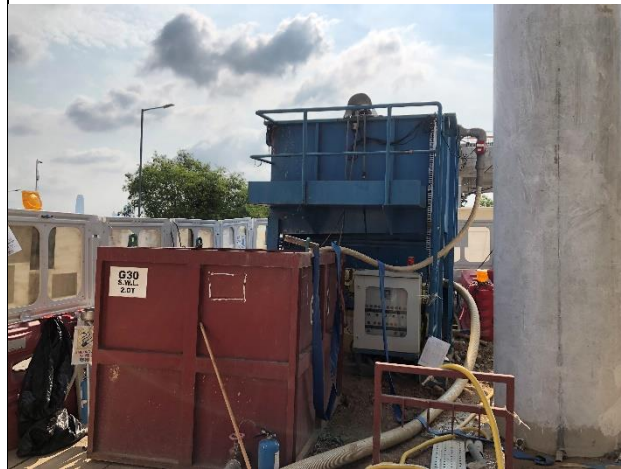
• Sedimentation tanks with sufficient capacity, constructed from pre-formed individual cells of approximately 6 to 8 m³ capacities, are recommended as a general mitigation measure which can be used for settling surface runoff prior to disposal. The system capacity shall be flexible and able to handle multiple inputs from a variety of sources and suited to applications where the influent is pumped.

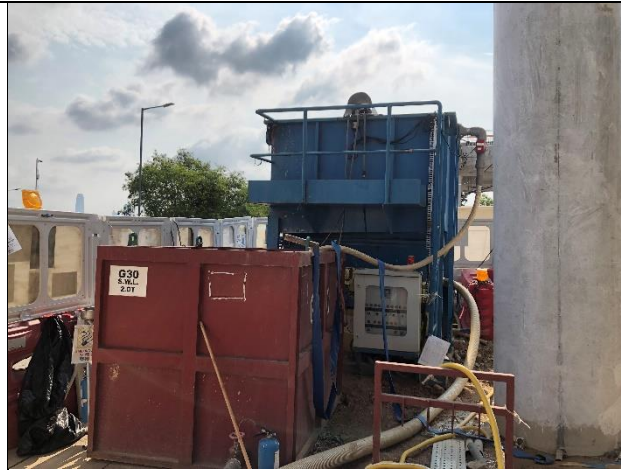
• The design of efficient silt removal facilities should be based on the guidelines in Appendix A1 of ProPECC PN 1/94. The detailed design of the sand/silt traps should be undertaken by the contractor prior to the commencement of construction.

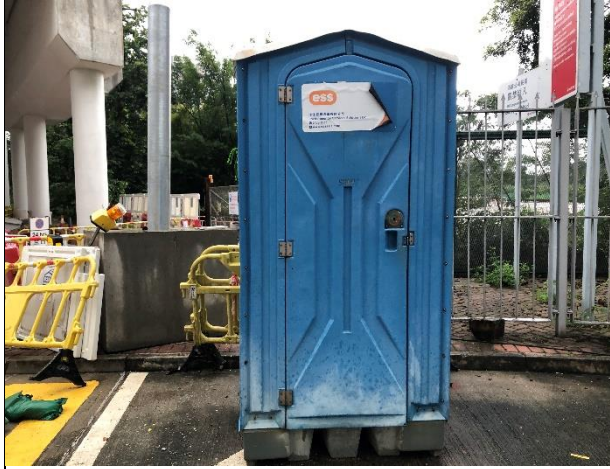
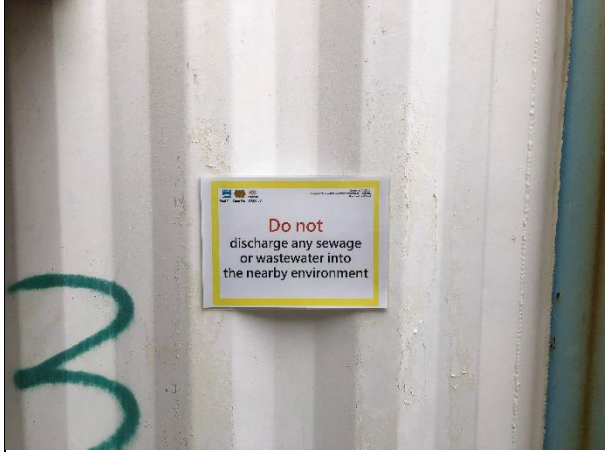
<ul style="list-style-type: none">• Portable chemical toilets and sewage holding tanks should be provided for handling the construction sewage generated by the workforce. A licensed contractor should be employed to provide appropriate and adequate portable toilets to cater 0.15m³/day/employed populations and be responsible for appropriate disposal and maintenance. • Notices should be posted at conspicuous locations to remind the workers not to discharge any sewage or wastewater into the nearby environment during the construction phase of the Project. Regular environmental audit on the construction site should be conducted in order to provide an effective control of any malpractices and achieve continual improvement of environmental performance on site.

•An additional water pump had been set up and the concerned outlet have been sealed up with concrete

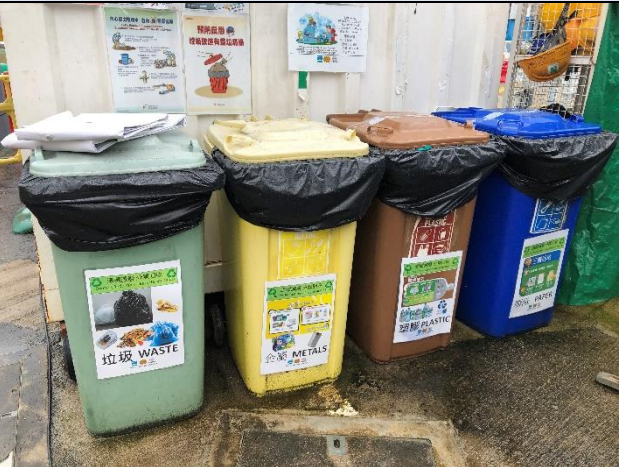
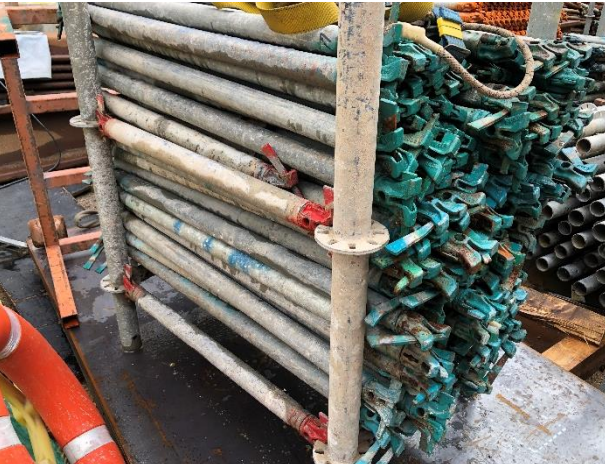
Ref*	Location/ Working Period	Anticipated Major Impacts	Recommended Mitigation Measures	Photo Records (Partial)
EIA S7.6	All site area	Waste Generation	<ul style="list-style-type: none"> • Segregate and store different types of waste in different containers, skip or stockpiles to enhance reuse or recycling of materials and their proper disposal; • Proper storage and site practices to minimize the potential for damage and contamination of construction materials;

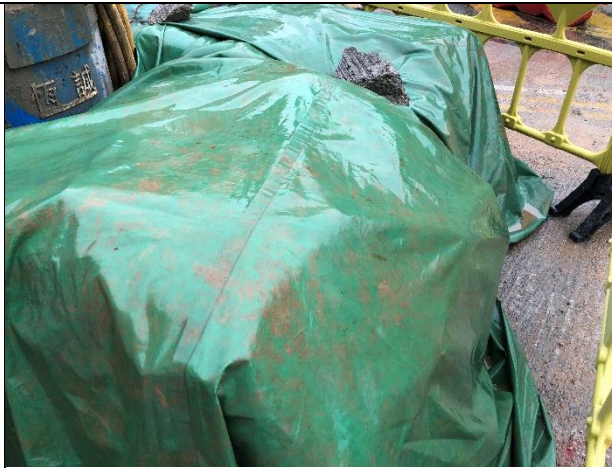
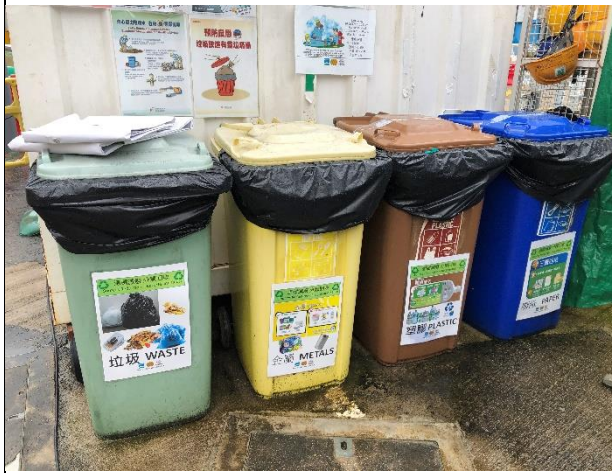
<ul style="list-style-type: none">• Proper storage and sorting of excavated inert materials to maximize on site reuse for backfilling • General refuse should be stored in enclosed bins separately from construction and chemical wastes. Recycling bins should also be placed to encourage recycling.

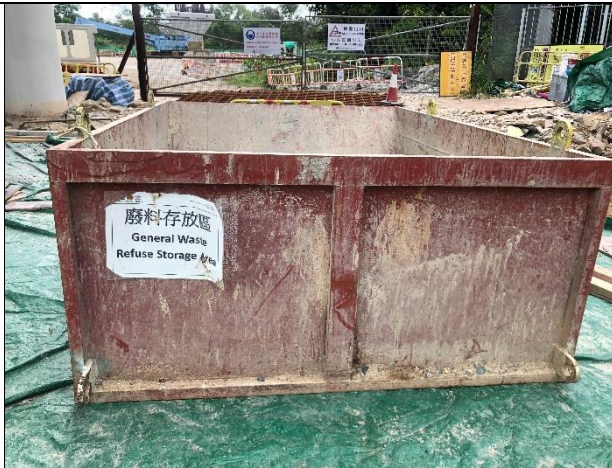
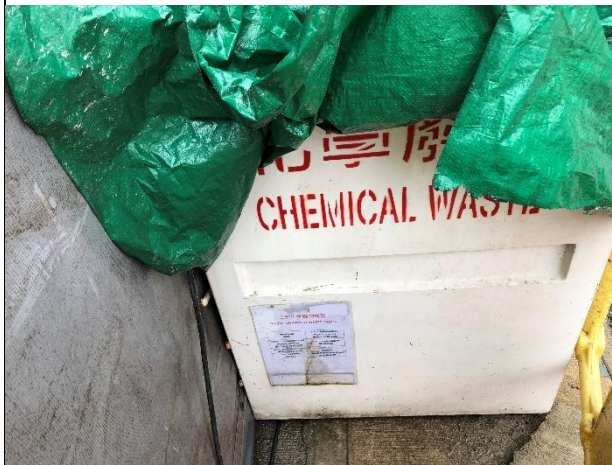
<ul style="list-style-type: none">• Preferably enclosed and covered areas should be provided for general refuse collection and routine cleaning for these areas should also be implemented to keep areas clean. • If chemical wastes are produced at the construction site, the Contractors should register with EPD as chemical waste producers. Chemical wastes should be stored in appropriate containers and collected by a licensed chemical waste contractor. Chemical wastes (e.g. spent lubricant oil) should be recycled at an appropriate facility as far as possible, while the chemical waste that cannot be recycled should be disposed of at either the Chemical Waste Treatment Centre, or another licensed facility, in accordance with the Waste Disposal (Chemical Waste) (General) Regulation.
