Decommissioning of West Ash Lagoon in Tsang Tsui

Project Profile

July 2024

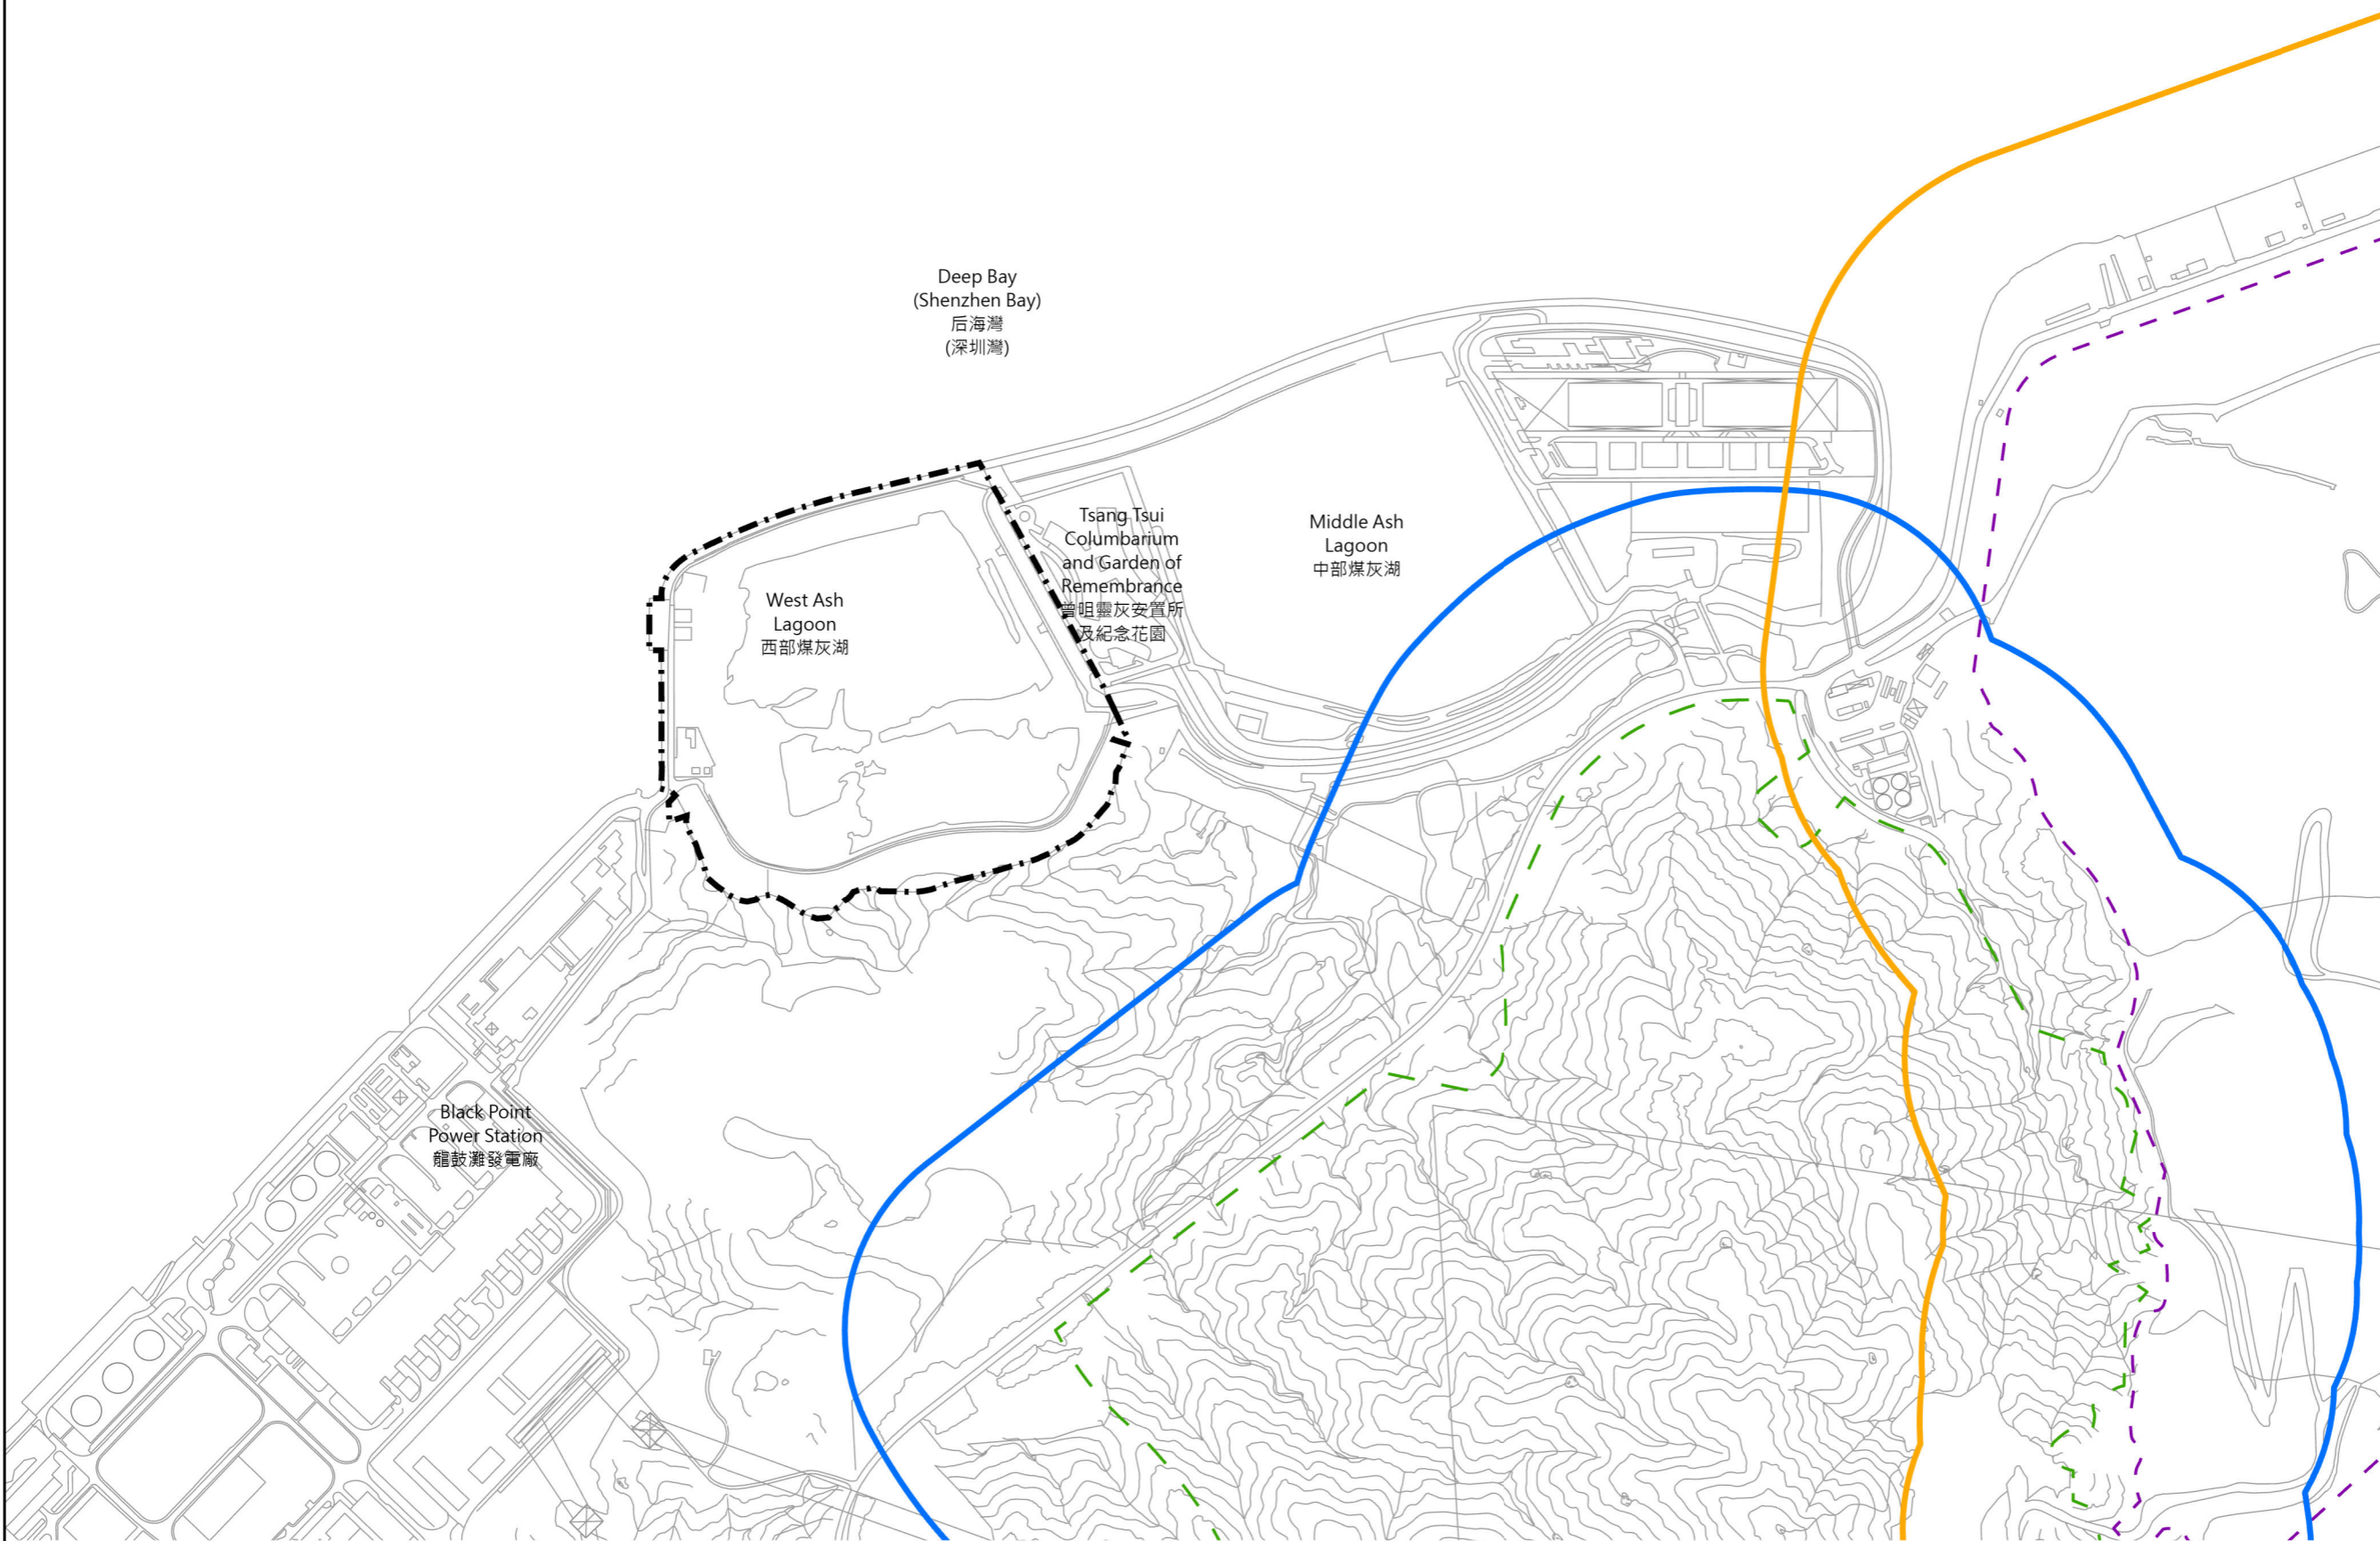
LANDFILL GAS CONSULTATION ZONE OF WENTX 新界西堆填區擴建計劃250米諮詢區

- 3.2.1.14. As shown in **Figure 3.6**, the Project site is located outside the 250m consultation zone of the existing WENT Landfill and the proposed WENTX. Landfill gas hazard associated with this Project is not anticipated.

- 4.2.9.1. The Project site is located outside the 250m consultation zone of the existing WENT Landfill and the proposed WENTX. Landfill gas hazard associated with this Project is not anticipated.
