# Decommissioning and Demolition of the Castle Peak A Power Station

Project Profile

Castle Peak Power Company Limited  
(CAPCO)

DATE  
4 October 2024

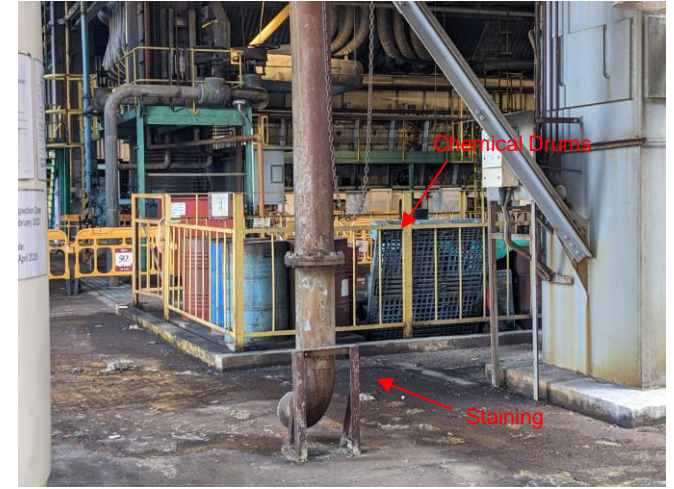
Photo 51: A chemical drum storage area was observed at unit A1 in the boiler house

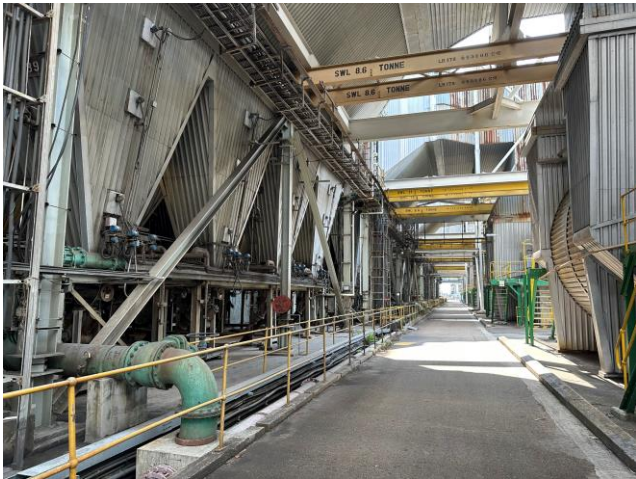
Photo 52: Electrostatic precipitator systems and induced draft fans

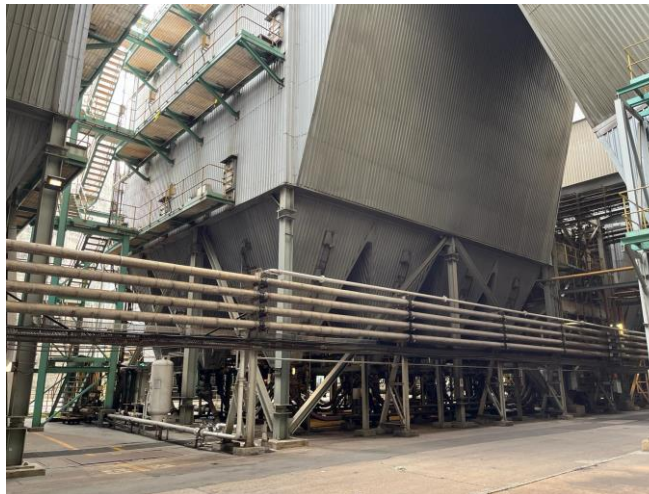
Photo 53: Electrostatic precipitator systems including ash hoppers for fly ash

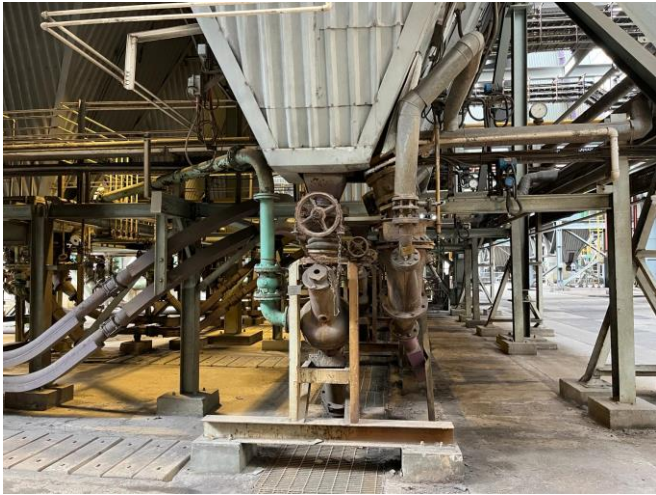
Photo 55: Bottom of electrostatic precipitator ash hopper structures

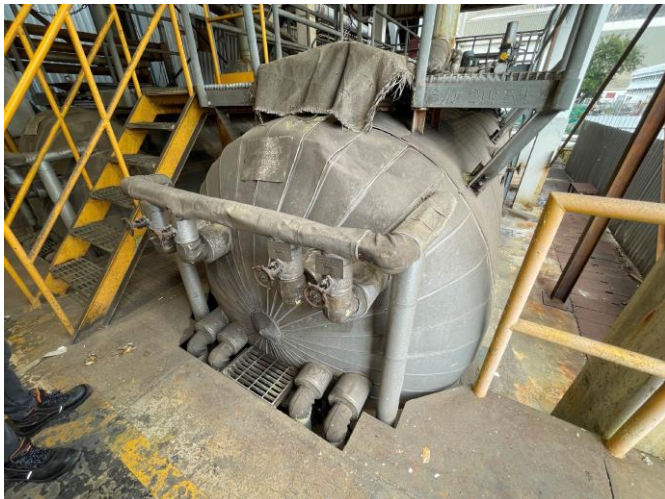
Photo 88: Sulphur melting tanks next to the sulfur store

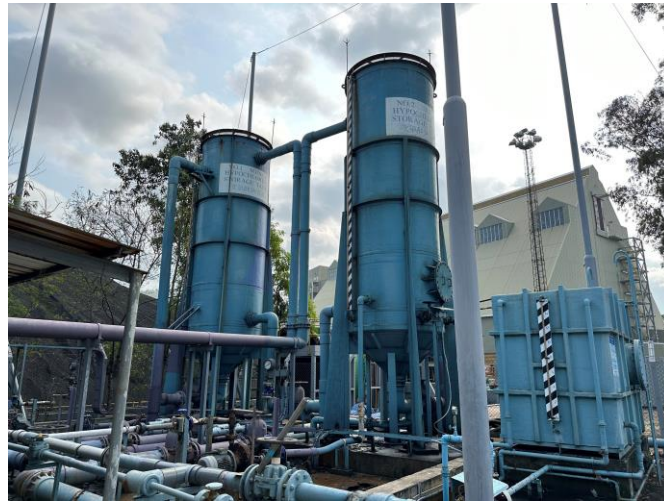
Photo 92: Two (2) aboveground tanks for storing sodium hypochlorite solution
