Location / 位置	Lung Tseng Tau
Type / 種類	House (Chan)
Map Ref. / 地圖參考檔號	—
Arch. Assessment Ref. / 考古通參考檔號	TCR01-1910
AMO Ref. / 古物古蹟辦事處參考檔號	
Photographic Ref. / 照片參考檔號	#3029 (23)

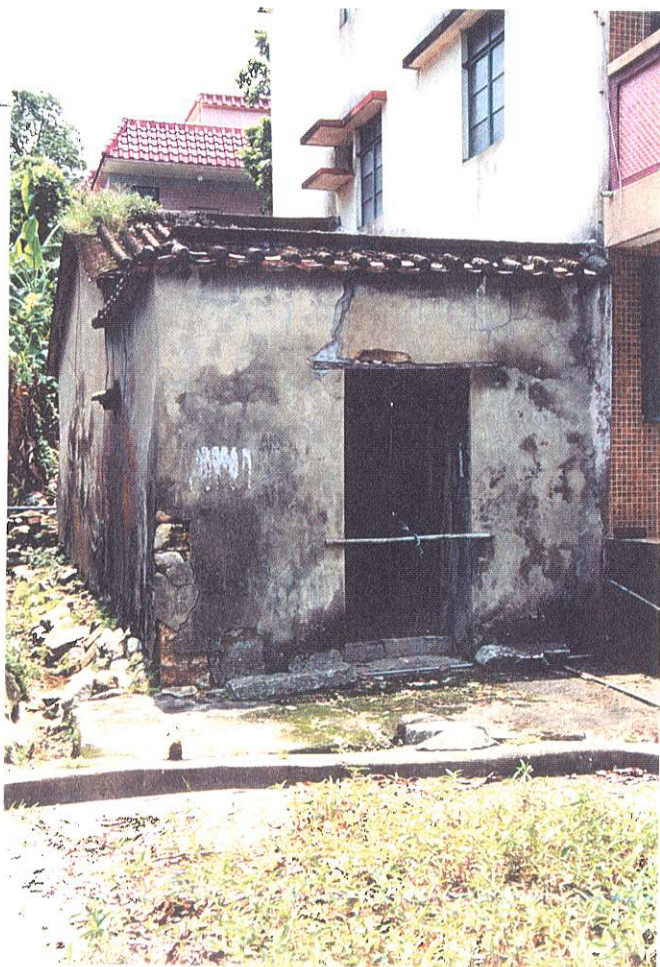
Courtyard style house; closed & apparently not in use. Rammed earth on lower stone courses. Cement rendering. Wood lintel, frame & doors. No decoration.
Tile and wood roof partly intact.
Stone lined drainage channels in front and beside house.
