Location / 位置	Lung Tsing Tau
Type / 種類	<del>stone</del> (chan) Ruin
Map Ref. / 地圖參考檔號	
Arch. Assessment Ref. / 考古通參考檔號	TUR01 - 2011
AMO Ref. / 古物古蹟辦事處參考檔號	
Photographic Ref. / 照片參考檔號	#3029 (22)

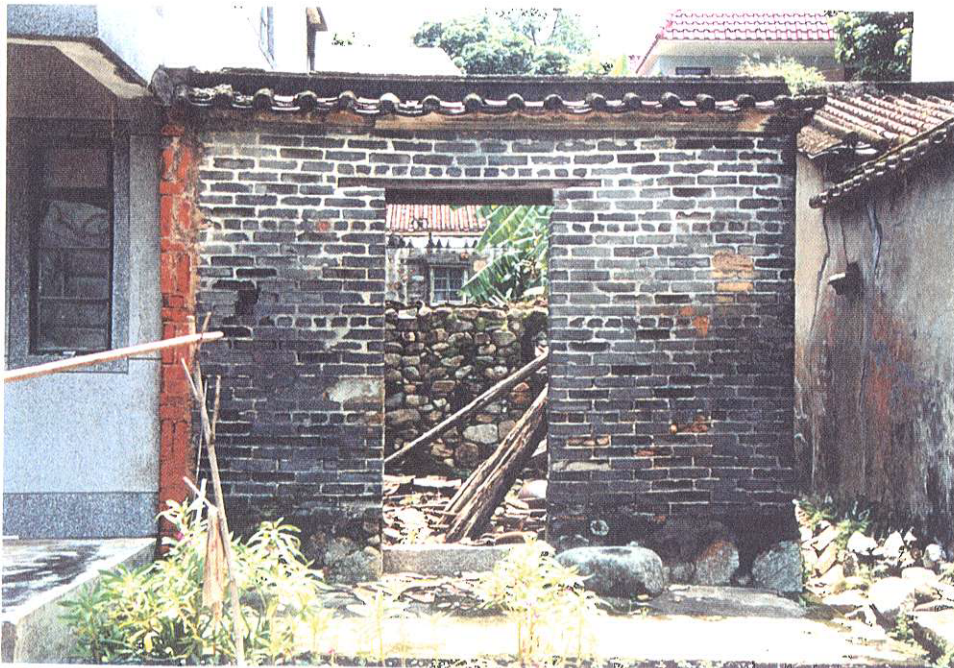
Photograph / 照片

Description / 說明	<p>Former courtyard house modified for use as a shed. Original grey brick facade, with stone threshold &amp; pivot blocks. Moulded frieze below eaves. Wood lintel. Uncut stone wall footing. Side &amp; rear walls are patches of mixed materials. No roof remains.</p> <p>Associated stone lined drainage channels line a back portion of house still visible.</p>
------------------	--
