Location / 位置	Lung Tsung Tau
Type / 種類	House (Chan)
Map Ref. / 地圖參考檔號	
Arch. Assessment Ref. / 考古通參考檔號	TCR-01-2314
AMO Ref. / 古物古蹟辦事處參考檔號	
Photographic Ref. / 照片參考檔號	#3029 (18)

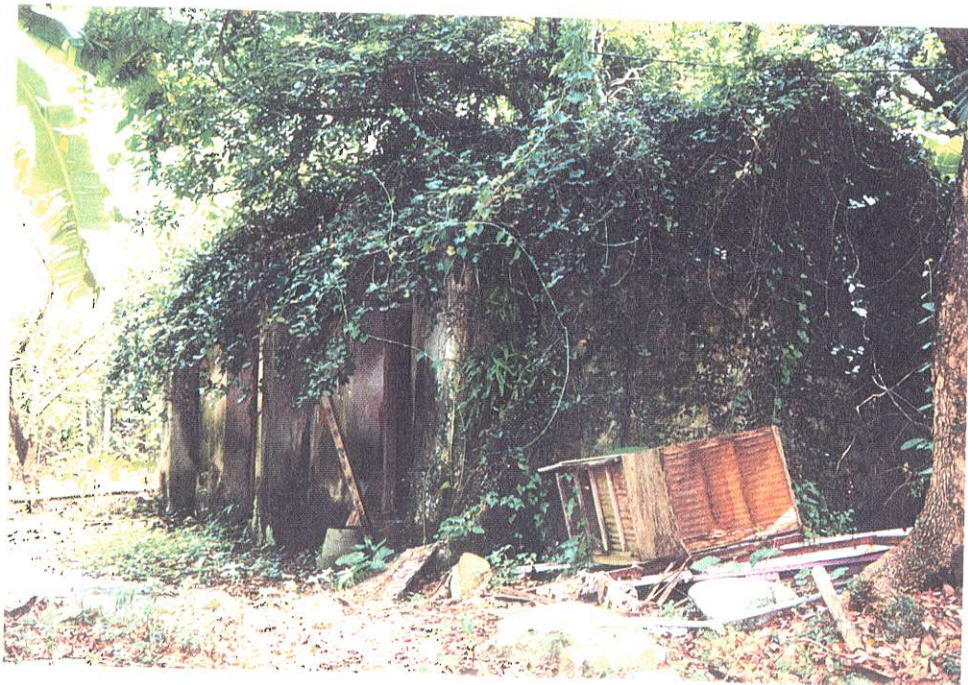
Description / 說明	Abandoned single storey structure, mud brick with render. Tile roof - very overgrown. Walls collapsed in places at rear. 2 windows at rear. stone metal bars. Double panel wooden door in left hand unit.
------------------	--
