Construction of Cycle Tracks and the Associated Supporting Facilities
From Sha Po Tsuen to Shek Sheung River
Environmental Impact Assessment

Title:	Photomontages - Vantage Point A (1 of 2)		
Date:	December 2008	Figure	12-10A

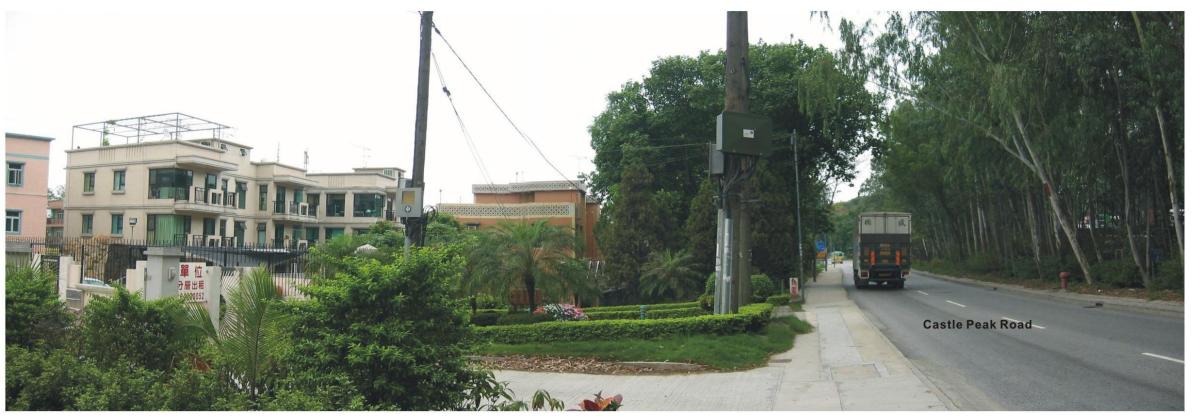
## **Existing Condition**

View northeast at footpath of Castle Peak Road adjacent to the entrance of Nga Yuet Villa. This view represents the visual quality of residents living in villages adjacent to Castle Peak Road. (VSR6 Residents of Village Settlement along Castle Peak Road between Tam Mei and Mai Po Section).

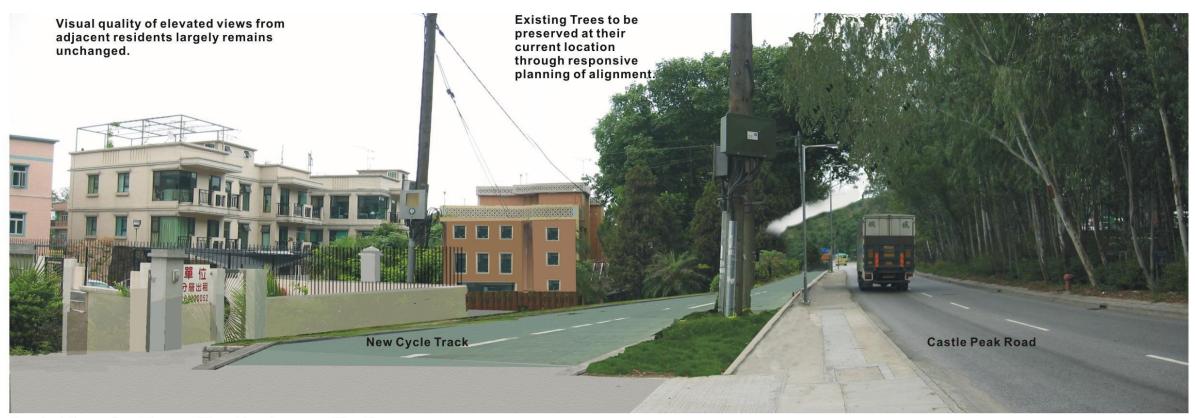
## Day 1 of Operation Phase without landscape mitigation measures

View northeast at footpath of Castle Peak Road adjacent to the entrance of Nga Yuet Villa. This view represents the visual quality of residents living in villages adjacent to Castle Peak Road.
