<p>Halcrow Halcrow China Ltd. As Engineering Sub-consultant</p>	<p>Agreement No. : WD 6/2007</p> <p>Project Title : Improvement to Pok Oi Interchange - Environmental Impact Assessment Study</p>	<p>Environmental Impact Assessment Report</p> <p>Photomontage from Visually Sensitive Receiver 2</p>	<p>Figure 8.8d</p>

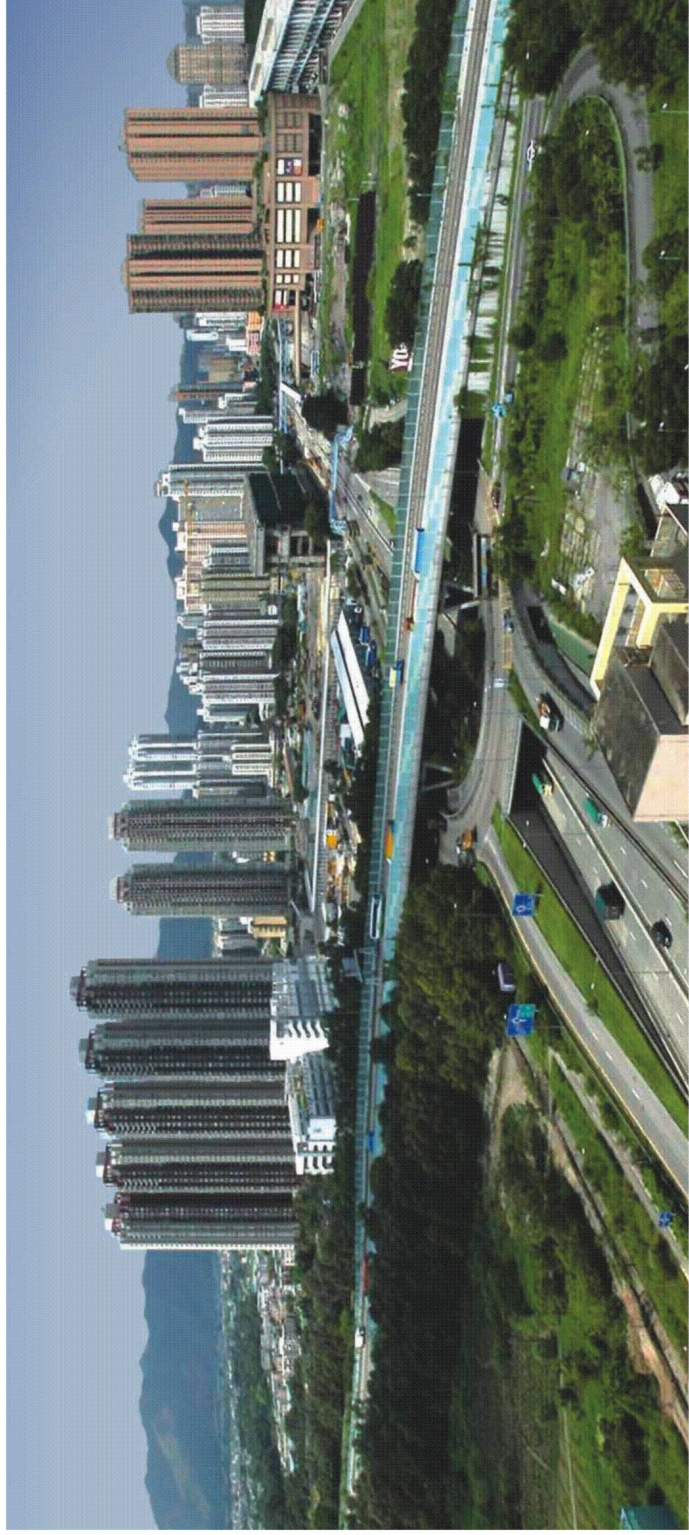
VSR 2 - LOOKING WEST FROM POK OI HOSPITAL: EXISTING CONDITIONS AT THE DEVELOPMENT SITE.

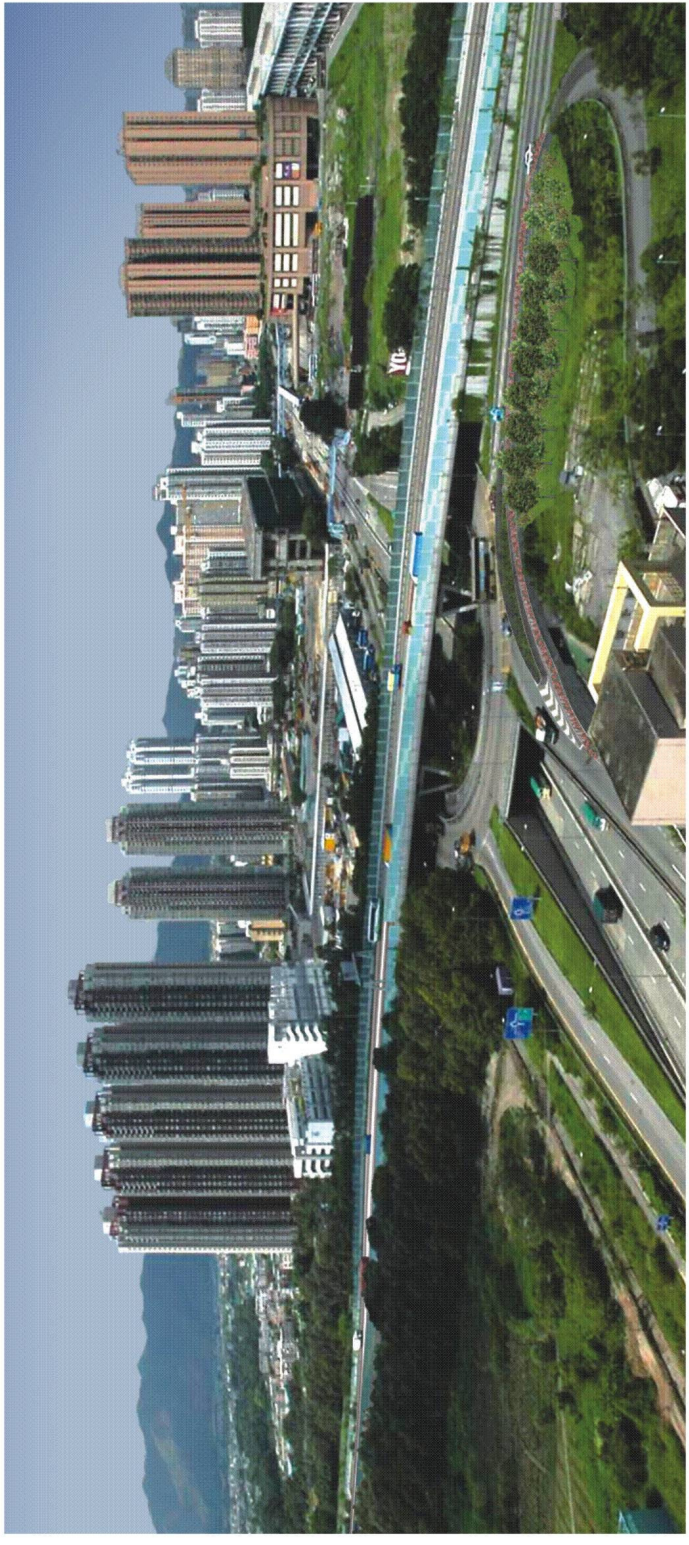
VIEW DISPLAYING THE 3D MODEL OF THE DEVELOPMENT SITE WITH LANDSCAPE AND VISUAL MITIGATION MEASURES AT DAY 1.

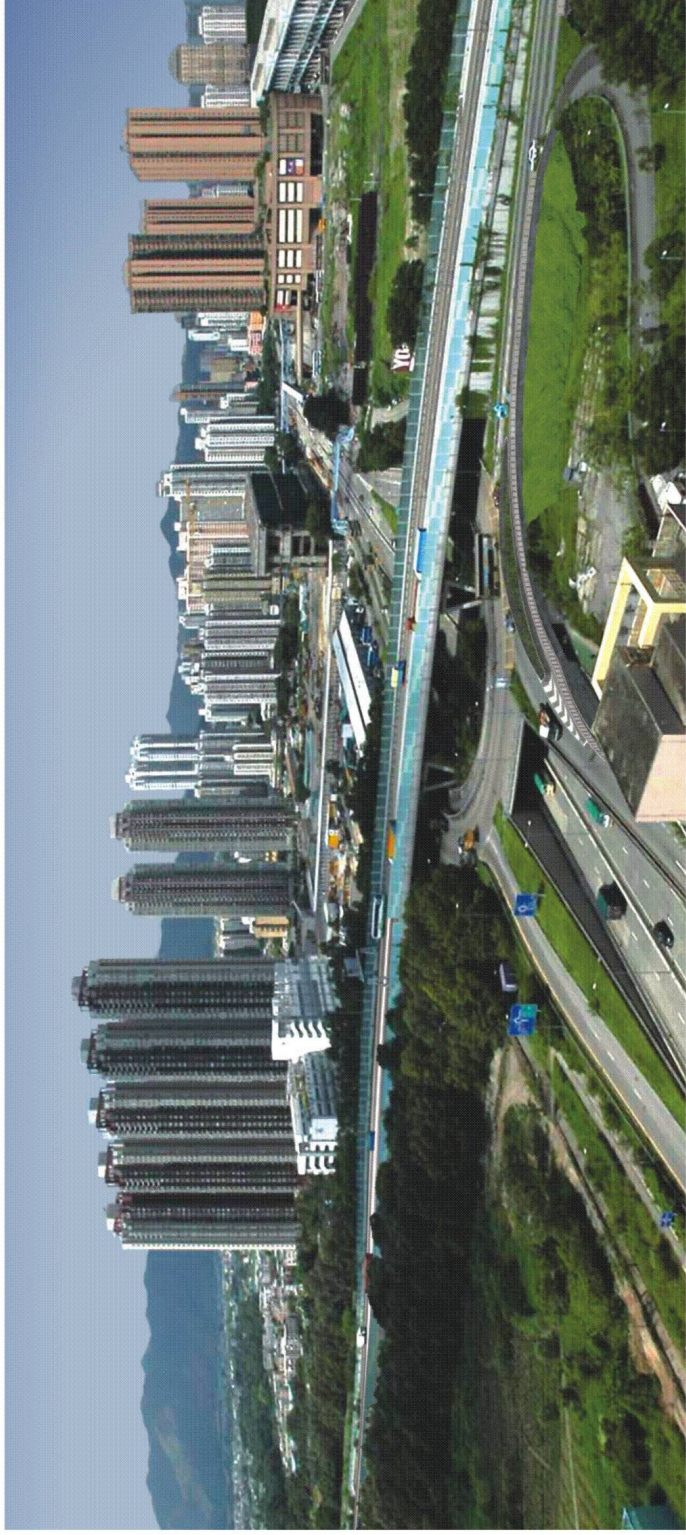
VIEW DISPLAYING THE 3D MODEL OF THE DEVELOPMENT SITE DAY 1 OF OPERATION WITHOUT LANDSCAPE AND VISUAL MITIGATION MEASURES

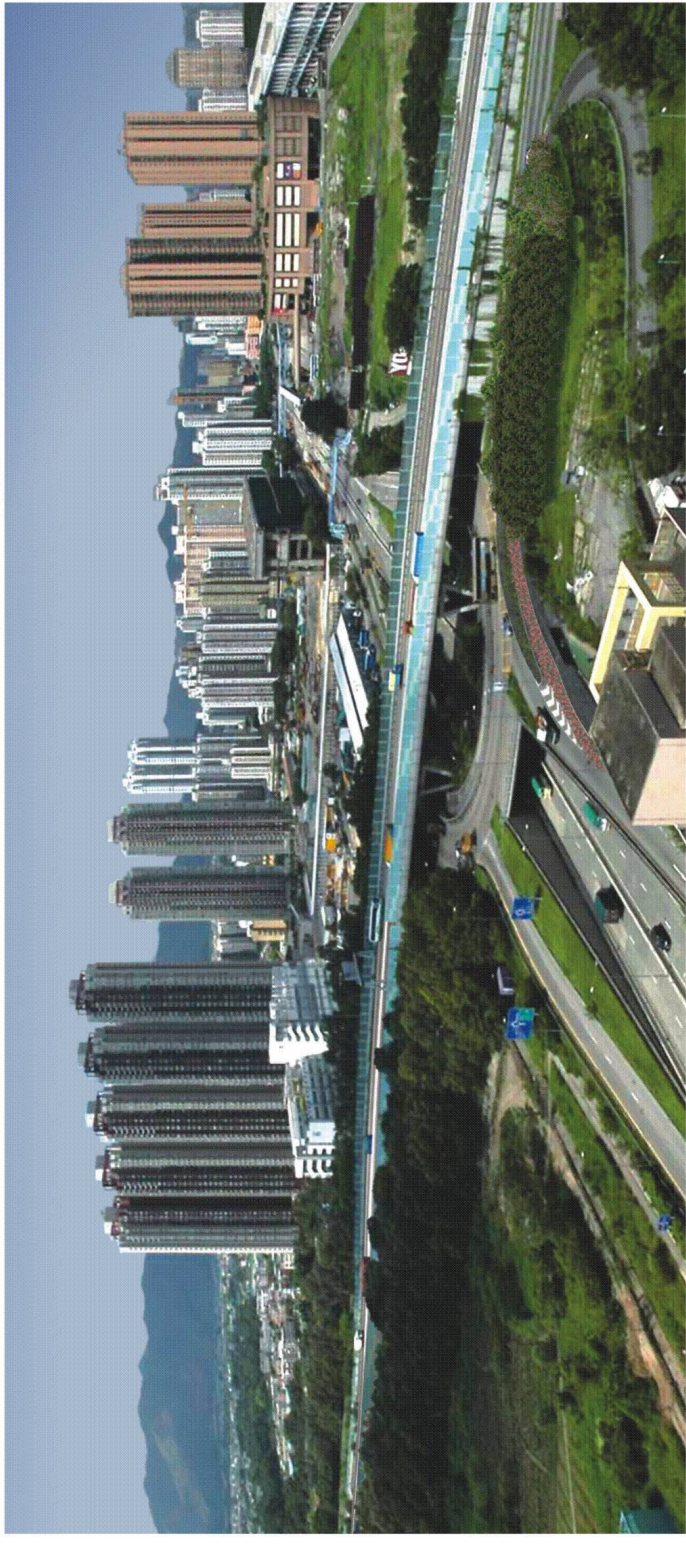
VIEW DISPLAYING THE 3D MODEL OF THE DEVELOPMENT SITE WITH LANDSCAPE AND VISUAL MITIGATION AT YEAR 10.
